# 1993 RIPARIAN MANAGEMENT ZONE SURVEY

**TFW Field Implementation Committee**

June 20, 1994

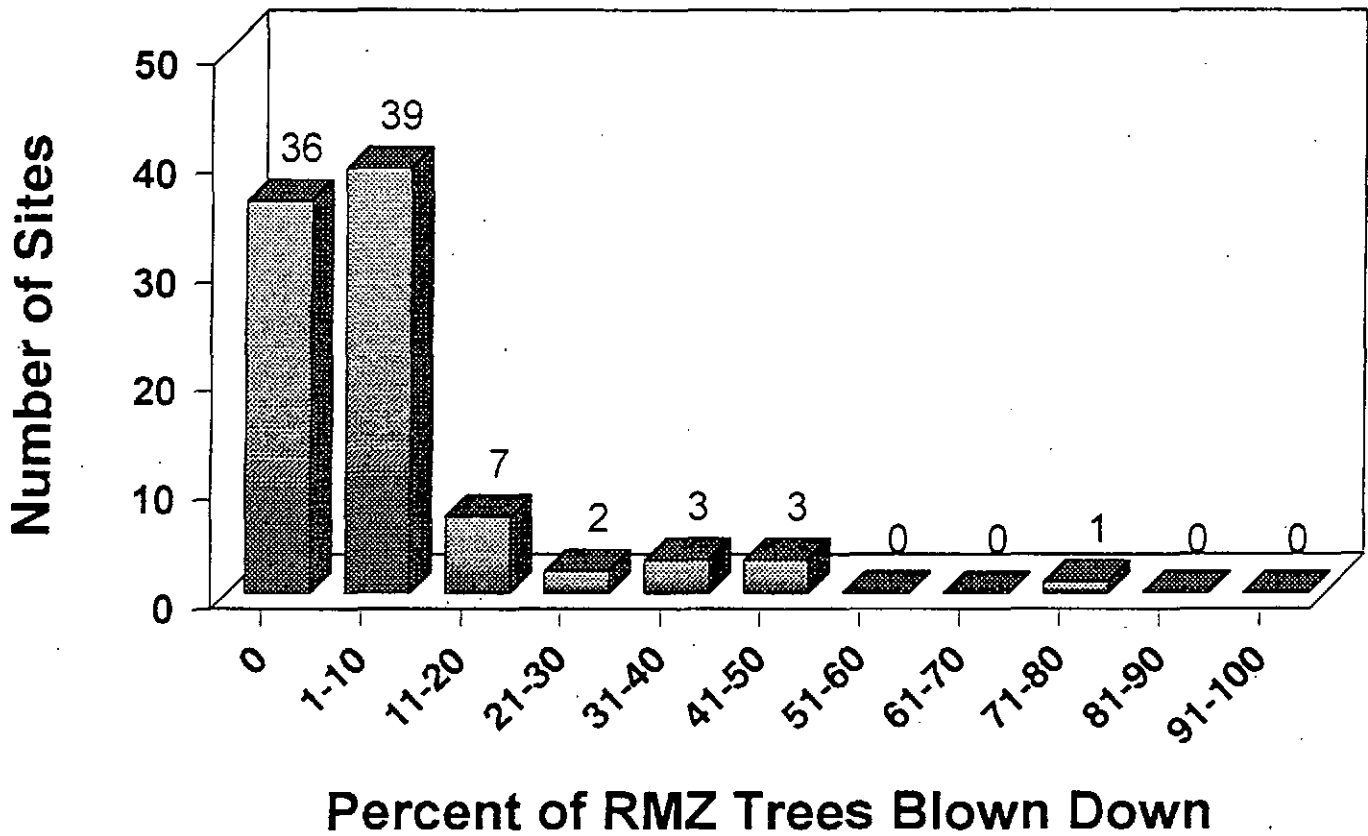
# RMZ Blowdown Survey Results

The results of the blowdown survey are shown in Figure 1. In summary, 82% of the RMZs surveyed had 10% or less of the leave trees blown down. Only one site had more than 50% blowdown. Three of the 94 samples were not used in this blowdown summary. Two samples were recently harvested and did not meet time requirements necessary to qualify for inclusion. One sample had no information.
