ENGINEERING GEOLOGIC FIELD RECONNAISSANCE

DEBRIS SLIDE AND DEBRIS AVALANCHE

VAN DEN HEUVEL PROPERTY

**3800 Nelson Road
Whatcom County, Washington**

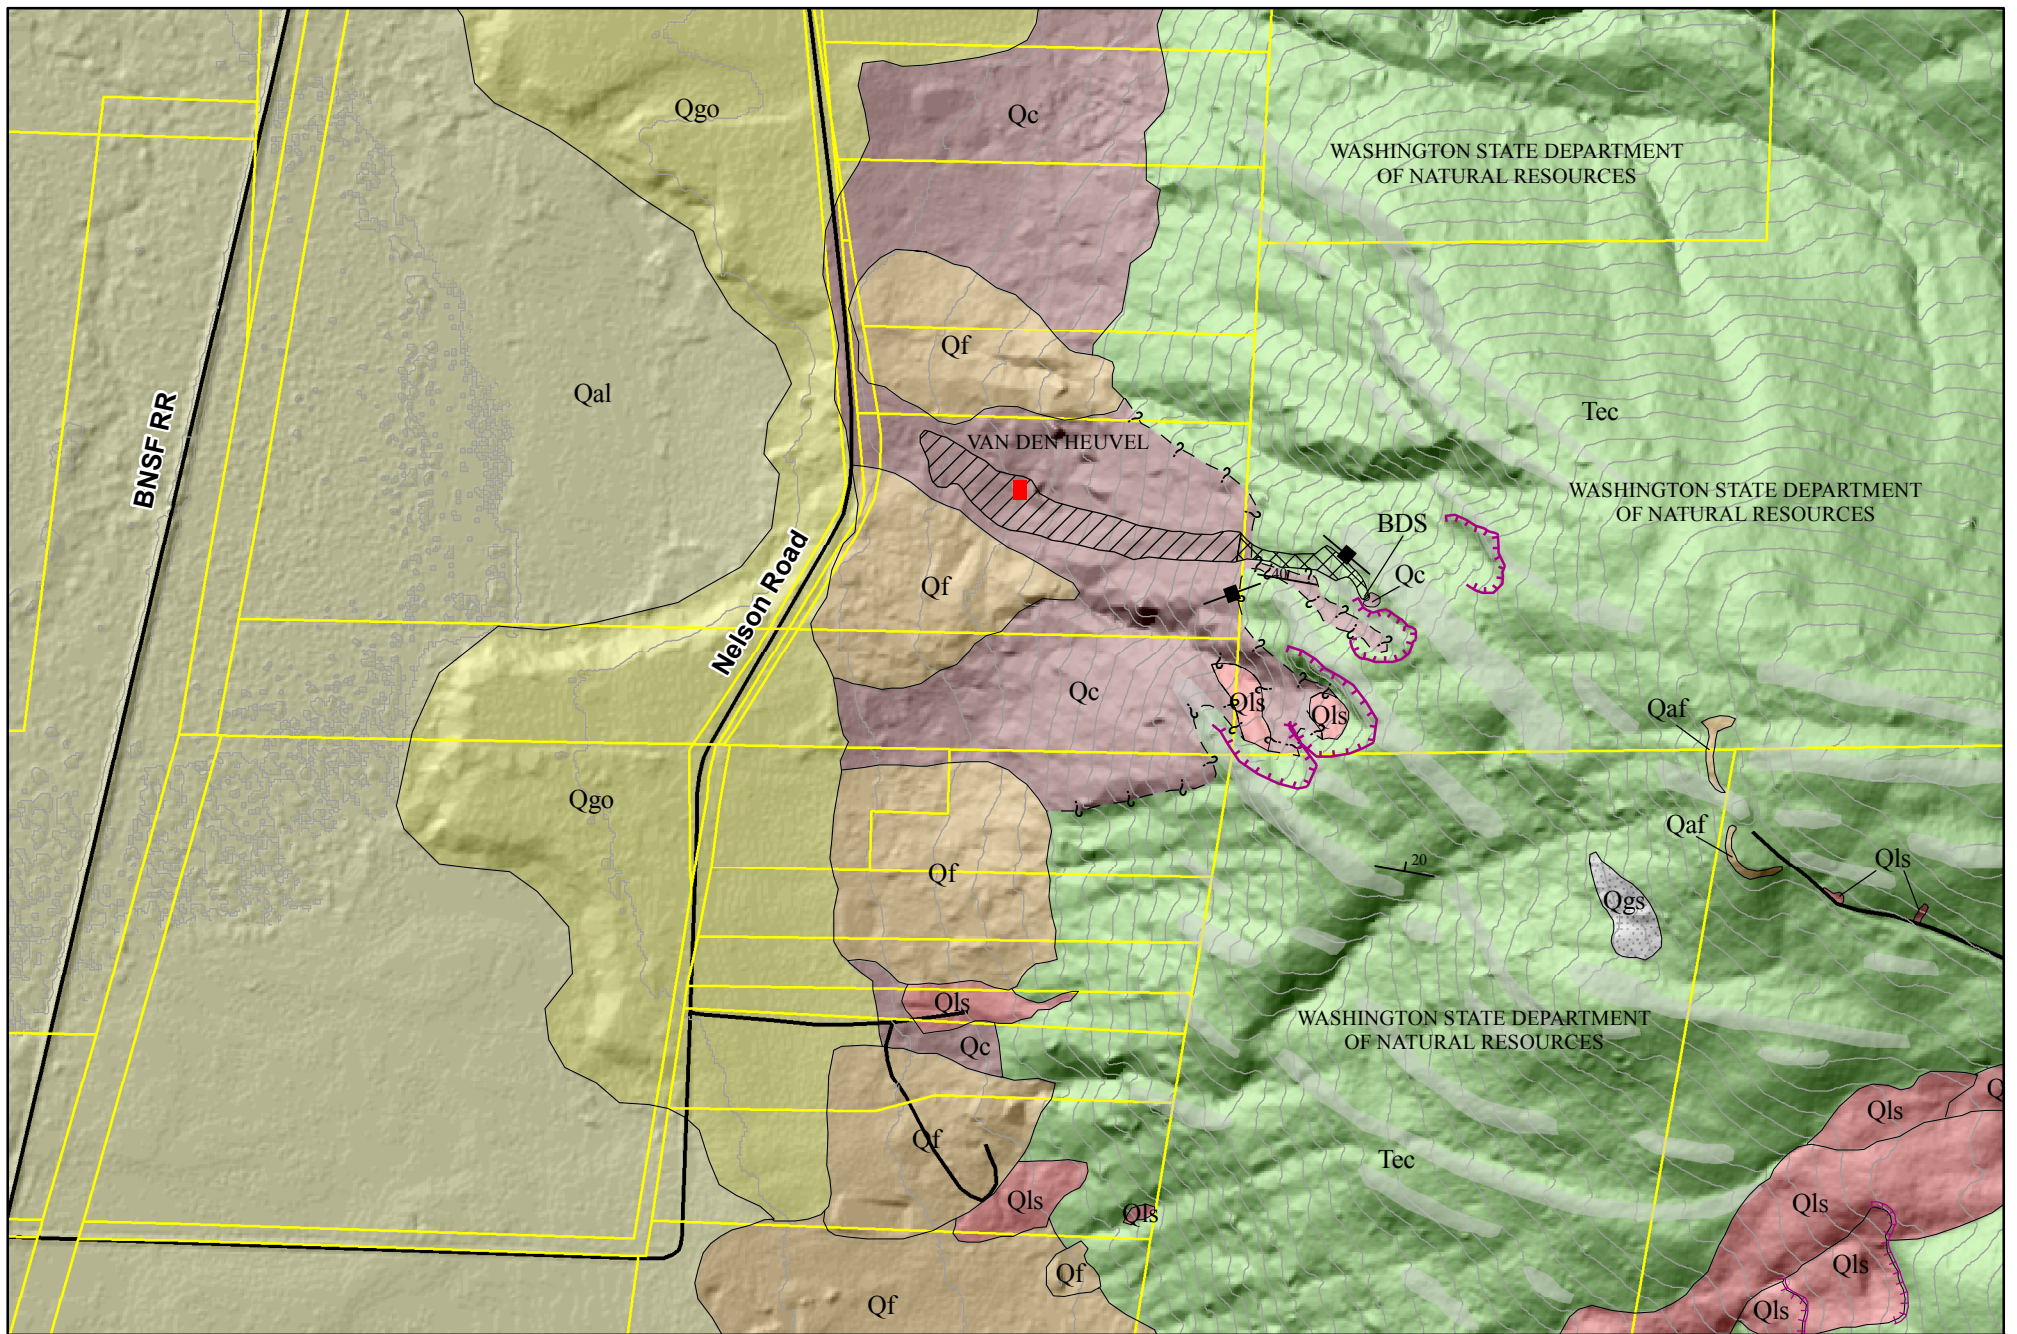
Figure 2. Geologic Site Map
 3800 Nelson Road
 See Figure 2A for explanation.

The debris slide involved a wedge of colluvium perched on a bedrock bench underlain by Chuckanut sandstone (Figure 2). The wedge was perhaps up to about 10-feet thick and may have been up to 100-feet or more long (Figure 2). In this report we refer to this debris slide as the Bench Debris Slide (BDS). The failure surface of the BDS is the bedding surface of a very thick bed of Chuckanut sandstone. The bench exhibits an inclination of about 40° (85%) to the northwest. We observed a small scarp about 1-foot high just behind the 16-foot wide scarp created by the current debris slide failure. About 30-feet up the bench from the current debris slide scar we observed a possible older subdued scarp about 10 feet high. The PI is on DNR-managed lands.

Slide debris moved down slope from the row of conifers, and into the area of the debris avalanche (Figure 6). The debris avalanche scar (Figure 2) is essentially linear and from the row of conifers down slope to the upper end of the debris deposit was about 400-feet long, from about 70- up to about 100-feet wide, and varying from 5-to 10-feet deep. In the upper area bedrock crops out sporadically. In the lower portions of the scar only colluvium is exposed. Shallow, eroded channels suggest flowing water in the scar following the failure.

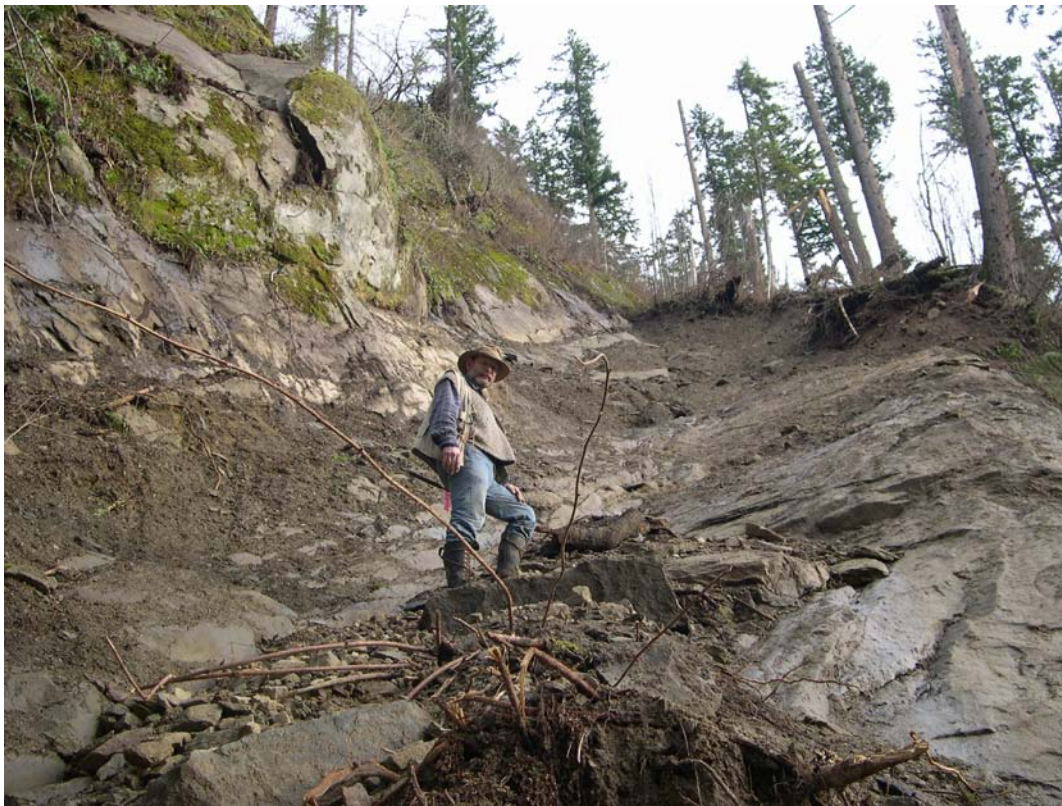
Figure 3. Bench debris slide (BDS) point of initiation. View looking southeast. (Photo by Casey Hanell, 2009)

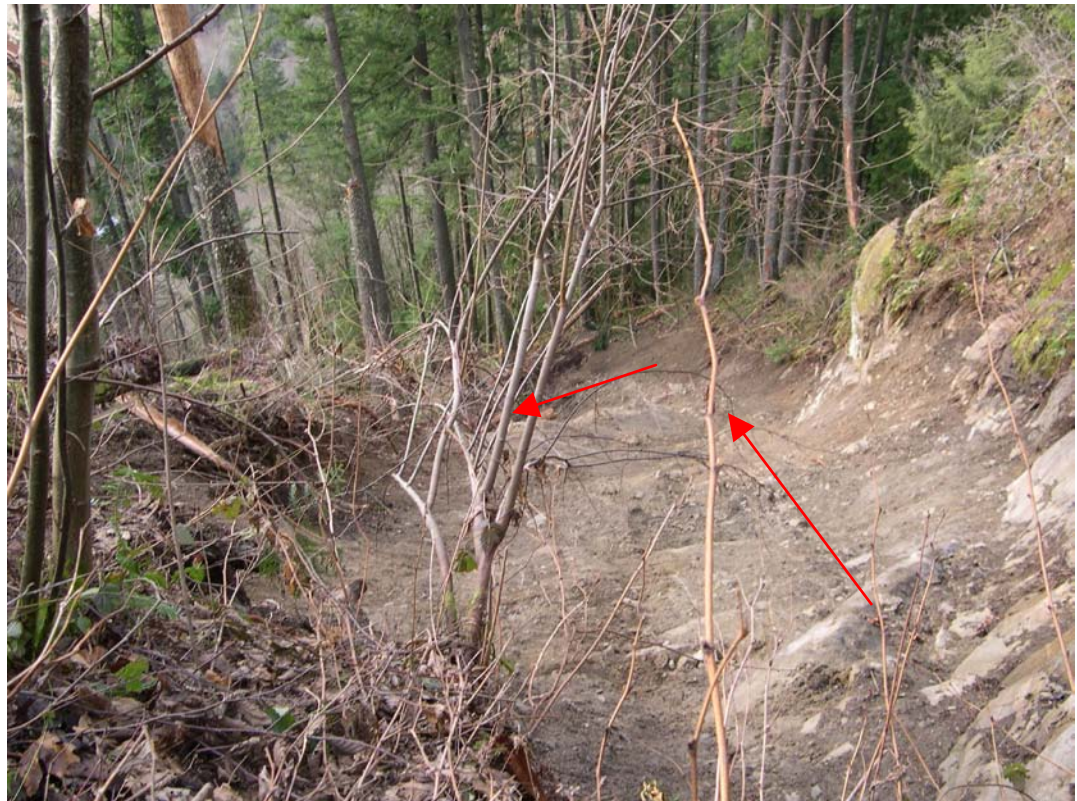
We observed evidence that the debris from the BDS, as it moved down slope, took two separate routes. One was northwesterly down the length of the bench where the debris encountered a subdued southwest-northeast ridge and was deflected to the west (Figure 4), into the northern portion of the row of conifers and then down slope toward the residence. The debris moved through and around both ends of the row of conifers. The other route was over the cliff face of the rock bench that borders the southwest edge of the PI and into the row of conifers, and then on down slope. Several trees that were

Figure 4. BDS scar from the crown of the scarp showing the direction of movement and direction change to due west. View facing northwest. (Photo by Casey Hanell, 2009)

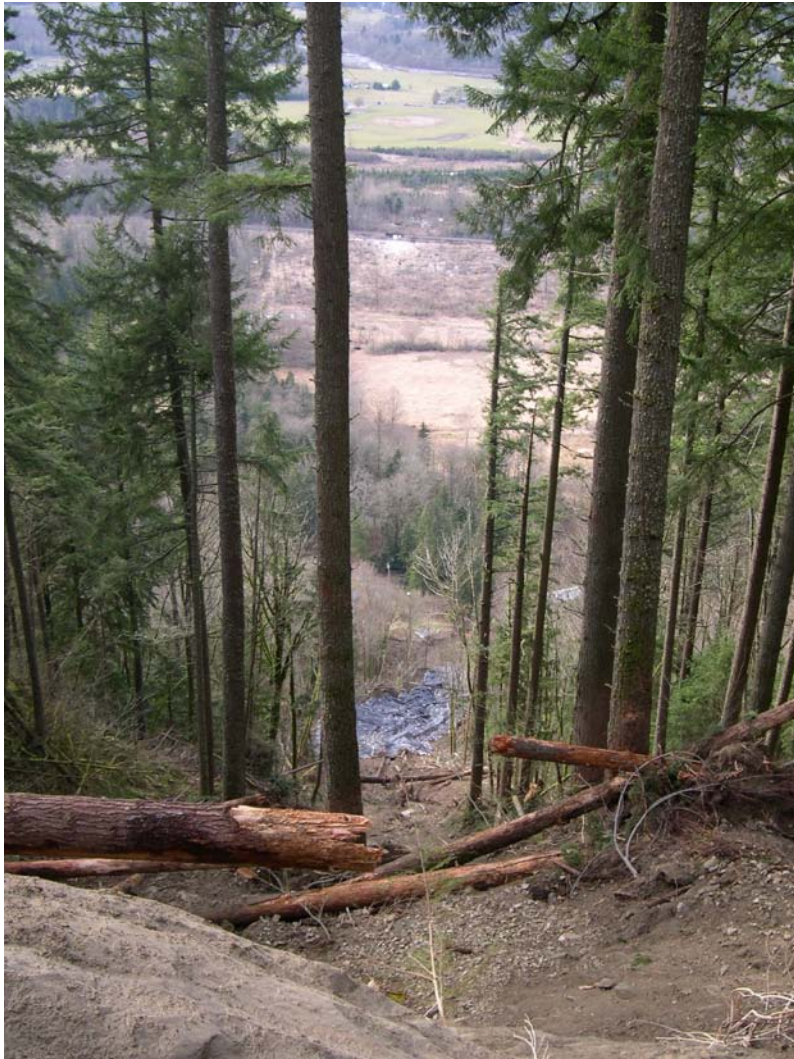
clearly from the bench and areas between the bench and the line of conifers, were observed piled up behind the row of conifers, in some cases as though they were “strained” out of the debris-flow material as the debris passed through the line of trees (Figure 5).

Figure 5. BDS from the point where it turns due west. View facing west.
(Photo by Casey Hanell, 2009)

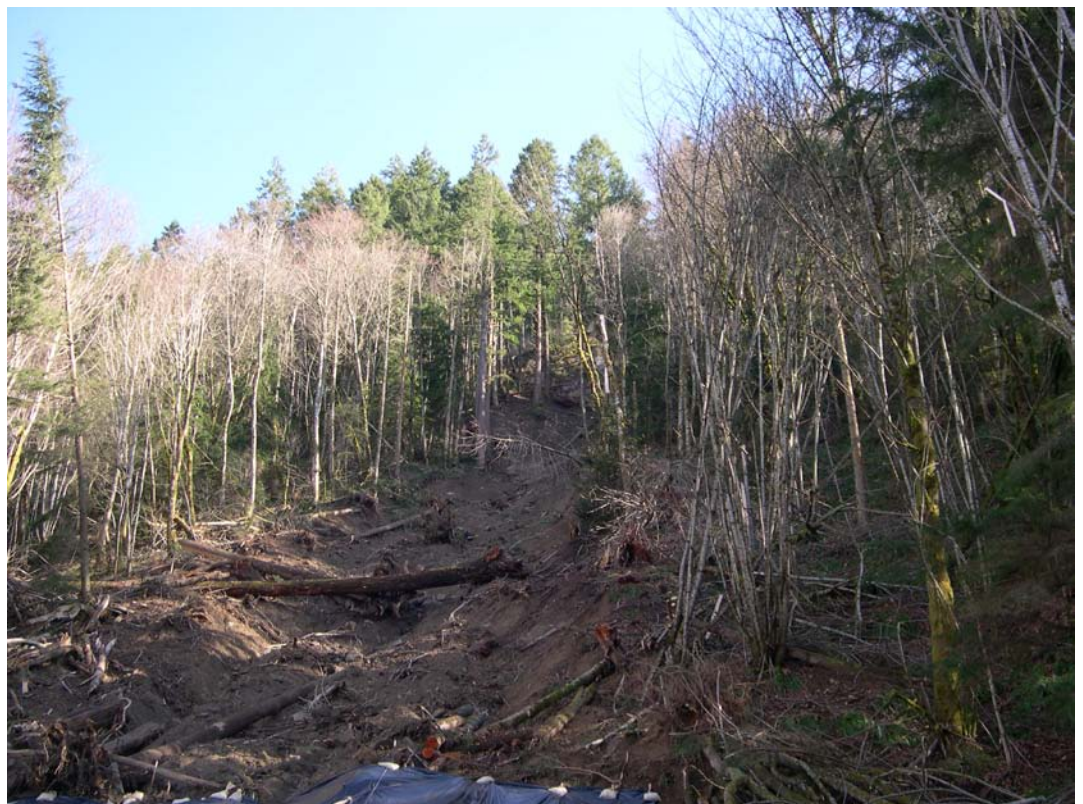
Figure 6. BDS path and upper portion of debris avalanche scar viewed from the bottom of the hill. View facing east.
(Photo by John Coyle, 2009)

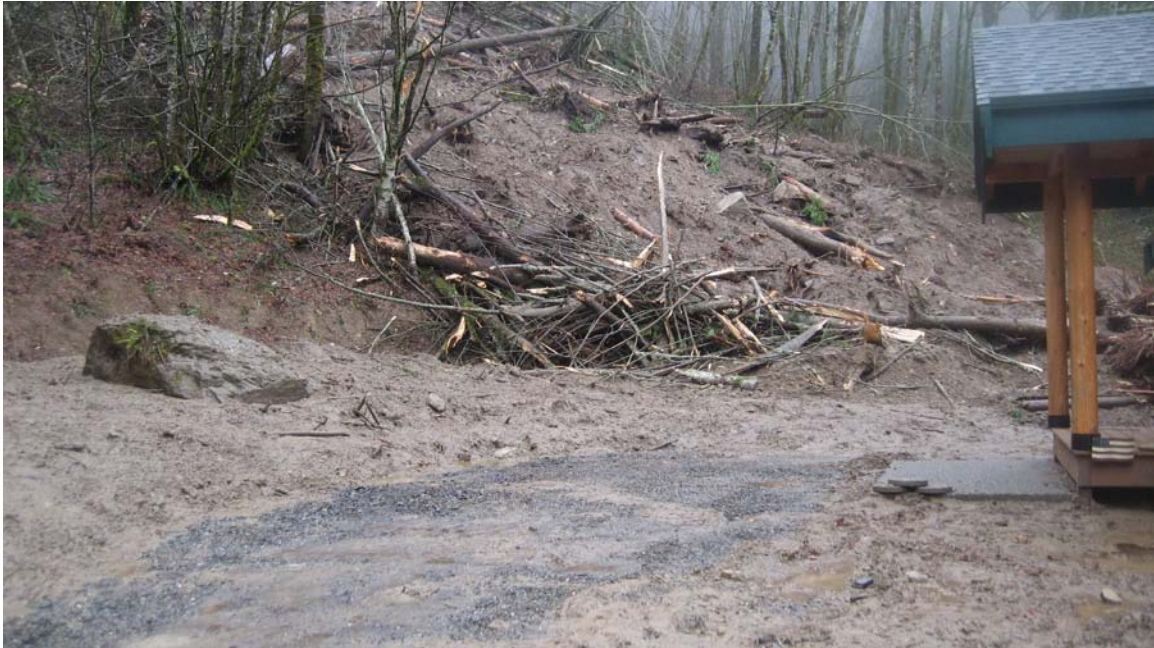
A large pile of slide debris accumulated at the bottom of the slope (Figure 7). As noted above, at the time of our reconnaissance the debris pile was largely covered by plastic sheeting; however we did observe the pile during an earlier site visit before it was covered. This pile was composed of earth and rock debris, and conifers from upper slope areas and maple and alder trees from lower slope areas. As already mentioned the debris pile came to rest just south and southwest of the residence (Figure 8). It was deflected slightly toward the residence by a low ridge that varies from about 150- to about 250-feet southeast of the residence. A portion of the railing of the porch on the south side of the residence was damaged by the slide debris along with steps leading up to the porch (Figure 8). We understand that the propane tank was ripped from the piping that serves the residence. Some slide debris and mud up to several-inches thick flooded the driveway area in front (that portion facing the hillside) of the house and down the driveway some distance (Figures 7 and 9). Mud also was deposited in alcove-like areas along the south side of the residence. The more fluid components of the debris continued to spread across the property down slope of the debris deposit (Figure 10) and toward Nelson Road. The DNR Northwest Region 2009 Storm Tracking Site reports mud reaching Nelson Road and possibly mud in the residence. We could not confirm either of these conditions.

Figure 7. Debris avalanche deposit overlying more fluid debris deposited by the BDS. Gray gravelly area exposed by later tractor work. View looking south. (Photo by Doug Hooks, 2009)

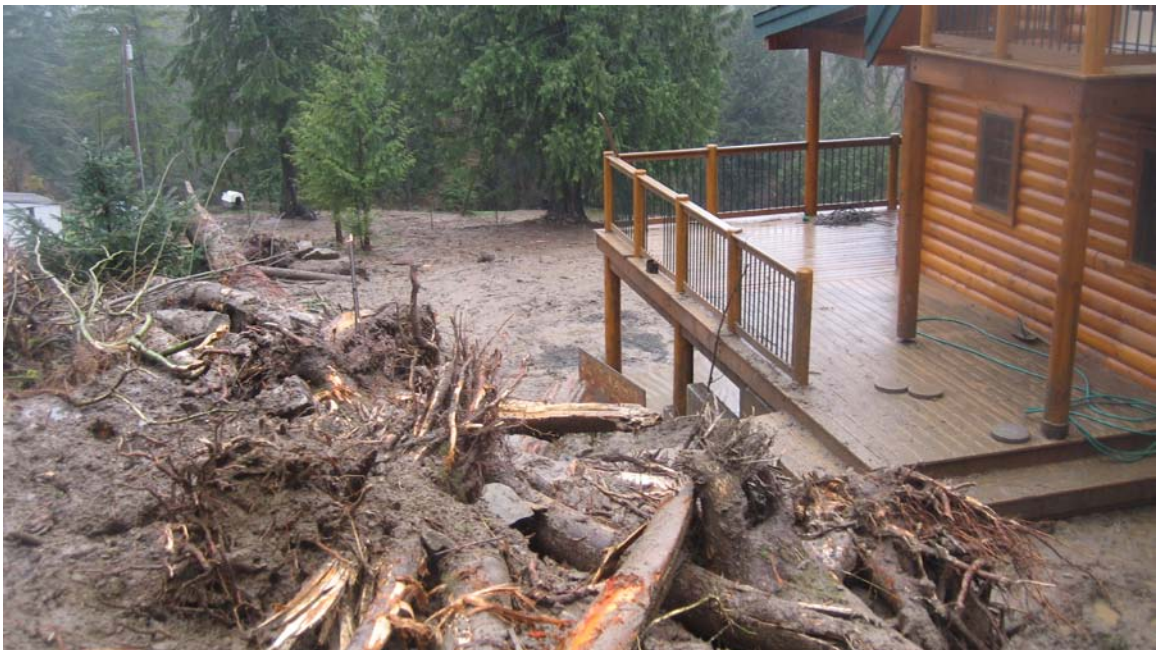
Figure 8. Debris piled near the southeast corner of the home. Note broken ballusters in deck railing. View looking west. (Photo by Doug Hooks, 2009)

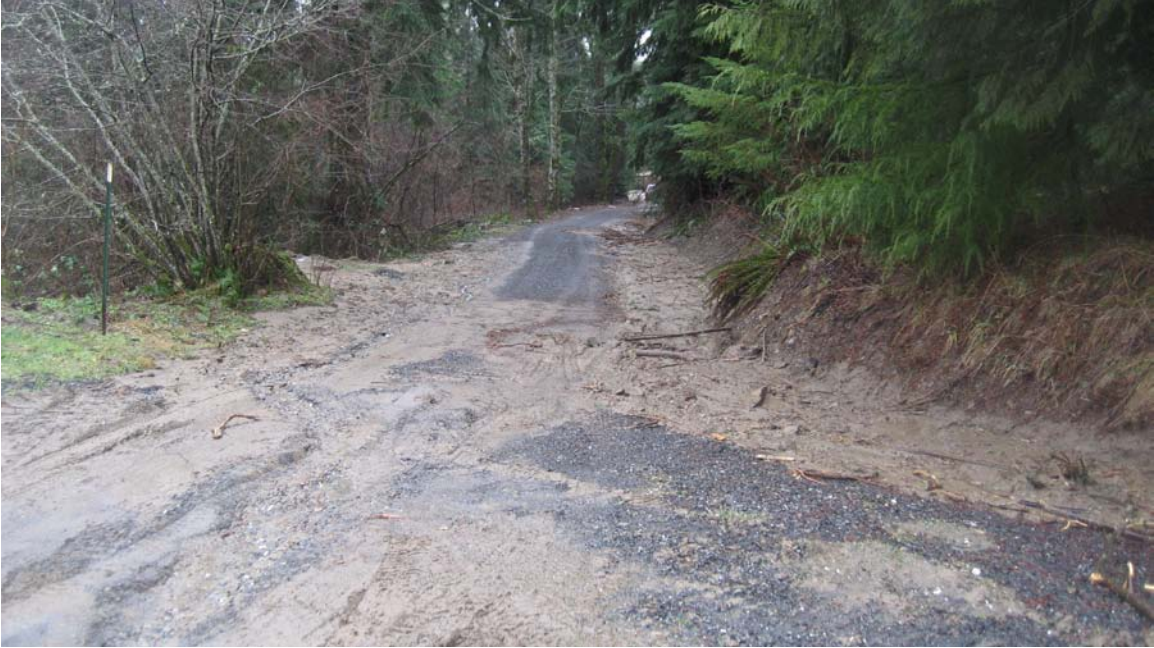
Figure 9. Lower portion of BDS deposition area illustrating fluid debris from BDS on driveway leading down to Nelson Road . View looking northwest. (Photo by Doug Hooks, 2009)

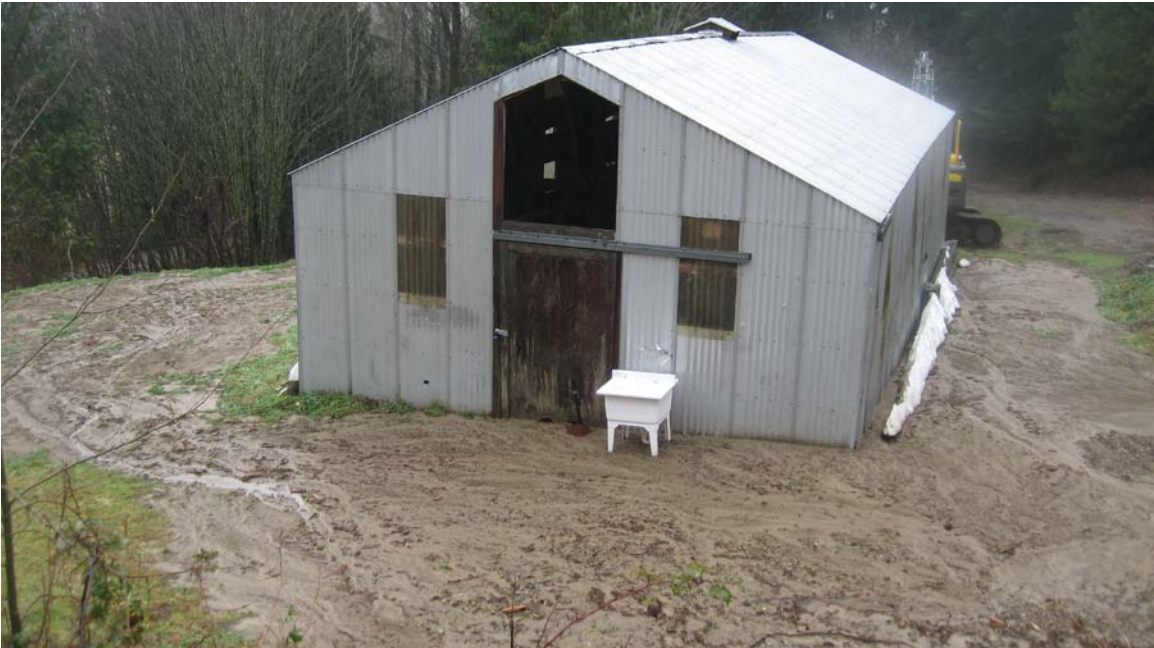
Figure 10. Lower BDS deposition area illustrating flow of debris around out building below the house. View looking northwest. (Photo by Doug Hooks, 2009)
