**Appendix 1: Cypress Island Net Pen Failure Engineering Review
(December 29, 2017)**

Cypress Island Net Pen Failure Engineering Review

December 29, 2017

Under contract with the State of Washington Department of Fish and Wildlife (DFW), Mott MacDonald reviewed information gathered following the collapse of Net Pen #2 on August 19, 2017. Net Pen #2 is owned by Cooke Aquaculture Pacific, LLC (Cooke) and is located near Cypress Island, Washington. The purpose of the work was to determine the physical cause(s) that led to the failure of the net pen structure.

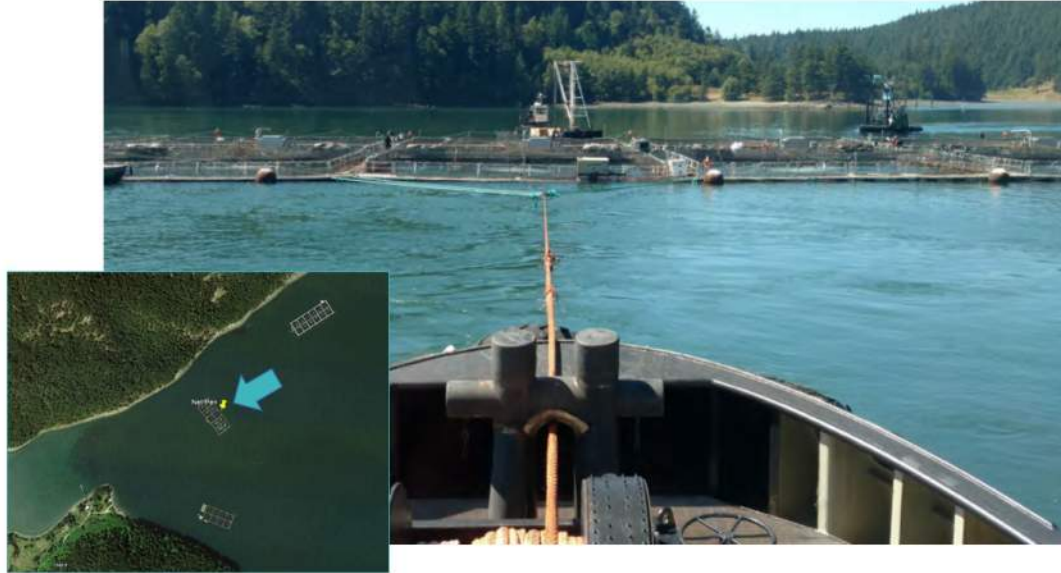
Tug operations to stabilize and reset the net pen facility following the July incident possibly exerted very high concentrated forces on the net pen structure. There is no documented procedure for the tug operations to ensure that no damage was done to the net pen structure.

Figure 4.3 – Net Pen #2 being stabilized by Millennium Star (July 2017) (Note reduced freeboard at the floats where the two lines are applying concentrated pulling force.) (Source: Harley Marine and Google Earth)

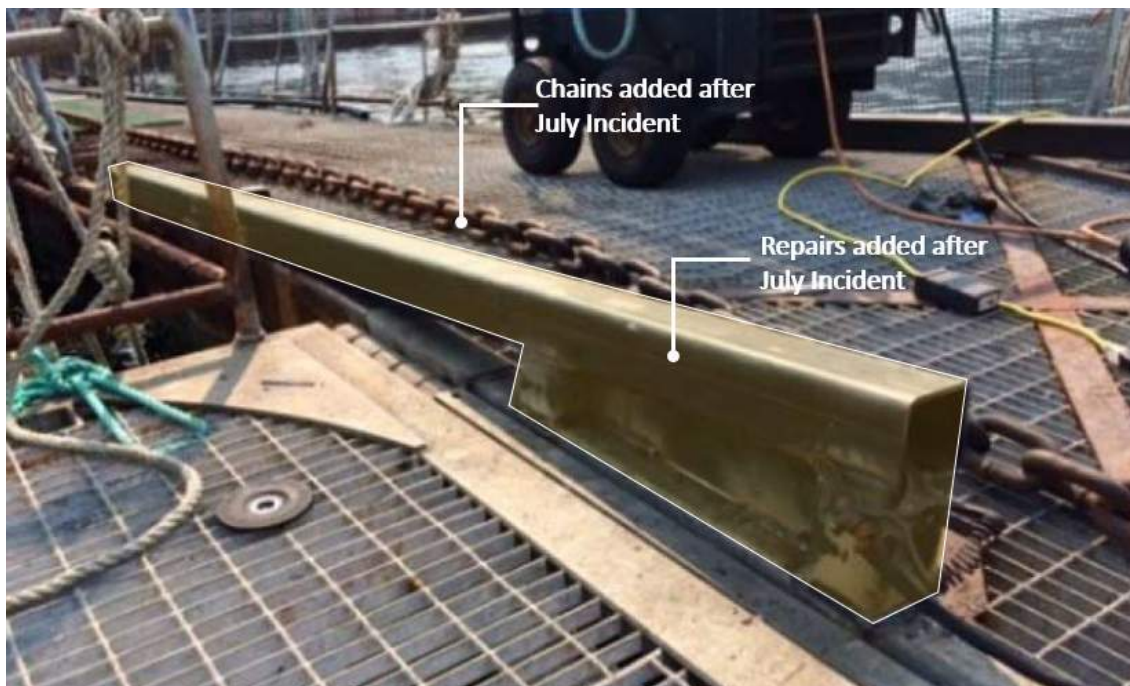
Based on available pictures of the repairs and the responses from Cooke (including the statements by Kyle Wood during the site visit on December 19, 2017), chains were laid across the top of the walkway decks to form an “exoskeleton” and secure the floats and connect the mooring lines. No engineering documents or calculations showing the design of the exoskeleton system were received or reviewed at the time of writing this report. Steel members were also added to the outrigger float sections to strengthen the permanently deformed floats, as shown in Figure 4.6.

Figure 4.6 – Example of repairs to Net Pen #2 following the incident on July 24, 2017. (Source: Mott MacDonald)

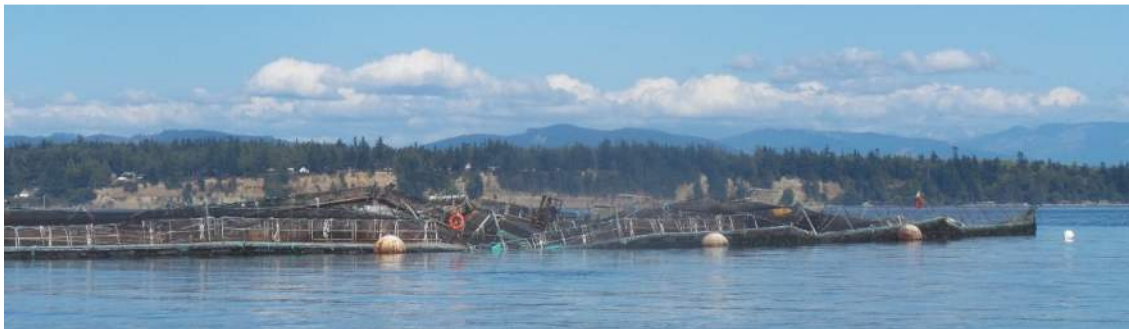
The eyewitness account from Jill Davenport states that a chain attached to the southeast corner buoys was dragging on the deck followed by the buoy jumping over the deck. Subsequently, the underside of the walkways of the pen on the southeast corner was visible, indicating that the walkway was listing severely. Cooke staff arrived at the net pen around 4:00 p.m. and tried to contain equipment on the net pen. They also towed two floats with equipment and a storage building. A tug arrived on site at around 5:00 p.m. followed by another tug a short while later.

Figure 4.7 – Witness photo (August 19, 2017) (Source: Jill Davenport)

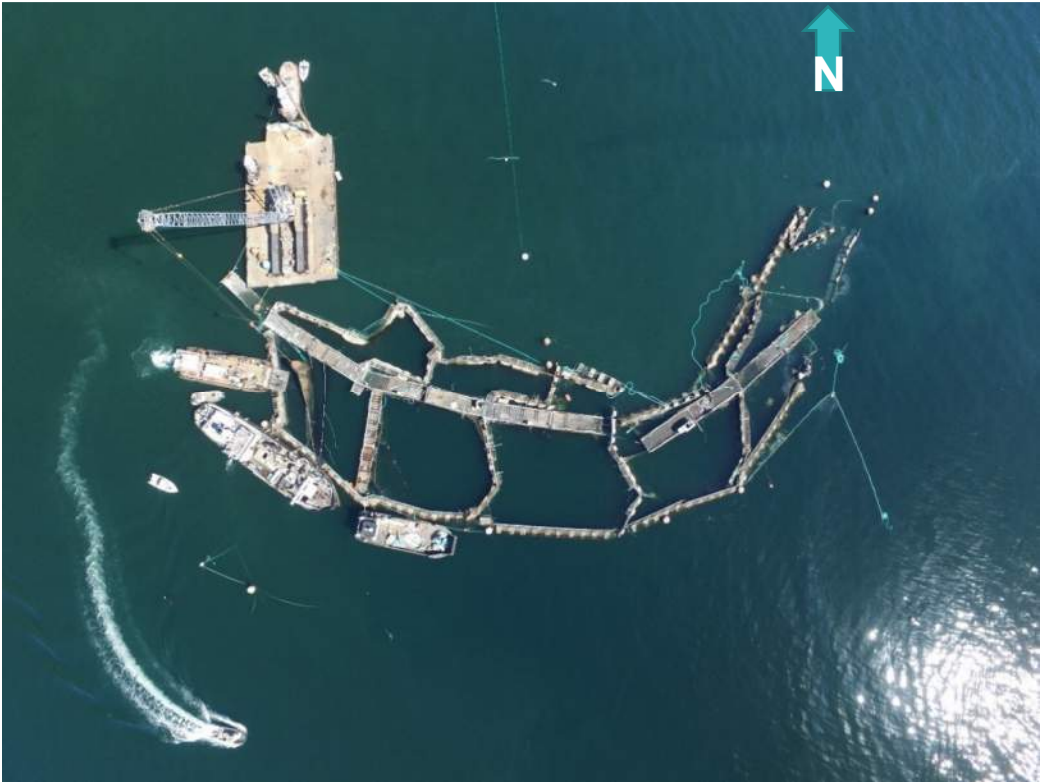
According to Cooke, a mooring failure occurred at the site. They believe this failure coincided with the afternoon flood tide. Two anchors on the north failed, three had dragged, and one anchor on the shore side had a broken mooring bracket, broken safety chain, and a broken cleat. Cooke was trying to stabilize the net pen with tugs and staff were monitoring the situation overnight. On the morning of August 20 at approximately 6:40 a.m., another corner anchor had failed. Efforts to stabilize the net pen were hampered by tides during the day. Due to continuous movement of the structure, the walkways had become unsafe to work on. Furthermore, the conditions were too dangerous for even divers to safely enter the water and move fish from the damaged cages to adjacent cages. By this time, the fish had escaped the stock nets from two cages but were contained in the predator nets. Cooke states that the eight other cages were secure. Through August 21 and August 22, Cooke states that they attempted to secure the site, but were inhibited by strong tidal currents (currents on these dates are investigated in Section 5). The net pen continued to move and displace during this time and fish had started escaping the cages. The integrity of the pen had been severely compromised; diving operations and assessments were suspended as they were deemed to be unsafe. On August 23, the site was declared a total loss. Following this, the efforts were focused on securing the site, preventing further loss of fish, recovering the remaining fish, and salvaging the components of the collapsed pen structure (Figure 4.8).

Figure 4.8 – Aerial view of Net Pen #2 on August 28, 2017 (Source: DNR)

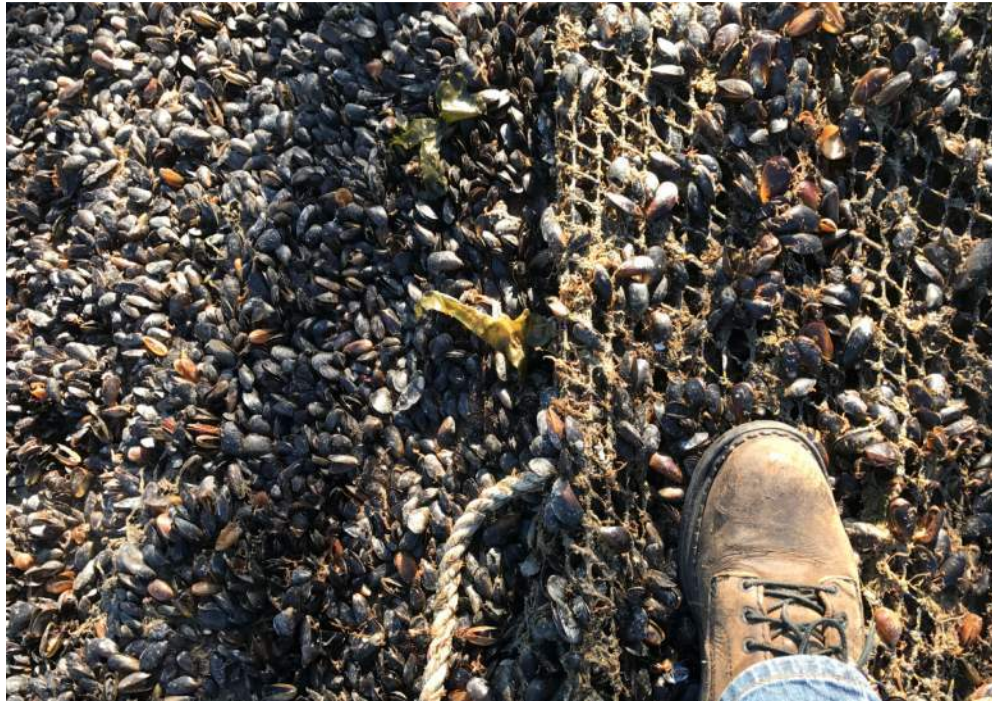
Figure 5.5 – Example of marine fouling found on stock nets removed from Net Pen #2 (Sept 1, 2017) (Source: DNR)

Biofouling can be a serious problem in marine aquaculture, and it has a number of potential negative impacts including increased forces on aquaculture structures and reduced water exchange across nets. (Gansel *et al.*, 2014). Several studies have been conducted that report increased hydrodynamic loads due to currents with increased fouling. Increased horizontal loading on net pen support structures due to marine fouling has been reported to increase between 43% (Gansel *et al.*, 2014) and 500% (Swain and Shinjo, 2015).

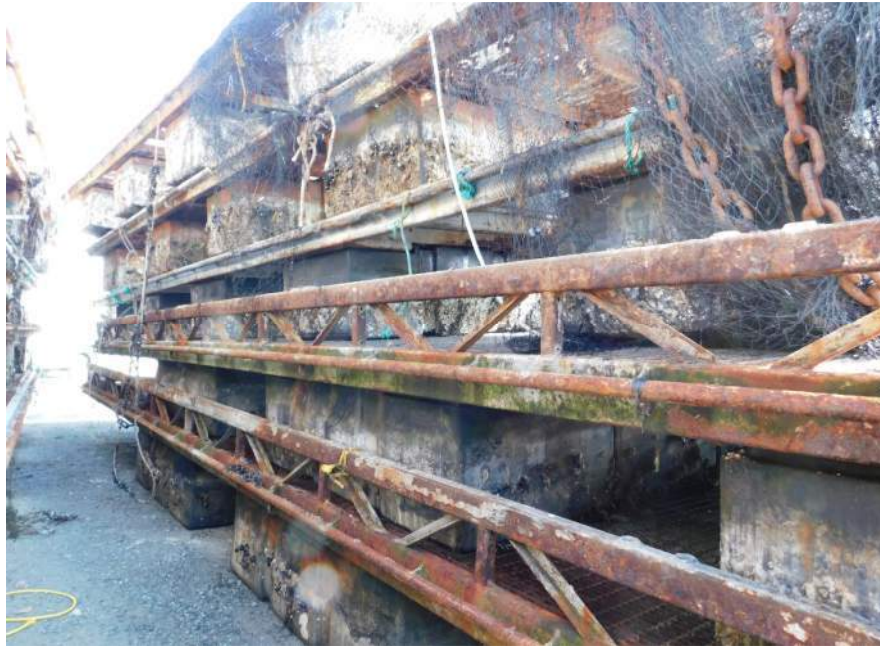
Based on site visits conducted to observe salvaged components from the net pen structure, several components showed severe corrosion. It is evident that the net pen structure was not adequately protected or maintained against corrosion.

Figure 7.3 – Floats showing corroded framing (Source: Mott MacDonald)

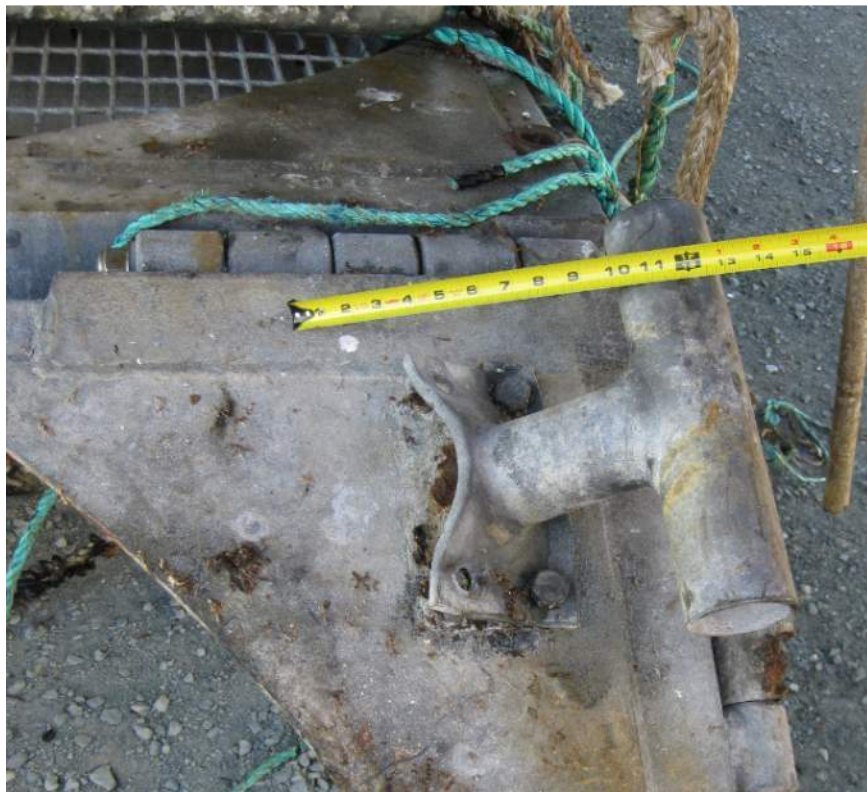
Figure 7.4 – Bent mooring cleat on an Outrigger Float (Source: Mott MacDonald)

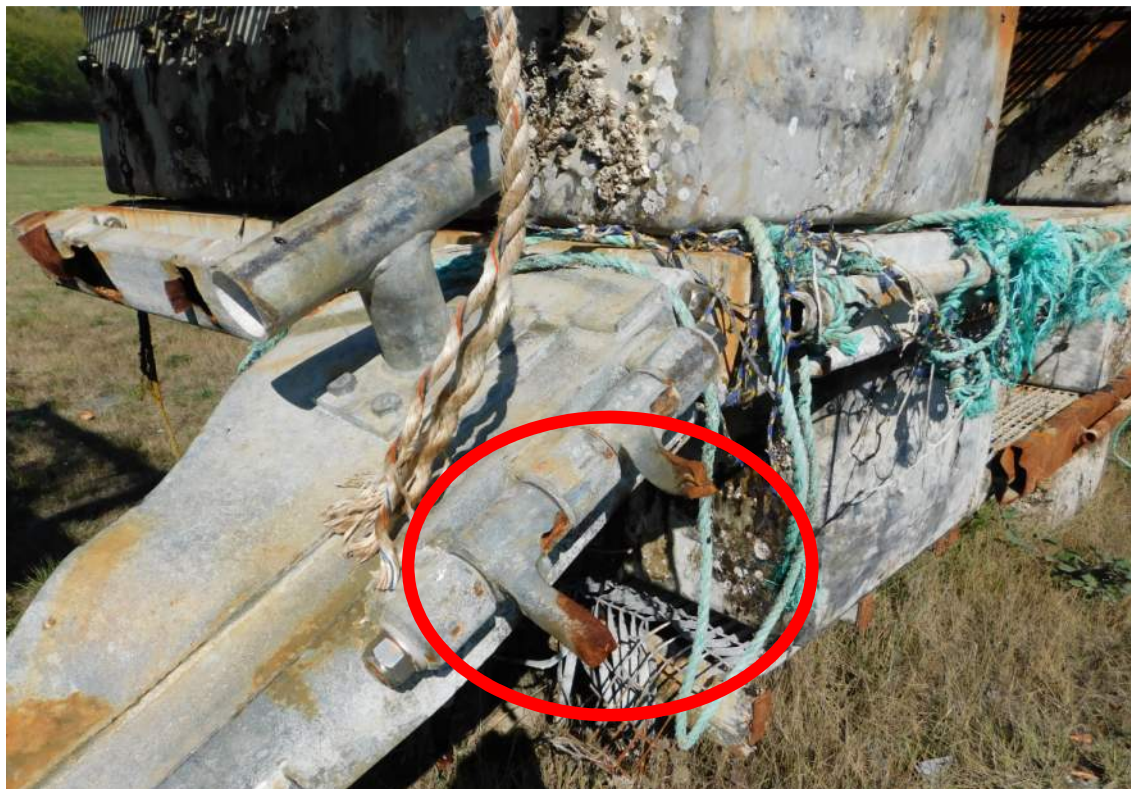
Figure 7.5 – Broken pad eyes on an Outrigger Float (Source: Mott MacDonald)

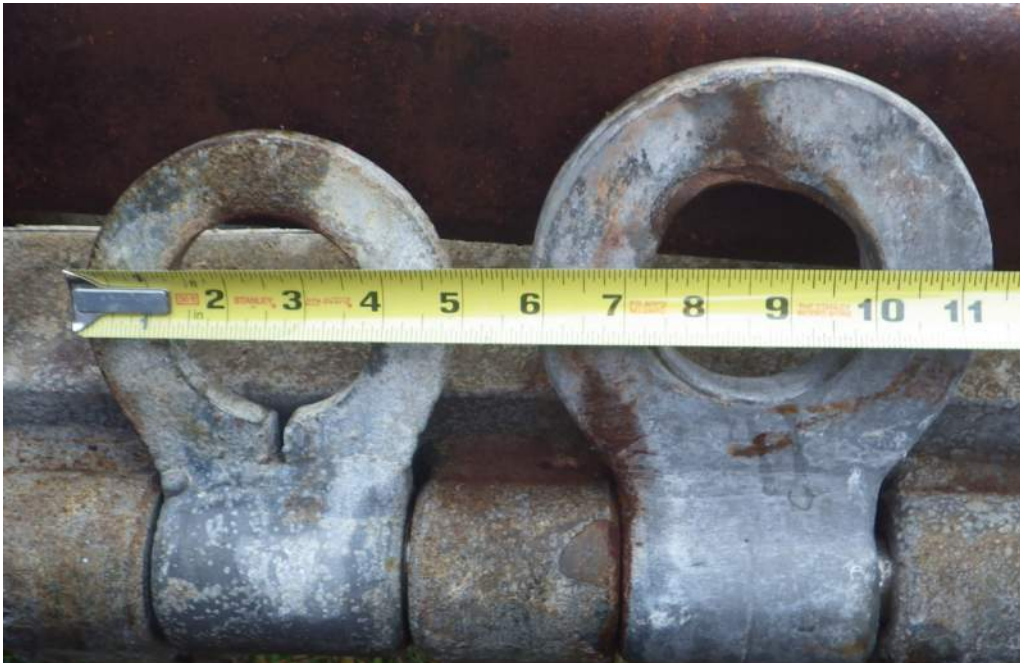
Figure 7.7 – Pad eyes of varying sizes on same mooring bracket (Source: Mott MacDonald)

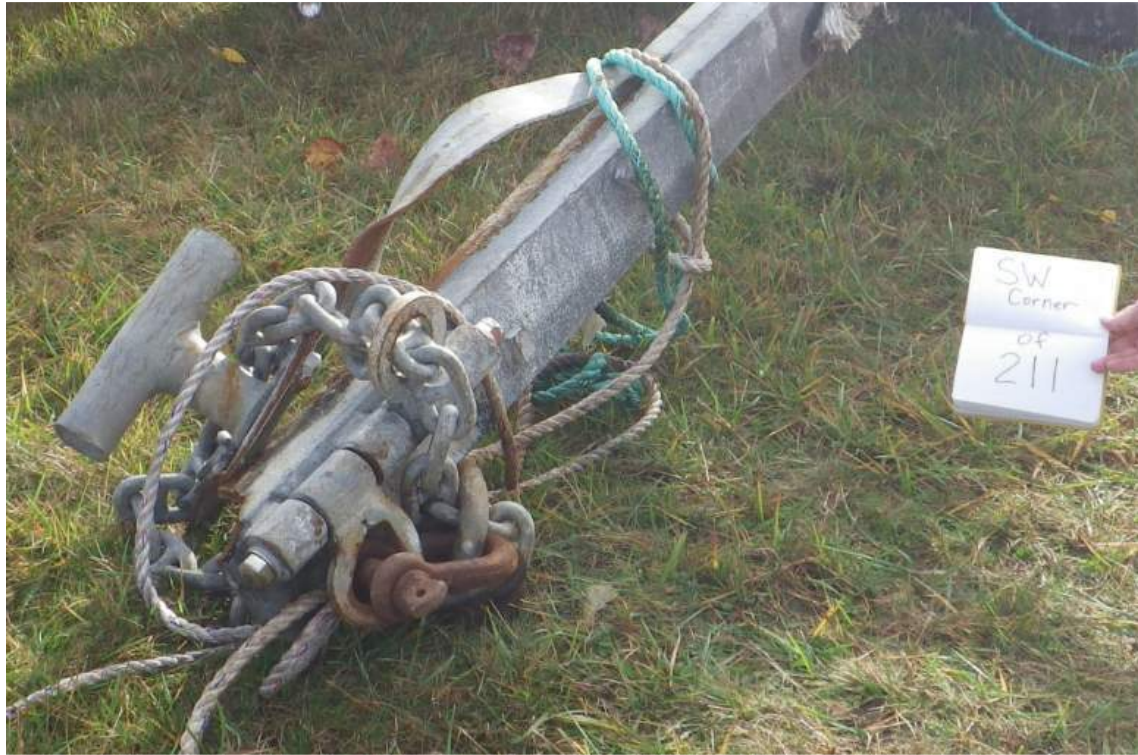
Figure 7.8 – Failed Outrigger Float section (Source: Mott MacDonald)

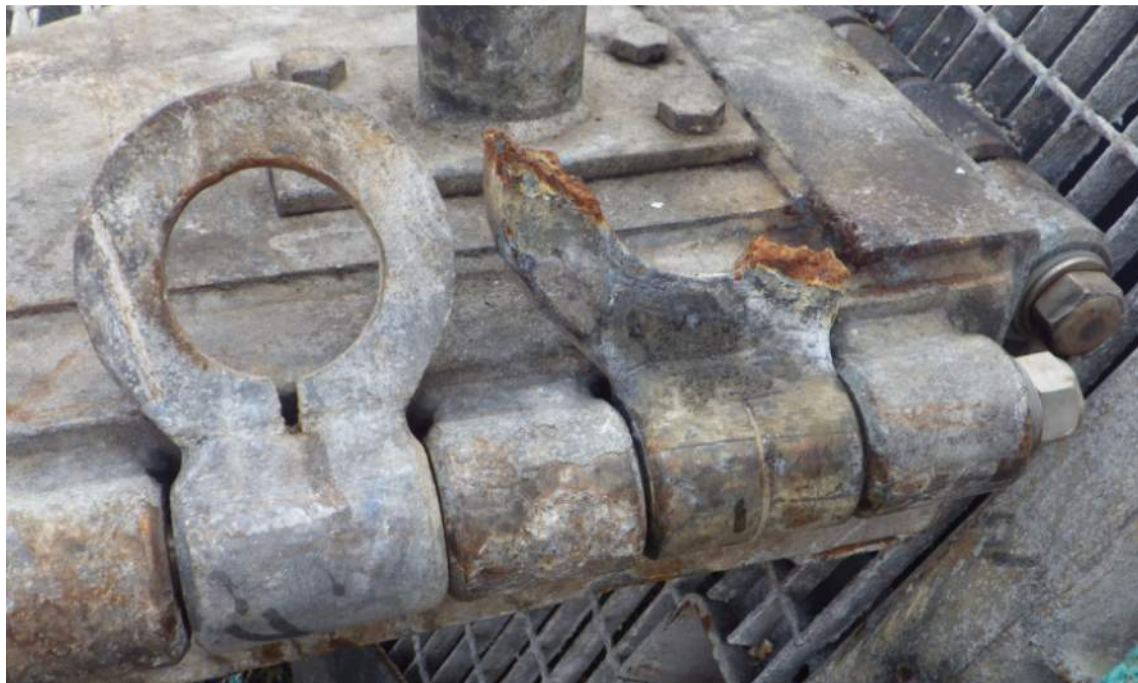
Figure 7.9 – Failed Pad Eye (Source: Mott MacDonald)

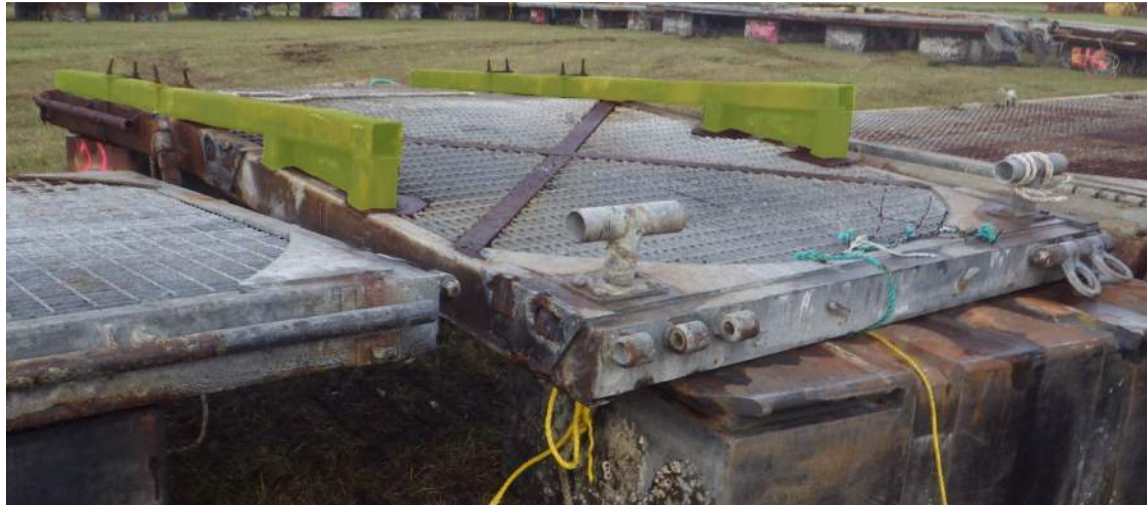
Figure 7.10 – Repairs to floats following July 2017 incident (shown in yellow) Cross-bracing on the surface of the floats was installed earlier in the life of the net pen structure. (Source: Mott MacDonald)

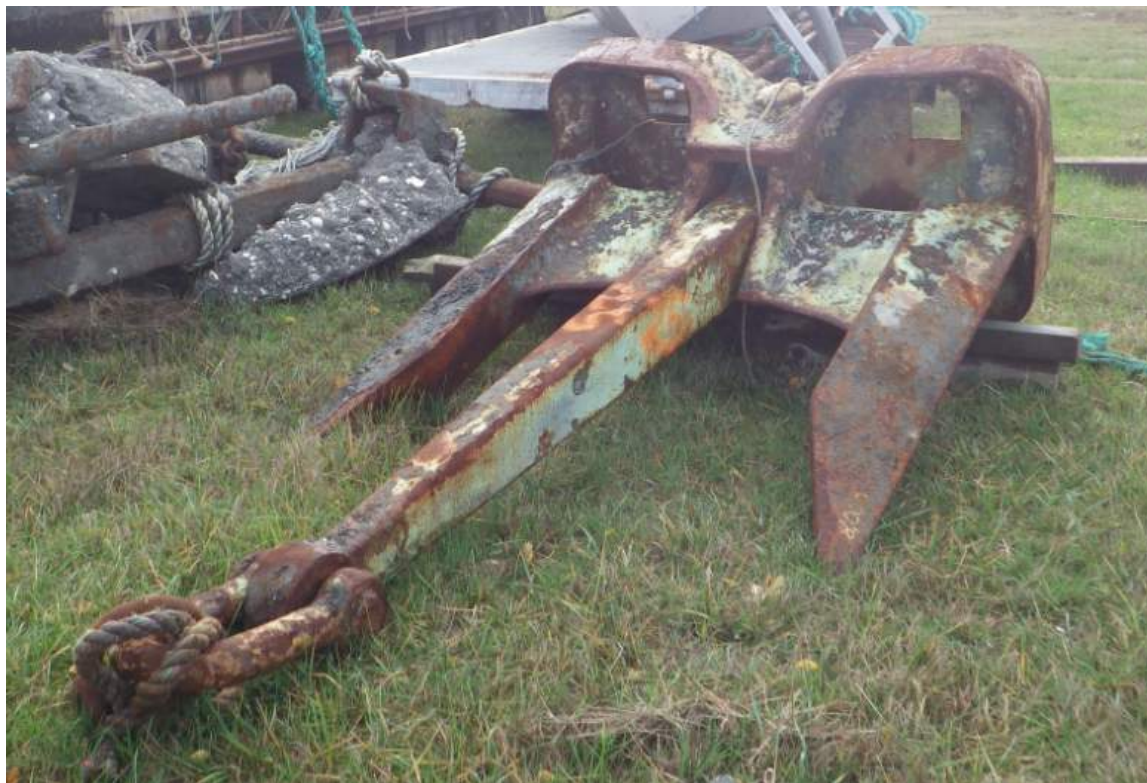
6. Eells Anchors were salvaged, though not reported by Cooke on the mooring plan (Figure 7.11).

Figure 7.11 – Eells anchor (Source: Mott MacDonald)

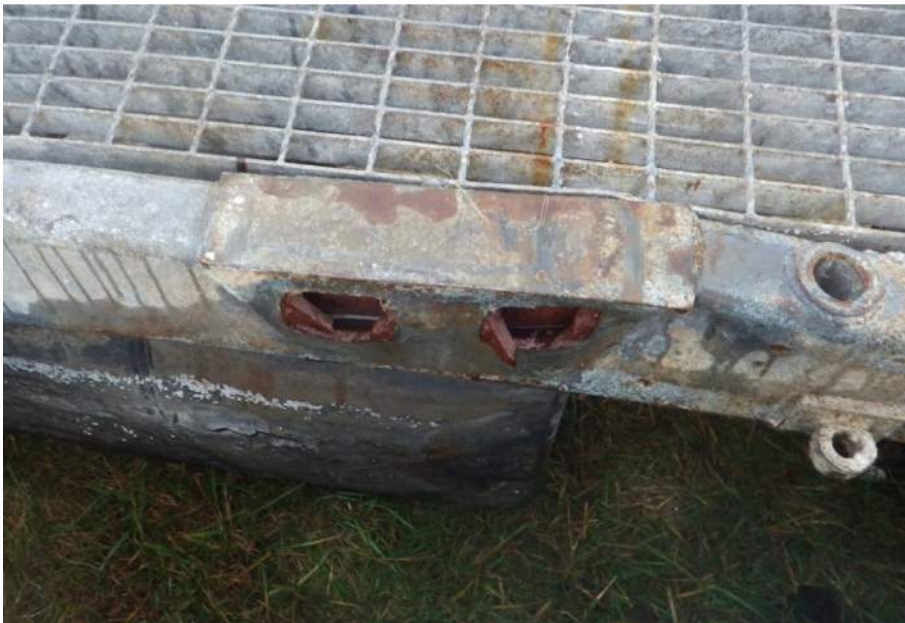
Figure 7.12 – Broken Hinge Connection on Catamaran Float at location of Main Bridge Float (Source: Mott MacDonald)

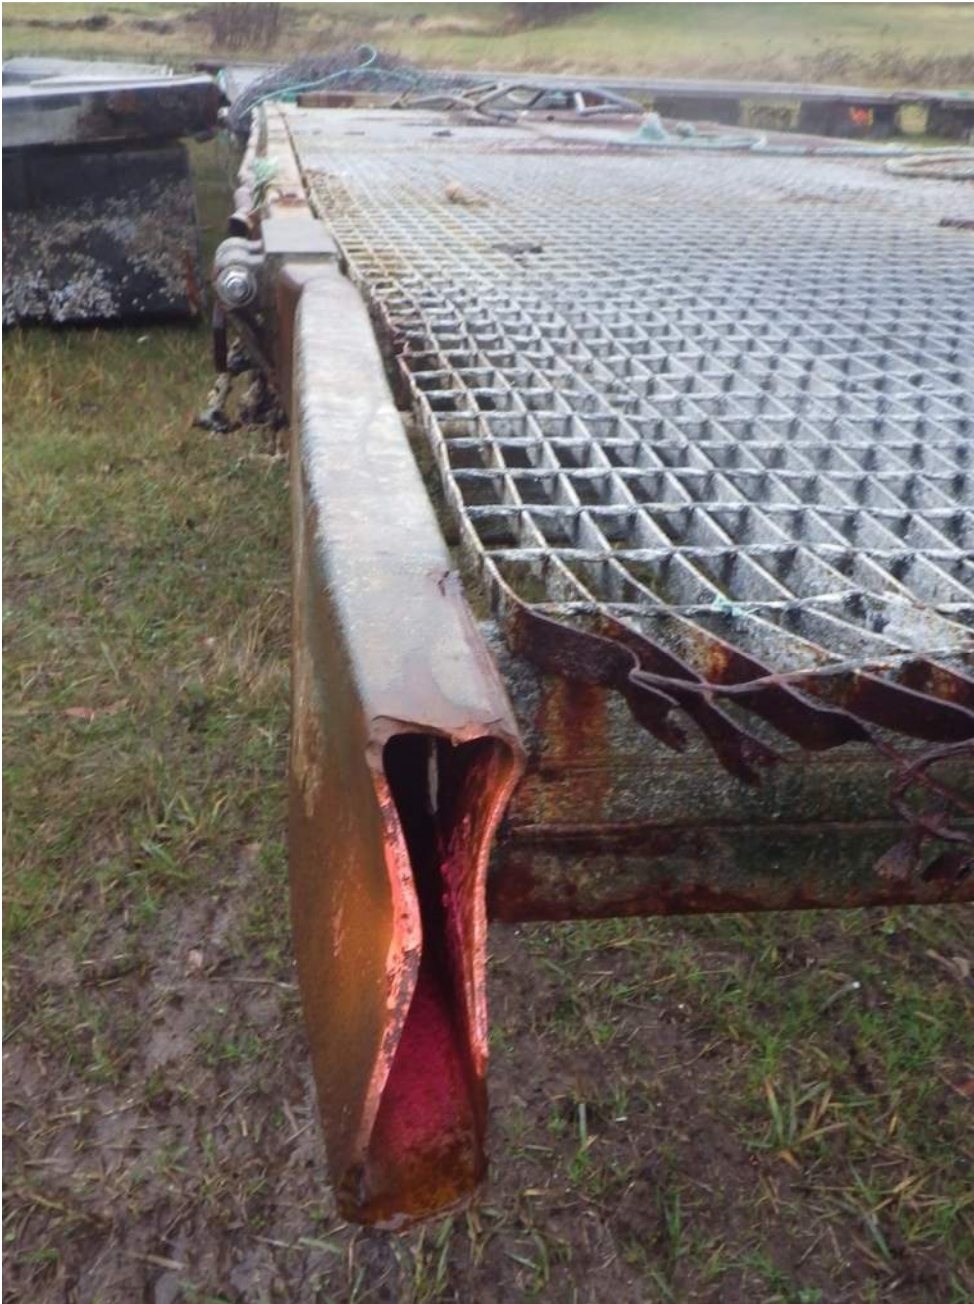
Figure 7.13 – Broken Structural Framing Member on Outrigger Float (Source: Mott MacDonald)

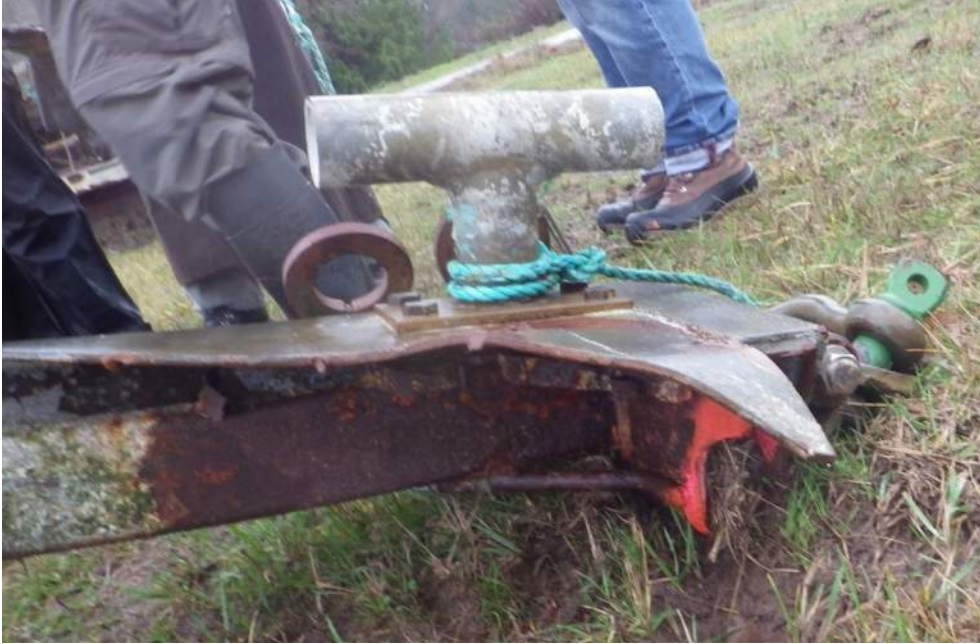
Figure 7.14 – Broken Structural Framing Member at Corner of Outrigger Float – Northeast Corner of pen 225 (Source: Mott MacDonald)

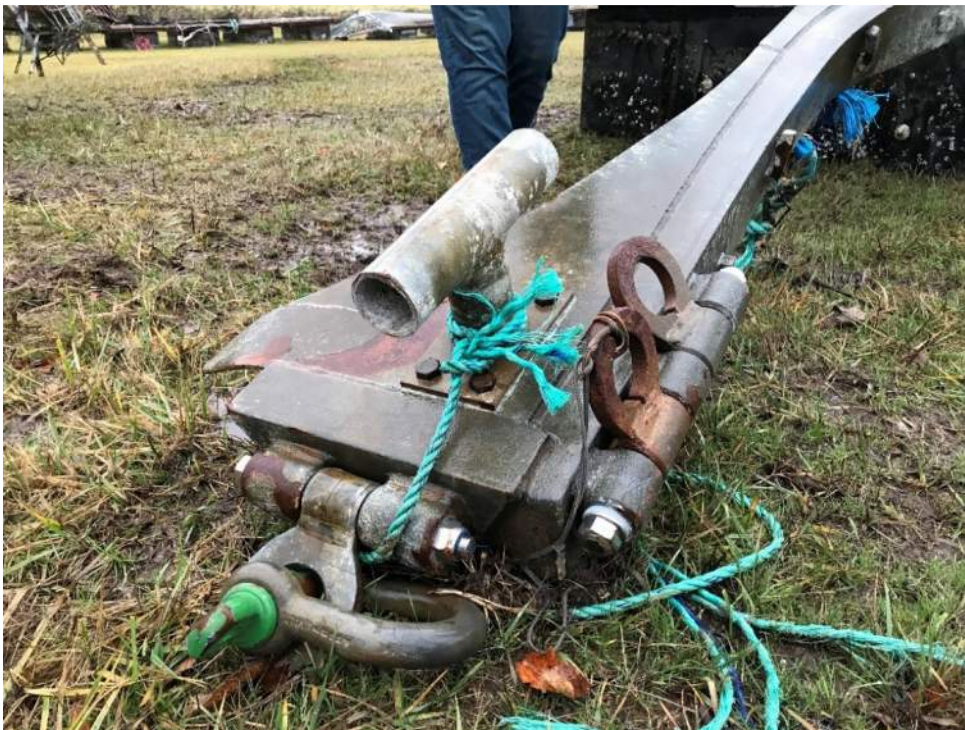
1. The “exoskeleton” system made up of chains stretched across the floats of Net Pen #2 was intended to relieve forces on the mooring brackets and hold the floats together.
2. The east end of Net Pen #2 failed first.
3. The hinges connecting the floats and the structural framing of the outrigger floats on the northeast corner of pen 225 had failed, while the pad eyes at that corner were intact.

Figure 7.15 –Corner of Outrigger Float – Northeast Corner of pen 225 (Source: DNR) Note intact pad eyes at the mooring brackets.

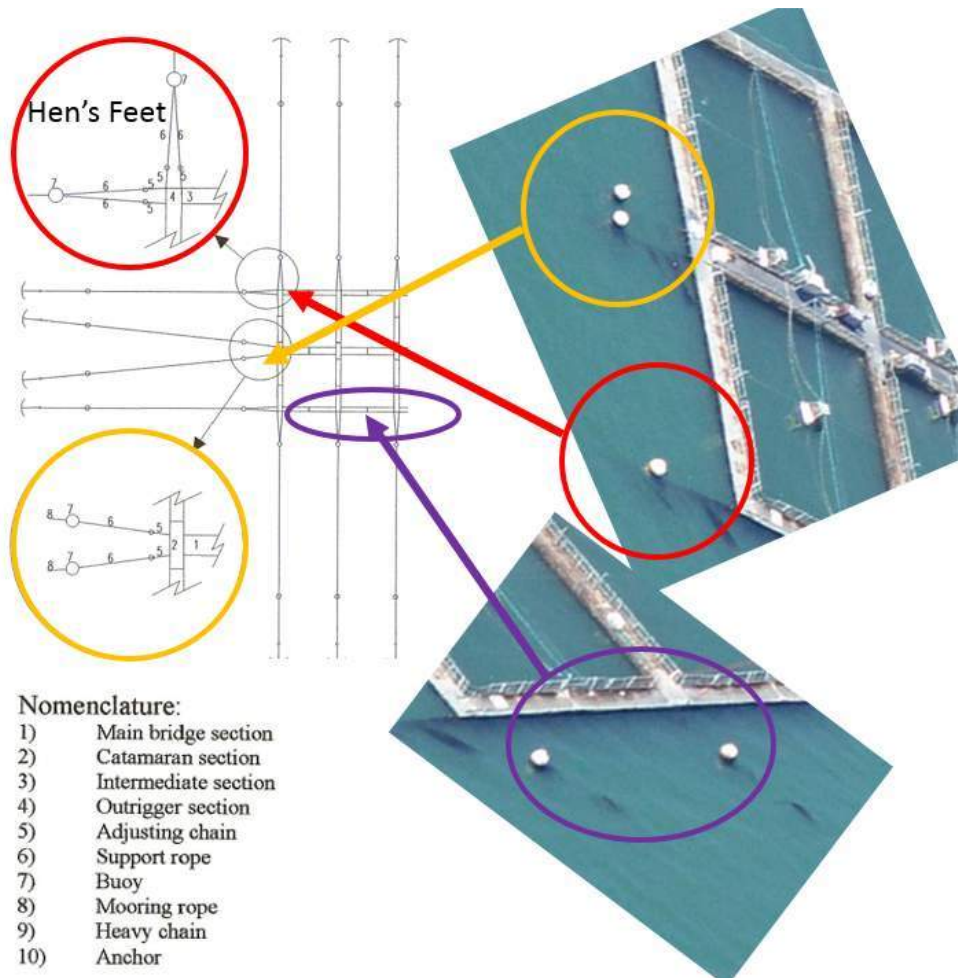
- **Corrosion:** Corrosion appeared to be present at several key elements, which likely reduced structural capacity.
- **General:** There are key factors that may have contributed to shortening the facility life span, resulting in the July and August incidents: Uneven mooring lines, corrosion, fatigue loading, and mooring point connections at the mooring brackets.

Figure 8.1 – Manufacturer recommended mooring connections and observed mooring connections (2009)
