**A ROAD DAMAGE INVENTORY  
FOR  
THE UPPER DESCHUTES RIVER BASIN**

By  
Steven Toth

A Final Report  
Submitted to the SHAMW Committee.  
by  
Steven Toth  
January, 1991

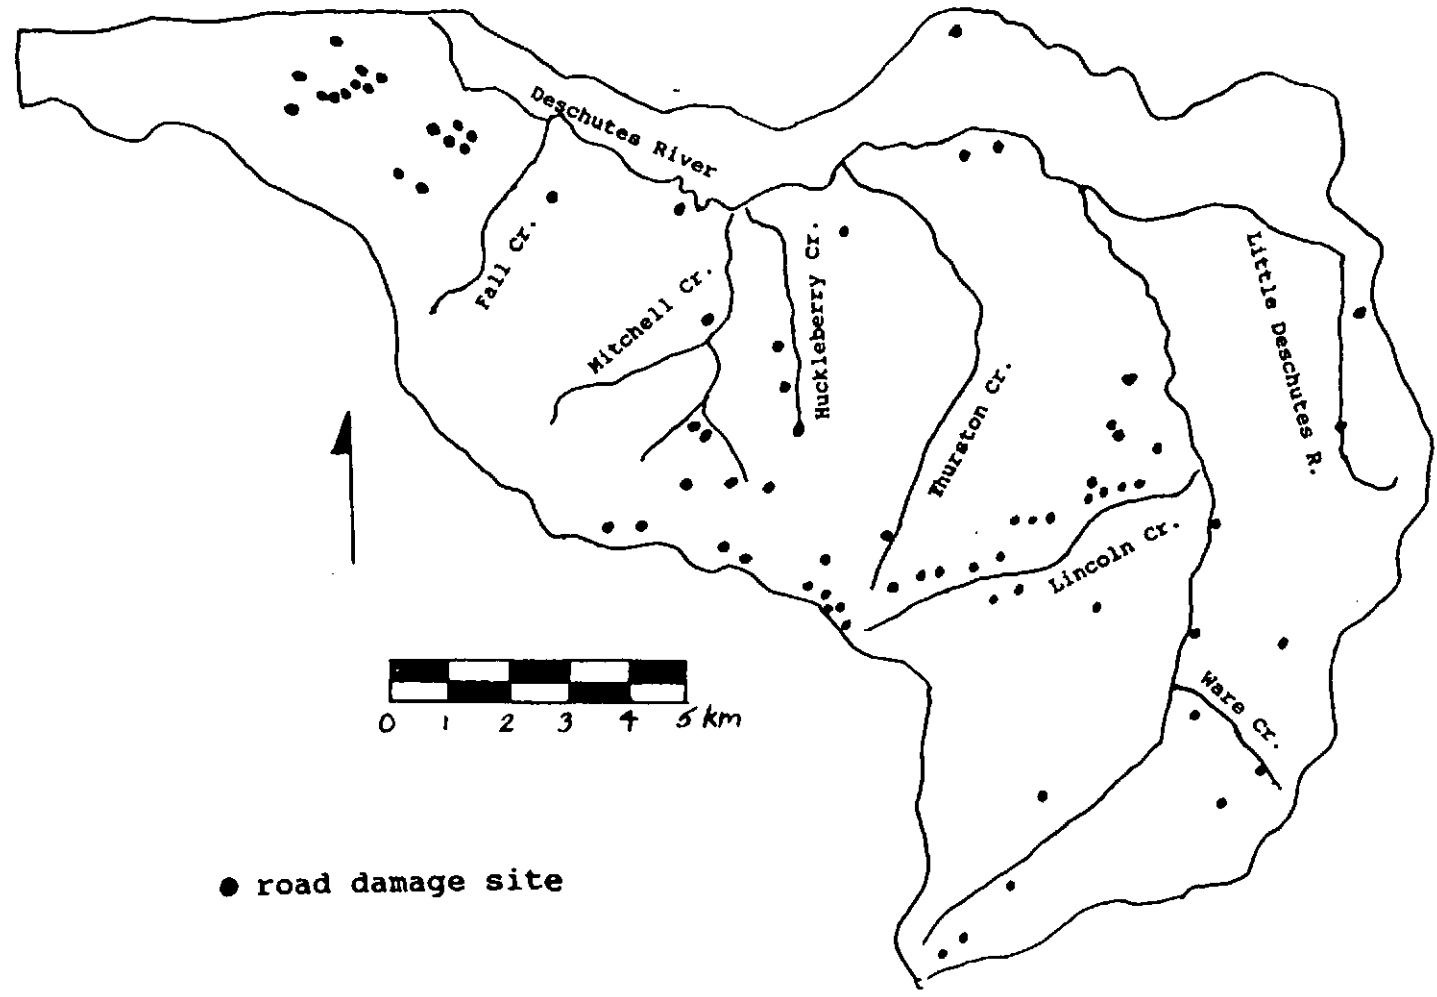
Figure 4. Location of Sample Road Damage Sites

A total of 76 road damage sites were evaluated for this study (see figure 4). The sites were chosen by the Vail Tree Farm road engineer. Since there were hundreds of sites that incurred varying degrees of damage, a sample of them needed to be taken. The sites, however, were not catalogued in any way, and therefore were simply chosen from memory by the engineer. Statistical analysis of the data was not possible because this was not a random and non-biased sample, but the information could still provide insight into the various types of problems in the watershed. The engineers felt it was a proportionately representative sample including most of the larger and more obvious problems that caused serious damage, as well as the smaller and less serious damage sites. Many of the sites had been repaired by the time of this study, making it difficult at times to accurately assess the causes for failure. The engineers, though, were able to provide the necessary information to evaluate the site conditions prior to repair work.

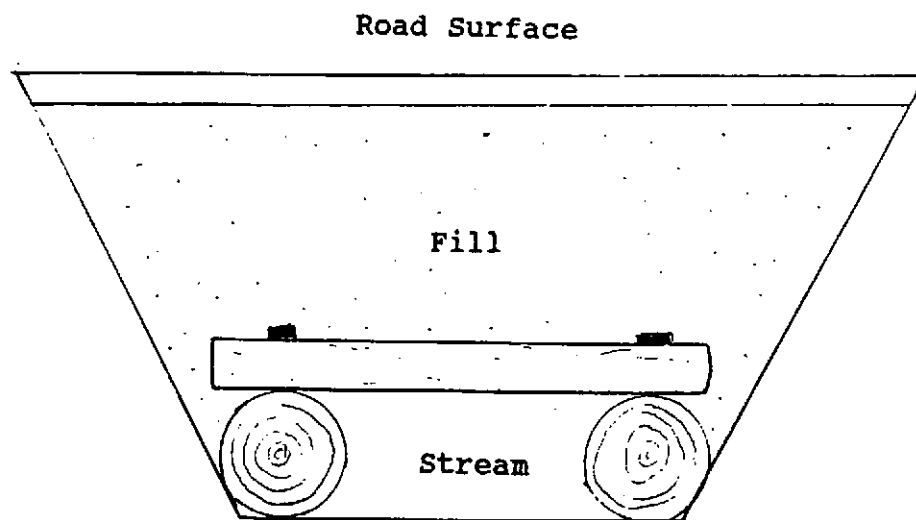
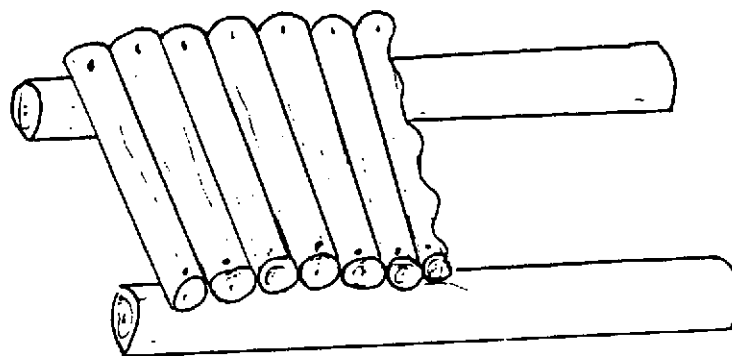
Figure 8. Cedar Puncheon Culvert

Culverts were the next most significant problem accounting for 29% of the damage sites. Stream culverts represented 22% and relief culverts 7% of the sites. Nearly half of the stream culvert problems involved cedar puncheon culverts, all of which caused some environmental damage. Eighty-one percent of the stream culvert problems caused significant environmental damage. The major cause of culvert problems was blockage of culverts (68% of the cases).

Culvert size is an important consideration presently because many of the older culverts need replacing. The cedar puncheon culverts were predicted to last 25-30 years (Silversides, 1949) and their replacement with steel culverts is long overdue. Many of these culverts have been replaced, but many remain in place. Considering the potential for environmental damage when they fail, replacing cedar culverts should be the top priority.

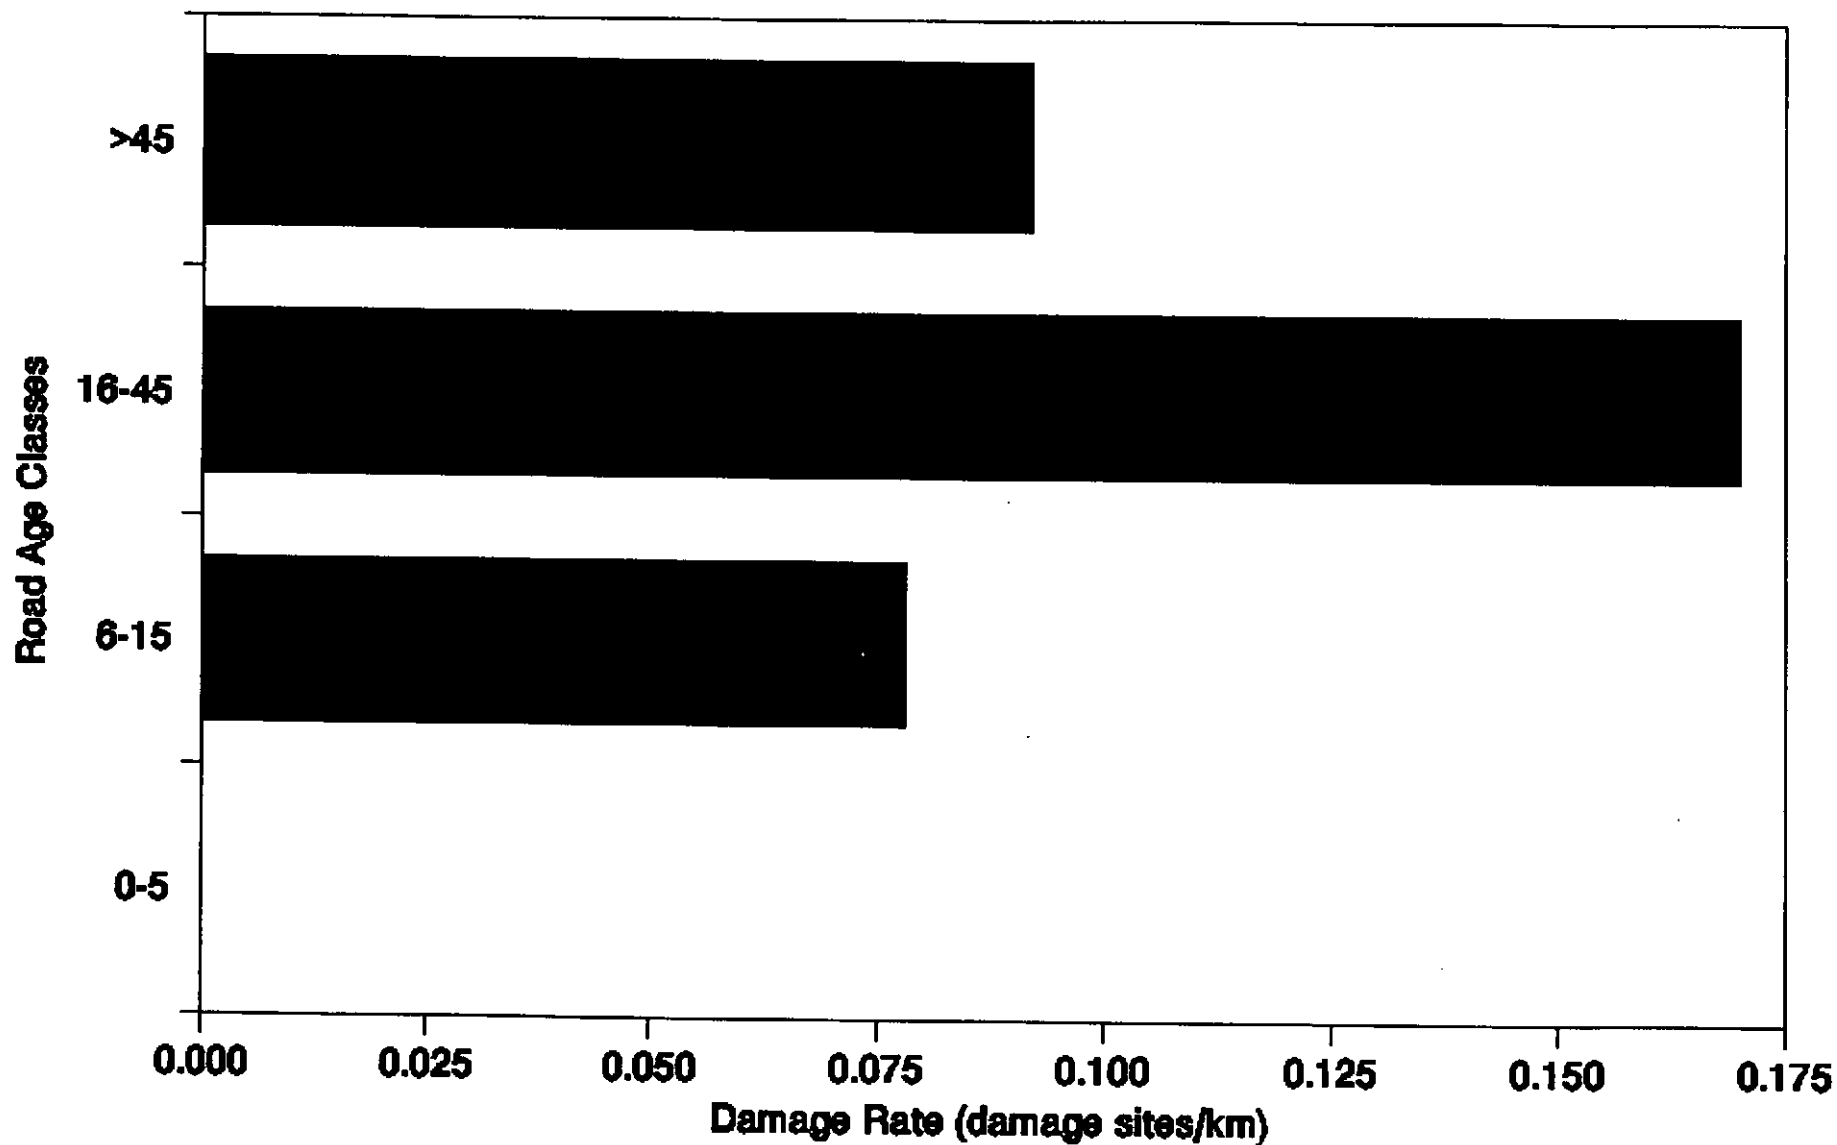
**Figure 9. Damage Rate by Road Age Class**

Combining the information from the age class map and road damage form showed significant differences in the damage rate between road age classes (see figure 9 and table 1). There was no damage to roads built in the last five years. Roads built from 6-15 years ago averaged .078 damage sites/km. Roads built from 16-45 years ago averaged .170 damage sites/km. Railroad grade roads averaged .092 damage sites/km. All of the damage on railroad-grade roads occurred in partially-reconstructed sections.

The oldest age class of roads and those built 6-15 years ago only averaged a damage site every 10.9 km and 12.8 km respectively. The durability of the youngest roads can be better tested in the future as more roads are built, and as they weather the elements longer.

The roads built from 6-15 years ago fared better overall than the older roads with about half the damage rate of the 16-45 year age class of roads. The most notable difference between these age classes, though, was that in the 6-15 year age class, there was not a single stream or relief culvert problem. Since the only major difference in the construction methods of these two age classes was the improved standards from the state forest practice regulations, it is assumed that they played a significant role in the reduction of culvert related problems. In addition, this information shows that culverts designed for a 50-year flood event in this basin can adequately accommodate flows from a 100+ year flood event.

The road age category with the highest damage rate, .170 damage sites/km, was the 16-45 year group. Most of the problems occurred with steep cutslopes and with culverts, but shoulder failures and road slumps were also significant problems. Averaging a damage site every 5.8 km, these roads should be a prime candidate for some reconstruction.

The oldest age class of roads built over 45 years ago had a moderate damage rate of .092 damage sites/km, similar to the 6-15 year age class. The moderate damage rate is probably due to the partial reconstruction of these roads. If the puncheon culverts had been replaced during reconstruction, these roads would have had very few damage sites. Another reason for the lower damage rate is that the old railroad grades are on rather flat terrain where we would naturally expect less problems with soil movement.

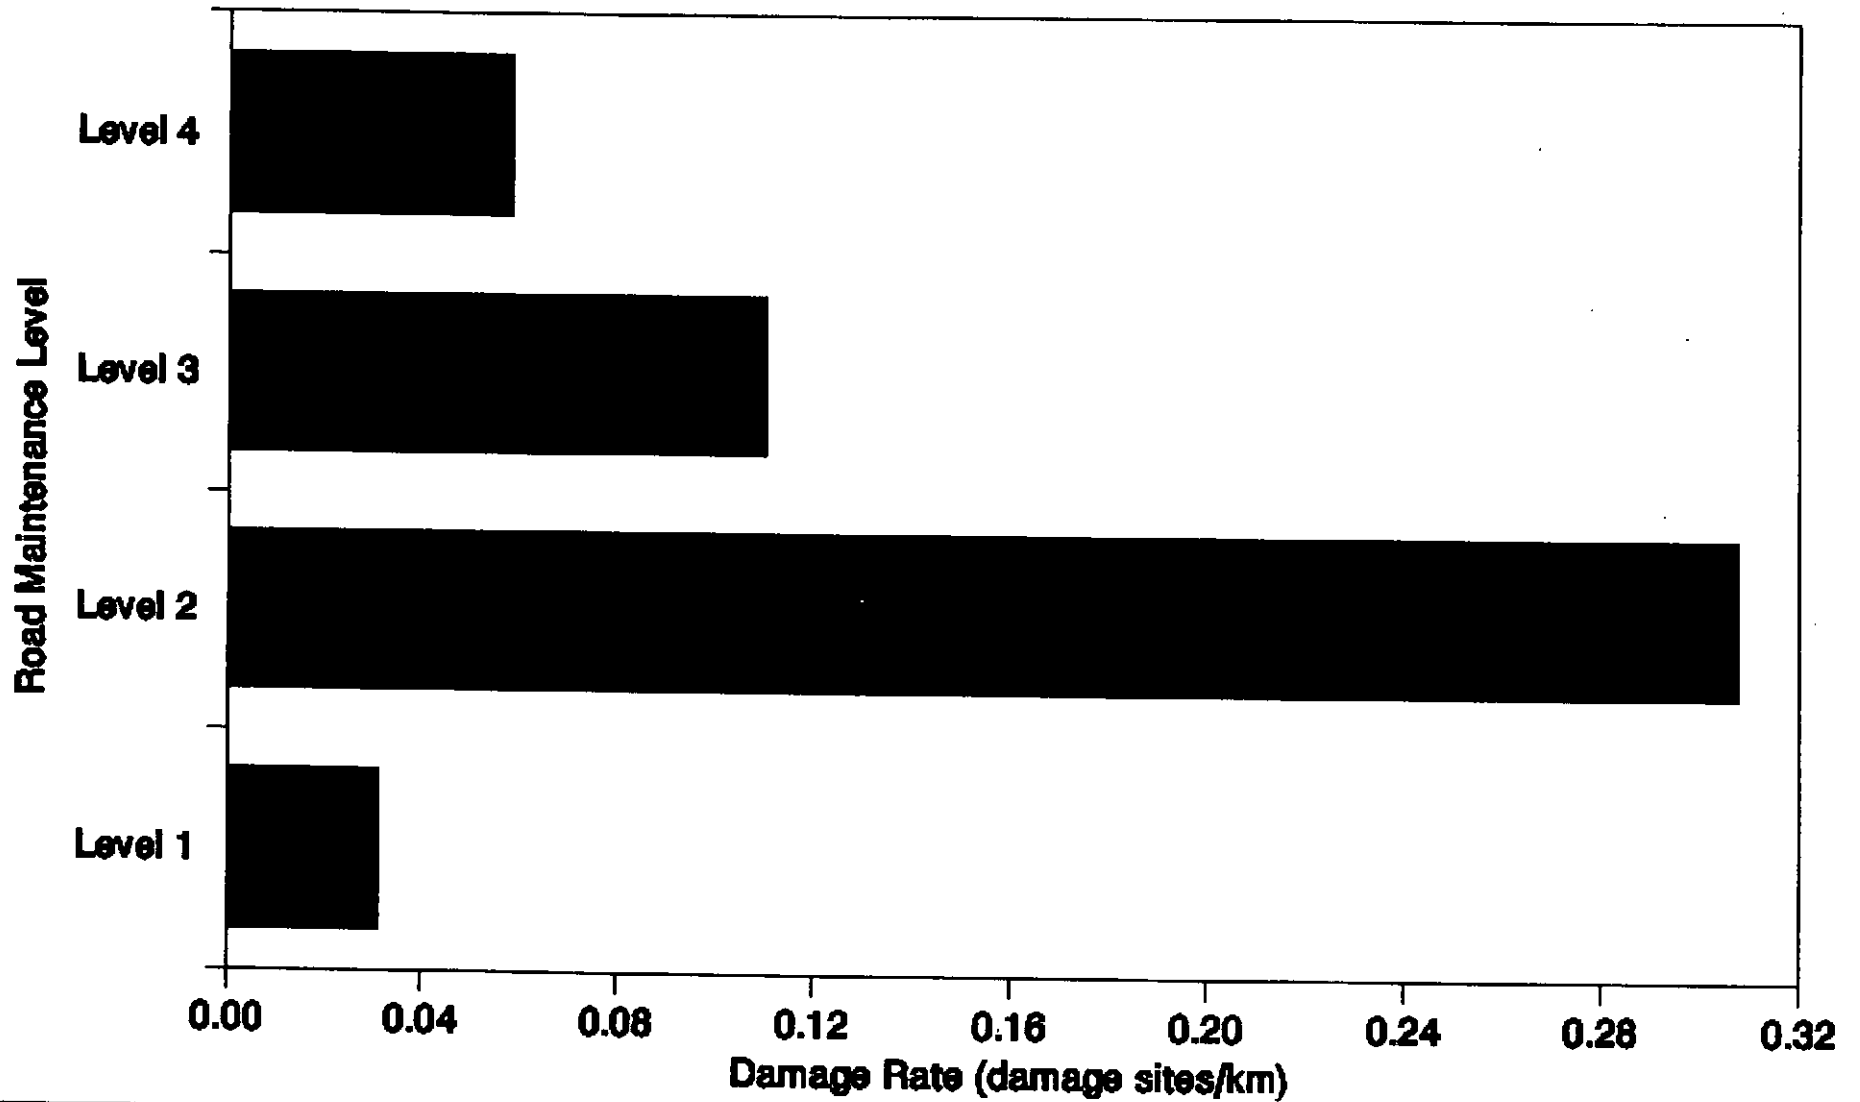
**Figure 12. Damage Rate by Road Maintenance Category**

Examining the information from the maintenance level map and the road damage form showed significantly different damage rates for each maintenance category (see figure 12). Level 1 roads averaged .031 damage sites/km, while level 2 roads averaged .308 damage sites/km. The damage rate for level 3 roads declined to .110 damage sites/km and for level 4 roads declined further to .058 damage sites/km.

One would expect the damage rate to decline progressively as maintenance increases, but level 1 roads seem to present an anomaly with its very low damage rate. One reason could be that most of

While the number of problems directly due to poor maintenance was low (17%), the fact that there is a progressive decrease in damage rate with better maintenance levels indicates it is of some importance. There is no record of how much damage was prevented by better maintenance, but the difference in damage rates between level 2 and 3 maintenance shows it was significant. One reason why railroad-grade roads might have fared better than expected was because they were all at either level 3 or 4 maintenance. This fact helps support the need for having a good road maintenance system.

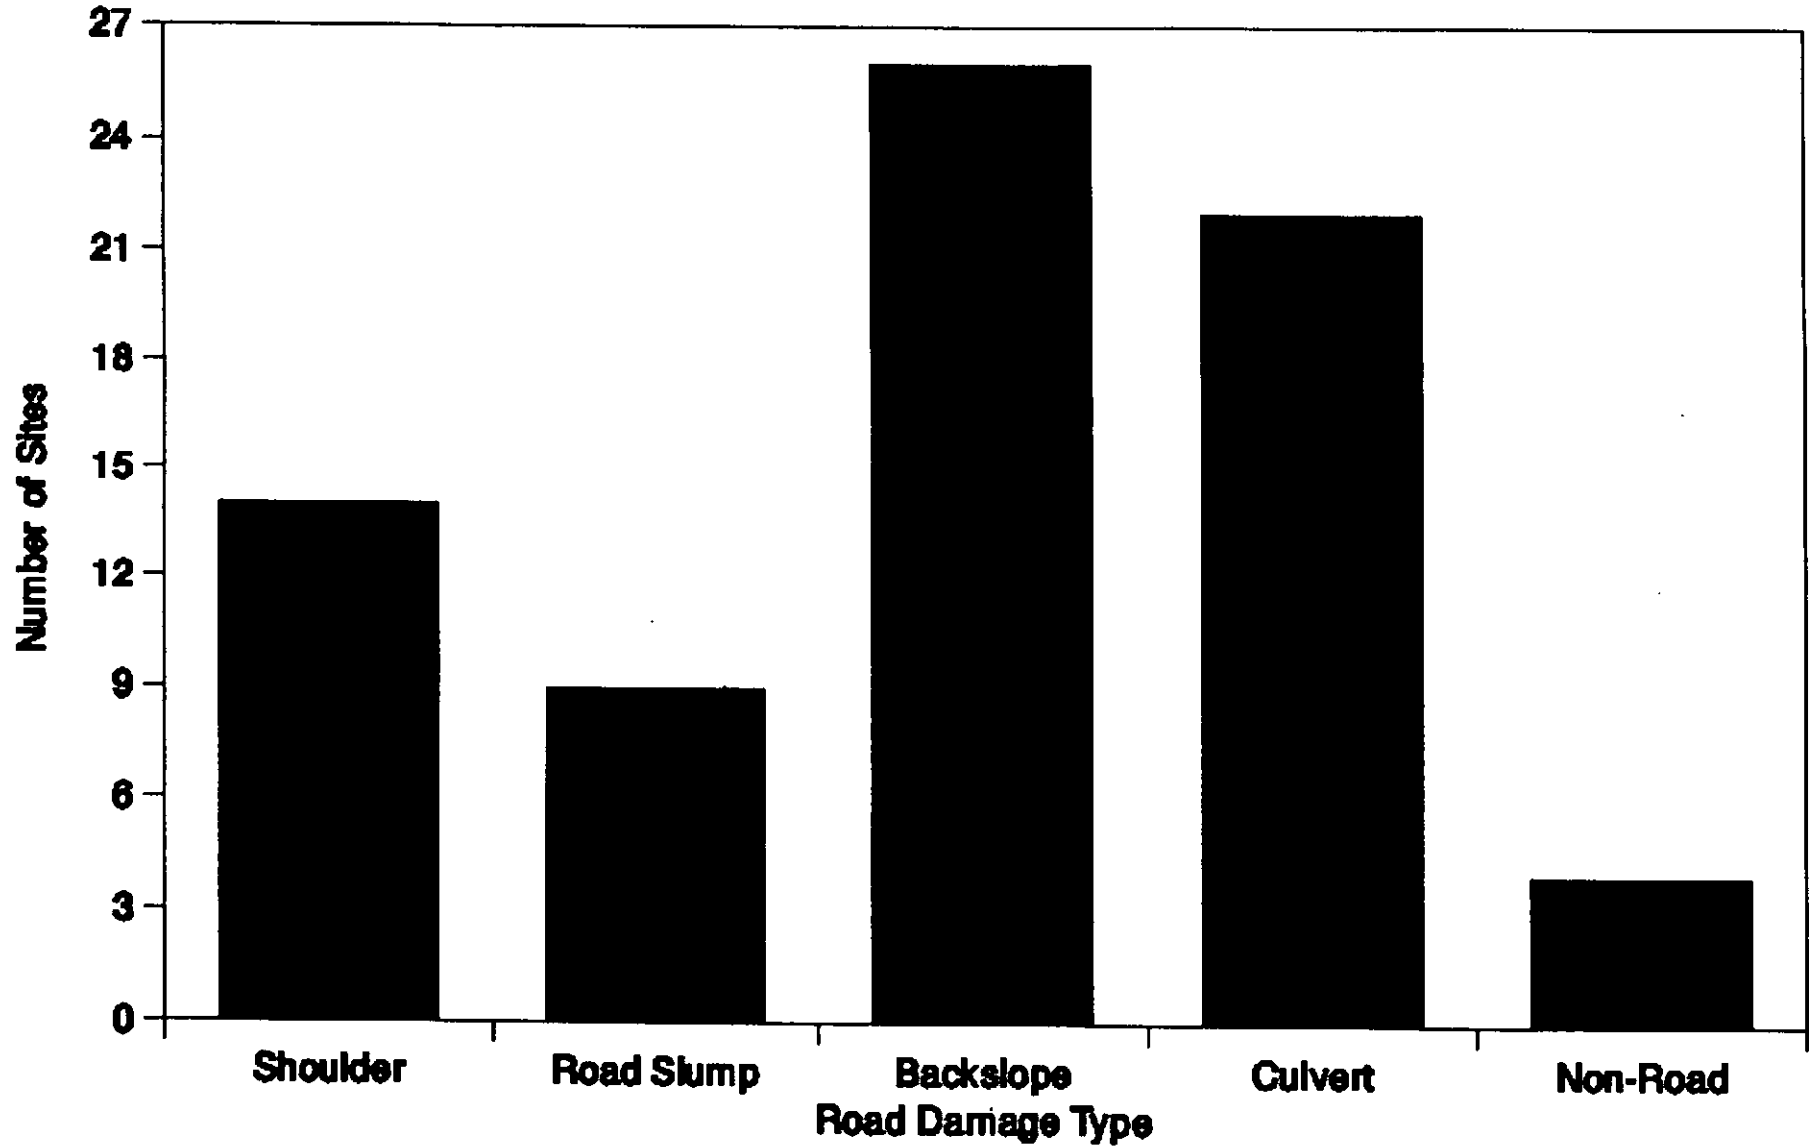
**Figure 13. Frequency of Road Damage Types**

Figure 13 contains the frequency distribution of the different types of road damage. The largest number of problems (34%) were located in the backslope. Of these failures, 65% were due to steep cutslopes. The average cutslope angle for all backslope sites was 43.7 degrees. The presence of unstable soil significantly contributed to failures in 58% of the cases. Unstable soils were defined as either coarse grained granitic soils or weathered volcanic soils with a high clay content that occurred on slopes exceeding 35 degrees. These areas usually had a past history of slides that were visible on the surrounding hillslopes.

Steep backslopes accounted for the most road damage of any of the different failure types. The cause of this seems to be steep cutslope angles in areas of unstable soil. This was especially apparent in the Lincoln Creek watershed. Many times the failures would simply land on the road and just needed to be cleared away. Just as often, however, they blocked a ditch or culvert and more serious damage resulted.

Shoulder failures were another important problem comprising 18% of the sites. Excess sidecast on steep slopes was a significant factor in 93% of the shoulder failures. The average fill slope was 38.9 degrees. Twenty-nine percent of the failures caused significant environmental damage.

Road slumps accounted for only 12% of the sites. Seventy-eight percent of the problems were due to inadequate drainage. Unstable soil and fill on steep slopes were significant causes in 67% of these sites. One-third of the sites were responsible for environmental damage.

Reducing the cutslope angle in areas with unstable soils and a history of failures would be of great help. Much of the road system, though, has problems with steep cutslopes and it is not very practical to reduce the angle of every slope. Another more feasible alternative would be to pull the ditches out a bit so that

small failures and cutbank raveling do not immediately cause problems. Also, maintaining a good crown on the road would keep excess water from flowing onto sidecast material and reduce the chance of failure.

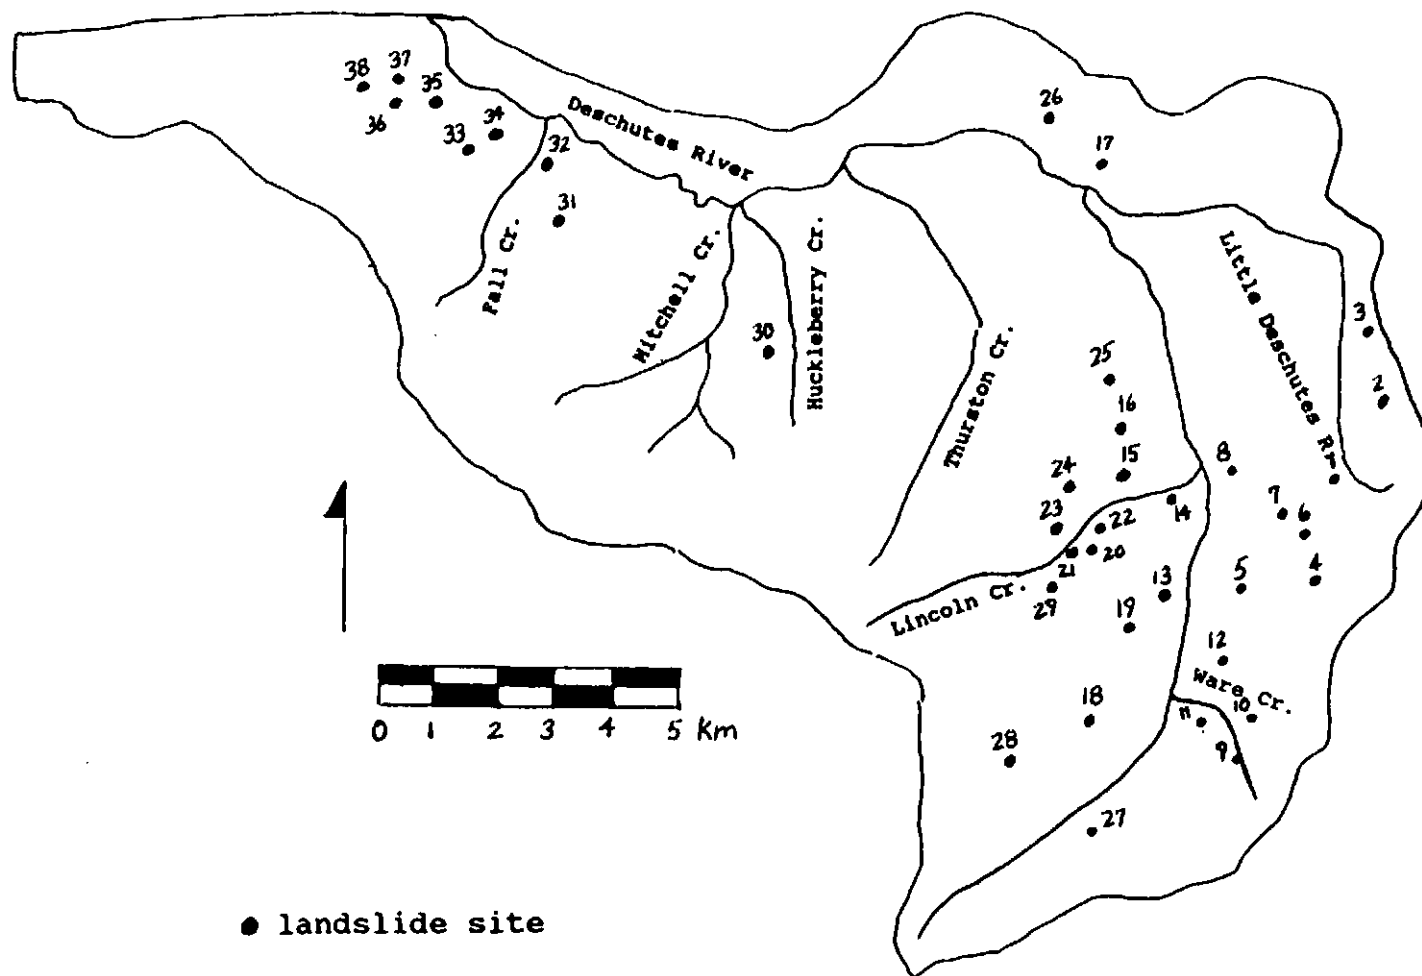
Figure 14. Landslide Inventory Sites

The landslide inventory data contained similar information to that collected in the road damage survey, but since the landslide inventory was a complete, non-biased sample, it was possible to do some statistical analysis. Figure 14 shows the location of the landslides and table 3 summarizes other information collected in the inventory. Two-thirds of the landslides in the sample were road related. There was no significant correlation between the origin of failure and the frequency of stream entry. The frequency of stream entry for both road and non-road related failures was approximately 60%.

results. For the sample as a whole, there was a significant difference in the frequency of slides between the younger and older stand age classes ( $X^2 = 11.4, \alpha = 0.5$ ), with nearly 80% of the failures occurring in stands less than 16 years old.

If we divide the sample into road and non-road related groups, however, there is a significant difference. For non-road related failures, there is still a significant difference in the frequency of slides between stand age classes ( $X^2 = 8.33, \alpha = 0.5$ ), but for the road related failures there is no significant difference. The results for non-road related failures agrees with other studies that have shown that as root strength diminishes, usually within 5-15 years after harvesting, the chances for failures greatly increases (Sidle et al., 1985). Stand age information, though, does not appear to be an important factor in determining the probability of road related failures.
