ENGINEERING GEOLOGIC FIELD RECONNAISSANCE

**DAM BREAK, DEBRIS FLOOD,
AND
AFFECTED PROPERTIES**

**Marshall Hill Road and Mt. Baker Highway
Whatcom County, Washington**

May 31, 2009

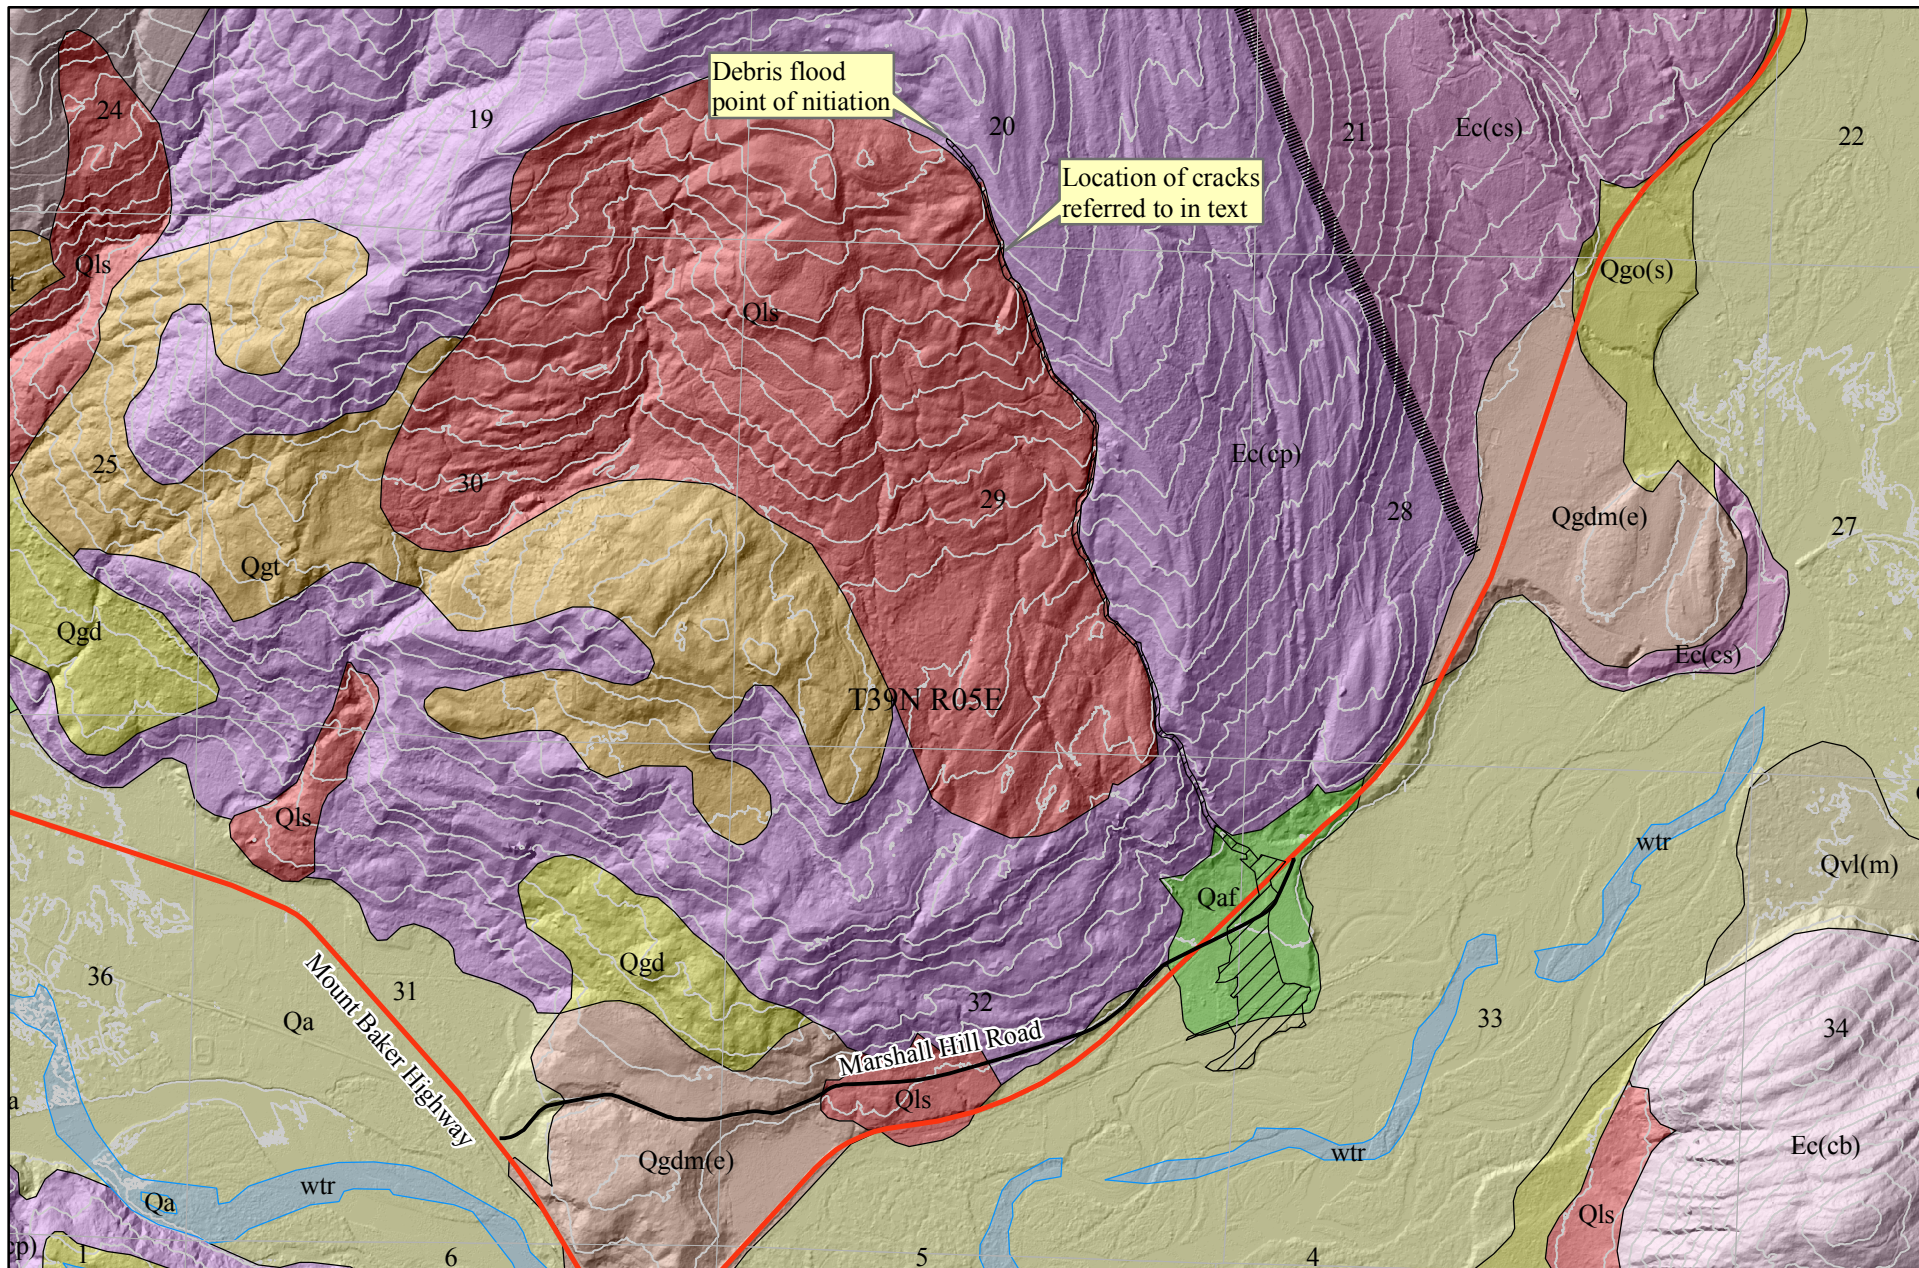
Figure 3. Geologic Site Map

to the side slopes of the drainages. As can be seen of Figure 3 a very large deep-seated translational slide underlies large portions of the hillside area just to the west of the debris flood track. Rockfall processes likely also occur at the Site, but are probably very rare and relatively small in scale, though the collapse of the entire hillside, as happened to the south (Devils Slide area), can not go unnoticed (Brunengo, 2001). Very large earth flows have been recognized and mapped on the east side of Sumas Mountain to the north of the Site.

Between the D-6100 and D-6200 forest roads, glacial material including glaciolacustrine deposits with abundant cobbles was observed. Landslide debris was also exposed in inner-gorge slopes. In addition, a shear zone up to about 2-feet thick with slickensides, polished surfaces, and mashed and broken rock was exposed in the inner gorge along this stream reach. This shear zone provides field evidence for the large deep-seated landslide mapped to the west of the debris flood track (Dragovich and others, 1997) of which the stream and debris flood track make up the eastern lateral margin (Figure 3).

On the west side of the inner gorge of the Marshall Hill Drainage at the east-west section line (Figure 3) between Sections 20 and 29 (about 7,200 feet from Mt. Baker Highway) we observed a system of ground cracks. This system is about 25 to 30 feet back from the top of the inner gorge. The cracks extended for perhaps a hundred feet or so. The cracks were open from 2 to 5 inches and appeared to be associated with a subtle break-in-slope that varied from about 1- to 6-inches high.

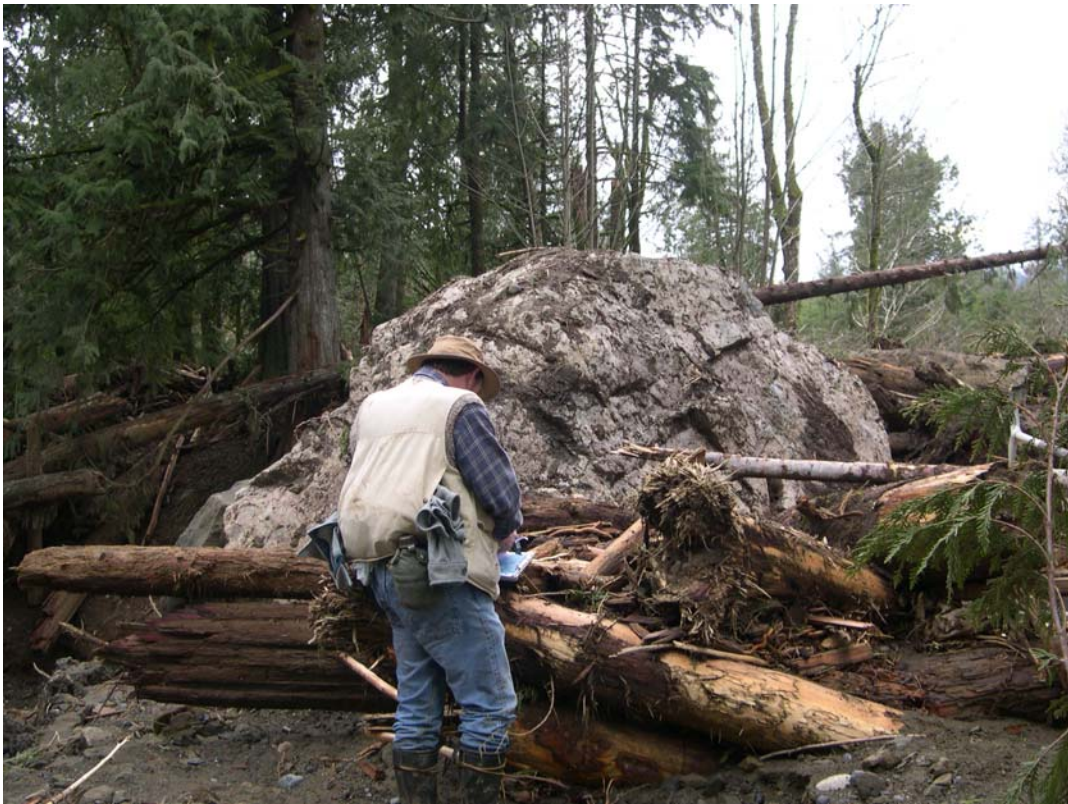
Evidence for the large volume of water and the high rate of flow was obvious everywhere along the channel. Both the D-6100 and D-6200 roads were washed out

during the debris flood event (Figures 4 and 5). From measurements of the deformed culverts left behind in the stream crossings, we estimate the culverts were 48 inches in diameter. A large boulder approximately 6 feet by 6 feet by 10 feet was deposited by the debris flood on the D-6100 road grade (Figure 4); another indicator of the extreme volume of water moving down the channel during the debris flood event. Logs and rocks were abundant on both road surfaces on either side of the washed out D-6100 road grade.

Figure 4. Photograph of Large Boulder Deposited on D-6100 Road. Photograph taken facing west.

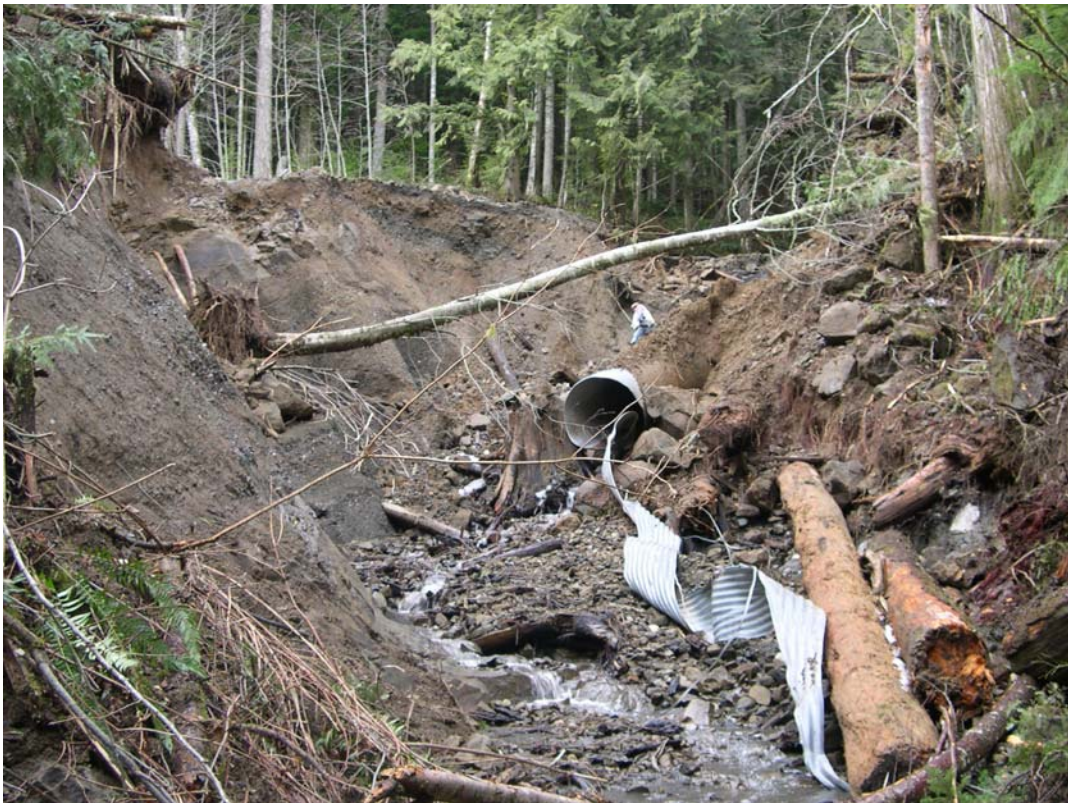
Figure 5. Photograph of Washed Out D-6200 Road. Photograph taken facing north.

Now that the orphaned road-fill at the wetland outlet is gone, the hazard of another event resulting from water ponding behind the fill is no longer present. We recommend that if the D-6100 and D-6200 roads are rebuilt across the debris flood track, additional attention is paid to appropriate culvert sizing. Also, if the orphaned road at the PI is ever proposed for reconstruction, we recommend an oversize culvert be placed in the fill during road use and that the culvert be pulled and the fill removed following road use.

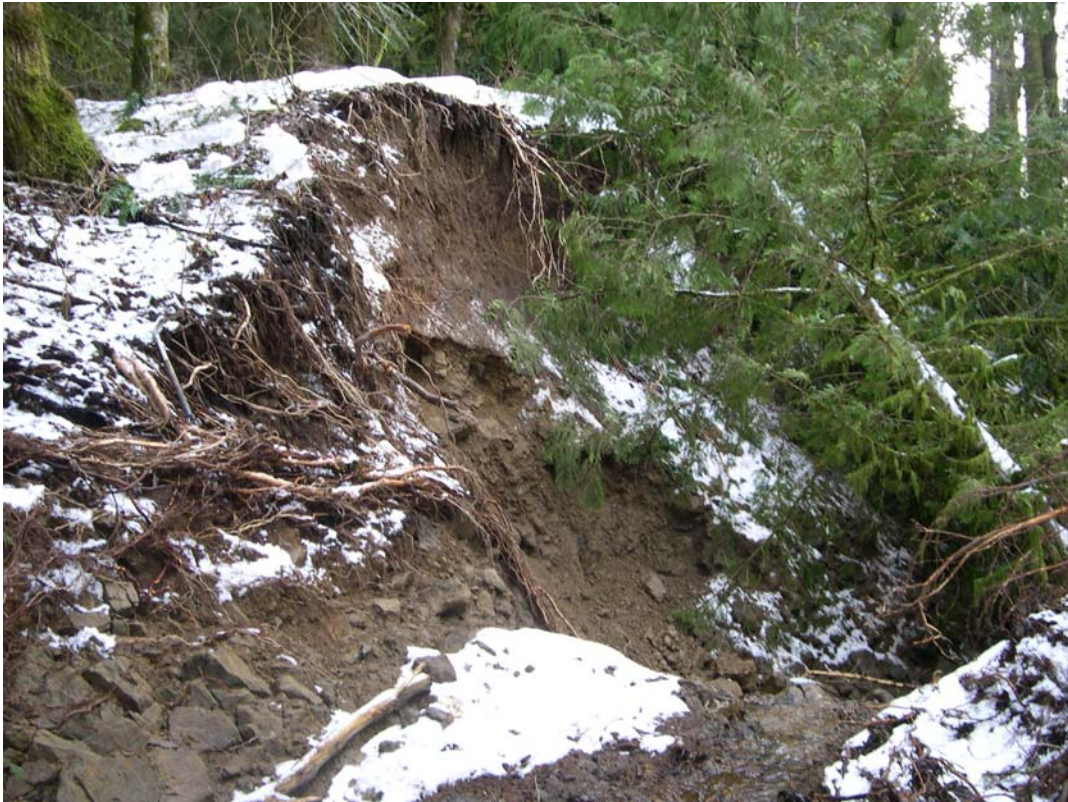
The debris flood PI is located at a failed orphaned road-fill prism (Figure 6) at the easterly end of a wetland approximately 1½ acres in size. The depth of the water behind the orphaned road prior to failure was an estimated 8 feet. The 8-foot depth is based on the apparent contact between snow and water prior to the presumed rapid draining of the wetland when the orphaned road prism failed. The snow-water or snow-ice on top of water contact was well preserved at the time of our field visit. The failed road prism appears to have been essentially level prior to failure. At the orphaned road centerline, the washed out gap measured 40-feet wide with an upstream gap of 30 feet and a downstream gap of 43 feet. The depth from the top of the upstream side of the road prism to the creek bottom was 22-feet, post failure. The up-stream side of the orphaned road fill appeared to be 9½ feet high, with respect to the bottom of the wetland, prior to failure. It does not appear that the impounded water overtopped the dam. Instead it appears that the fill prism failed by some other mechanism, most likely saturation of the fill. It was unclear from field observations whether a culvert was present in the fill prism prior to failure. No culvert remnants were observed in this area at the time of the field visit, however it would be expected that evidence of a small culvert would be washed away in an event of this magnitude. The fact that the fill prism had not failed sooner suggests that a culvert was likely present, but was not functioning in order for the water to accumulate to a depth this time to saturate the fill and trigger the failure and flood.

In our opinion, the Marshall Hill Debris Flood was not a natural event. The field evidence clearly shows that the orphaned road grade created a dam. A large pond developed behind the dam as the result of several days of extreme rain and warming that caused significant snowmelt. Either a culvert existed, and at the time of the storm could not drain the pond fast enough because it was too small or damaged, or there was no culvert and this ROS event was so much greater than any other earlier event that the fill prism was overwhelmed by the water in the pond and failed. The catastrophic failure of the orphaned road-fill prism allowed the pond to drain very rapidly, initiating the debris flood. Without the orphaned road-fill prism damming the wetland outlet and creating a pond, it is our opinion that a debris flood of this magnitude would not have occurred.

Figure 6. Photograph of Debris Flood Point-of-Initiation, Dam Break Site. Photograph taken facing southeast.

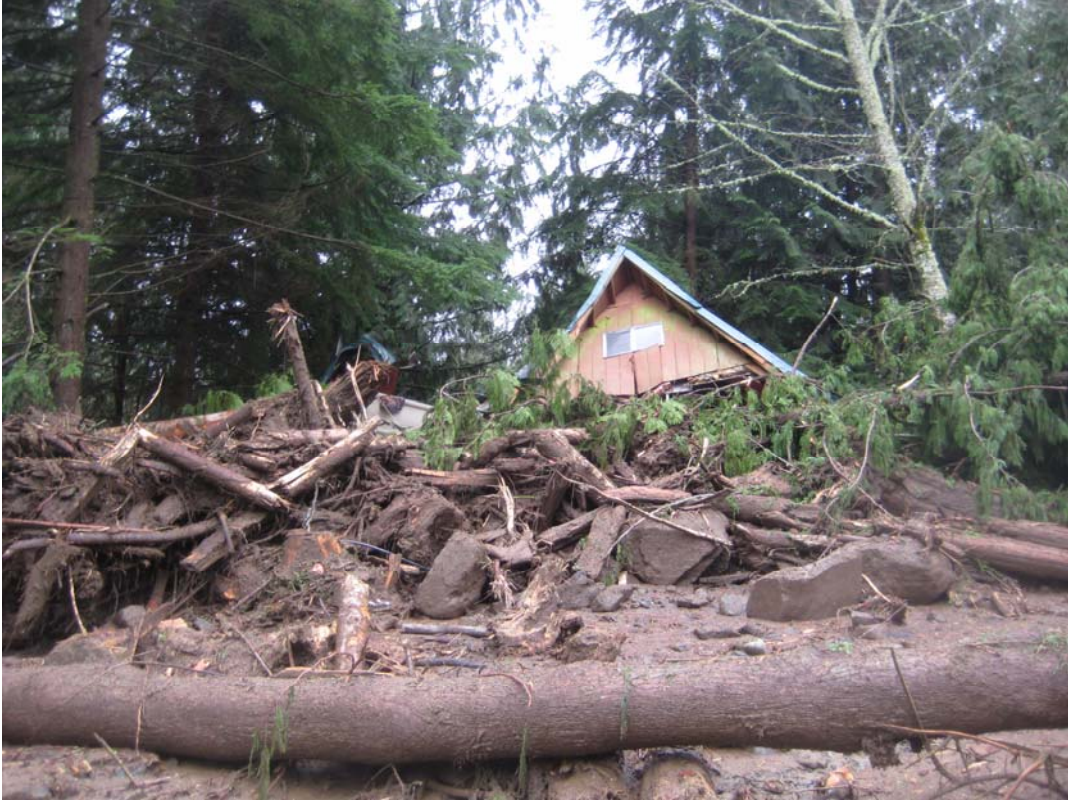
Brester Property – About half the property was inundated with mud and debris. An existing small house was crushed and a small trailer wrecked (Figure 7).

Figure 7. Photograph of Brester Residence Post Debris Flood. Photograph taken facing west.

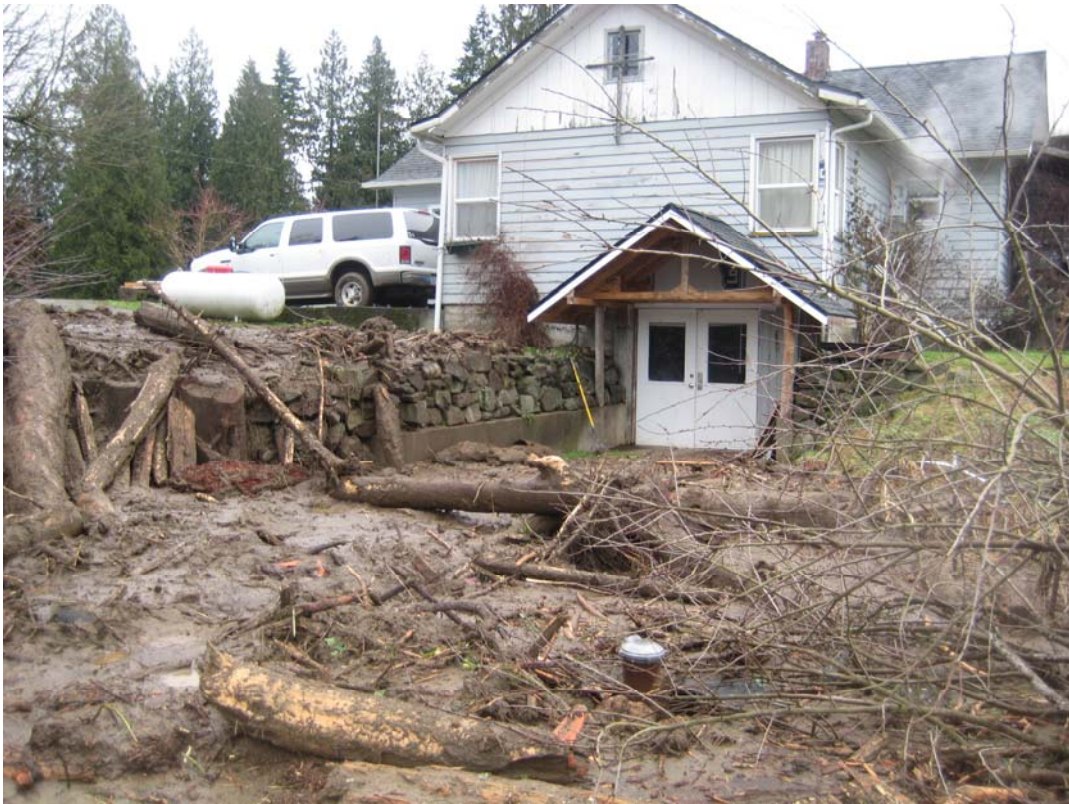
Cronk Property – Debris just grazed the existing house but apparently did little if any damage to the house. Mud and debris was deposited over a good portion of the western areas of the property covering a large area of pasture land (Figure 8).

Figure 8. Photograph of Cronk Residence Post Debris Flood. Photograph taken facing east.

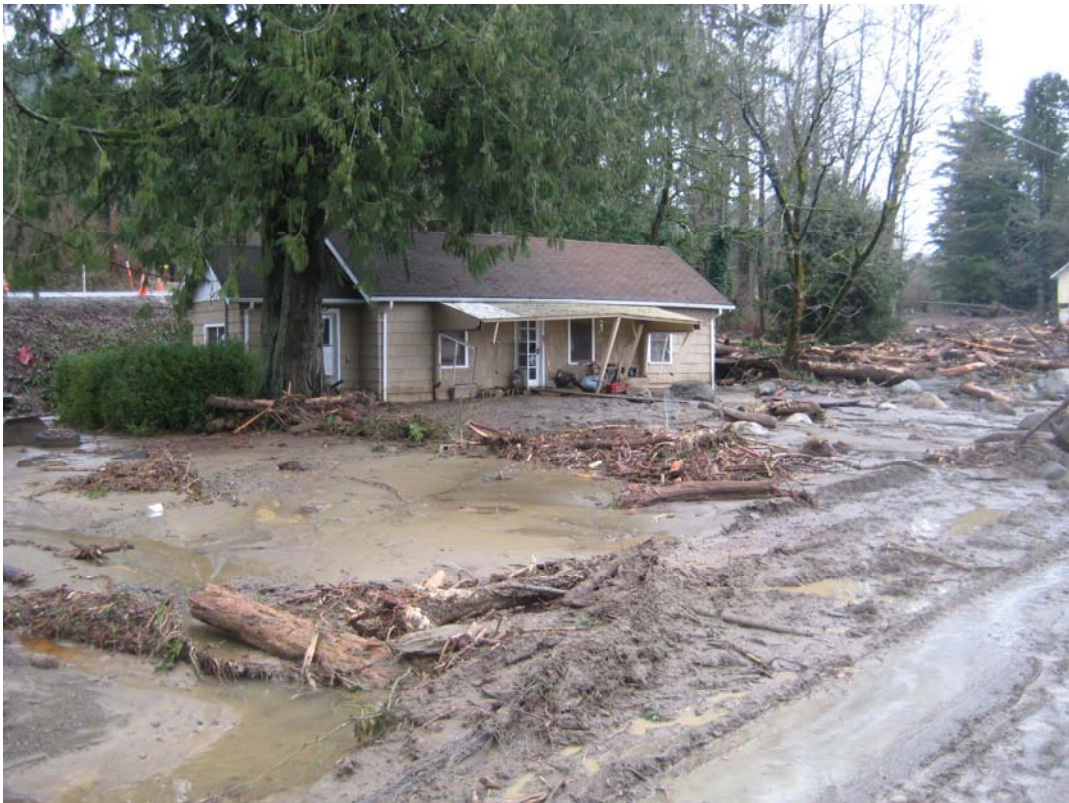
Johnson Property – The house on the Johnson property was surrounded by mud and debris, including beneath the house (Figure 9). Mud also got into the interior of the house.

Figure 9. Photograph of Johnson Residence Post Debris Flood. Photograph taken facing northeast.

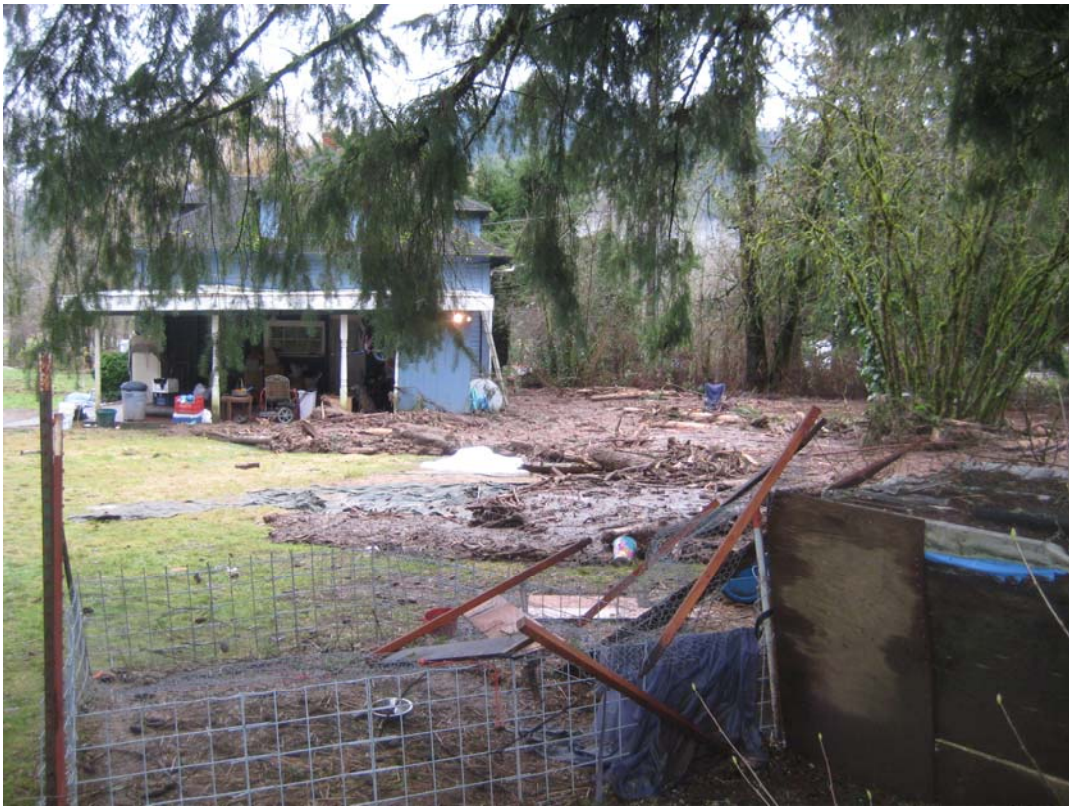
Knebel Property – It appears that there are two homes on this property. One located near Highway 542 and the other is near the creek, set back from the highway about 250 feet. At the house near the highway mud and debris was deposited adjacent to the house (Figure 10). At the other house Debris was placed against the house and mud splattered on the sides of the house (Figure 11). At least one window was broken and mud got into the house.

Figure 10. Photograph of first Knebel Residence Near Highway 542 Post Debris Flood. Photograph taken facing southeast.

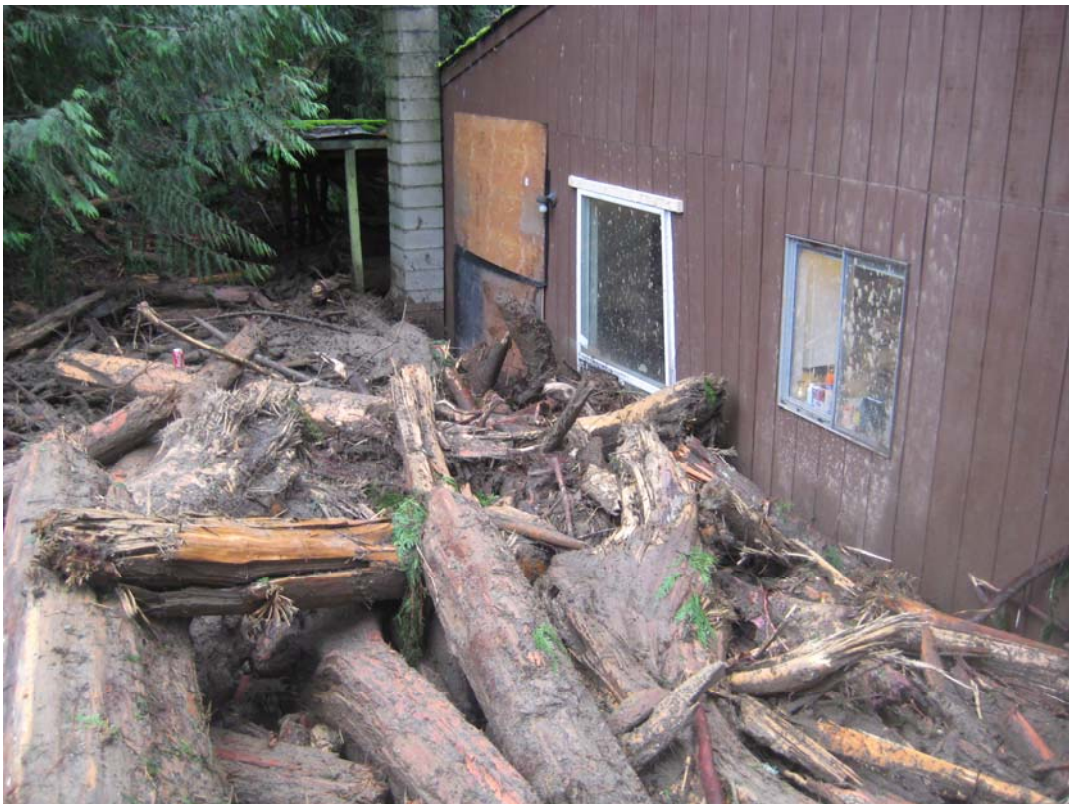
Figure 11. Photograph of second Knebel Residence Approximately 250 Feet Northeast of Highway 542 Post Debris Flood. Photograph taken facing northeast.

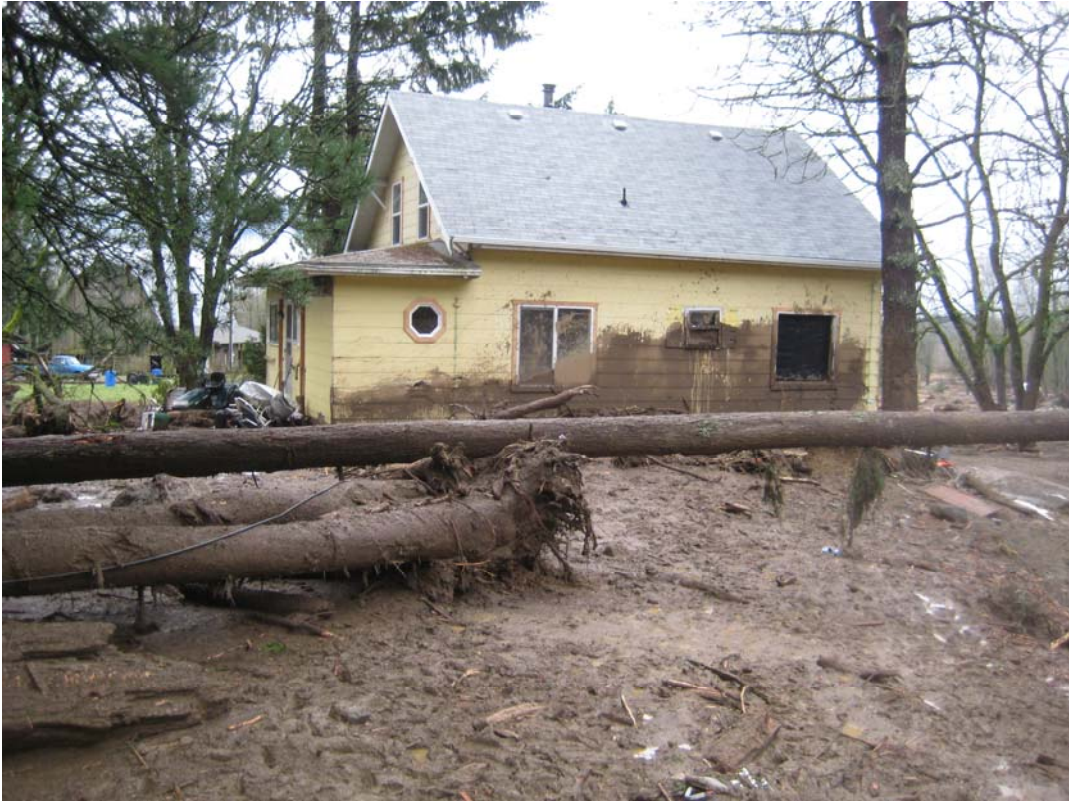
Monaghan Property – Mud and debris was placed against the house and spattered on the exterior walls (Figure 12). Windows were broken and mud got into the interior of the house. It appears that a metal awning on the south side of the house was ripped off the house and incorporated into the debris and carried away toward

the North Fork Nooksack River along with a motor vehicle. The property was almost completely covered with flood debris.

Figure 12. Photograph of Monaghan Residence Post Debris Flood. Photograph taken facing southeast.

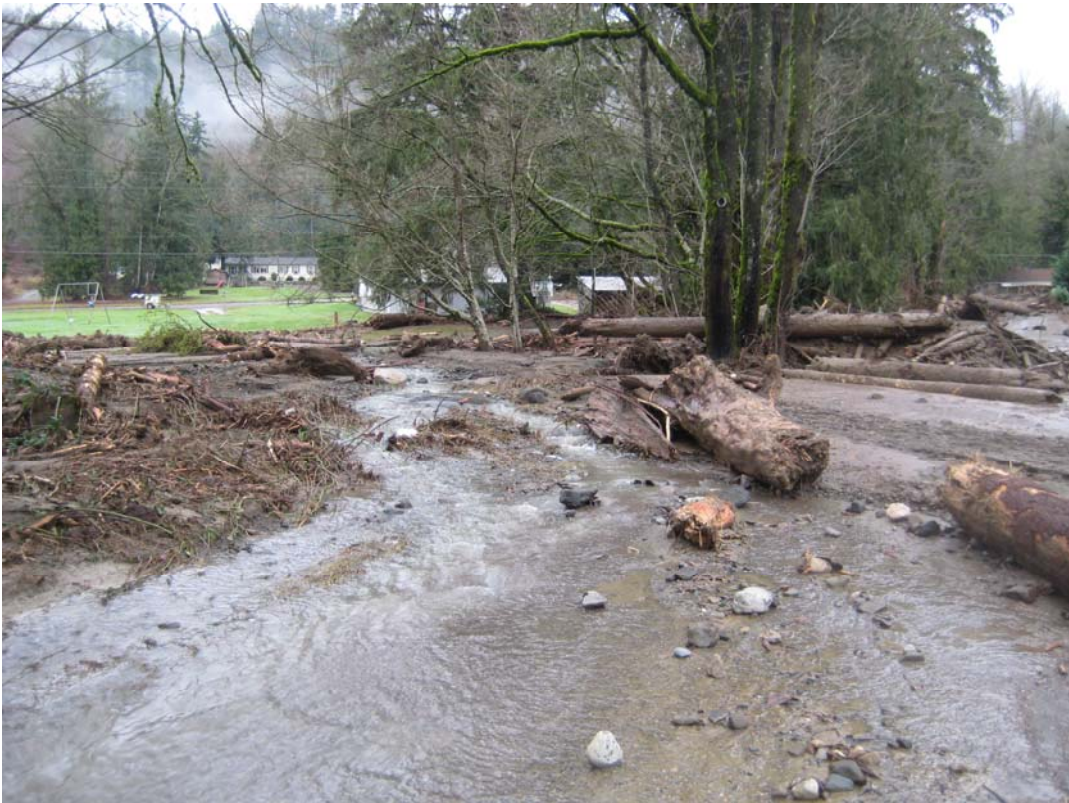
Raper Property – Mud and debris was deposited across the eastern portions of the property. Some came to rest next to the existing residence (Figure 13).

Figure 13. Photograph of Deal Road and Raper Residence Post Debris Flood. Photograph taken facing north.

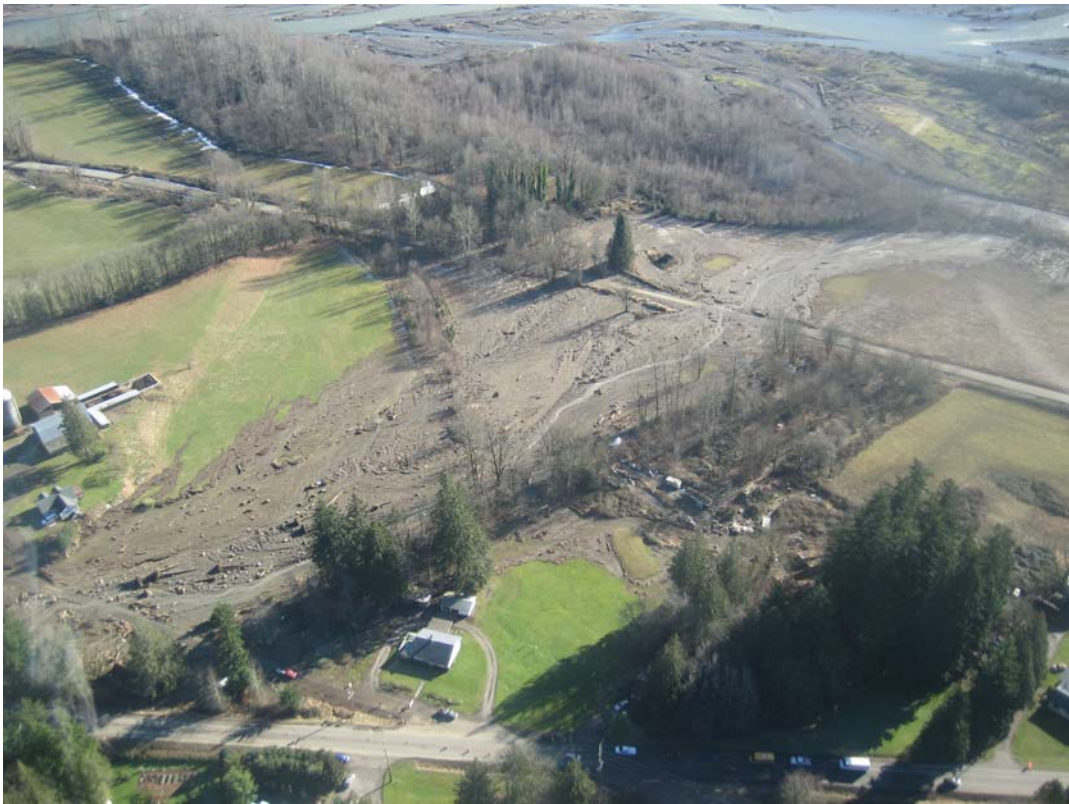
Figure 14. Photograph of the South End of the Debris Flood Deposition Area.
Photograph taken from helicopter facing southeast.

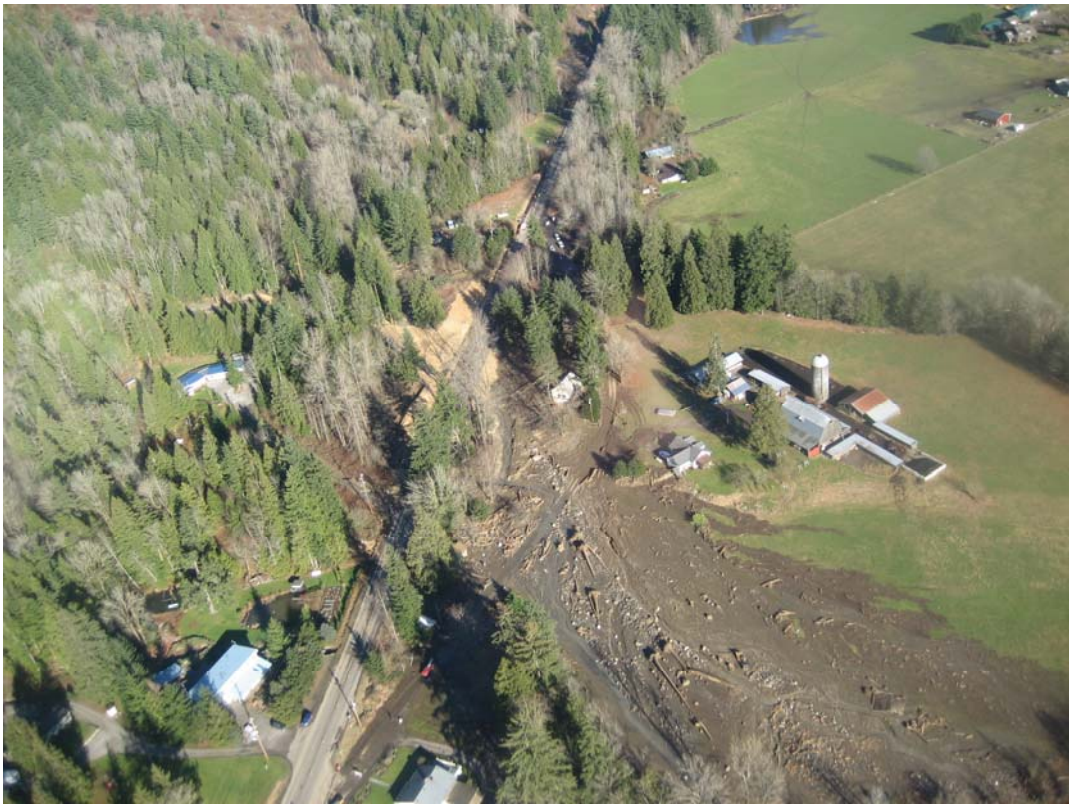
Figure 15. Photograph of the North End of the Debris Flood Deposition Area.
Photograph taken from helicopter facing northeast.
