ENGINEERING GEOLOGIC FIELD RECONNAISSANCE

**DEBRIS SLIDE, DEBRIS FLOOD,
AND
AFFECTED PROPERTIES**

**3312, 3334, 3363, and Two Un-Addressed Properties, Clipper Road
Whatcom County, Washington**

September 3, 2009

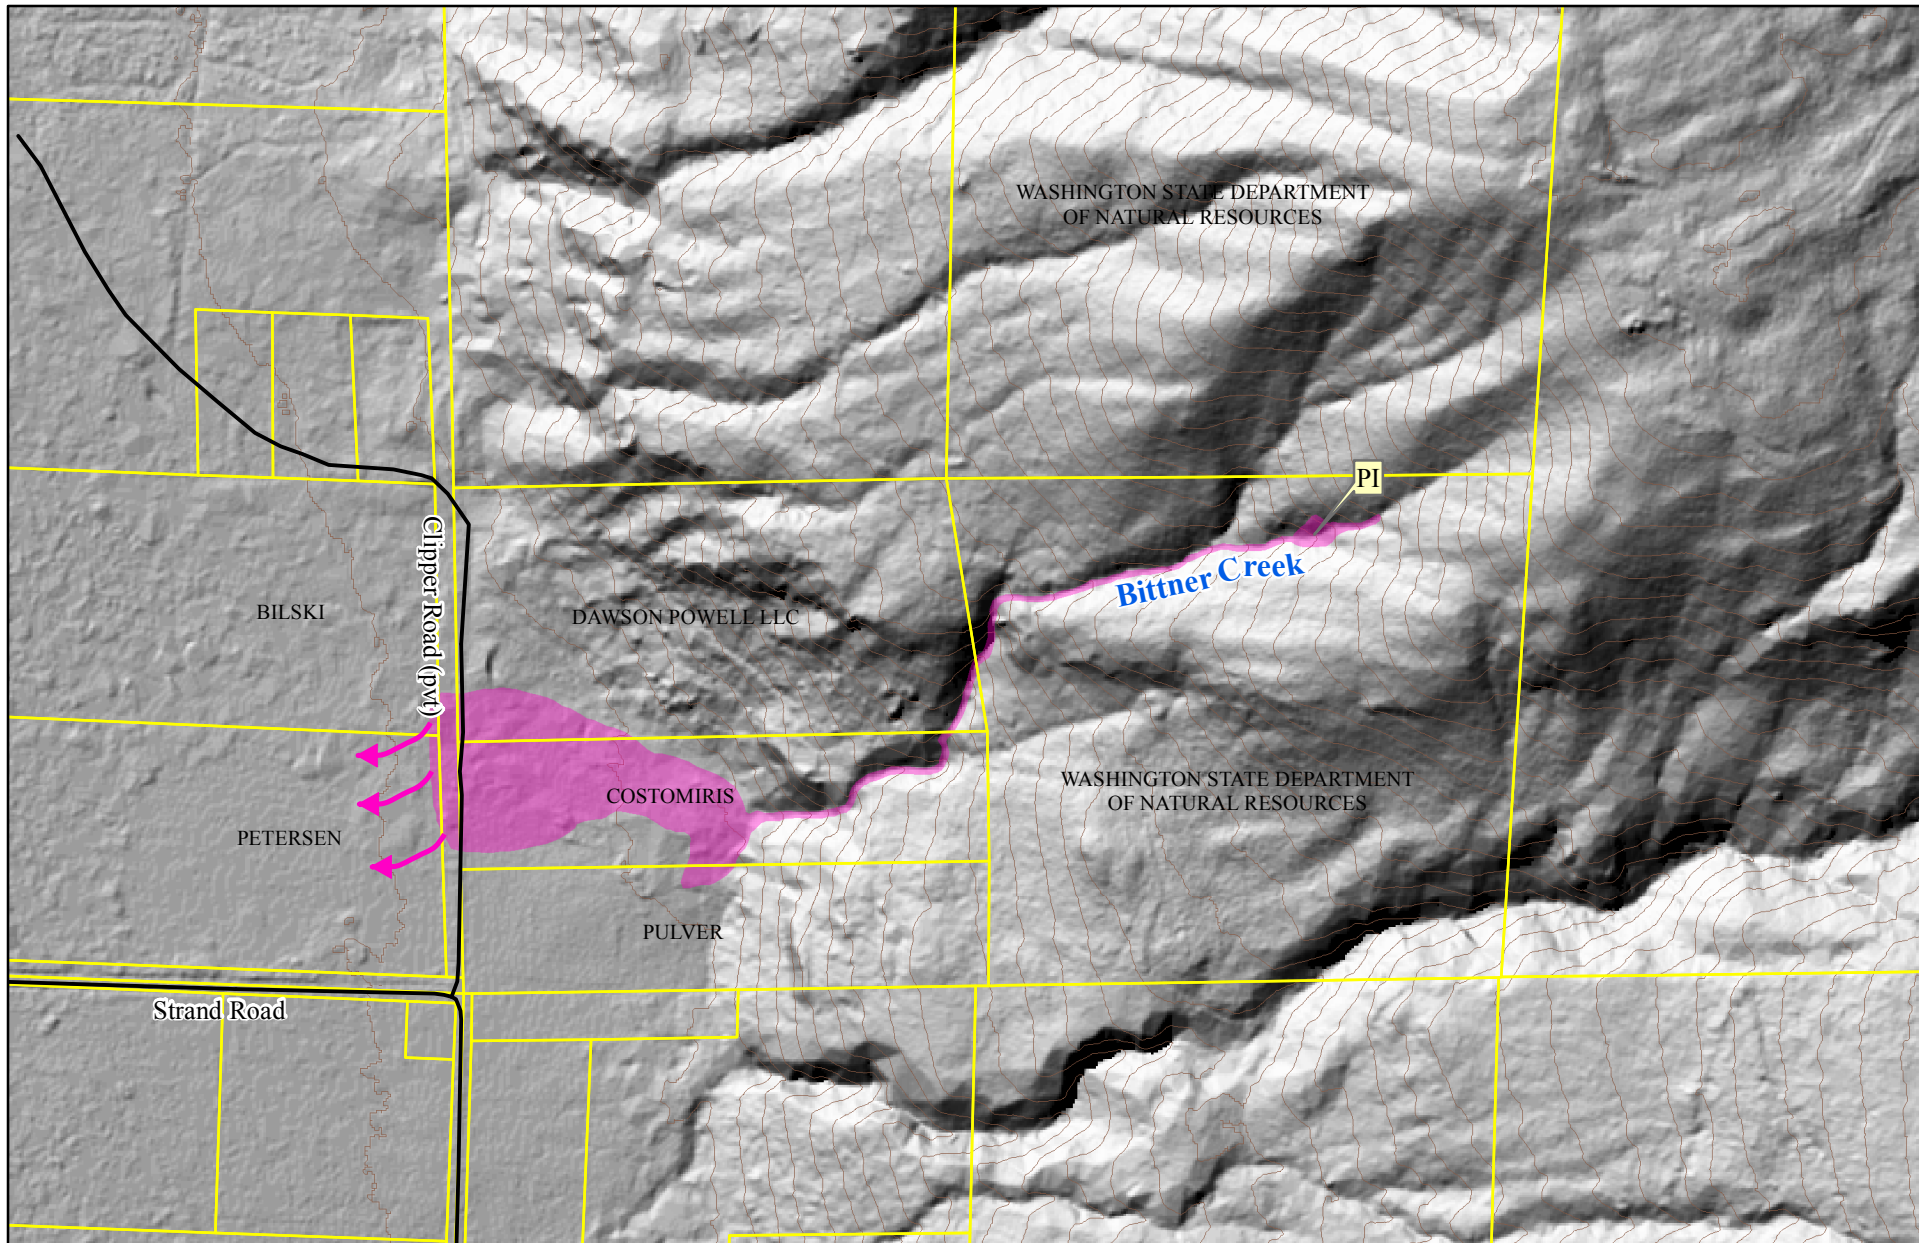
Figure 2. Simplified Map Showing Property Owners, Debris Flow Track, and Approximate Depositional Areas.

The DNR Northwest Region 2009 IIR reports substantial amounts of mud surrounding the house and several outbuildings at 3334 Clipper Road (Pers. comm, Doug Hooks, 2009). In addition, it reports mud and sediment crossing Clipper Road with minimal damage. We observed evidence of surface water flow from the base of the slope to Clipper Road and into the brush on the west side of the road (Figure 2).

Depositional patterns should only be considered an approximation.

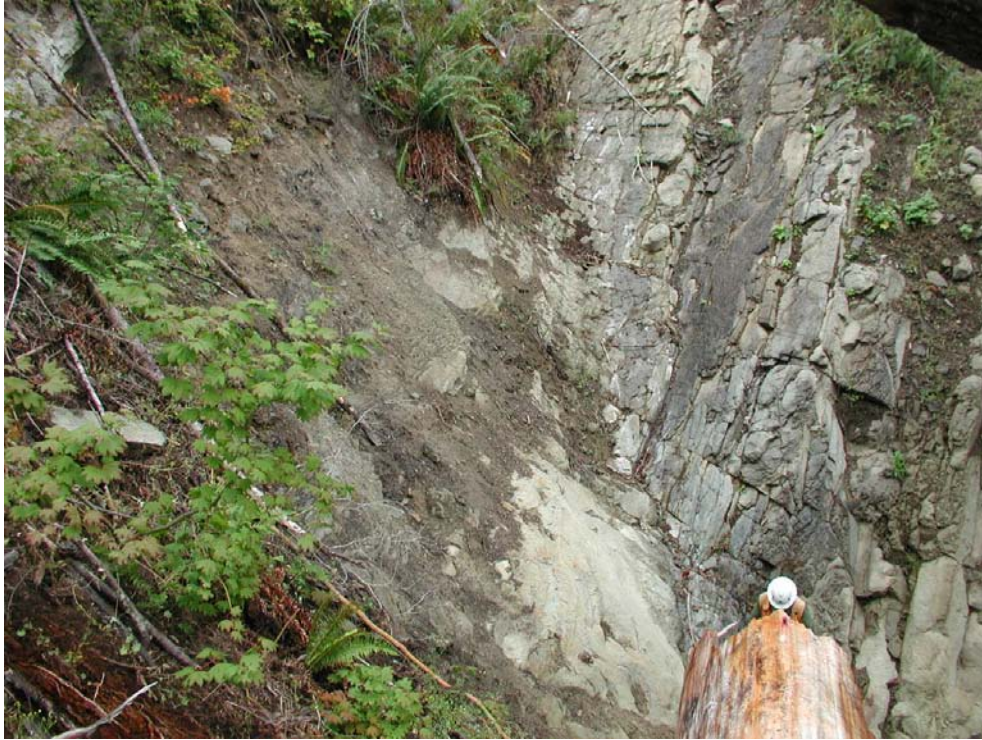
The PI is located on DNR-managed land. The debris slide PI involved the detachment of the soil layer from the underlying bedrock within an inner-gorge landform, and the channelized transport of this soil and debris down slope (Figure 4). The inner-gorge landform was within a buffer of standing conifer trees with diameters of approximately 2 feet – 4 feet at breast height. Slopes outside of the inner gorge landform in the vicinity of the PI were recently clear-cut as part of the Jack Straw Aerial Timber Sale.

Figure 4 Main Bittner Creek PI. Soil layer and organic debris slid off of bedrock surfaces on both sides of channel. View looking east. (Coyle, 2009)

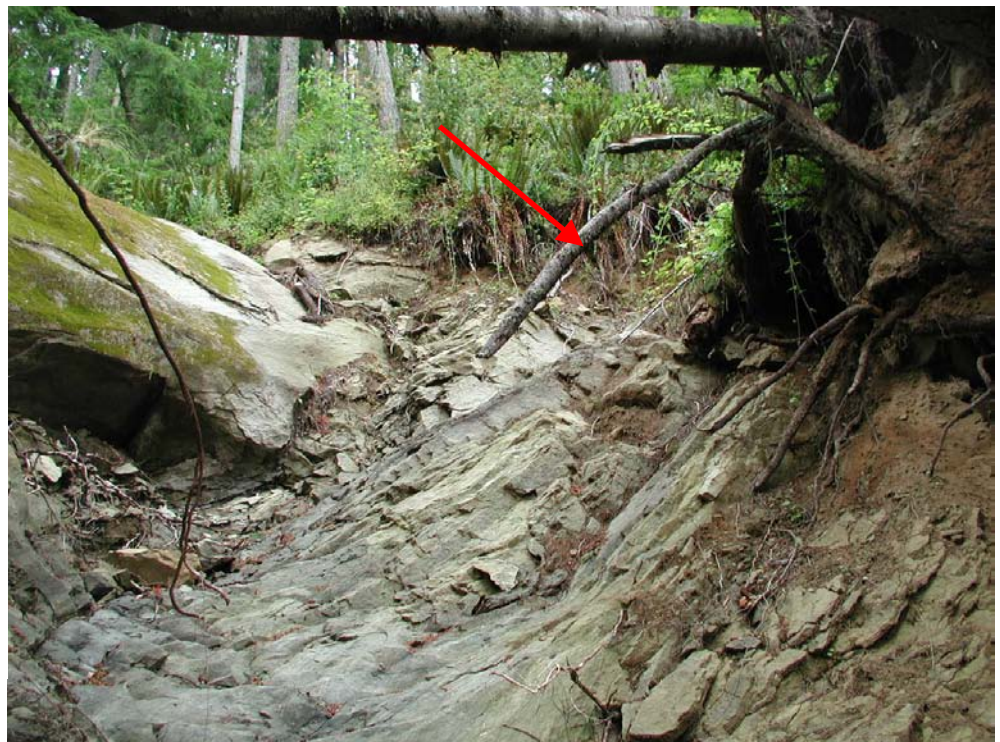
Fresh scour down to bedrock was noted along the channel in the inner gorge for 250 feet upslope to the east of the PI. Two small scale translational debris slides were noted in this reach, one approximately 210 feet upslope of the PI to the east and the other at the beginning of the scoured section 250 feet upslope of the PI (Figure 5). The scoured portion of the channel above the PI is evidence that a larger than usual volume of water was flowing through the channel during the January 2009 storm event. This likely eroded soil from the base of the inner-gorge slopes, destabilizing the soil layer on the steep inner-gorge slopes. In addition, the likely increase in soil moisture as a result of the storm increased the weight of the soil upslope. The removal of the soil down slope and the increase in weight of the soil upslope were likely major contributors to the translational failure of the soil layer over the bedrock.

Figure 5 Beginning of scour in Bittner Creek channel, approximately 250 feet upslope and to the east of the main PI. Note bedrock hollow landform and small debris slide scar indicated by the red arrow. View looking east. (Coyle, 2009)

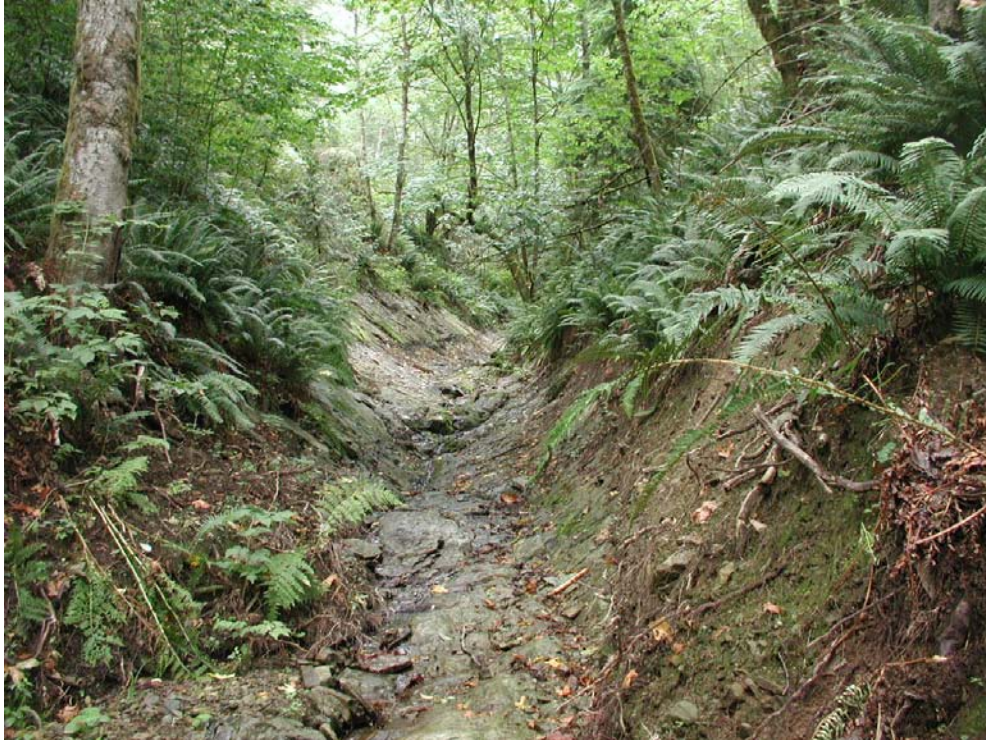
The pulses of debris, likely originating at the main PI, travelled down Bittner Creek as a debris flow (Hung, 2001) in the channel to depositional area at the base of the slope. Evidence of scour was observed along the entire length of the channel, from the PI to the mouth of the creek (Figure 6). In addition, we observed two translational earth slides in the inner-gorge along our traverse (Figure 3). In both cases, most of the material involved in the slides remained on the hillslope.

Figure 6 Bittner Creek channel scoured to bedrock. View looking east. (Coyle, 2009)

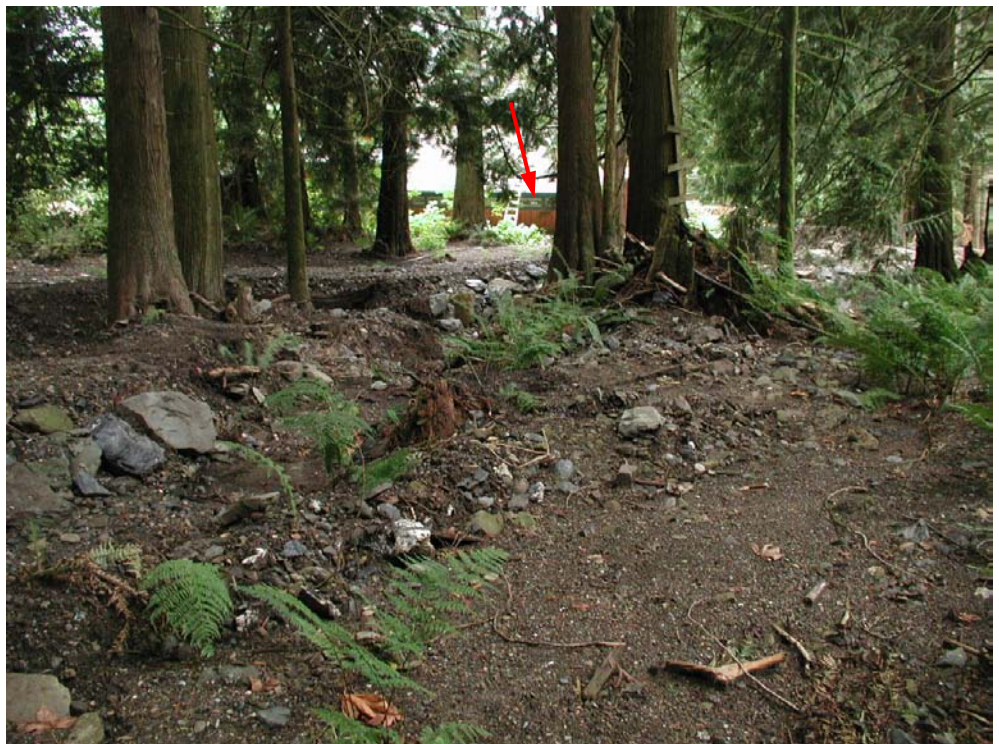
A large pile of slide debris accumulated at the base of the slope (Figure 2 and 3). Evidence for at least three separate lobes of material was observed in the field and likely

represents the flow of debris and water into topographic lows and around topographic highs. The main lobe of material and a reportedly newly formed stream channel flowed around and to the north of the house and outbuildings at 3334 Clipper Road (Figure 7, 8, and 9). Remnants of a water intake system for domestic water use were observed in the debris deposit along with wood, rocks, and sediment. Debris deposited west of the base of the slope generally consisted of cobble size particles and smaller. Evidence of particle sorting was observed indicating significant amounts of water likely deposited or reworked the material post deposition. In addition, a lobe of sediment and organic debris was observed trending toward the residence at 3312 Clipper Road.

Figure 7 Debris flood deposition area. House at 3334 Clipper Road is indicated by the red arrow. View looking southwest. (Coyle, 2009)

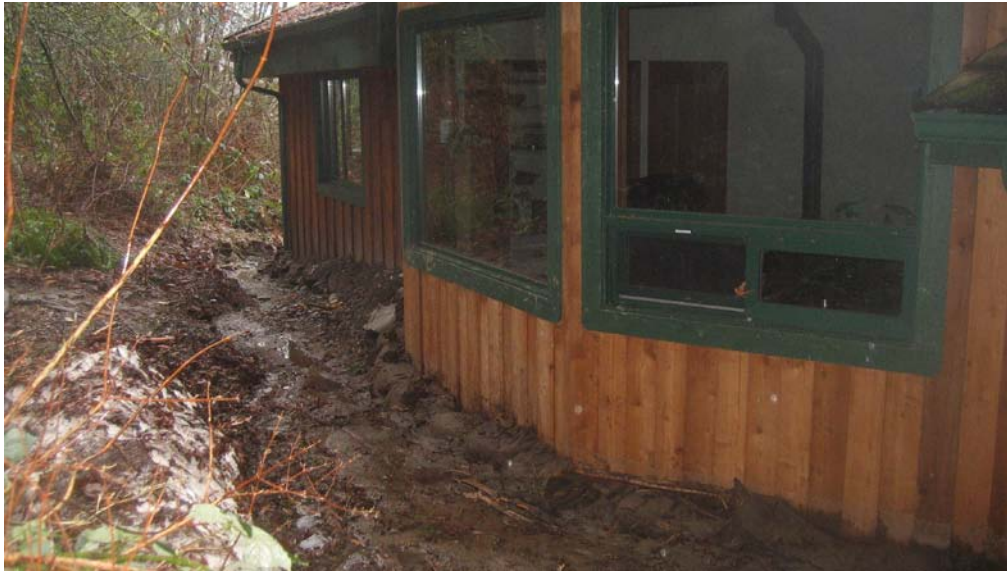
Figure 8 Debris flood deposition along the east side of the residence at 3334 Clipper Road. View looking south. (Hooks, 2009)

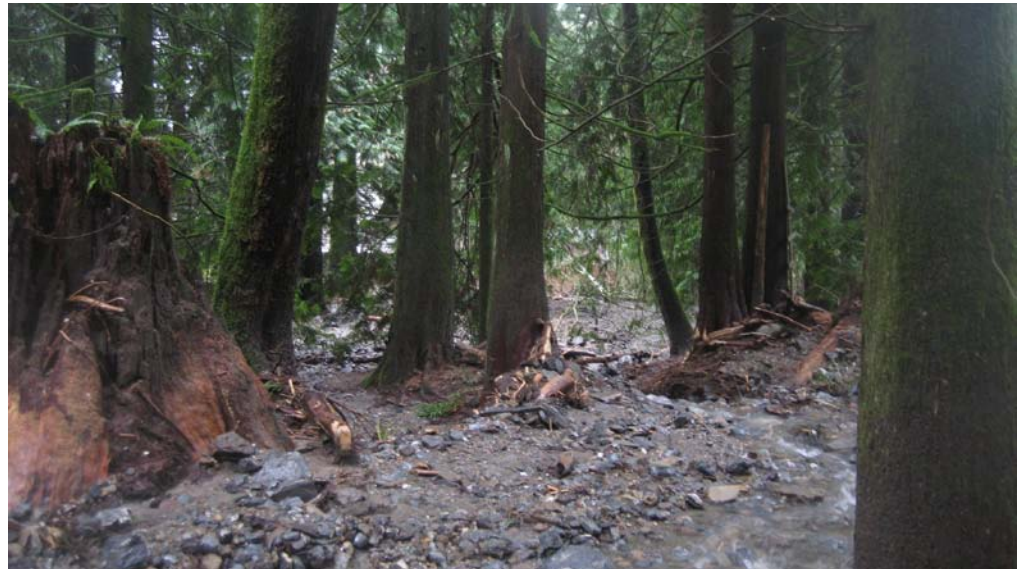
Figure 9 Debris flood deposition area. Note newly formed stream running through deposition area. View looking west. (Hooks, 2009)
