ENGINEERING GEOLOGIC FIELD RECONNAISSANCE

**DEBRIS SLIDE, DEBRIS FLOOD,
AND
AFFECTED PROPERTY**

**6578 Goodwin Road
Whatcom County, Washington**

July 17, 2009

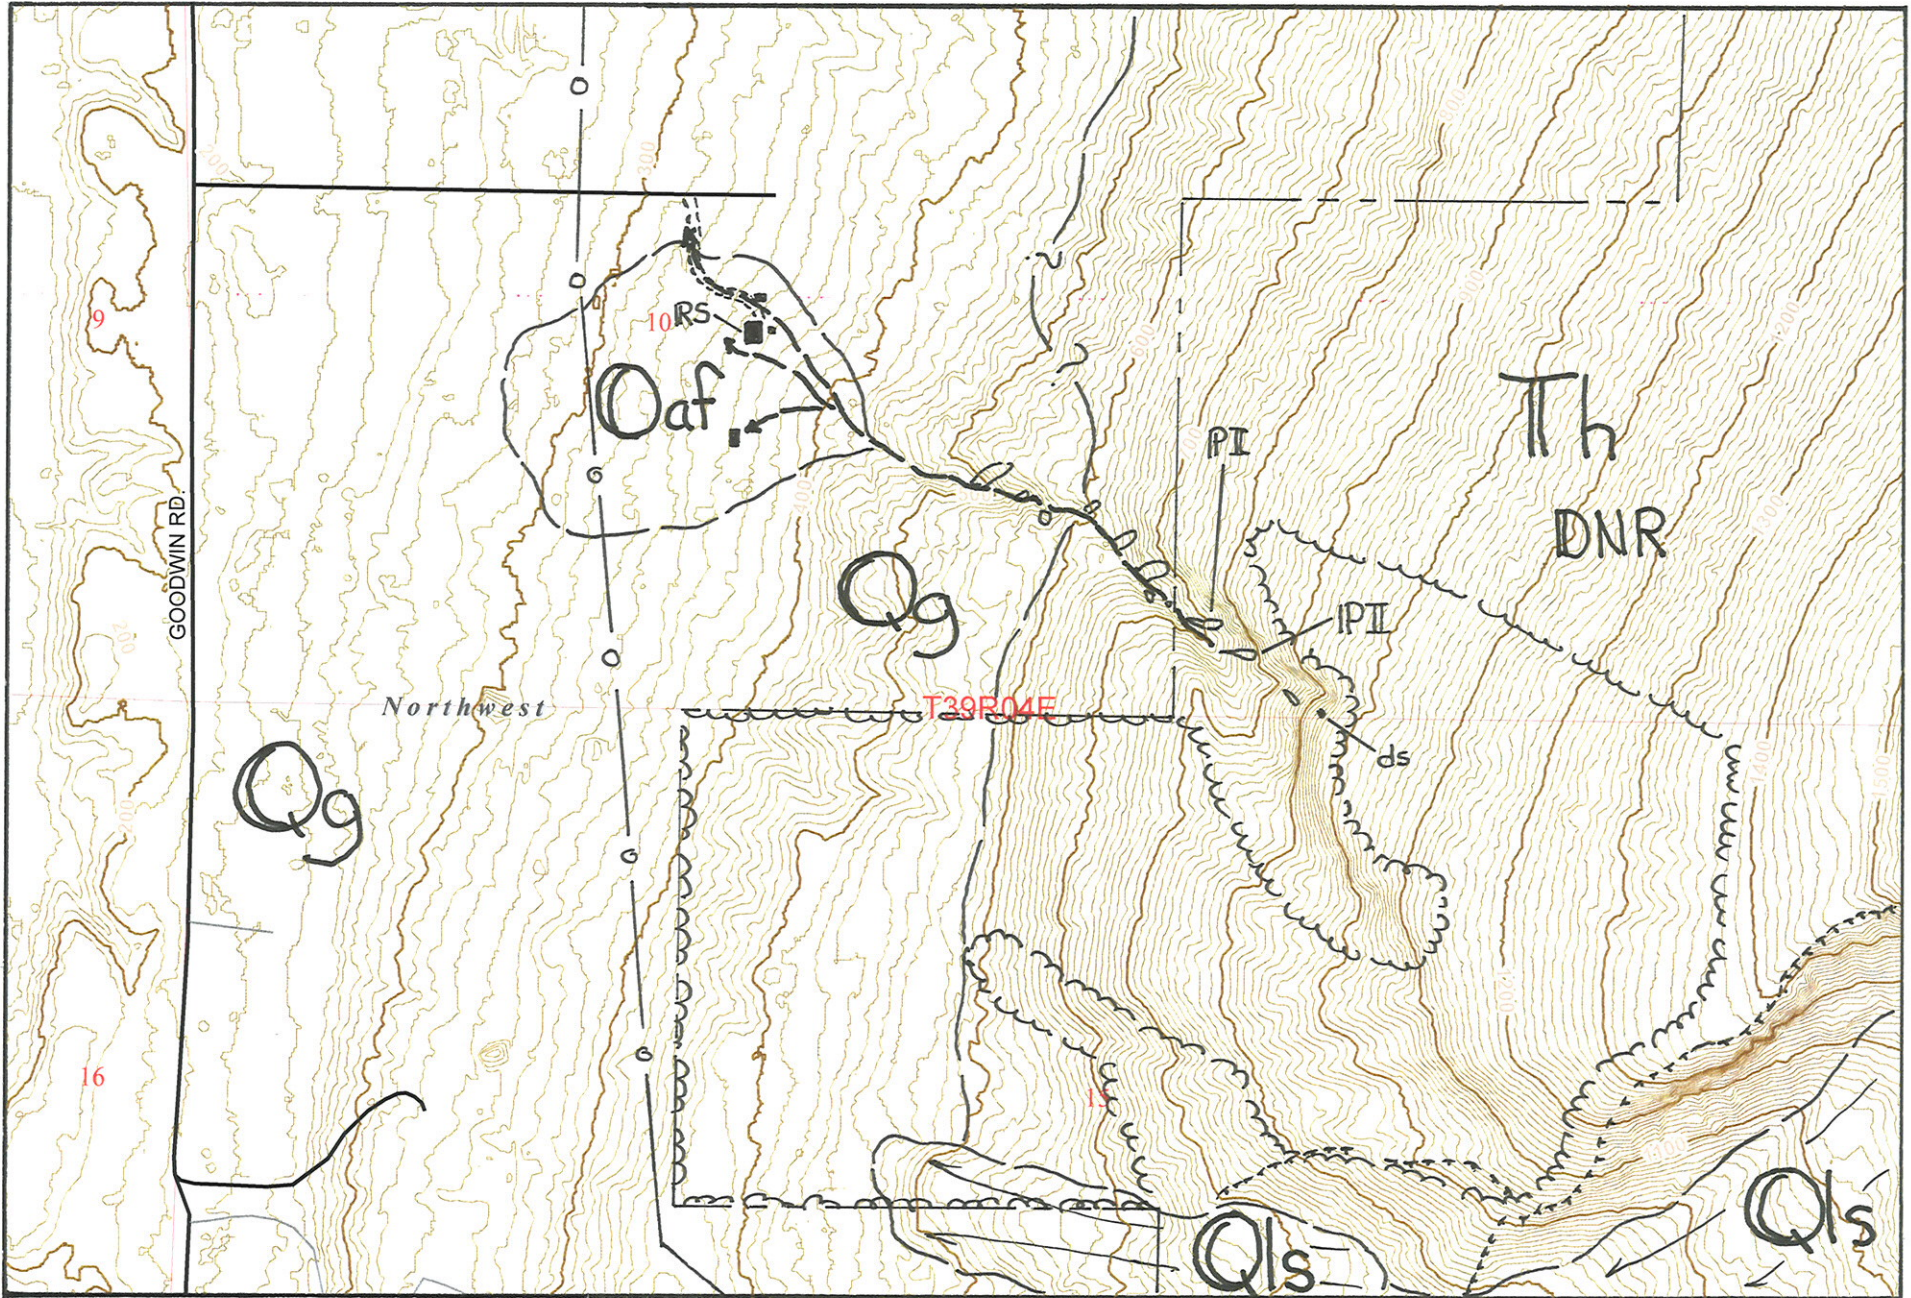
Figure 2. Simplified Geology Map
 Engineering Geologic Field Reconnaissance
 Debris Slide and Debris Flood Affecting 6578 Goodwin Road
 Whatcom County, Washington

Topographic evidence (e.g., bedrock hollows, convergent topography, and alluvial fans) suggesting past debris slide activity is present (Figure 2) in the area of the Site. The PI developed on steep slopes in an area of planner topography (Figure 2).

Several debris slide scars predating the early January storm were observed during our field reconnaissance of Jones Creek (Figure 2). These scars varied from shallow (est. < 1 ft. thick) soil slips occurring on steep bedrock surfaces to modest-size failures on inner-gorge slopes. These failures varied in length from 20 to 60 feet and width up to about 20 feet. All involved the soil cover and locally underlying weathered bedrock.

As Figure 2 shows the debris slide and associated flood began on a west-facing slope in the upper reaches of Jones Creek. It appears that two separate debris slides, that are in close proximity of each other, were the causative slides. It is uncertain if the slides failed at essentially the same time, or failed with some period of time between the failures. In this report these two slides are together treated as the Point of Initiation, the PI. The area of the PI is in an un-managed area (Figure 3) below a portion of the Gasping Goodwin Aerial timber sale. The PIs are in the mature timber near the base of an approximate 50- to 60-foot high bedrock cliff. The eastern most PI occurred on planner slopes characterized by 70% to 90% inclinations. The area of this PI is underlain by colluvial deposits, no bedrock was observed in the debris slide scar. The crown of the scar is estimated to be about 40-feet wide and the scar about 3-feet deep. No evidence for concentrated water flow following failure was observed. About 70 feet to the west is the other debris slide scar also clearly associated with the January 2009 storm. This scar certainly also contributed to the debris flow and flood. It is estimated to be about 20-feet wide and about 30- to 40-feet long and several feet deep. This scar (as noted earlier in **Section 4.5.**) exhibits a relatively shallow gully suggesting concentrated water flow following failure. Again the slide appears to be confined to colluvium, for no bedrock was observed. The bedrock cliff above this scar is characterized by joints that have created a very steep poorly-developed cleft-like feature that could concentrate surface-water flow; however, evidence for concentrated surface flow from the cliff was not noted.

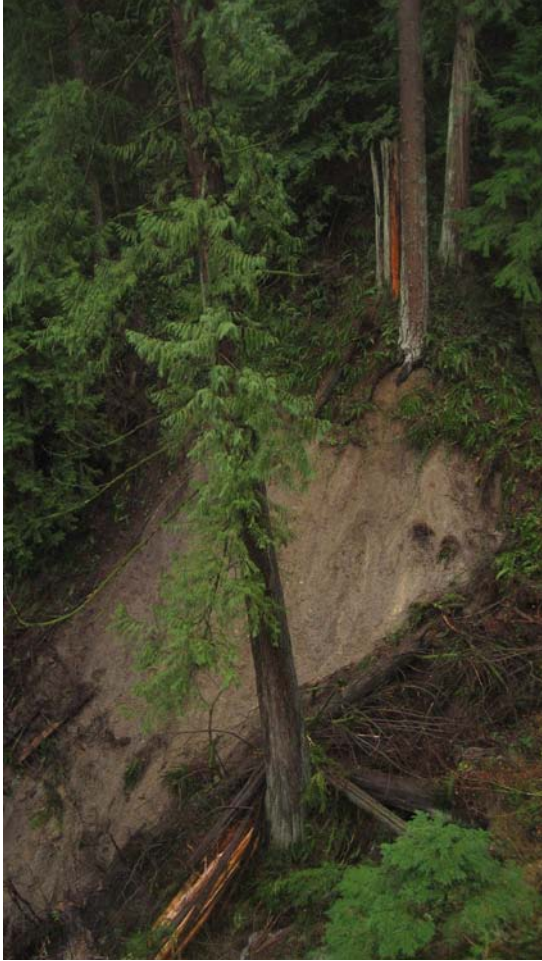
Figure 3. Upper portion of eastern most debris slide scar of the PI. The other debris slide scar that is part of the PI is about 70 feet to the west (left in the photo). View looking to the north.

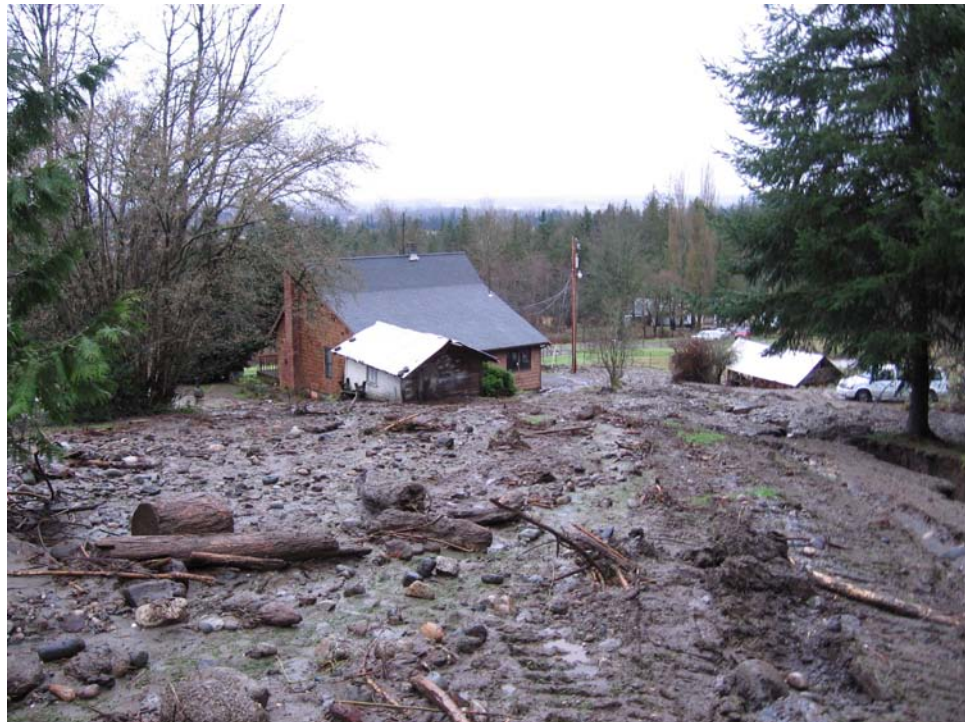
The earth materials (sand, gravel, and finer sediment) along with the organic debris that became the debris flood at the mouth of Jones Creek were deposited across areas of the property (Figure 2), predominately portions of the lower areas of the property (Figure 4). The debris apparently filled the artificial ditch constructed to carry the creek to the south, and the creek cut a new course to the northwest down the gravel/dirt driveway (Figures 5 and 6). Locally the depth of the new channel was significant. A “blanket” of gravel was deposited across the driveway and, locally, hillside areas to the north side of the residence (Figure 7); the gravel blanket extended down slope toward the one-lane road that extends eastward from Goodwin Road (Figure 8 and 9). Run off from the newly eroded channel continued along the western margin of the property and into a drainage ditch on the south side of the one-lane road.

Figure 4. View of debris deposited on upper area of alluvial fan. Residence with blue-gray roof, other structures are out buildings. View looking northwest.
(Photograph by D. Hooks)

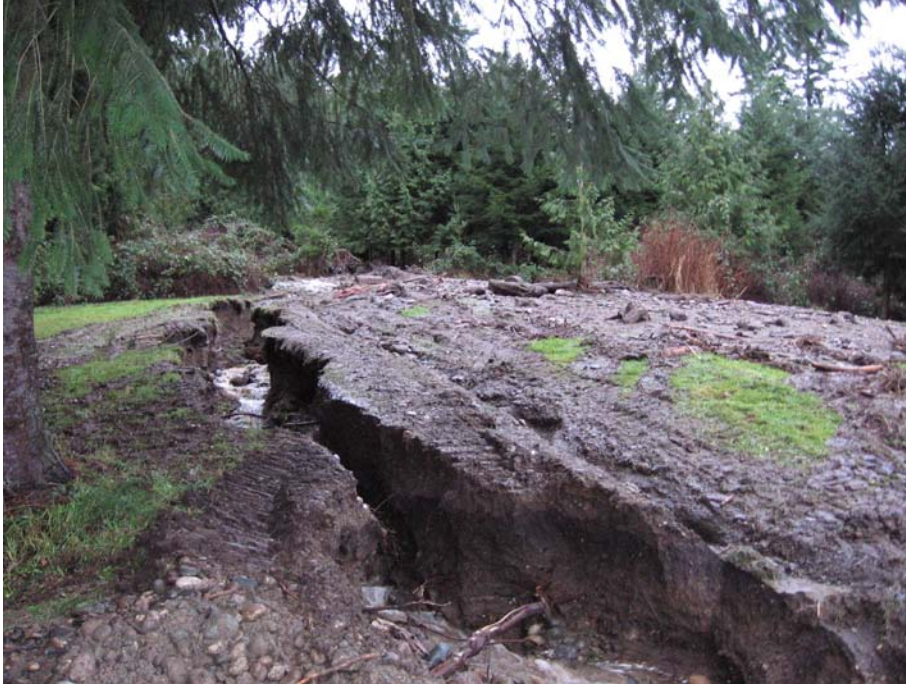
Figure 5. View looking up slope toward apex of alluvial fan that has developed at mouth of Jones Creek. Gully eroded by storm runoff crosses left area of photograph. Sediment and organic debris deposited by debris flood seen to left (south) of gully. View looking southeast.

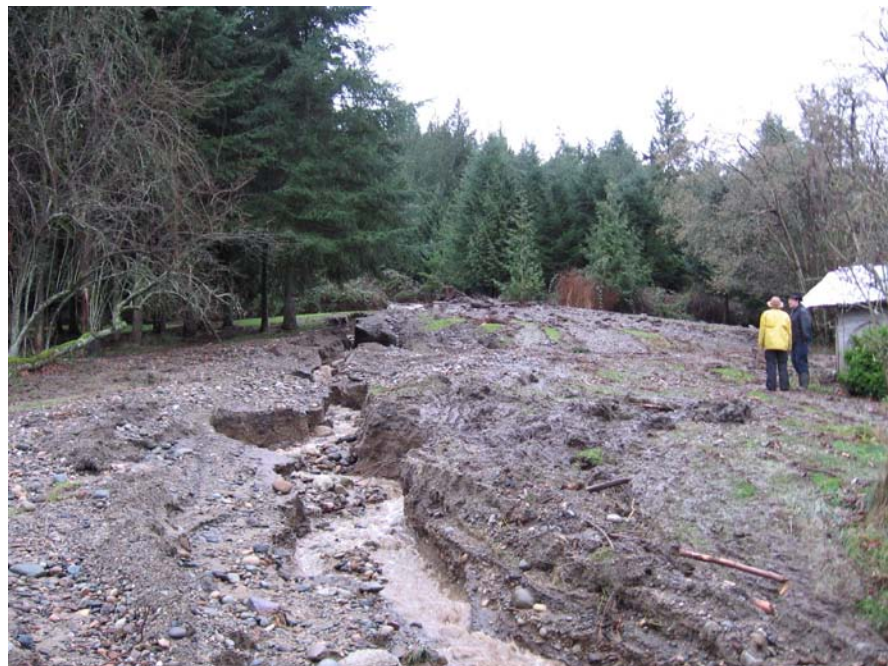
Figure 6. Photograph looking up slope on alluvial fan and gully showing volume of debris deposited and water in gully. View looking southeast.

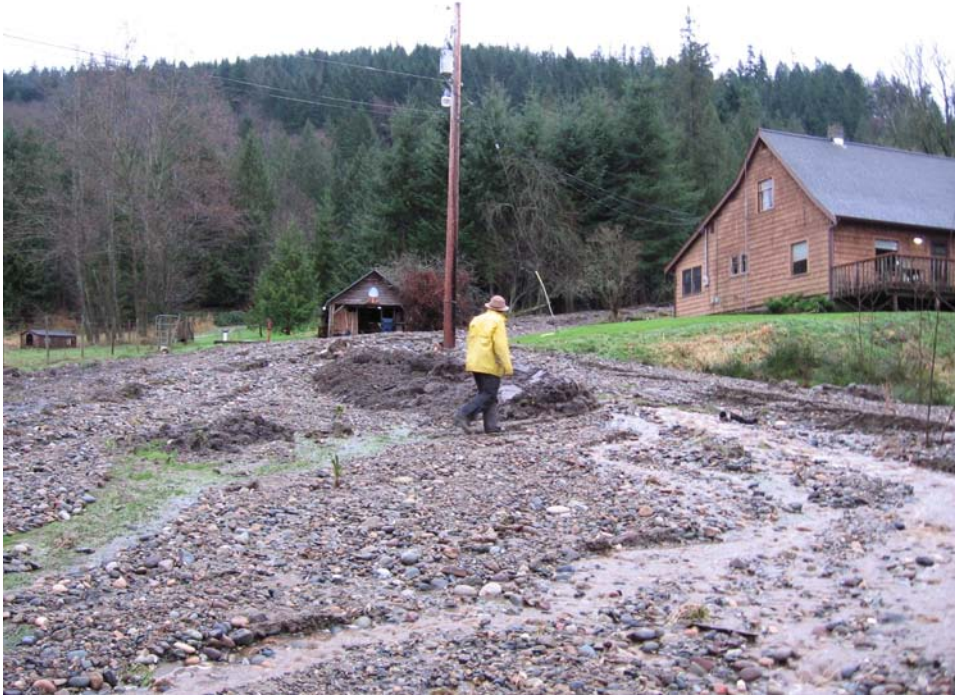
Figure 7. View of debris deposited on lower area of alluvial fan and covering driveway. Note runoff in shallow channels eroded in debris. View looking southeast.
(Photograph by D. Hooks)

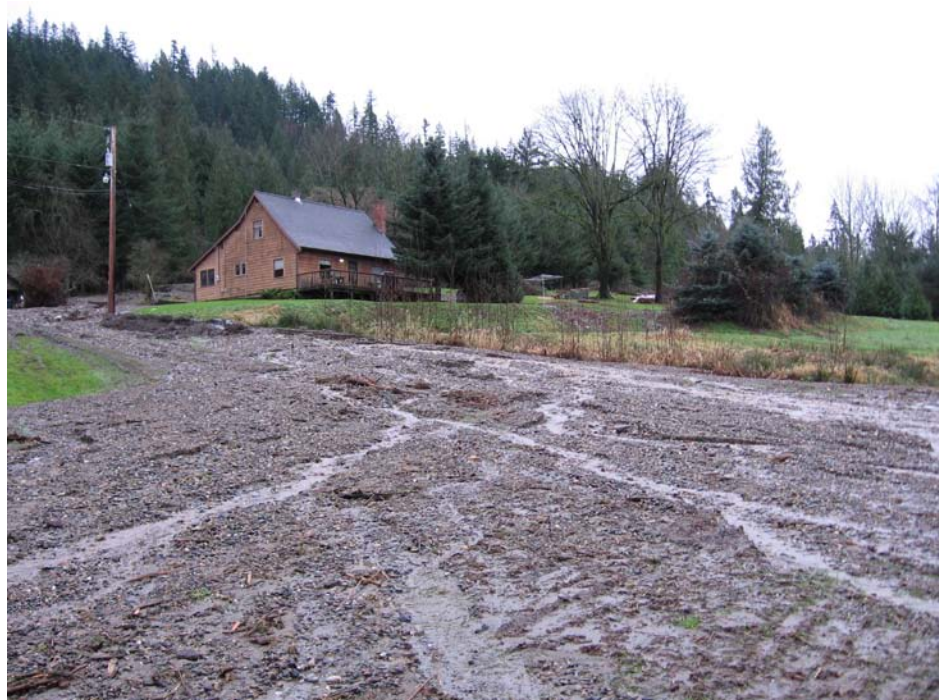
Figure 8. View of debris spread out across lower areas of Site, including driveway and vegetated areas. View looking to the southeast.
(Photograph by D. Hooks)

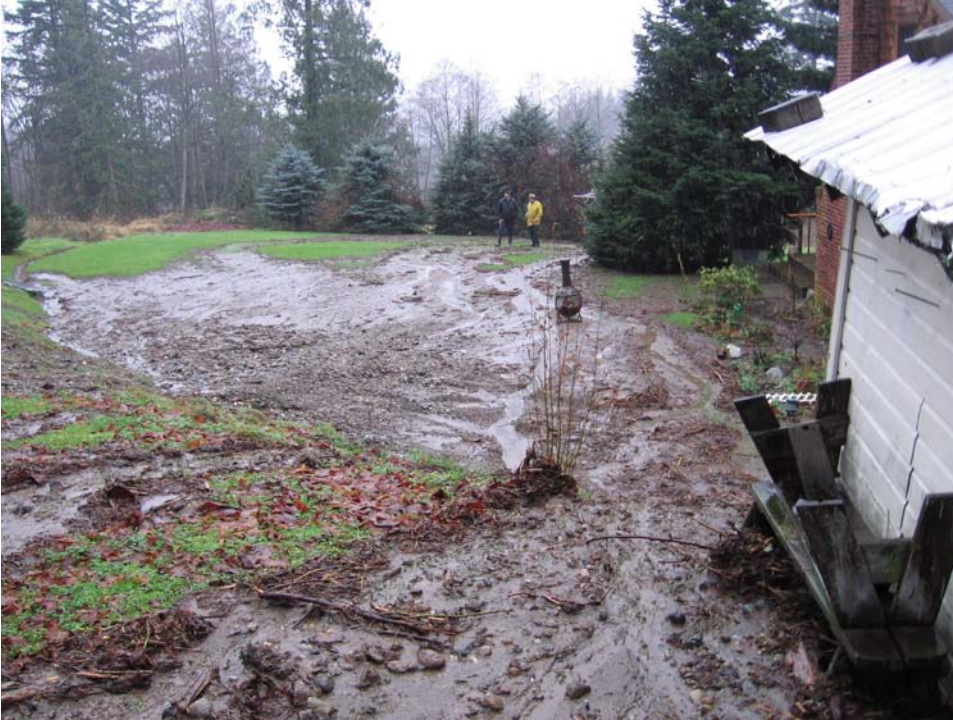
Figure 9. Lobe of debris that flowed over vegetated areas on south side of residence (red brown structure in background on right side of photograph). White structure is an out building. View looking west.
(Photograph by D. Hooks)

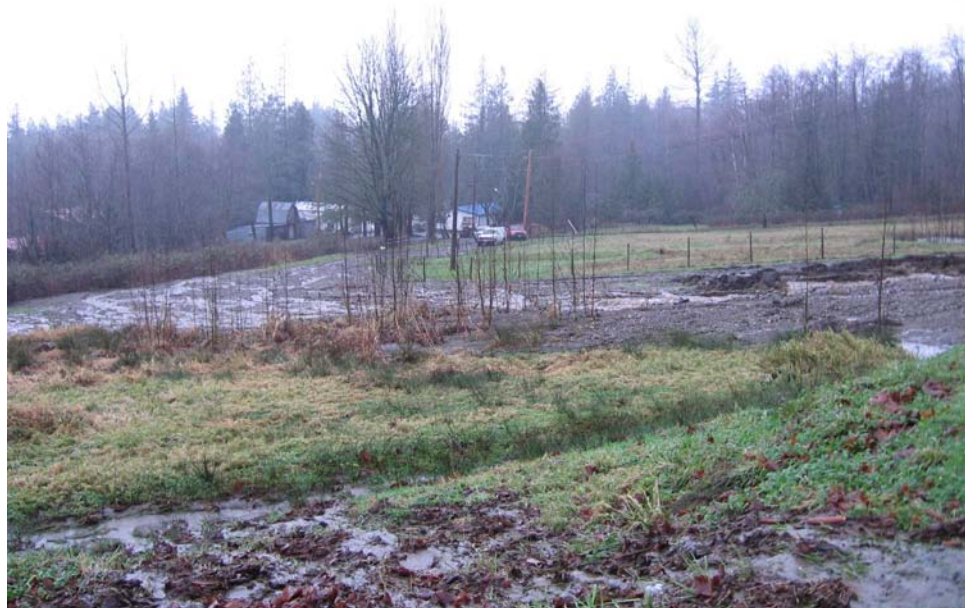
Debris was also deposited in areas on the south side of the residence (Figure 10) and sediment accumulated in the narrow walkway area on the eastern side of the residence. Though no mud or debris entered the residence, sediment entered or surrounded small outbuildings to the north or east of the residence. Sediment also accumulated along the east side of the workshop and entered that structure.

Figure 10. Overview of debris deposited on lower areas of Site and driveway extending to the western edge of the property. View looking northwest.
(Photograph by D. Hooks)
