ENGINEERING GEOLOGIC FIELD RECONNAISSANCE

**DEBRIS SLIDE, EARTH SLIDE, DEBRIS FLOODS,
AND
AFFECTED PROPERTIES**

**3208, 3235, 3260, and One Un-Addressed Property, Clipper Road
Whatcom County, Washington**

September 3, 2009

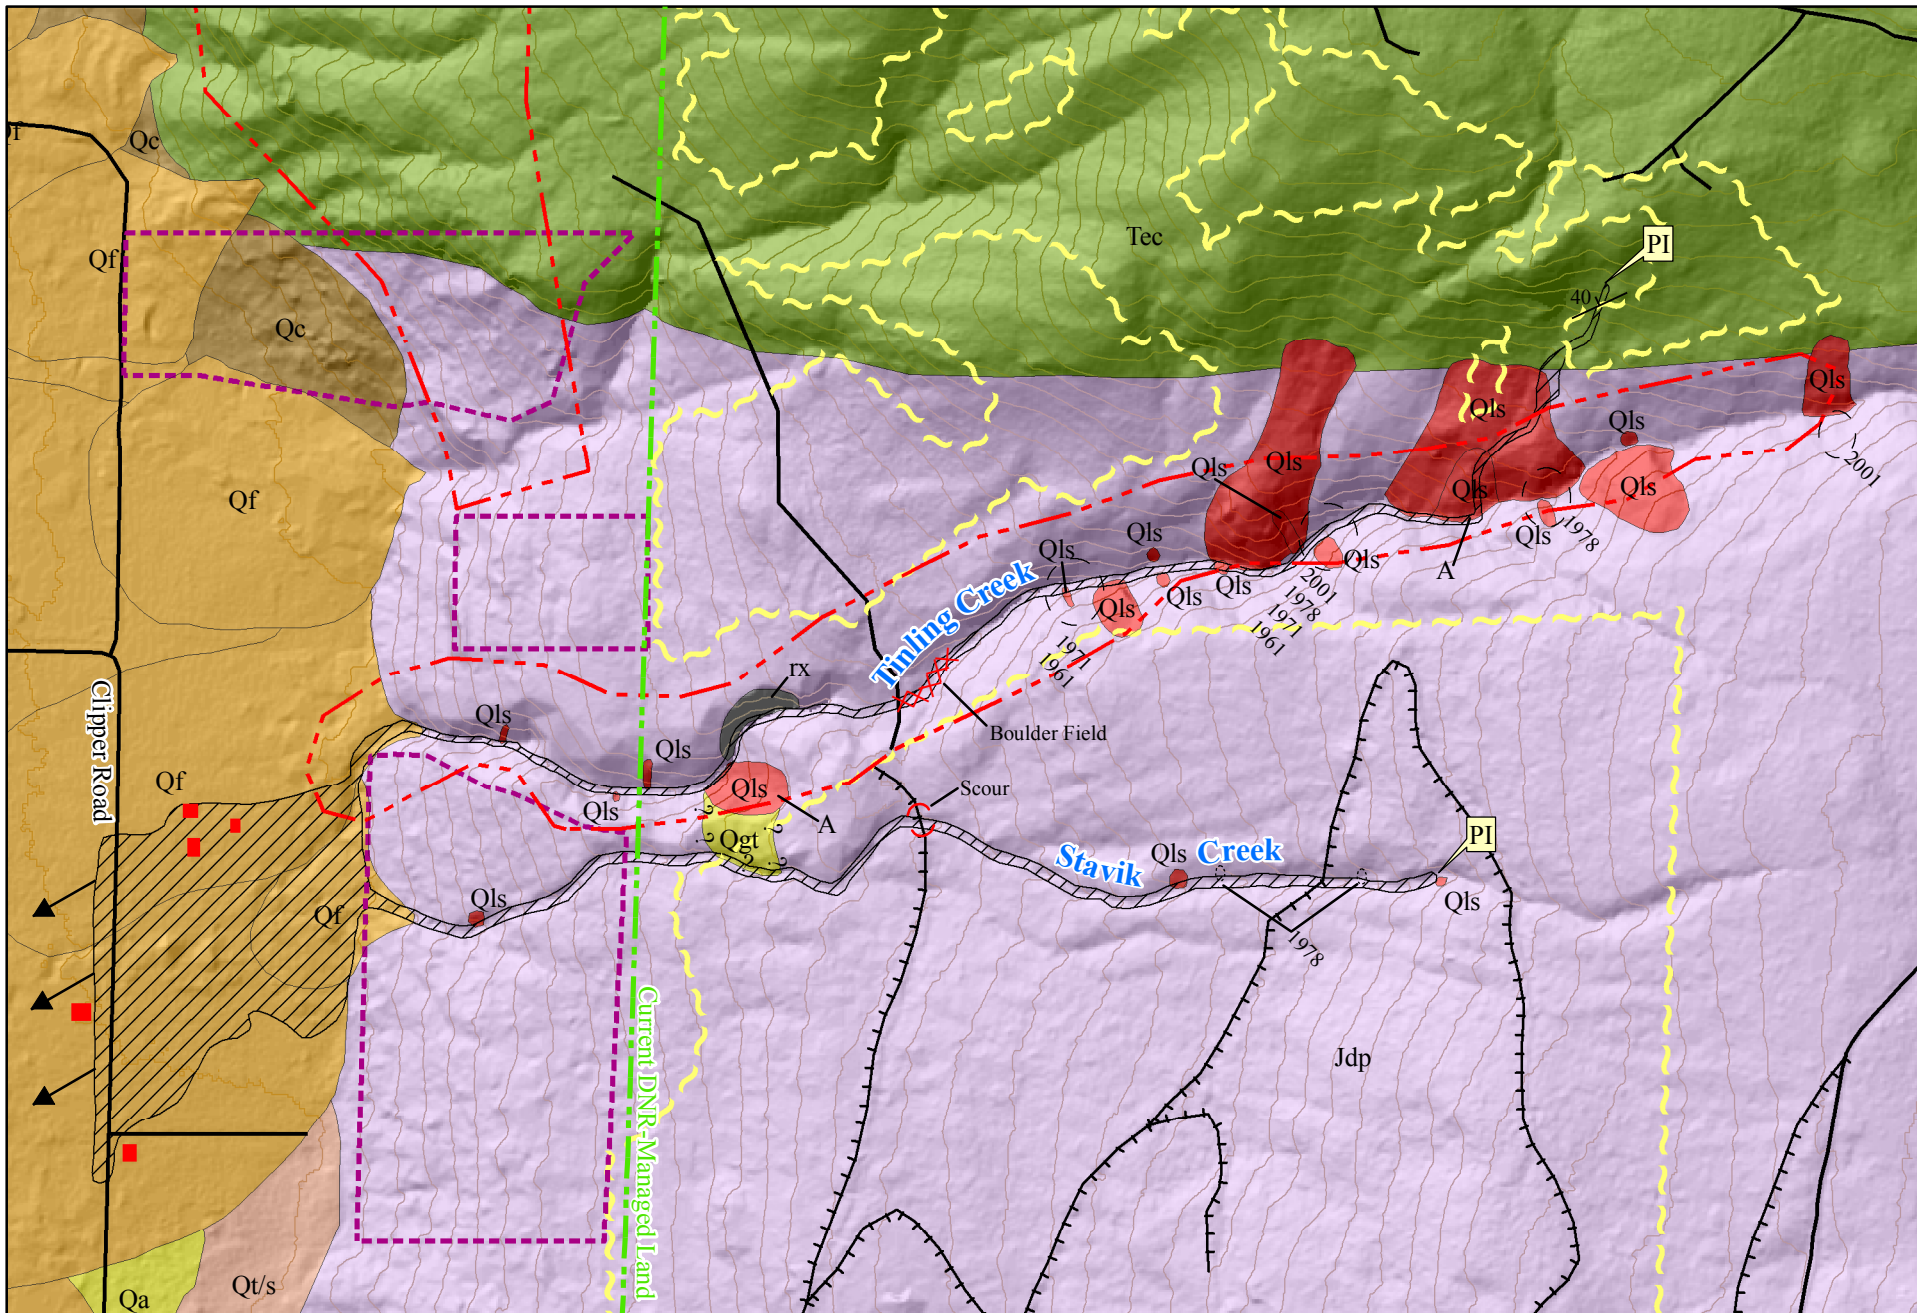
Figure 3. Geologic Site Map

A significant size rock fall was observed on the north side of Tinling Creek about 900 feet from the mouth of the creek (Figure 3). The rock fall is about 200-feet long; an estimated 100-feet high, and may be related to other landslide processes affecting the slope at that location. In the channel the rock fall deposit may be up to 10- to 15-feet thick. It appears that the rock fall likely occurred after the main debris slide/flow event, for no debris, except for a few small sticks, were observed on the blocks of rock in the channel.

Active channel side-slope landslides observed during field reconnaissance of Tinling Creek. Slides with arrows are deep-seated slides inferred by topographic contours; rx = rock fall

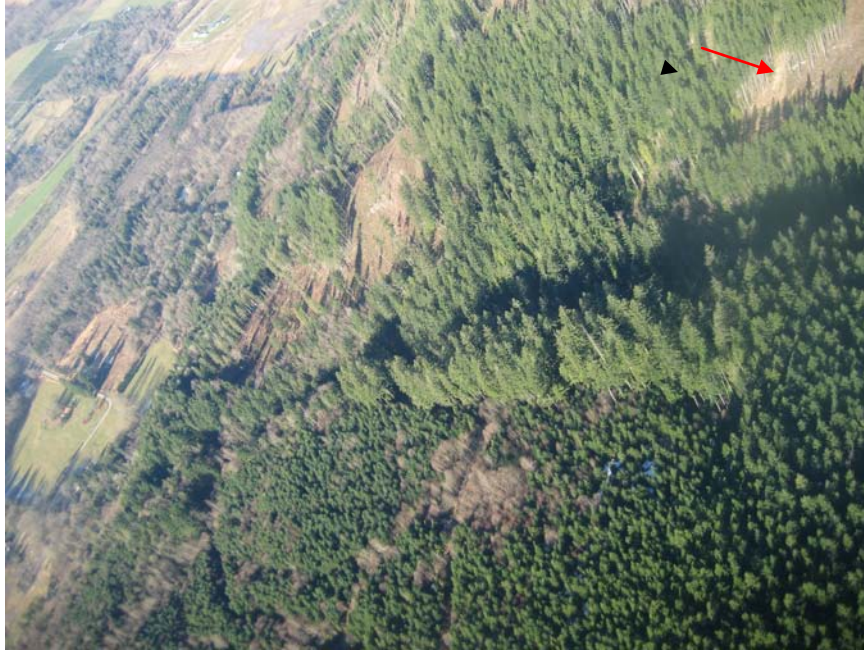
the scar following the failure event. No evidence for overland flow into the area of the PI was observed on the slopes above the PI. In our opinion, this slide scar marks the main PI of the debris slide event that coursed down Tinling Creek.

Figure 4 Aerial view of Tinling Creek PI. Red arrow in the upper right corner of photograph points to PI and debris slide scar. Tinling Creek is in shadowed area through central area of photograph. Photo is inclined due to position of helicopter at time photograph was taken. View looking northwest. (Hooks, 2009)

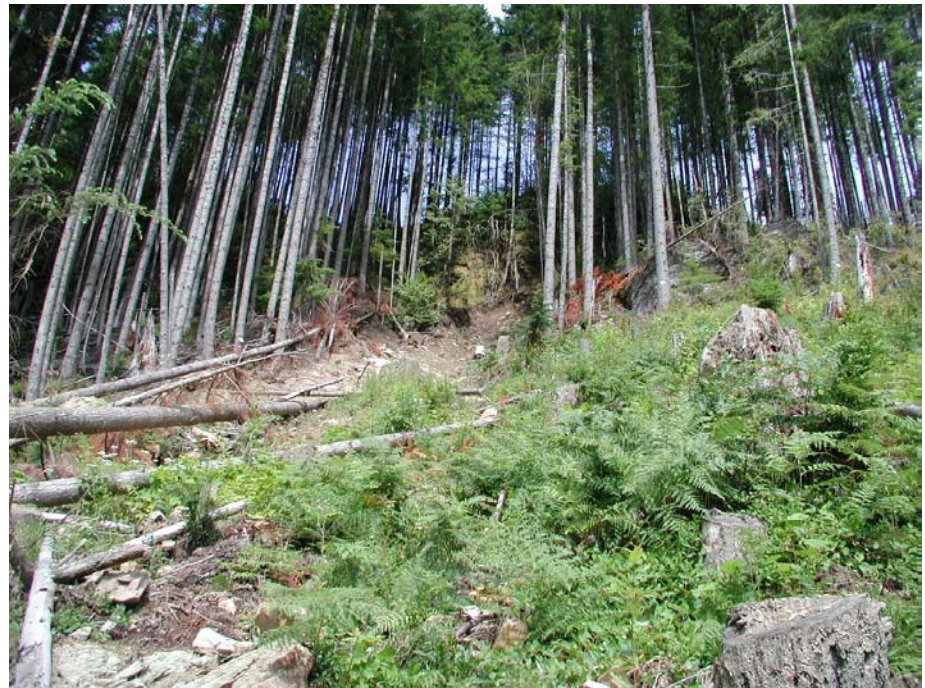
At the Tinling Creek PI it appears that the fractured nature of the bedrock combined with the steep, broadly convergent topography of the PI to concentrate groundwater. At the Stavik Creek PI, the steep topography of the channel-side slope and the bedrock structure could have been the likely factors contributing to the failure at that site.

Figure 5 Ground level view of Tinling Creek PI. Head scarp can be seen in stand of mature trees. View looking northwest. (Hanell, 2009)

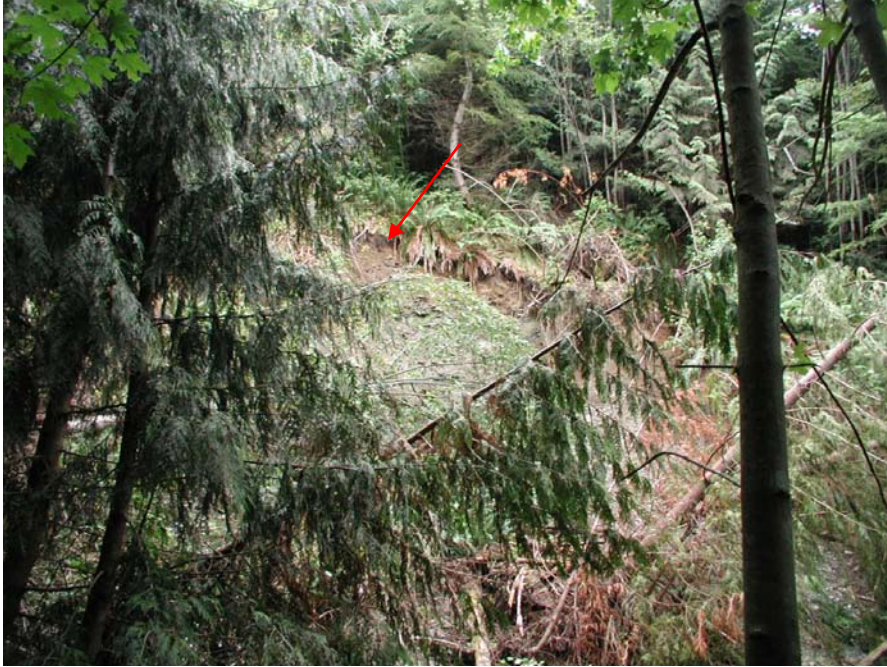
Stavik Creek – In Stavik Creek the PI developed at an elevation of about 1,300 feet on the south side of the channel (Figure 6) between the upper two pulled road-crossings (Figure 3). The PI is a modest-size slide estimated to be about 50-feet long, 100-feet wide along the channel bottom, and up to about 5- to 7-feet thick. The channel is not scoured above this slide, but the channel does show evidence for scour below the slide. The side slopes at the PI exhibit inclinations of about 85%. A couple of seeps were noted above the PI, but at the PI water is flowing in the channel. It appears that not all the slide debris associated with the PI was mobilized and perhaps 40% of the total volume of the initial slide is still present.

Figure 6 Stavik Creek PI. Red arrow points to bare ground in scarp in central area of photograph. View looking south. (Hanell, 2009)

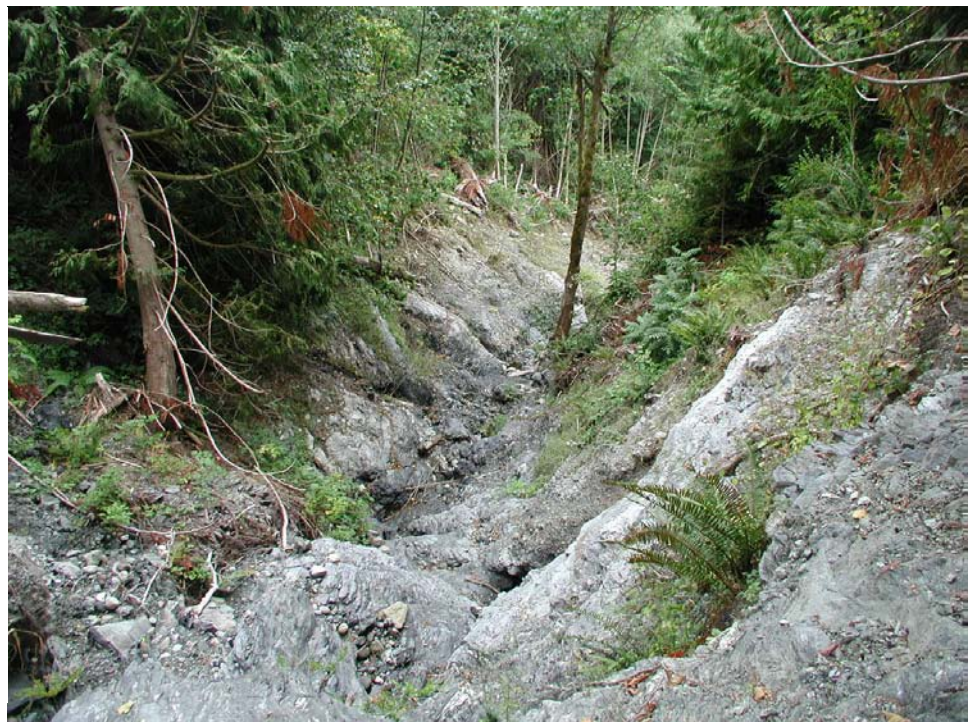
Figure 7 Scoured channel of Tinling Creek. Phyllite bedrock is exposed in sides and bottom of channel. View looking downstream to the west. (Hanell, 2009)

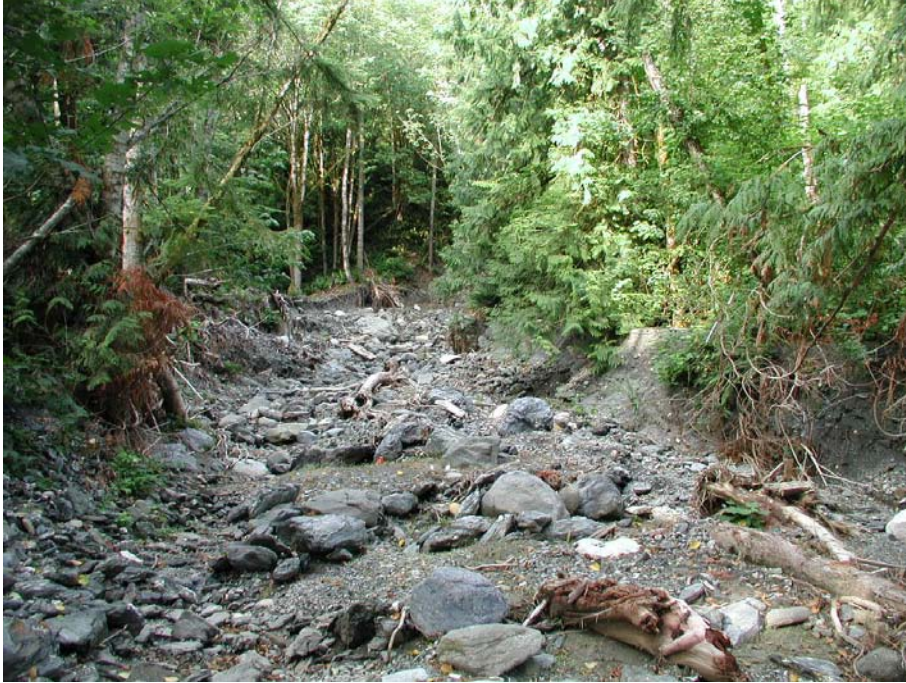
Figure 8 Boulder field in Tinling Creek. Phyllite bedrock exposed. View looking down channel to the west (Hanell, 2009)

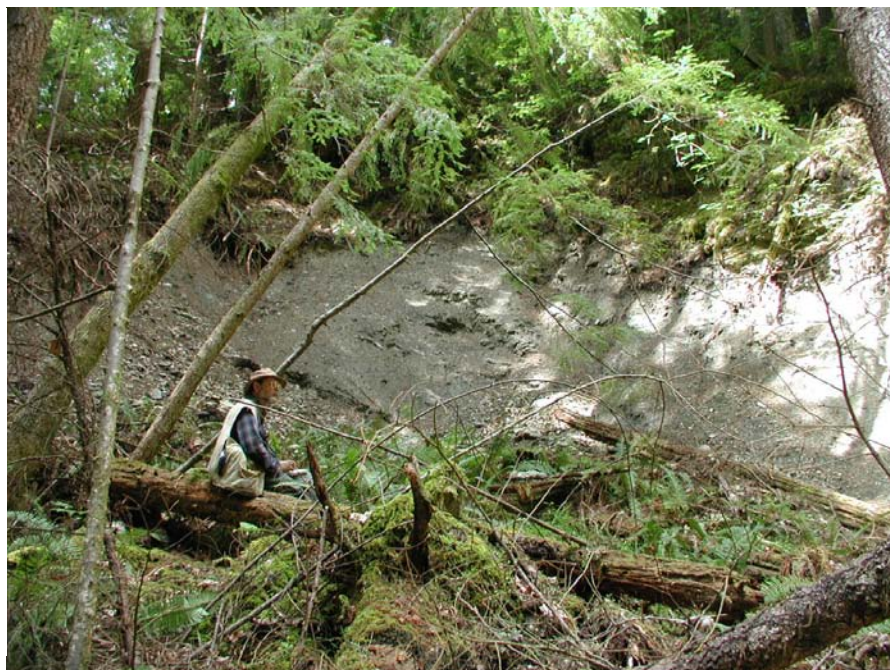
As discussed earlier the passage of the debris may have triggered some of the relatively smaller channel-side slides noted in **Section 4.4** (Figure 9). However, it is more likely that most of these slides occurred well after the passage of the debris flow. The general intact nature of the slide deposits where they sit on the channel floor and the lack of evidence that they have been modified by passage of anything but running water suggest that they occurred after passage of the debris flow. Likewise the lack of sediment and rock debris and the lack of organic debris of any appreciable size and amount suggest the rock fall discussed in Section 4.4. also occurred after passage of the debris flow.

Figure 9 Channel side-slope slide. in Tinling Creek. View looking up channel to the east. (Hanell, 2009)

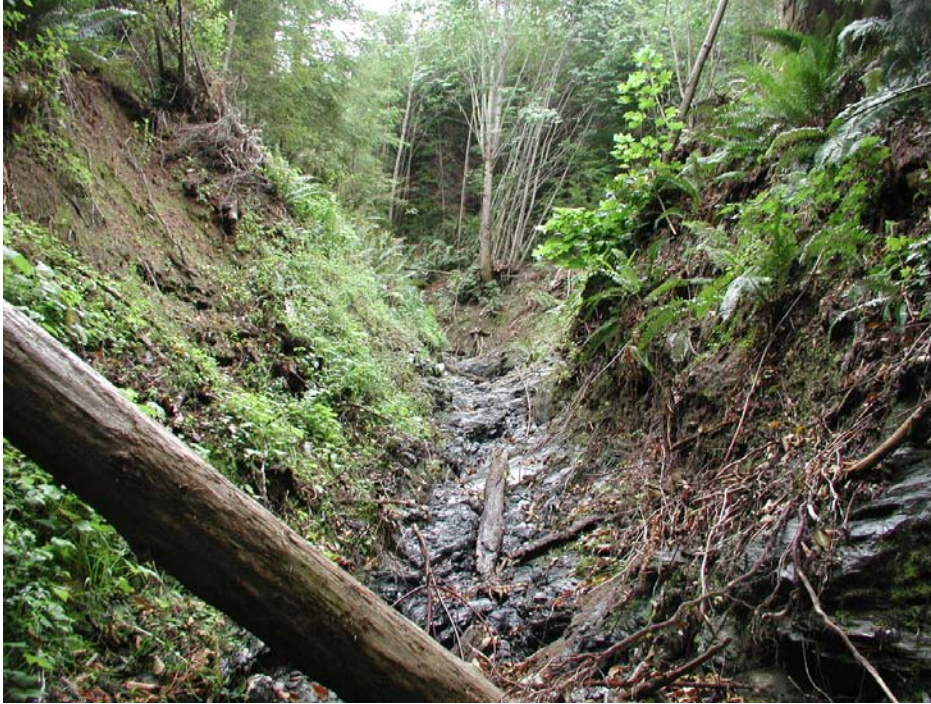
Figure 10
Scoured
portion of
Stavik Creek.
Phyllite
bedrock is
exposed in
channel
bottom. Note
side-slope slide
in left side of
photo. View
looking down
stream to west.
(Hanell, 2009)

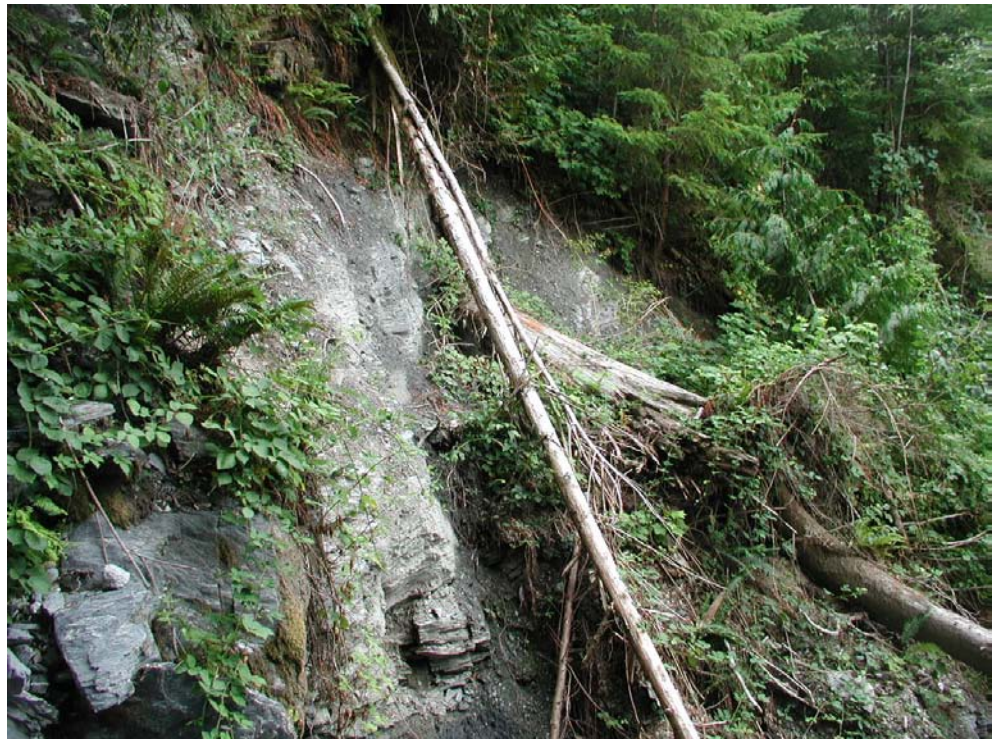
Figure 11
Channel
side-slope
slide in
Stavik
Creek.
Phyllite is
exposed in
slide scar.
(Hanell,
2009)

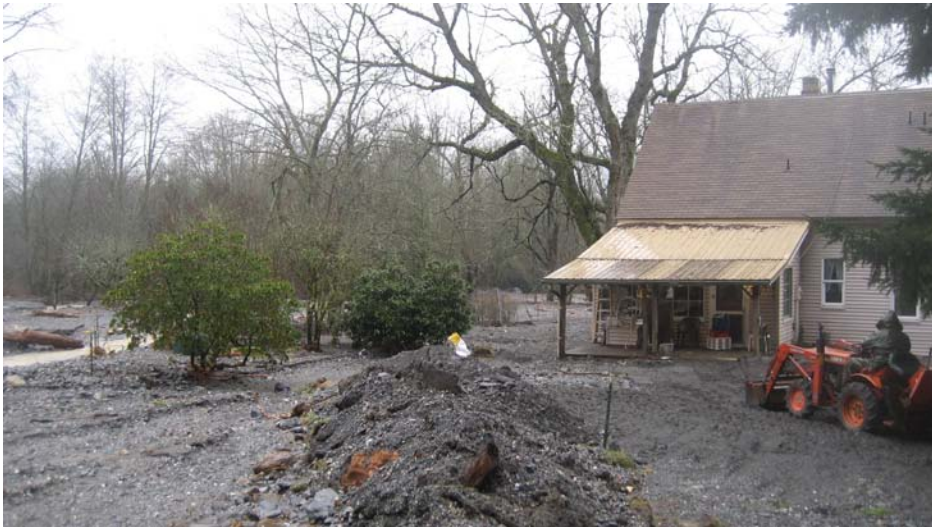
Figure 12
Debris flooded area behind Stavik residence. Note debris up to porch and “new” stream course in left of photograph. View looking southwest. (Hooks, 2009)

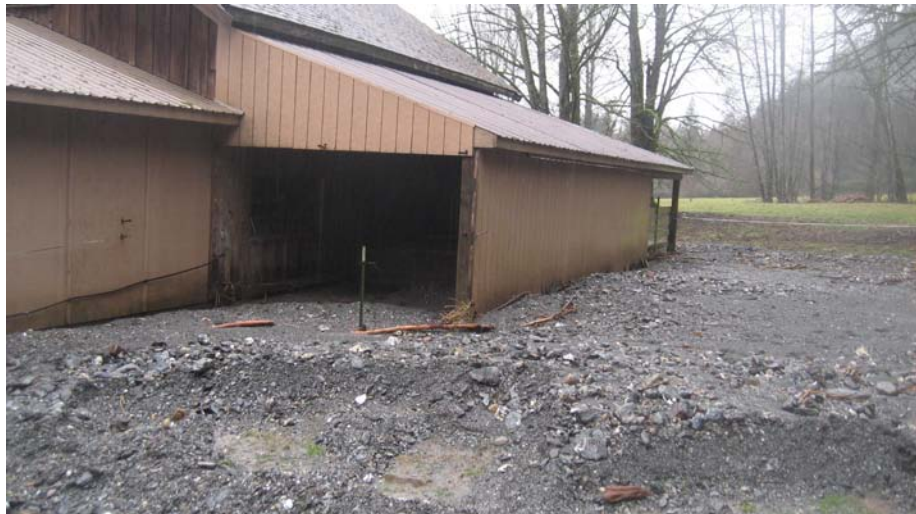
Figure 13
Debris against barn walls, Stavik property. View looking northwest. (Hooks, 2009)

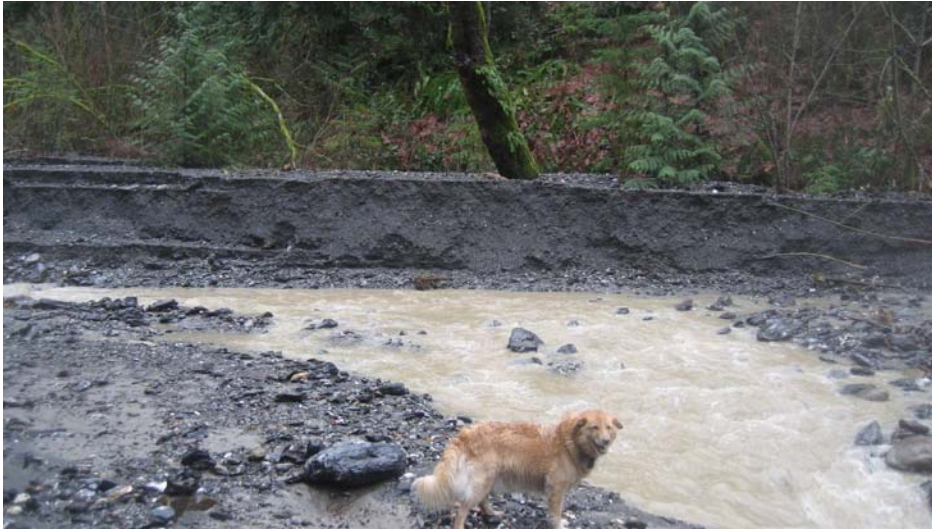
Figure 14
Photograph showing thickness of sediment deposited by debris flood from Tinling Creek. View looking east. Maggie for scale. (Hooks, 2009)

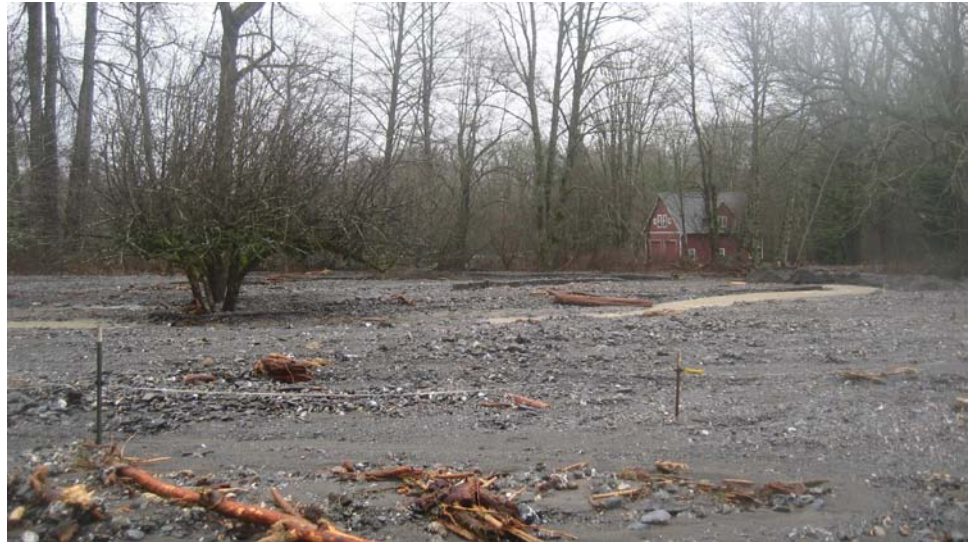
sediment, and small organic debris. The culvert under Clipper Road was blocked. The debris ran down Clipper Road to the south and across Clipper Road and on to properties on the west side of the road (Figure 15). A layer of sand and silt, small rock fragments, and minor amounts of small organic debris was deposited over the approximate area shown on Figure 3. As also noted earlier, deposition of the flood debris forced Tinling Creek to create a new channel across the southern area of the Stavik property; but in the same general area it was in prior to January 2009.

Figure 15 View of southern area of Stavik property. Red residential structure at 3235 Clipper can be seen in the background. (Hooks, 2009)
