# THE PUGET LOWLAND EARTHQUAKES OF 1949 AND 1965

REPRODUCTIONS OF SELECTED ARTICLES  
DESCRIBING DAMAGE

Compiled by  
GERALD W. THORSEN

WASHINGTON DIVISION OF GEOLOGY AND EARTH RESOURCES  
INFORMATION CIRCULAR 81

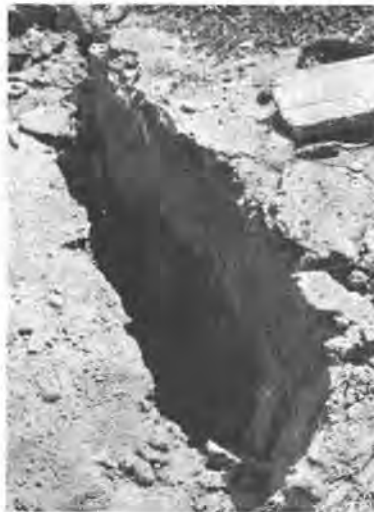
**THIS FISSURE** and others extended about 100 ft. in an old gravel pit near Centralia. At many locations, consolidation of alluvium by vibratory action of the earthquake freed water retained in spaces between soil particles, causing geysers of mud.

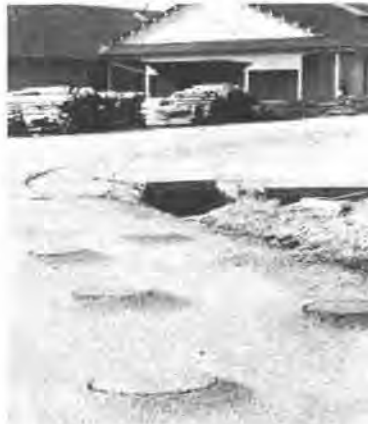
**SUBSIDENCE OF FILL** brought this old piling to view through asphalt pavement in Olympia. In other areas, piles not driven to refusal dropped out of sight, while some freestanding piles rose.

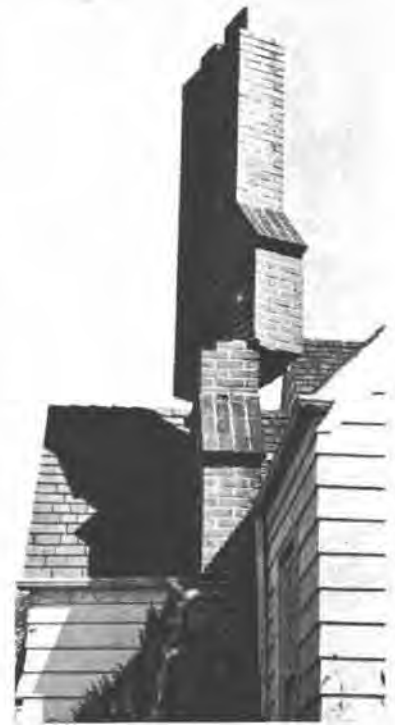
**MORE THAN 10,000** unreinforced brick chimneys in the Northwest required repair after the quake. Many just turned on a mortar joint, as at this residence in Kelso, but far too many created hazards by toppling.

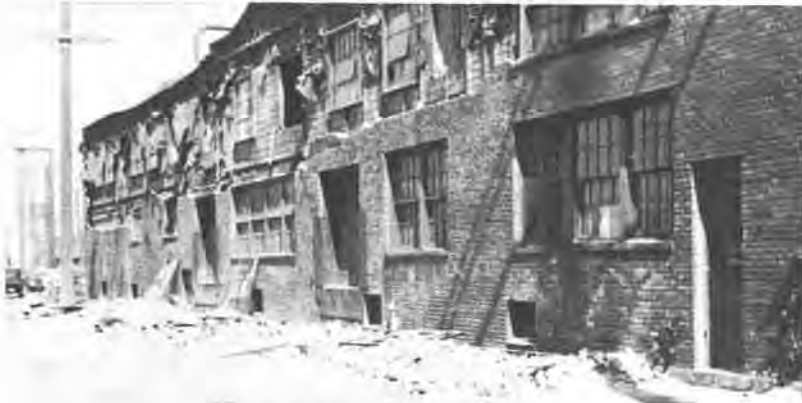
TOP—Poorly anchored brick veneer was knocked off Seattle structure. The obvious lesson here is that building facings must be designed to resist a reasonable amount of horizontal force.

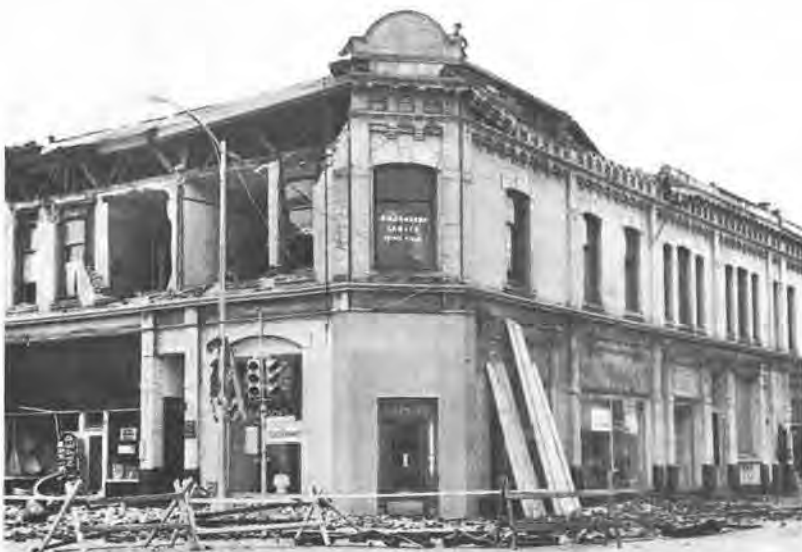
BOTTOM—A man was killed in downtown Centralia by the falling upper walls of this 2-story corner building. Had such damage occurred during the rush noon-hour, more would have died.

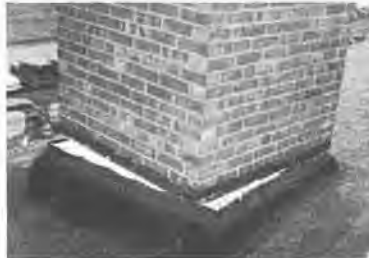
MANY UNREINFORCED masonry chimneys were fractured and rotated far more than this one, which gave way at the flashing point above the roof. A competent designer could have avoided this weakness.

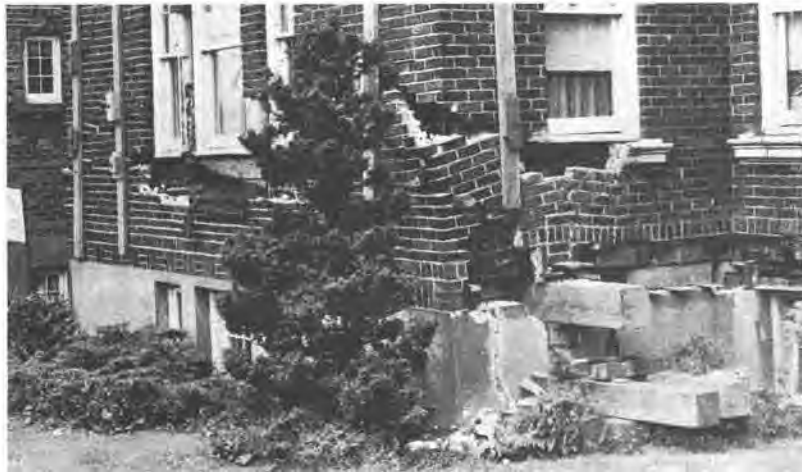
BRICK VENEER failed when improperly anchored to poorly braced frame structure. All structures built of unit material must be thoroughly tied together to move as a whole.

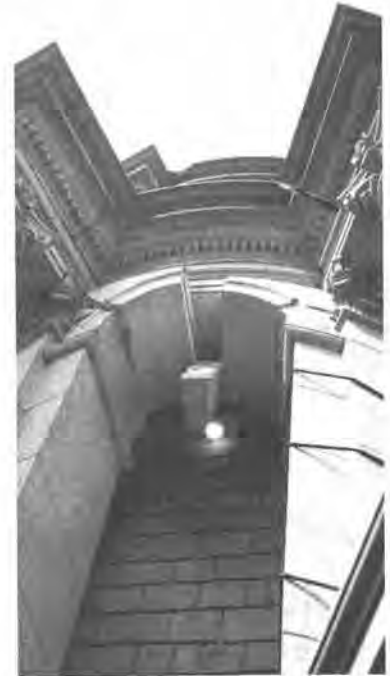
tions were set up by the earthquake which caused the near-collapse of this lantern as well as typical shear cracks and minor movements in other parts of the structure. Many of the stones of the lantern were separated from the adjoining ones, a few had dropped out and others were hanging loose when the quake stopped.

IN THE CAPITOL DOME at Olympia, erected in 1925, unanchored keystone dropped and column caps broke away. It takes strong mortar, steel and concrete, besides stone, to make such structures earthquake-resistant.

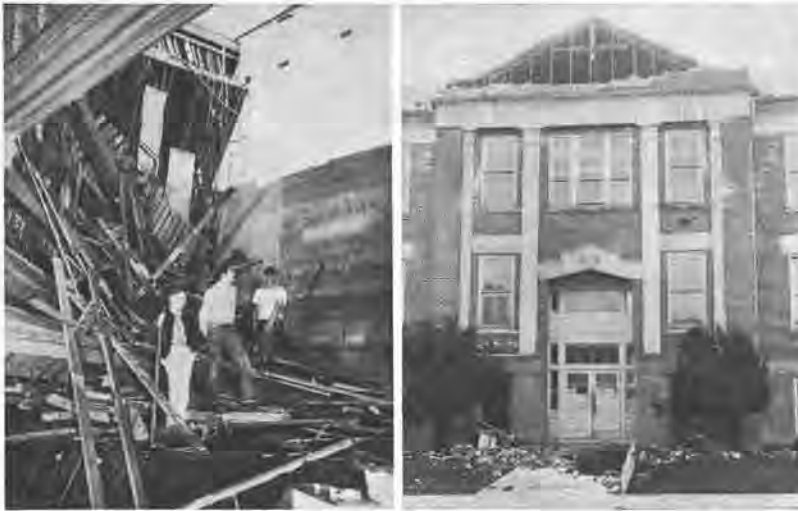
LEFT—Unanchored roof and ceiling beams over the stage of Puyallup high school auditorium slid off supporting masonry walls and crashed to floor, causing \$100,000 damage.

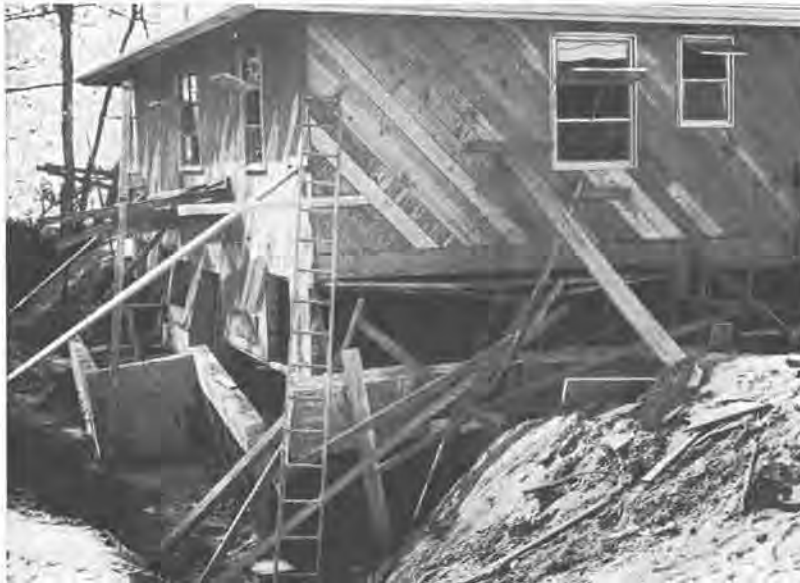
A SMALL RESIDENCE on unconsolidated fill lost its foundation when settlement dropped the concrete wall and the horizontal movement added to the damage.

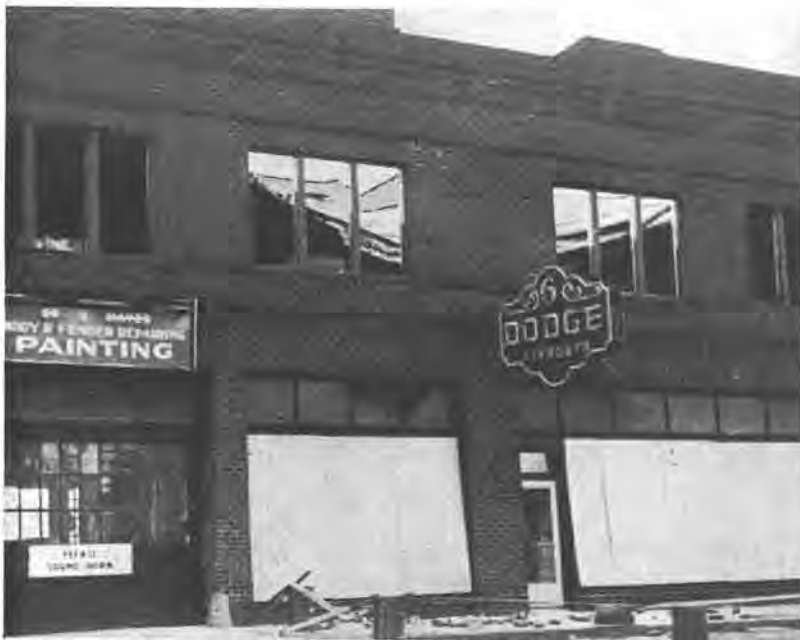
BECAUSE roof joists were not anchored to the wall, the framing pulled away and the roof collapsed. Tops of the parapet wall shook loose and fell onto the sidewalk.

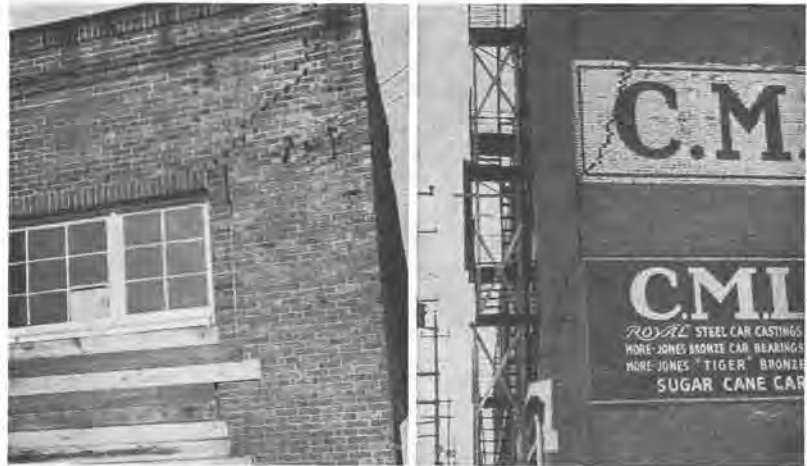
LEFT—Unsupported by any adjoining building, the corner of this structure moved out from under the roof the distance indicated by the crack.

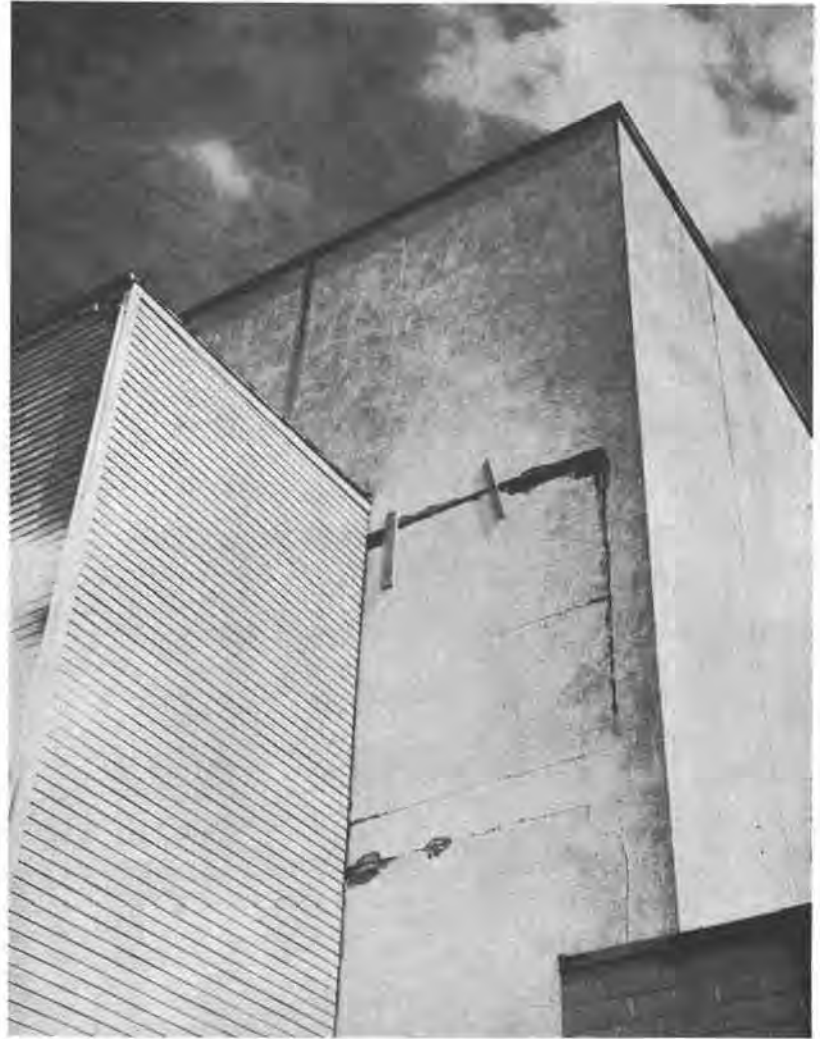
ON THIS SCHOOL building at Chehalis the action of the earthquake broke out the masonry filler walls in this concrete frame with complete separation from beams and column.

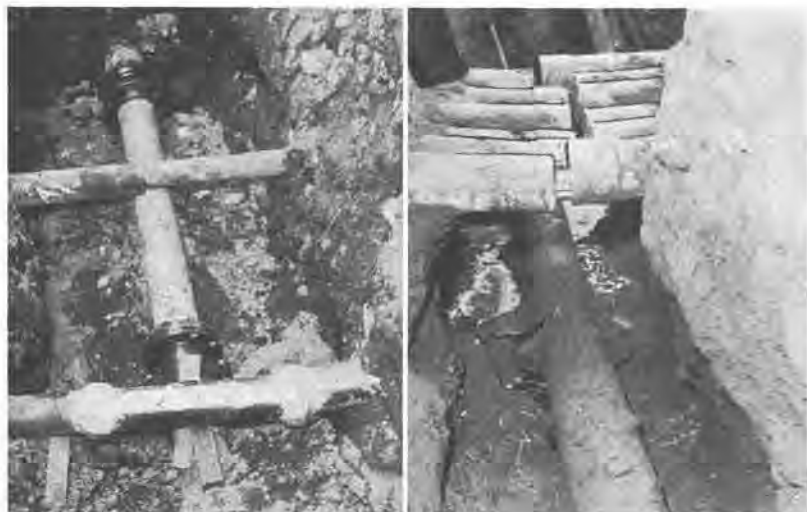
LEFT—Water and sewer lines fractured with pollution inevitable unless break is uncovered.  
RIGHT—Movement in soft ground pulled open these conduits in spite of locknuts.

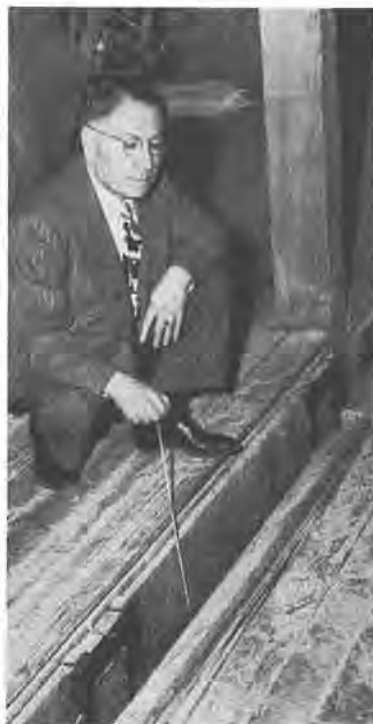
WATERFRONT STRUCTURES supported on piles driven into fill material shows a differential settlement of 8 in. on the fill side.

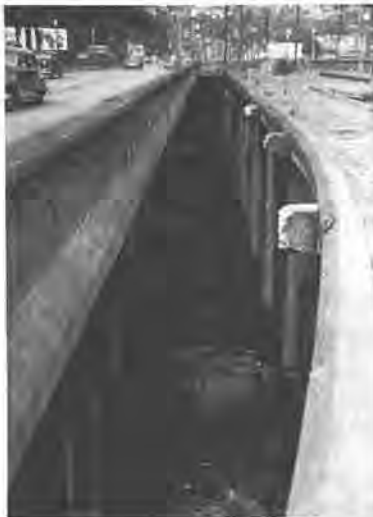
**BRIDGES** damaged by the quake. Left—Horizontal reinforced concrete struts between viaduct and trestle in Spokane were destroyed by differential movement of the structures. Below—Adna bridge over Chehalis River moved perpendicular to center line of road to bend pin plates on all shoes.

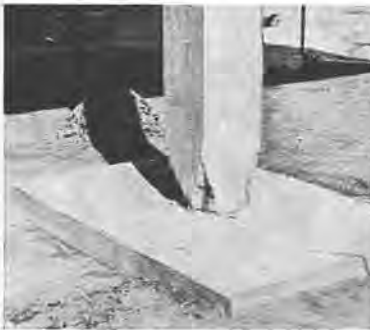
**CONNECTIONS** between structures must be rigid enough that both structures move as a unit or be separated so they move independently. Above, damaged base of an unbraced column.

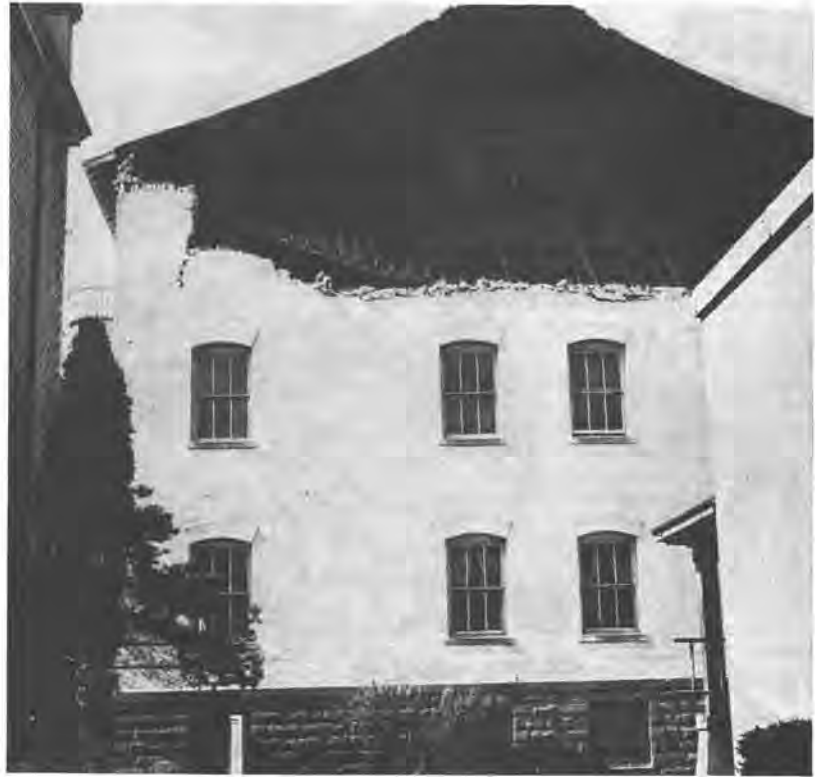
**TYPICAL** of pre-1900 buildings, this tall thin wall and unanchored gable were easily knocked out by flexing of wood structure. Crack to left shows side wall about to fail.

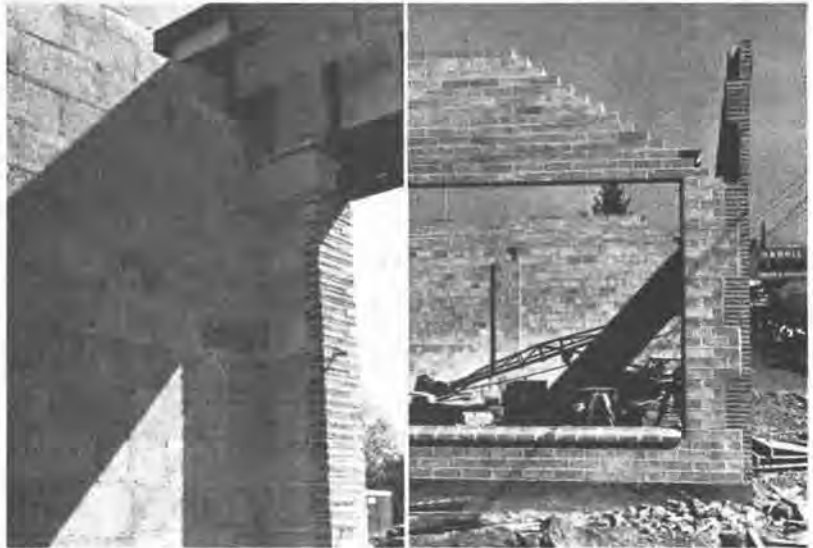
**STREET FRONTS** and parapets must have strong support. Building under construction above was entirely inadequate. At left, note light I-beam bearing on thin veneer with concrete block above for back-up only. At right, note thin support for the front wall, giving no lateral stability.

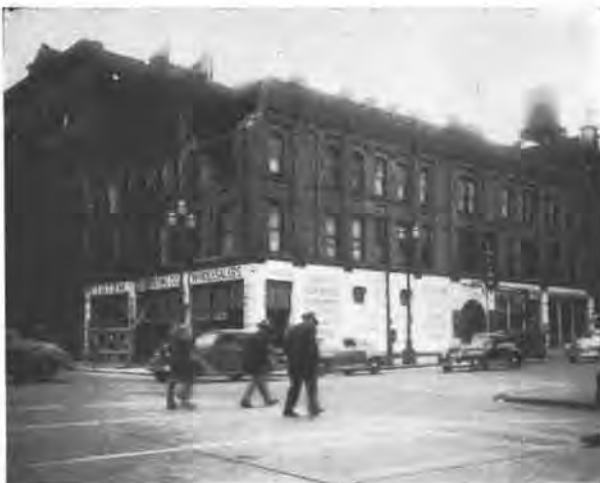
FIG. 2—This entire building is constructed with a very inferior grade of masonry, weak mortar and lack of joint filling. The parapet wall near the corner fell because of defective masonry and lack of anchorage.

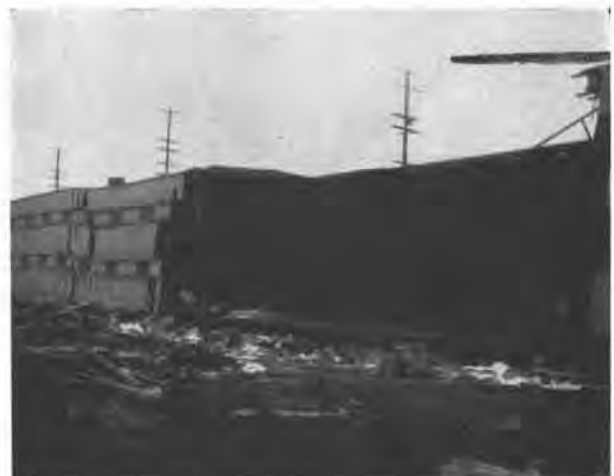
FIG. 3—This is a wood frame building resting on concrete piers. Apparently the foundation collapsed, allowing the floor to slope and catapult the contents of the building through the exterior wall.

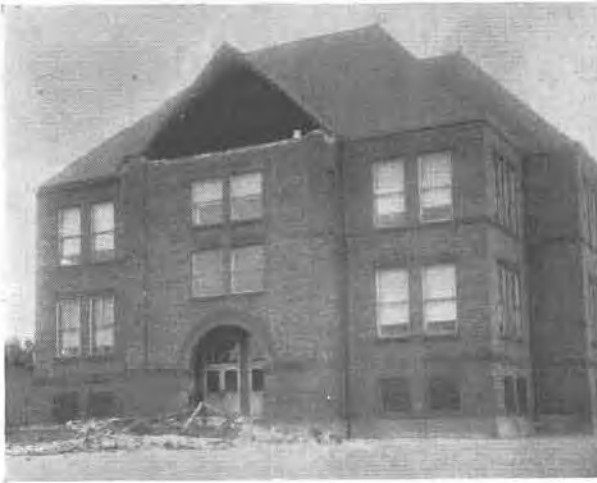
FIG. 4—Lafayette School in west Seattle. The gable fell because of lack of adequate anchorage and defective masonry. The masonry fell on the landing in front of the main entrance

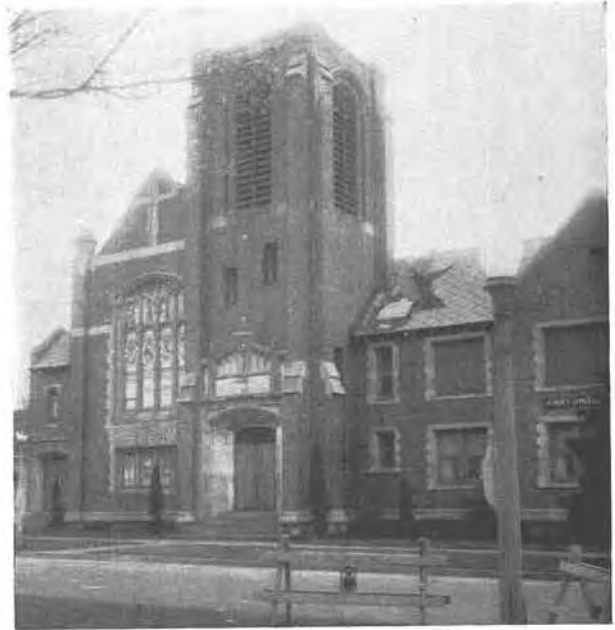
FIG. 7—This church steeple in Tacoma had a spire at each corner. The spires were thrown off and two of them went through the roof of the building.

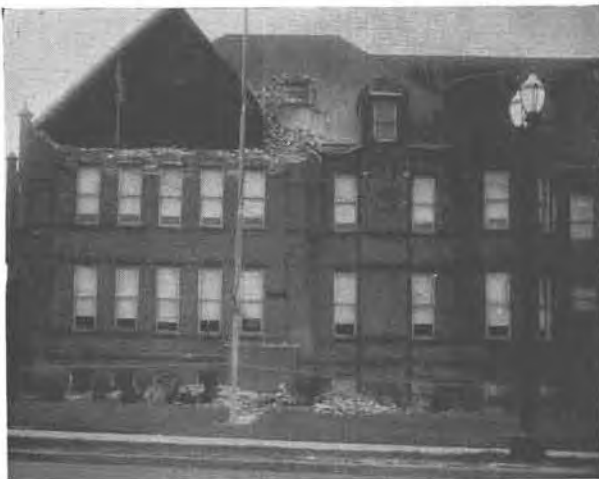
FIG. 6—Lafayette School, west Seattle. Gable and chimney fell due to weak masonry and inadequate anchorage.

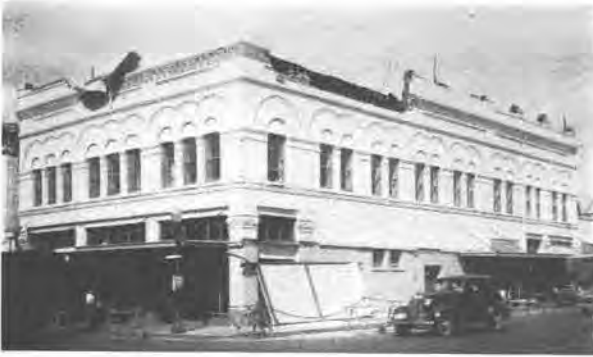
FIG. 9—Olympia. Parapet wall was knocked off and carried a canopy to the sidewalk with it.

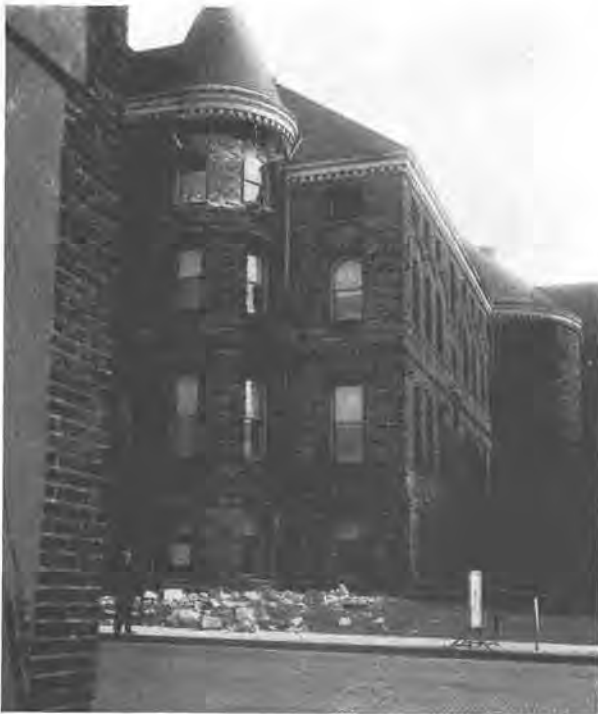
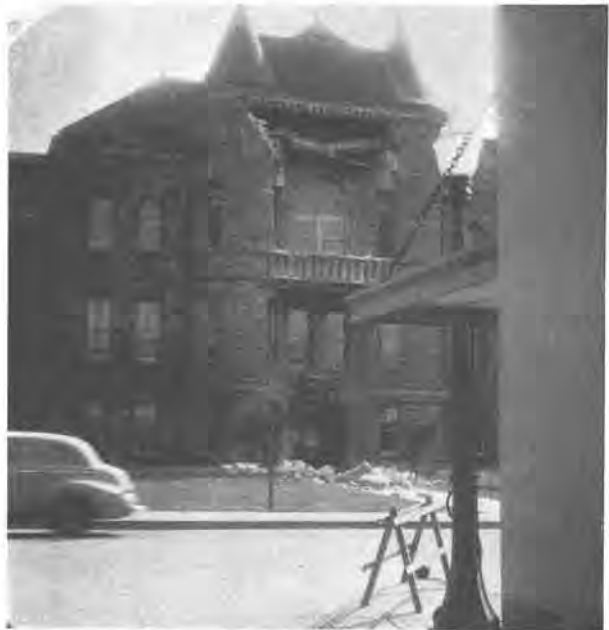
FIGS. 10 AND 11—Old State Building, Olympia. Heavy sandstone walls, weak mortar and lack of adequate anchorage contributed to this damage.

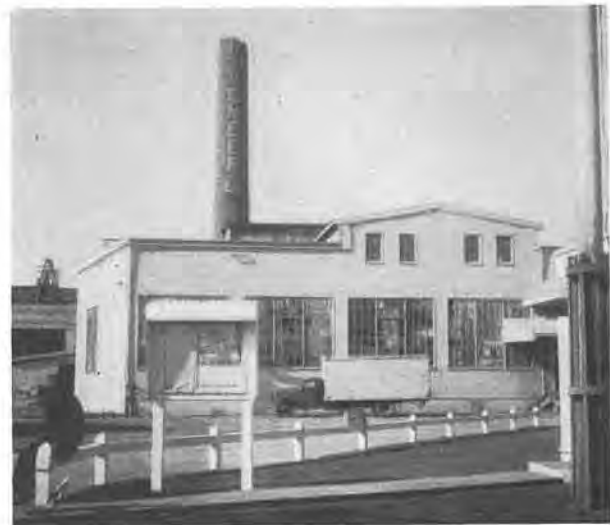
FIG. 14—Industrial plant at Olympia. Brick chimney was originally 250 feet high; about 60 feet of the top was thrown off, producing fatality.

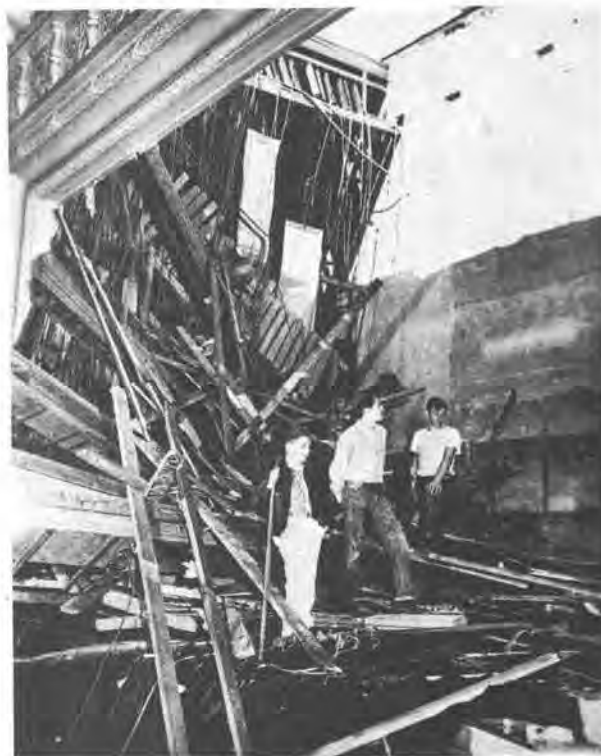
FIG. 2—Open-air theater: Three members of the stage crew at Puyallup High School survey the wreckage of the stage, where the roof was caved in by the earthquake just as they were leaving for lunch. Under the debris are a ping-pong table and a grand piano.—Seattle Times staff photo by Larry Dion.

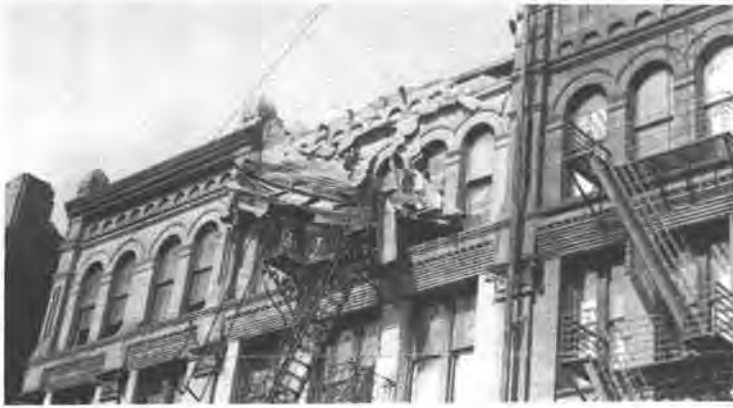
FIG. 4—Failure of parapet wall and collapse of fire escape.  
—Photo by U. S. C. & G. S.

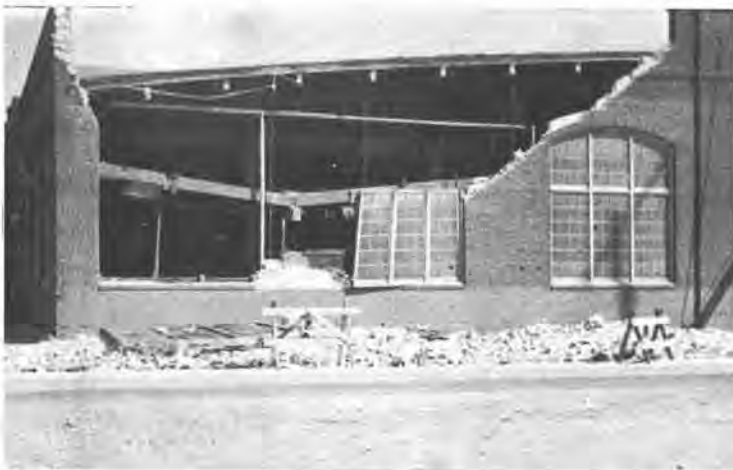
FIG. 5—Collapse of brick filler wall. This wall at the Crane Company, East Marginal Way and Hinds Street, Seattle, boiler and radiator shop, fell outward in the earthquake, saving workmen inside.—Seattle Times photo.

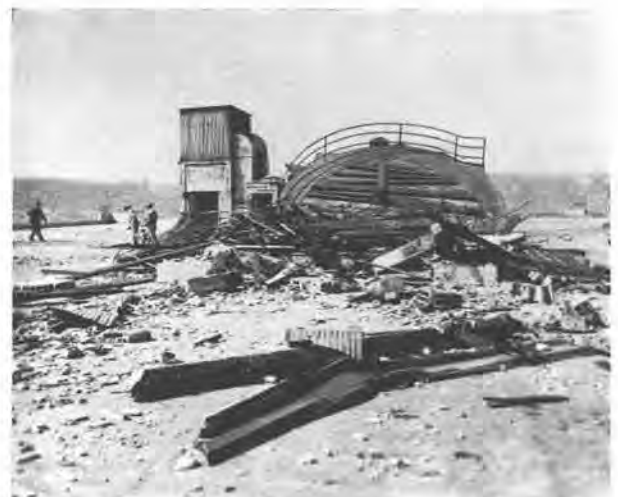
FIG. 6—Collapse of 54,000-gallon wooden tank on roof of six-story reinforced concrete cold storage plant at Seattle.—Photo by Harry Davis, Seattle.

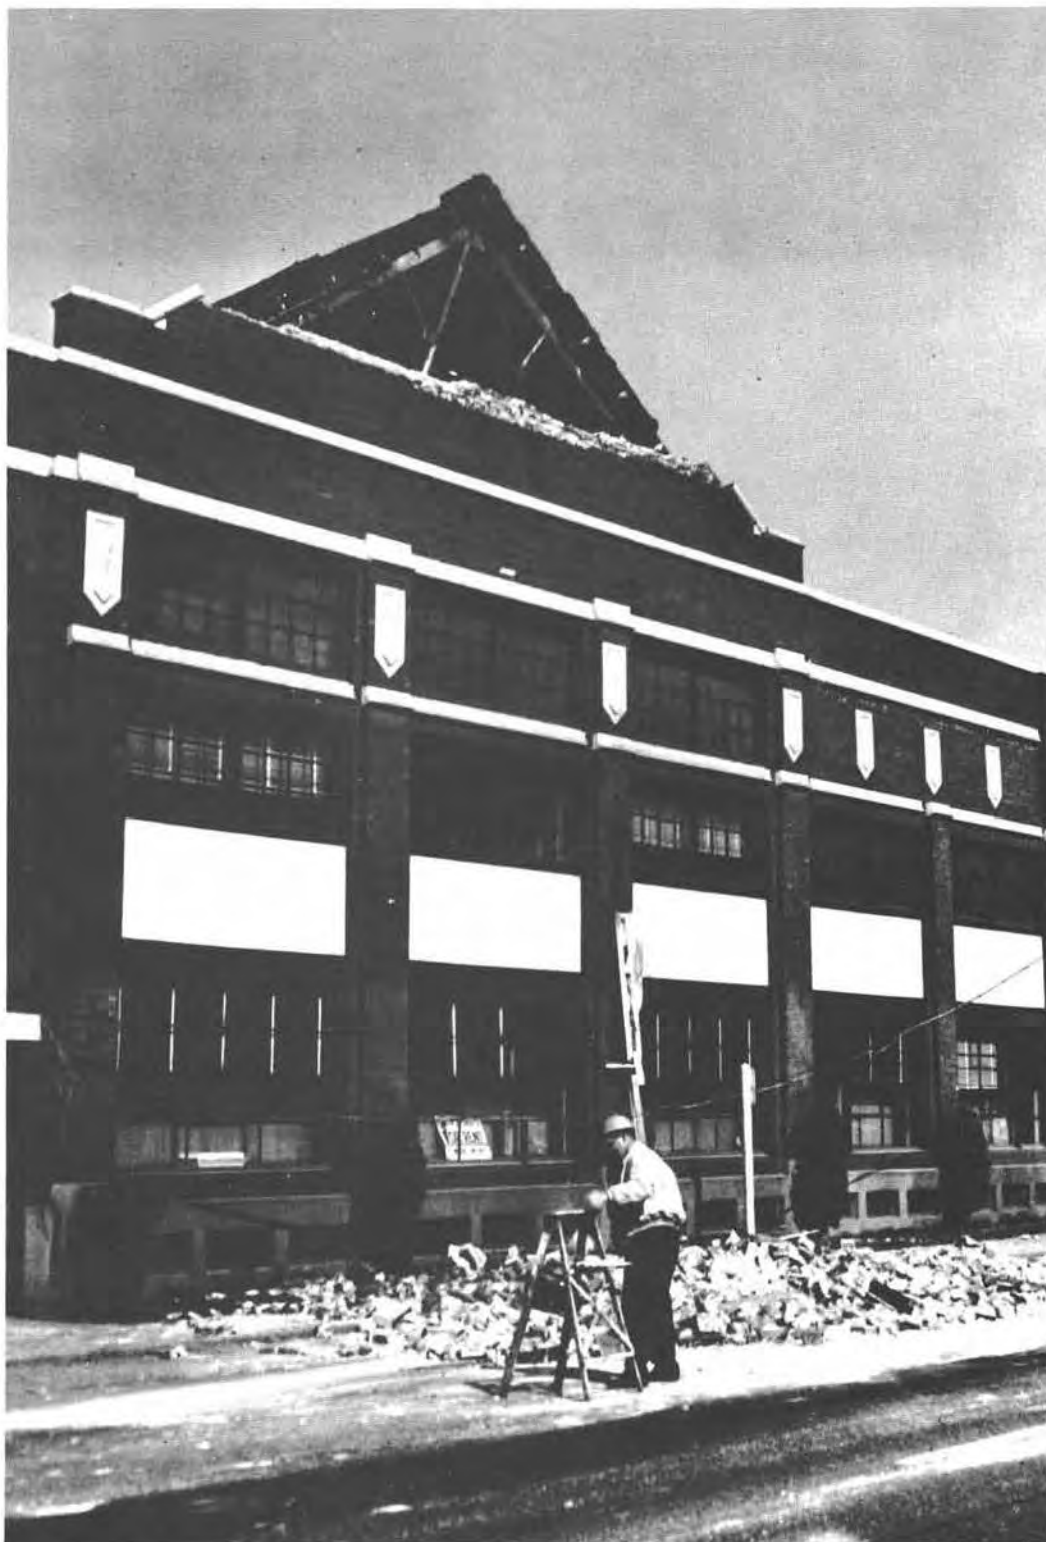
*Figure 13.—Failure of an unreinforced brick gable in Seattle. The masonry fell on a parked car, injuring occupant (see Figure 14). (Photo by Seattle Fire Department.)*

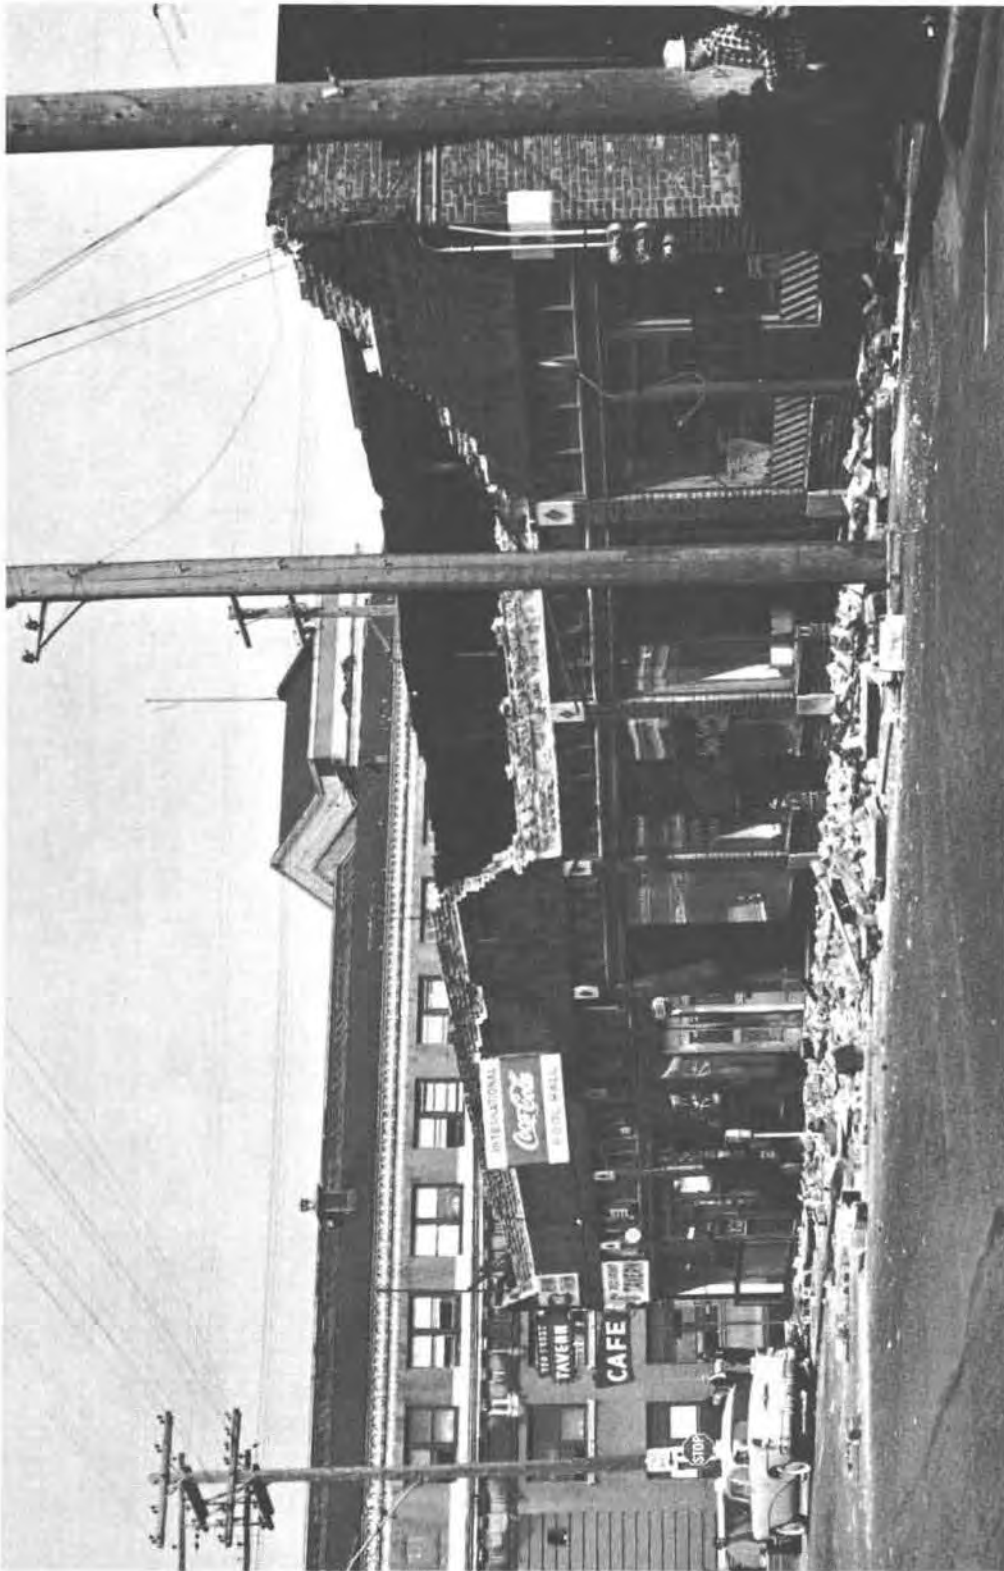
Figure 16.—Failure of unreinforced brick parapet wall in Seattle. (Photo by Seattle Fire Department.)

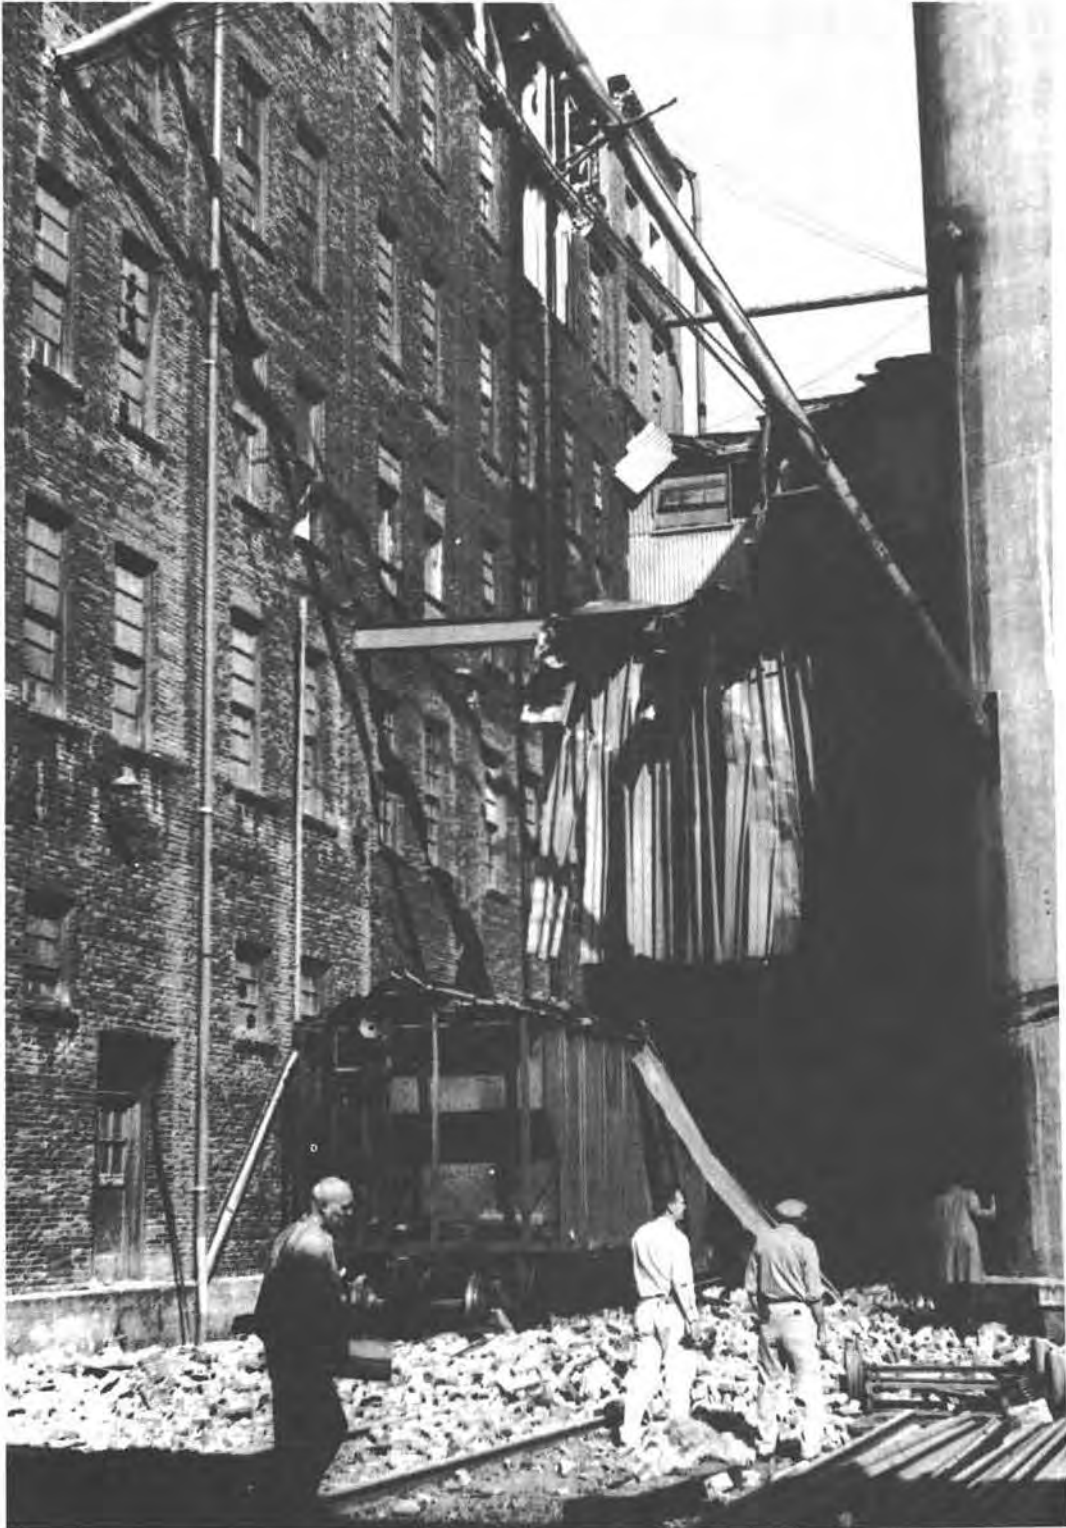
Figure 17.—Unreinforced brick fell from top story at Fisher Flouring Mills, Seattle. (Photo by John Vallentyne, Seattle Post-Intelligencer.)

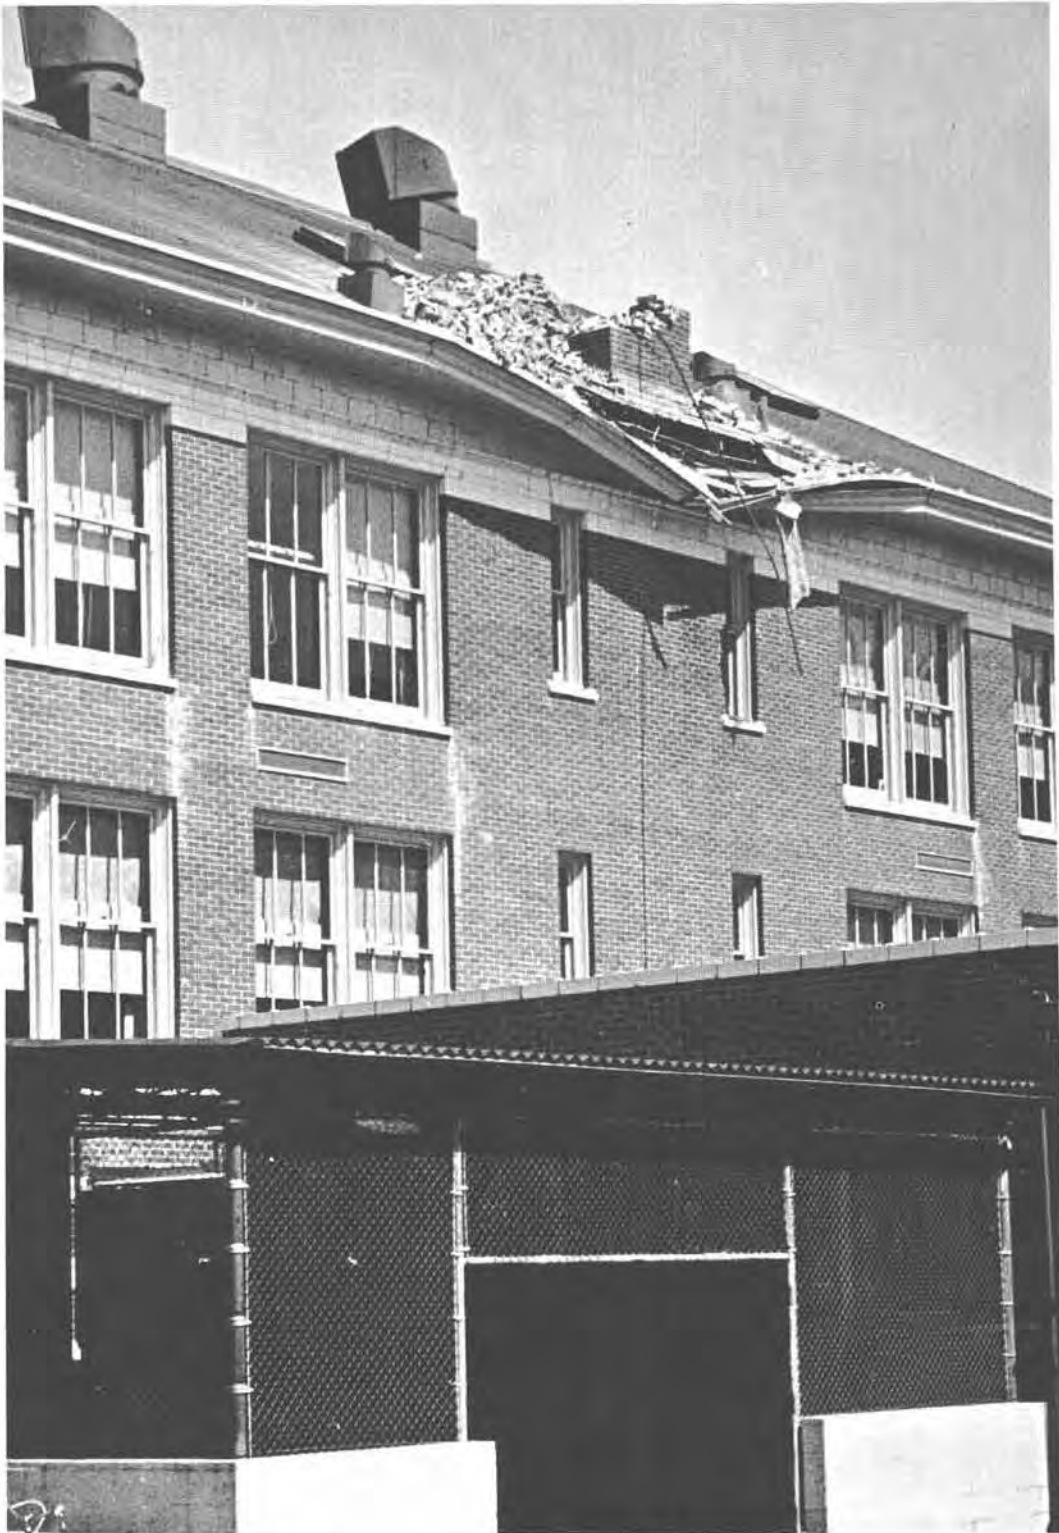
*Figure 18.—The 60-foot brick chimney at the Alki Elementary School in Seattle collapsed on the one-story boiler room, severely damaging it. (Photo by Cory Tolman, Seattle Post-Intelligencer.)*

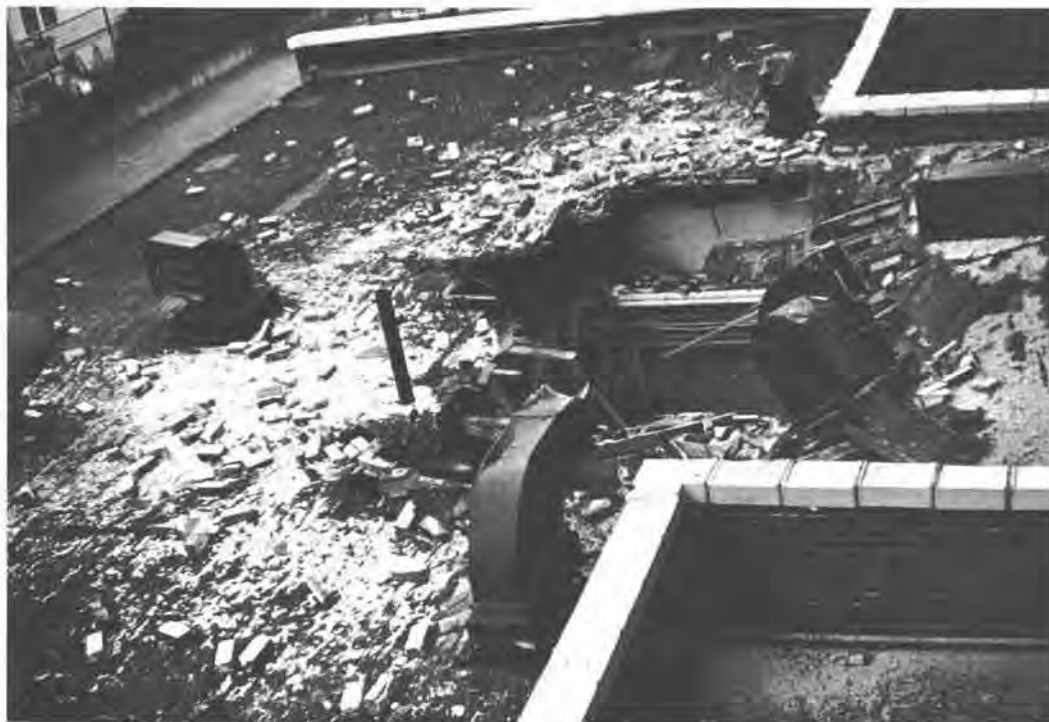
Figure 19.—Hole in the roof due to the collapse of the chimney shown in Figure 18. (Photo by Karl V. Steinbrugge.)

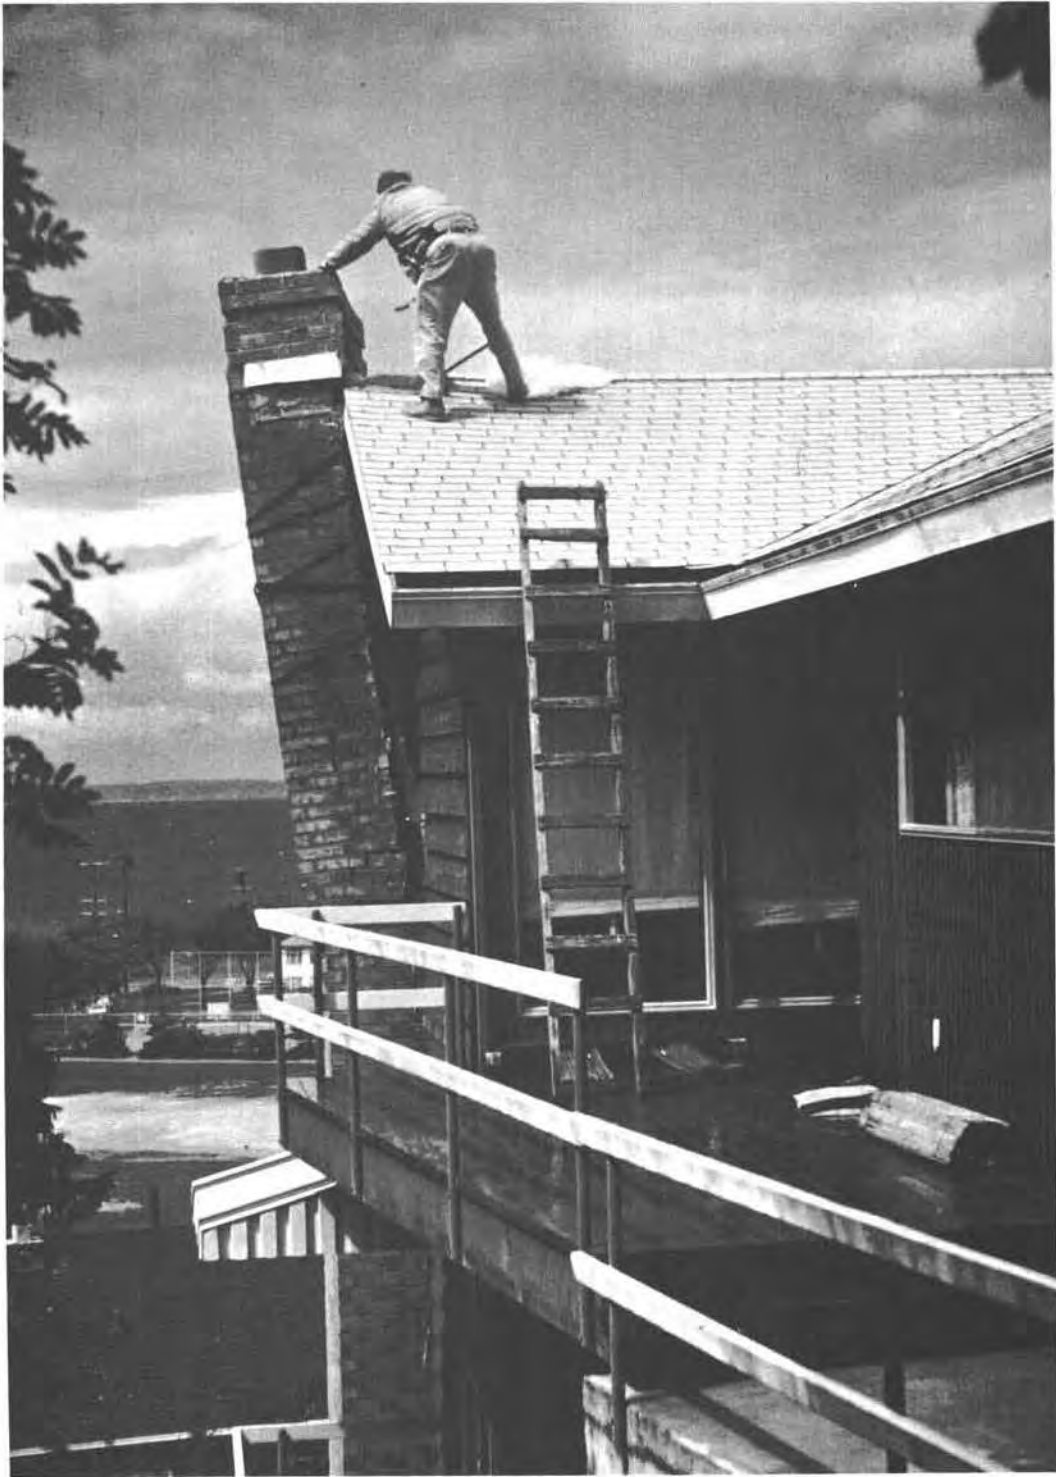
Figure 20.—Chimney damage in West Seattle. (Photo by Karl V. Steinbrugge.)
