# THE PUGET LOWLAND EARTHQUAKES OF 1949 AND 1965

REPRODUCTIONS OF SELECTED ARTICLES  
DESCRIBING DAMAGE

Compiled by  
GERALD W. THORSEN

WASHINGTON DIVISION OF GEOLOGY AND EARTH RESOURCES  
INFORMATION CIRCULAR 81

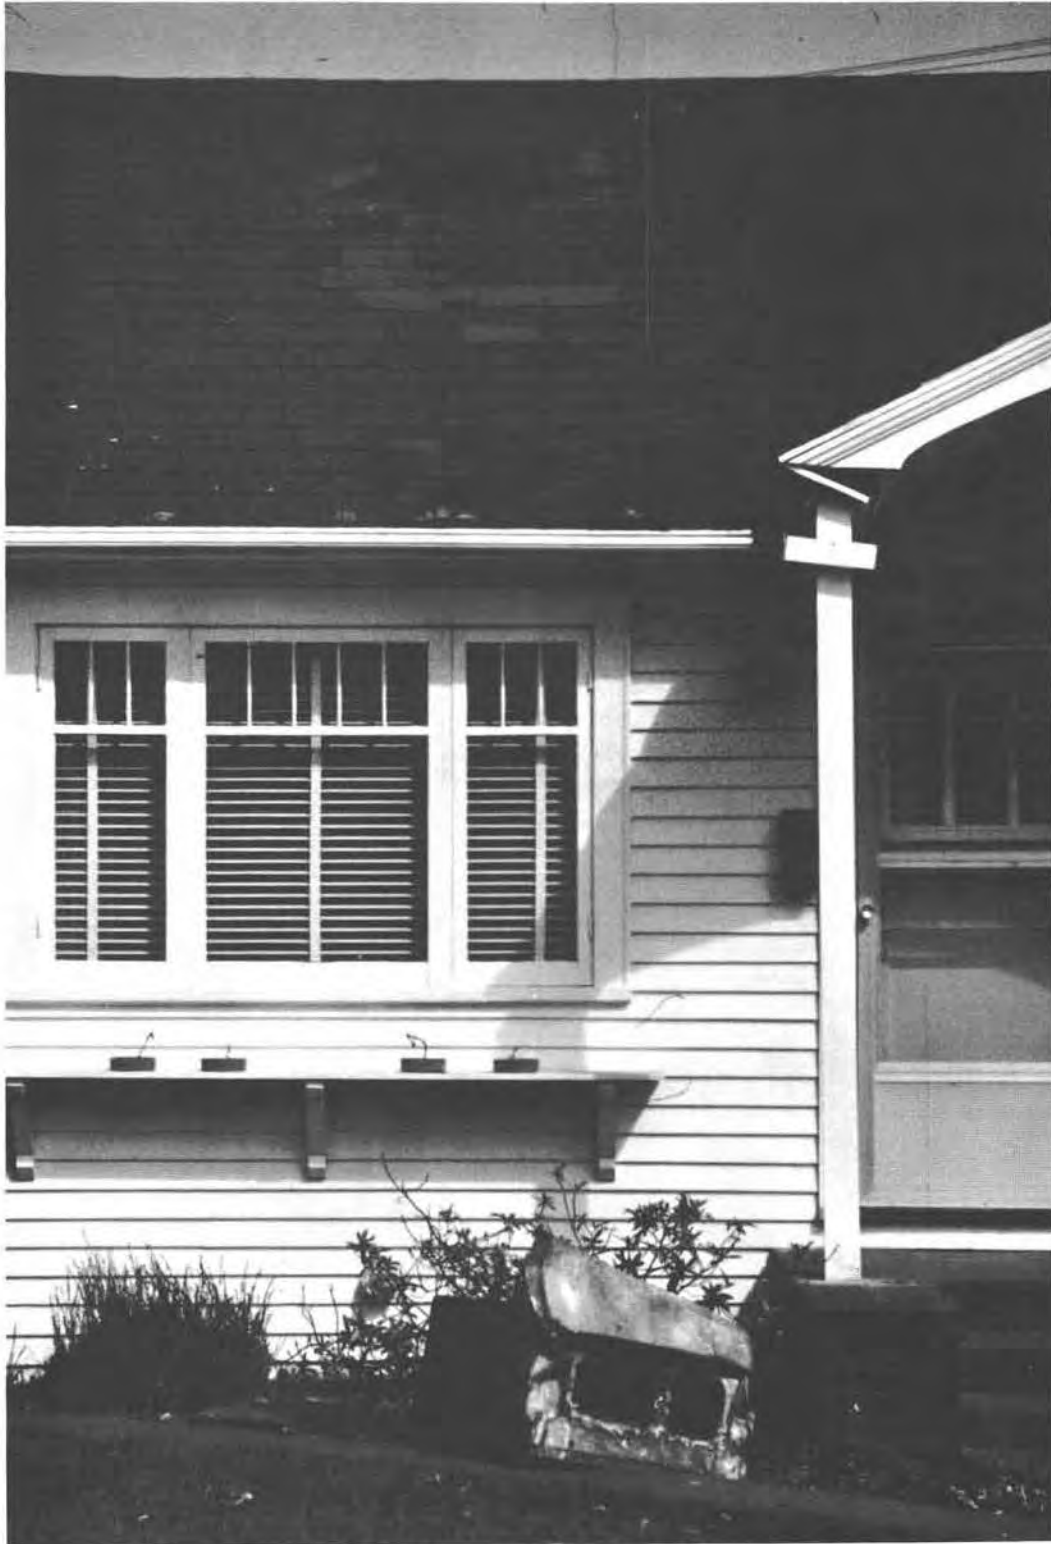
*Figure 21.—Chimney damage in West Seattle. (Photo by Karl V. Steinbrugge.)*

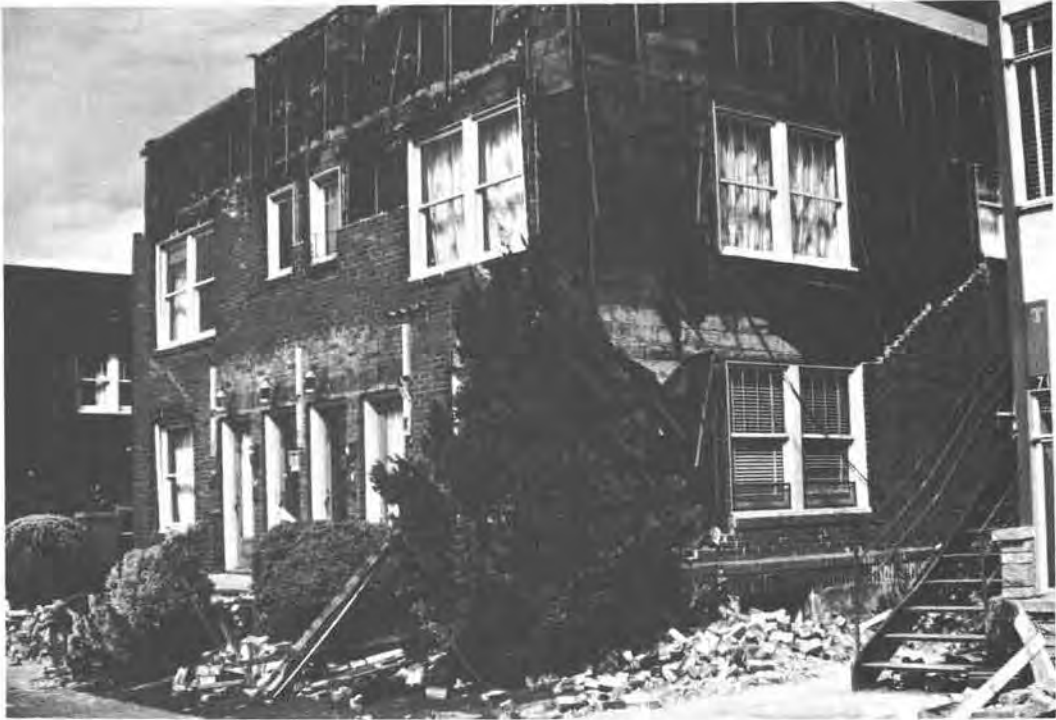
Figure 22.—Four-inch thick brick veneer peeled off of this wood frame structure in Seattle. The galvanized metal anchors were imbedded in a bed of low strength mortar. (Photo by Karl V. Steinbrugge.)

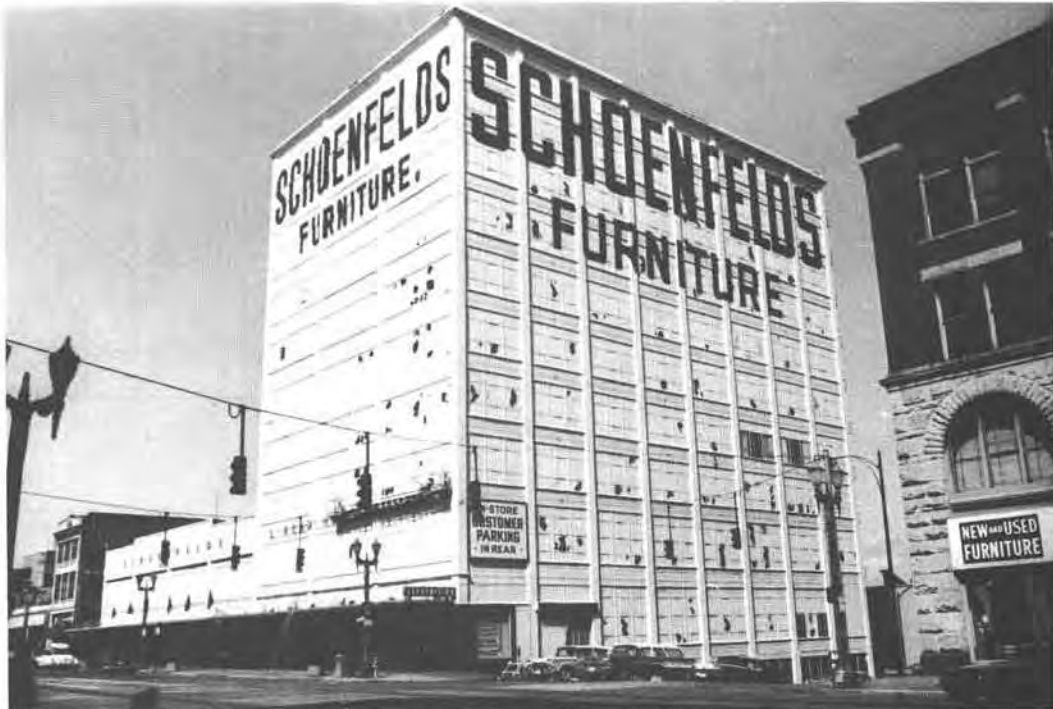
Figure 23.—Glass windows broke on three sides of this 10 story building in Tacoma. The fourth side had no wall openings. (Photo by B. J. Morrill.)

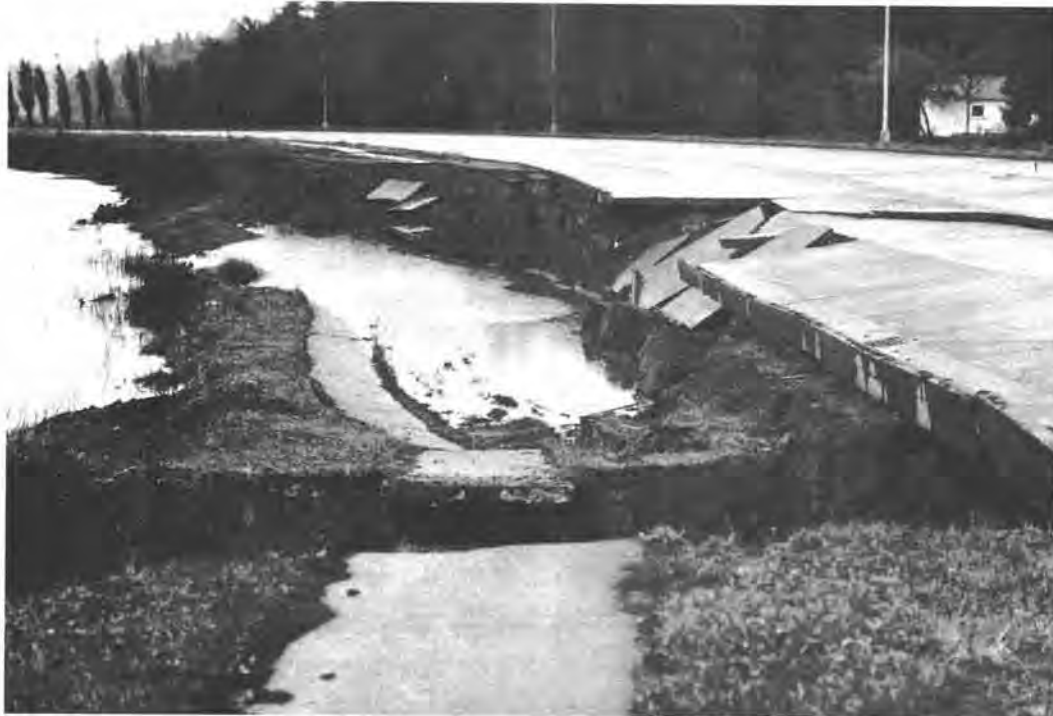
Figure 24.—Landslide damage to a roadbed in Olympia. (Photo by Karl V. Steinbrugge.)

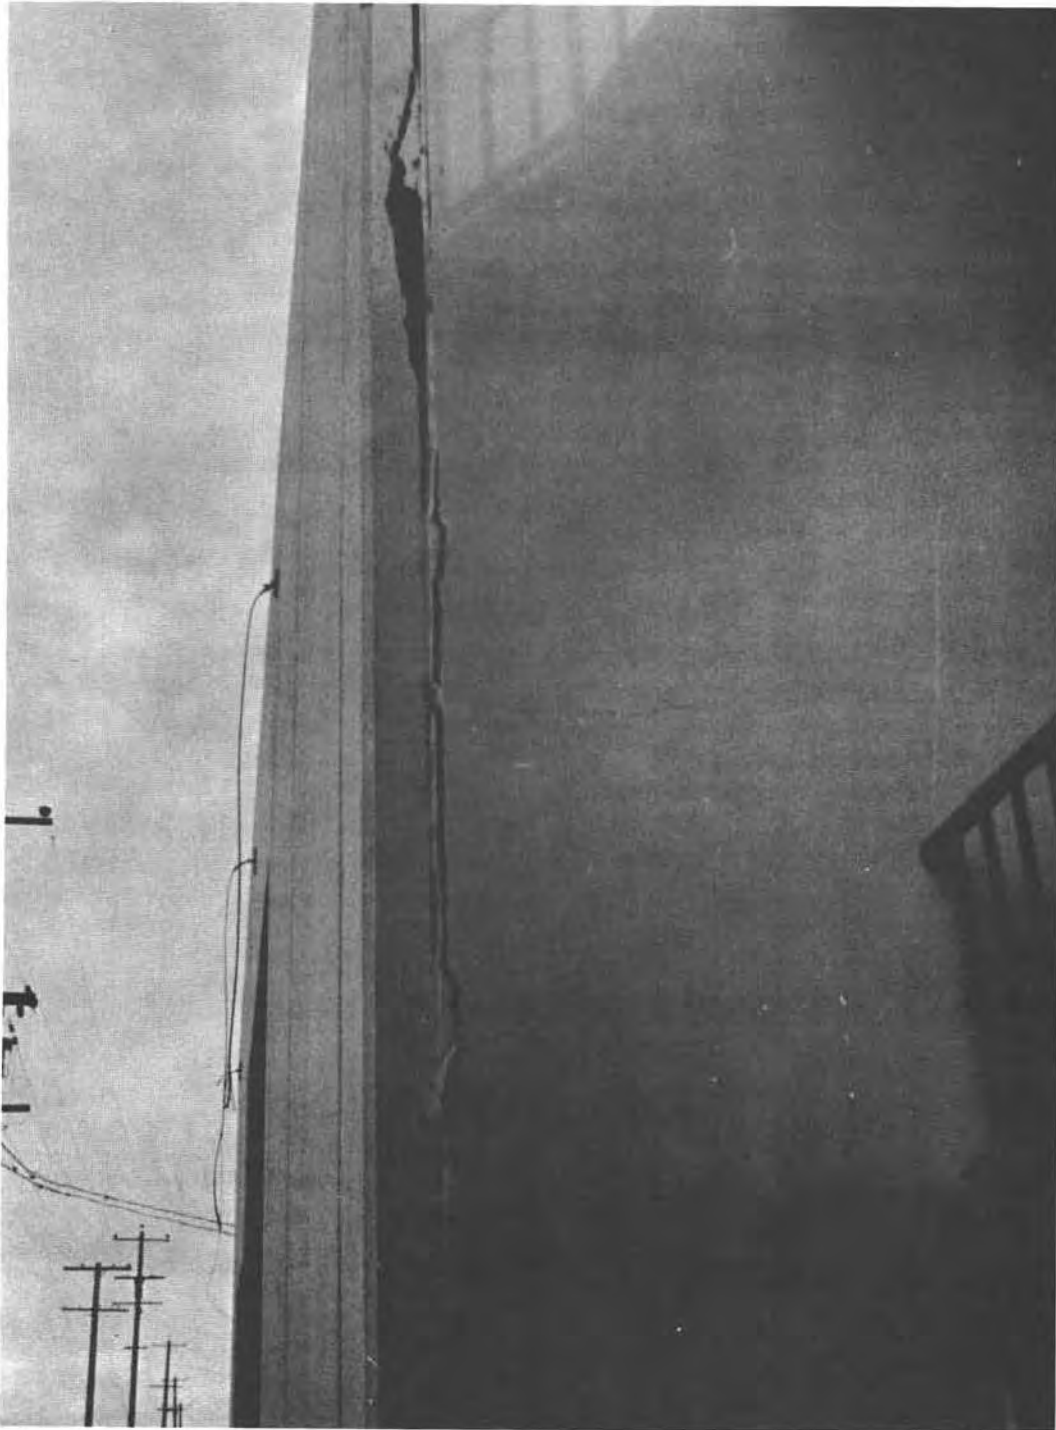
*Figure 25.—Some of the structural damage to a newly built precast reinforced concrete building on Harbor Island in Seattle. (Photo by B. J. Morrill.)*

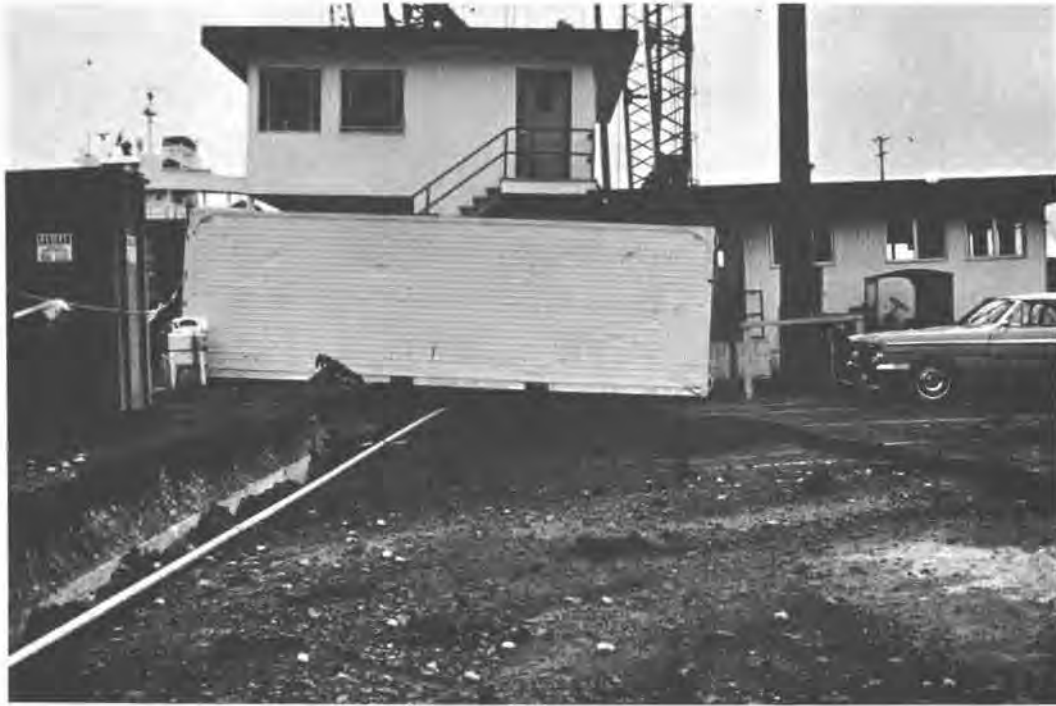
Figure 26.—Ground dropped due to the pier at the left shifting toward the water. Location is Harbor Island in Seattle. (Photo by Karl V. Steinbrugge.)

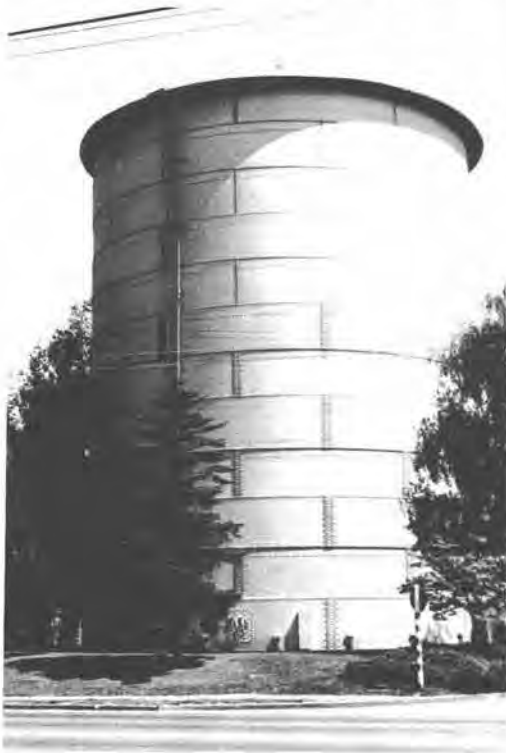
Figure 27.—Woodland Park Standpipe, Seattle. Typical damage to anchor bolts may be seen in next figure. (Photo by Washington Surveying and Rating Bureau.)

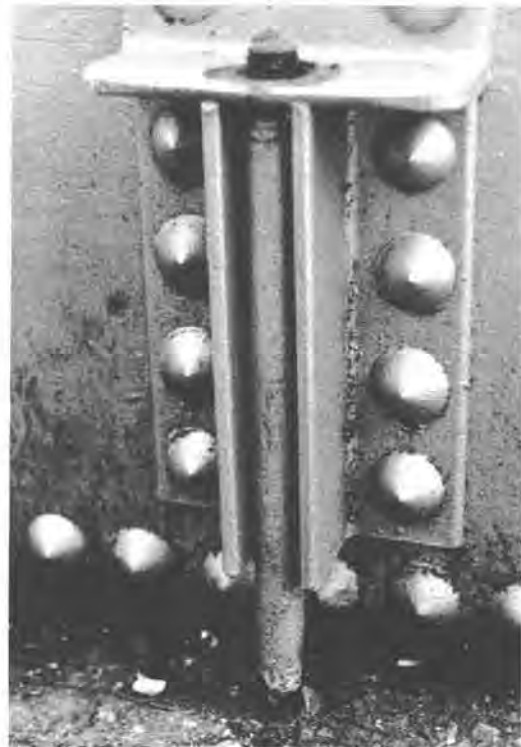
Figure 28.—Typical anchor bolt damage at Woodland Park Standpipe, Seattle. Note that the anchor bolt has necked where it meets the concrete and that the bolt failed in the threads. (Photo by Washington Surveying and Rating Bureau.)
