**ENGINEERING GEOLOGIC FIELD RECONNAISSANCE**

**DEBRIS SLIDES, DEBRIS FLOODS,  
AND  
AFFECTED PROPERTIES**

**6459, 6488, 6489, and 6500 Goodwin Road, and 6474 Siper Road  
Whatcom County, Washington**

July 2, 2009

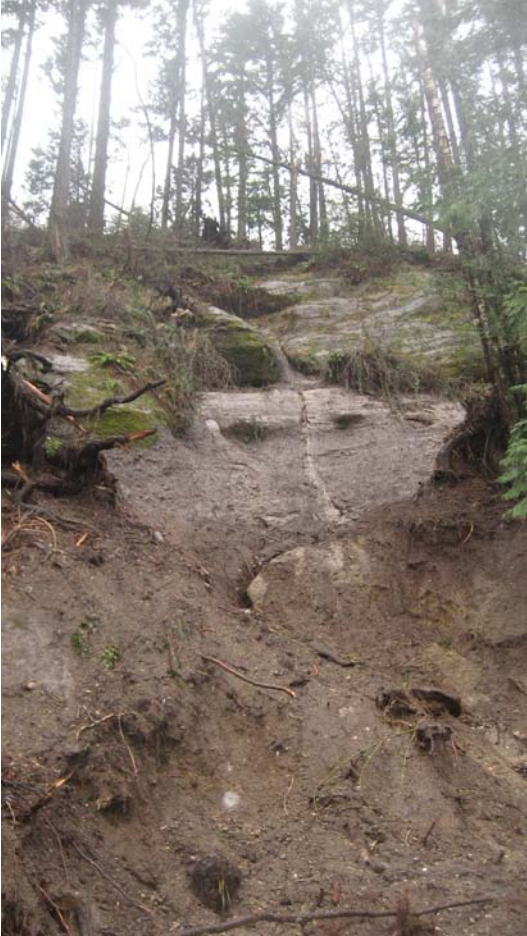
**6.1.1. North PI** – The PI is more-or-less at the base of an approximately 50- to 60-foot high cliff-like landform in the mature timber that stocked the leave-tree area of the sale (Figure 2). The scar at the North PI is estimated to be about 30- to 40-feet wide, and varies in depth from a few feet to about 5- to 6-feet deep. Bedrock is exposed in the scar and it appears the failure was essentially confined to the colluvial deposits that had accumulated at the base of the cliff and the patches of soil that developed on the bedrock surfaces. Inclinations of the adjacent colluvial slopes are steep and range up to about 100%. The inclination of the newly-exposed bedrock surfaces vary from 80% to vertical. Roots from the trees that were lost in the failure do not appear to have penetrated into the bedrock. To the north of the slide scar a ground crack about 10-feet long was observed. The crack was about 4-inches wide. At the time of the January 8<sup>th</sup> reconnaissance channelized runoff was observed flowing across the rock face (Figure 3). The development of the channel was controlled by bedrock joints and bedding. LiDAR topography suggests some subdued channeling on the westerly-facing hillside above the bedrock cliff.

**Figure 3** North PI. Note water flowing across bedrock surface. Photograph taken 1/8/09. View looking east.  
(Photo by D. Hooks)

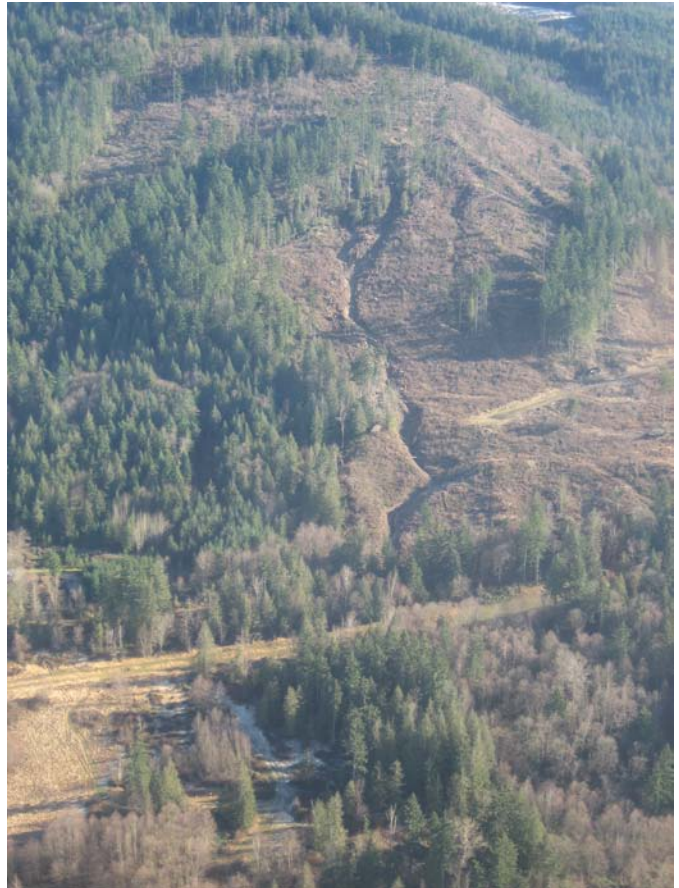
The debris-flow track extends about 2,900 feet from the PIs to Goodwin Road (Figure 4). Past Goodwin Road the track extends another 800 to 900 feet to the area on the Soares Property where water ponded (Figure 2). As noted above, at a point about 550 feet down slope from the PIs the debris-flow tracks from the North and South PIs merged and became one track from there down slope. The debris scoured the slope and the drainage channel picking up more earth materials and organic debris (Figure 5). Elsewhere, the slide material ran across the ground surface doing little damage except to vegetation (Figure 6). Subsequently running water from the PIs locally eroded narrow gullies up to 7-feet deep and 4- or more feet wide. At a turn in the lower area of the timber sale the debris jumped out of the drainage channel and across a hillside area before being redirected, by the local topography, back into the channel. Before exiting DNR property a small portion of the debris broke away from the main mass and traveled across the hillside to the northwest for a distance of about 350 feet before coming to rest. As shown on Figure 2 the debris-flow track crossed the buried Williams gas pipeline but apparently did no harm (pers. comm; A. Kammereck, P.E.; Golder Associates). On the gentler slopes of the Franks Property the slide debris spread out somewhat before overflowing on to the Franks driveway and also continuing down the drainage onto the Gassman Property. Mud splatter was observed on tree trunks up to 4 feet above the ground surface. At Goodwin Road the fraction on the Franks Property split, some going north along the east side of Goodwin Road for about 400 feet. The remainder either piled up on the road and plugging the culvert along with the fraction that spilled on the Gassman Property, or continued across the Goodwin Road and on the Benson Property, spilling onto the driveway and lawn areas, some splitting off and going a relatively short distance before coming to rest north of the Benson residence. The remainder went down either the driveway and into the garage or was directed southwestward into the old drainage and on down to the subtle depression-like area on the Soares Property.

**Figure 4** Aerial photograph showing debris-flow track (furrow on hillside) from PIs to pipeline right-of-way (grass strip across lower area of photograph). Treeless areas delineate Gasping Goodwin Aerial timber sale. View looking southeasterly.  
(Photo by D. Hooks)

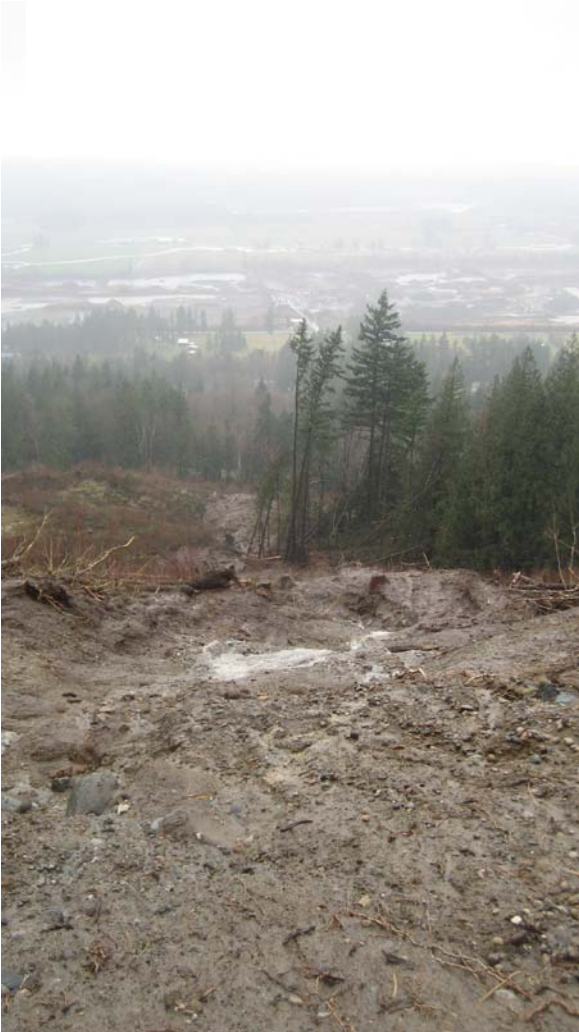
**Figure 5** View looking west and down slope along debris-flow track. Photograph taken 1/8/09 just below junction of debris slide tracks.

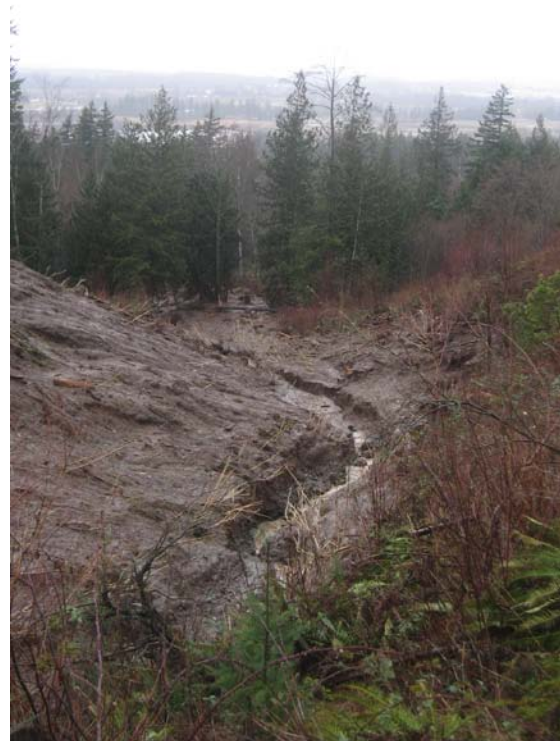
**Figure 6** View of debris-flow track in lower area of Gaspig Goodwin Aerial timber sale. Note area in left half of photograph where debris passed over hillside area. Photograph taken 1/8/09. View looking west.  
(Photo by D. Hooks)

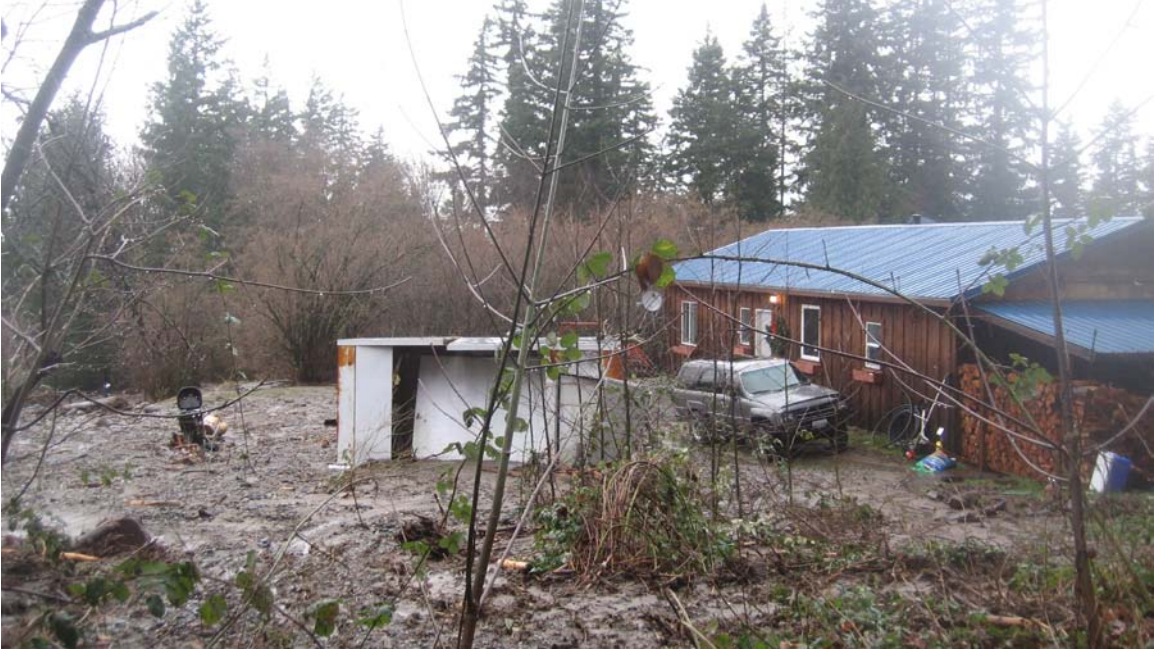
**Figure 7** View of area at 6500 Goodwin Road blanketed by debris from debris flood. View looking northwesterly. Photograph taken 1/8/09.  
(Photo by D. Hooks)

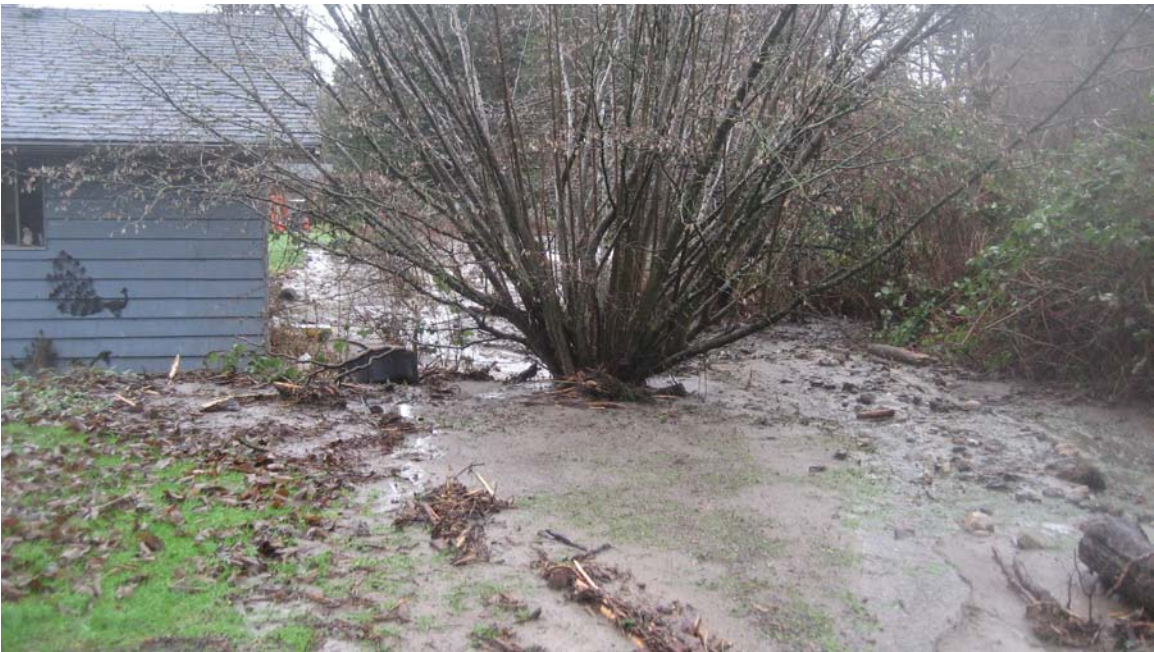
**Figure 8** View of area at 6488 Goodwin Road blanketed by debris from debris flood. View looking westerly. Photograph take 1/8/09.  
(Photo by D. Hooks)

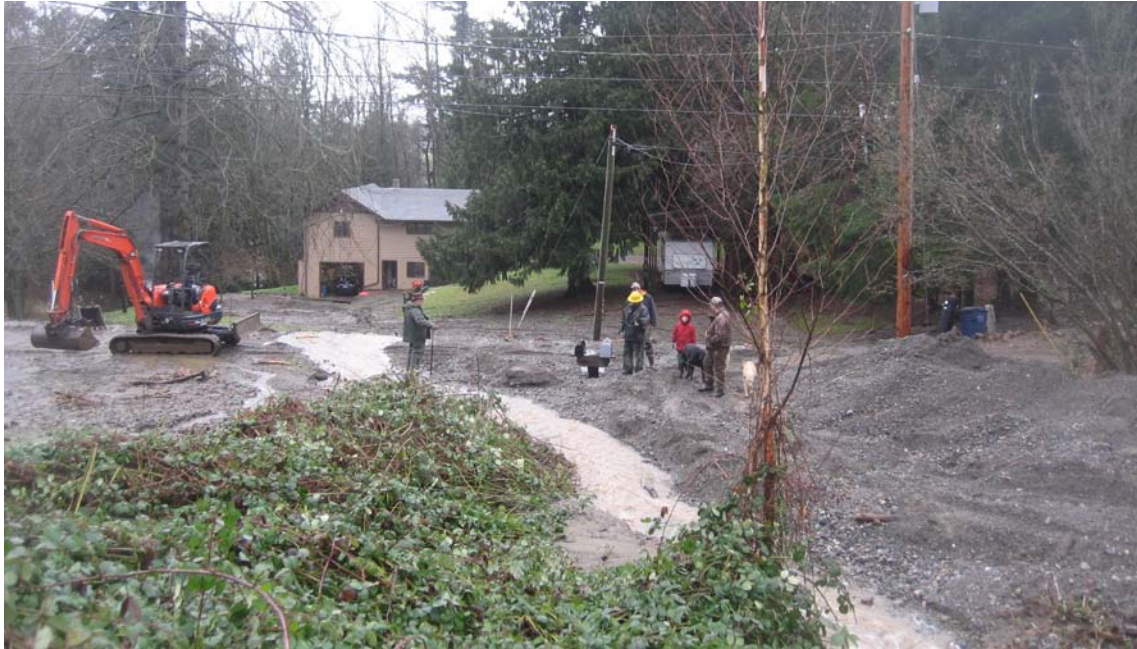
**Figure 9** View of area along Goodwin Road in front of 6488 and 6500. Stream is essentially flowing in same location as prior to debris flood event. However, stream is now several feet above original channel. Residence at 6489 Goodwin Road in background. Debris flowed over surface in front of house and into an area to the right. View looking westerly. Photograph taken 1/8/09. (Photo by D. Hooks)

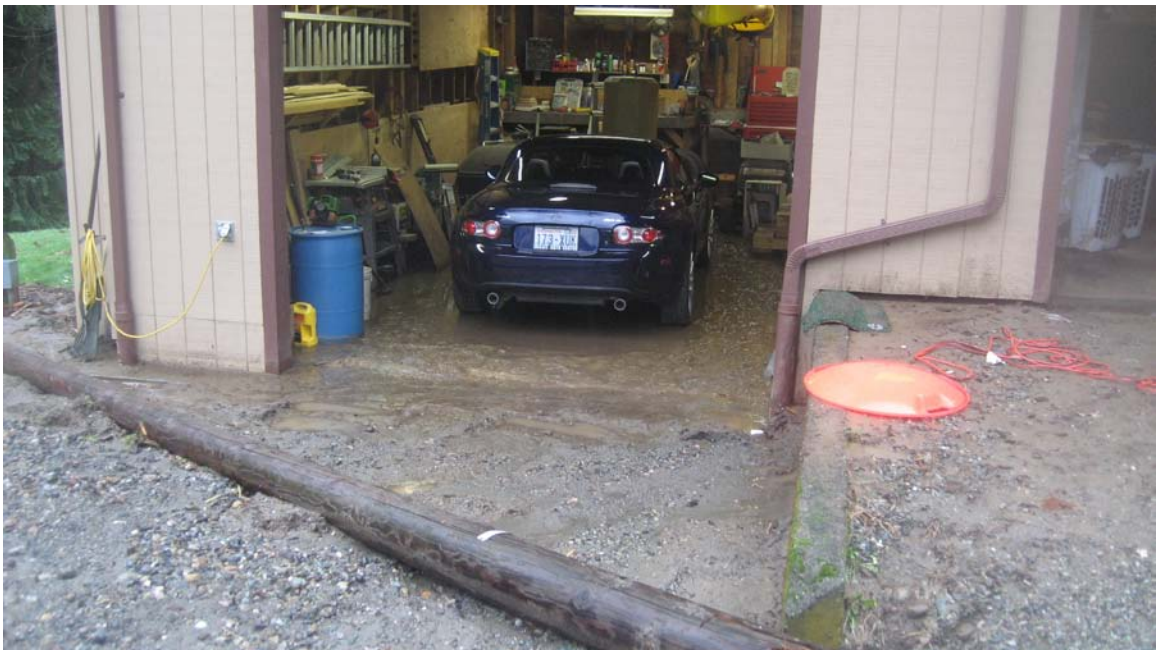
**Figure 10** View of garage at 6489 Goodwin Road and pole placed to divert debris. Some debris entered garage before placement of pole. View looking southwest at southeast corner area of garage. Photograph taken 1/8/09. (Photo by D. Hooks)

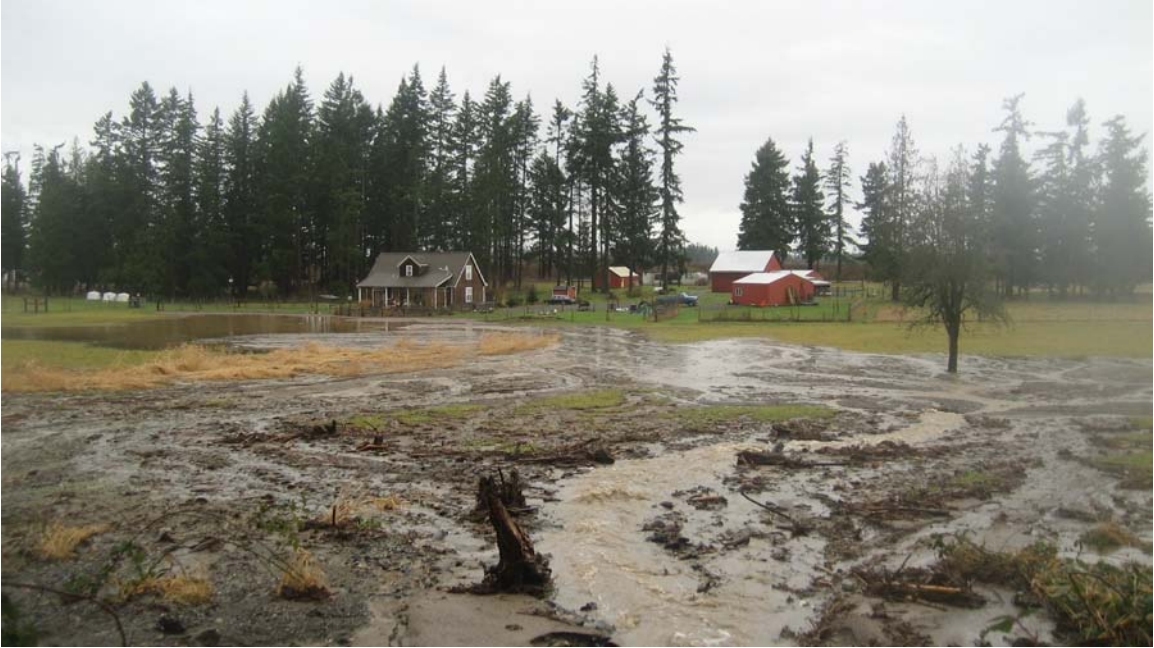
**Figure 11** Water and debris filling subdued depression to east of 6474 Siper Road. Affected residence between water and trees. View looking southwest. Photograph taken 1/8/09. (Photo by D. Hooks)

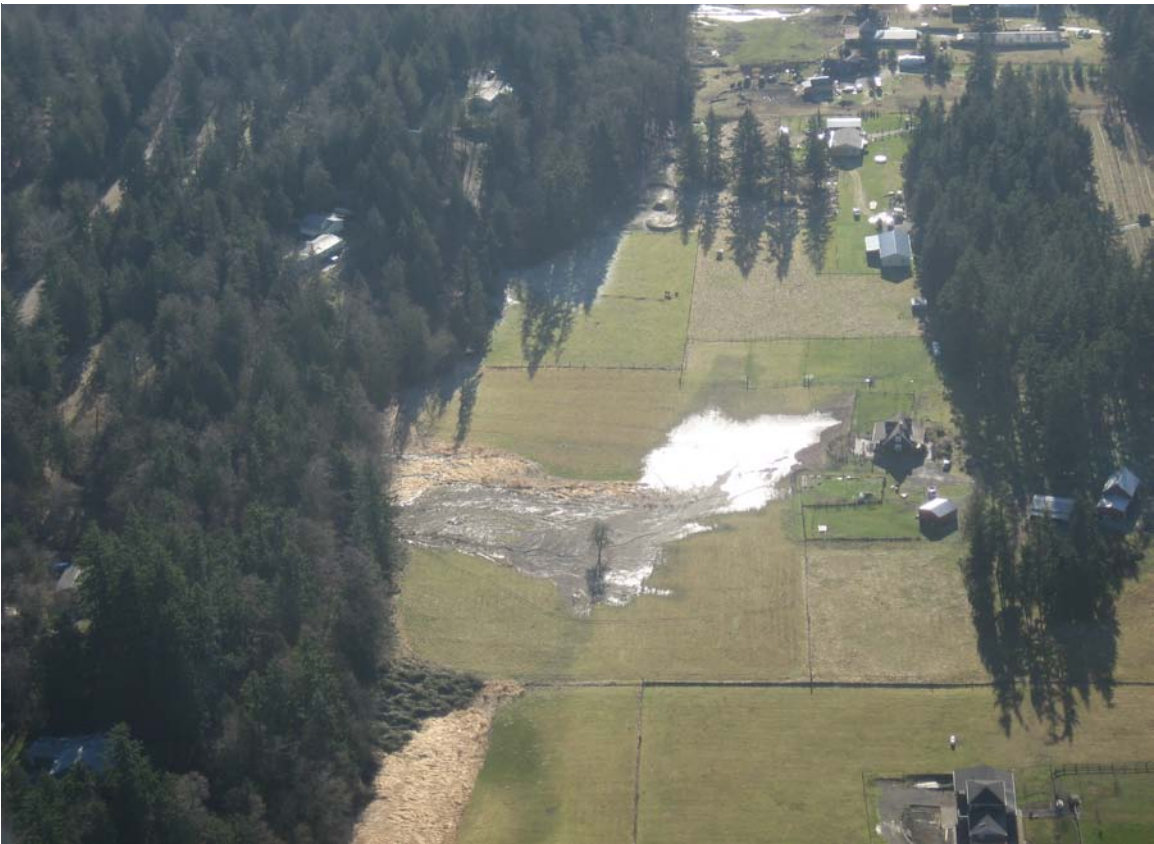
**Figure 12** Aerial photograph of flooded area east of 6489 Siper Road. Residence is structure just to right of ponded water. View looking to south. Photograph take 1/20/09. (Photo by D. Hooks)
