GEOLOGIC REPORT FOR THE 2409 REMNANT HARVEST UNIT AND ROADS

May 13, 2024

Harvest Unit Name: 2409 Remnant
HPU Number: 122112
Watersheds: North Fork of the Toutle River
Location: Cowlitz County, Washington
Sections 15, 21, & 22
T10N R2E, W.M.

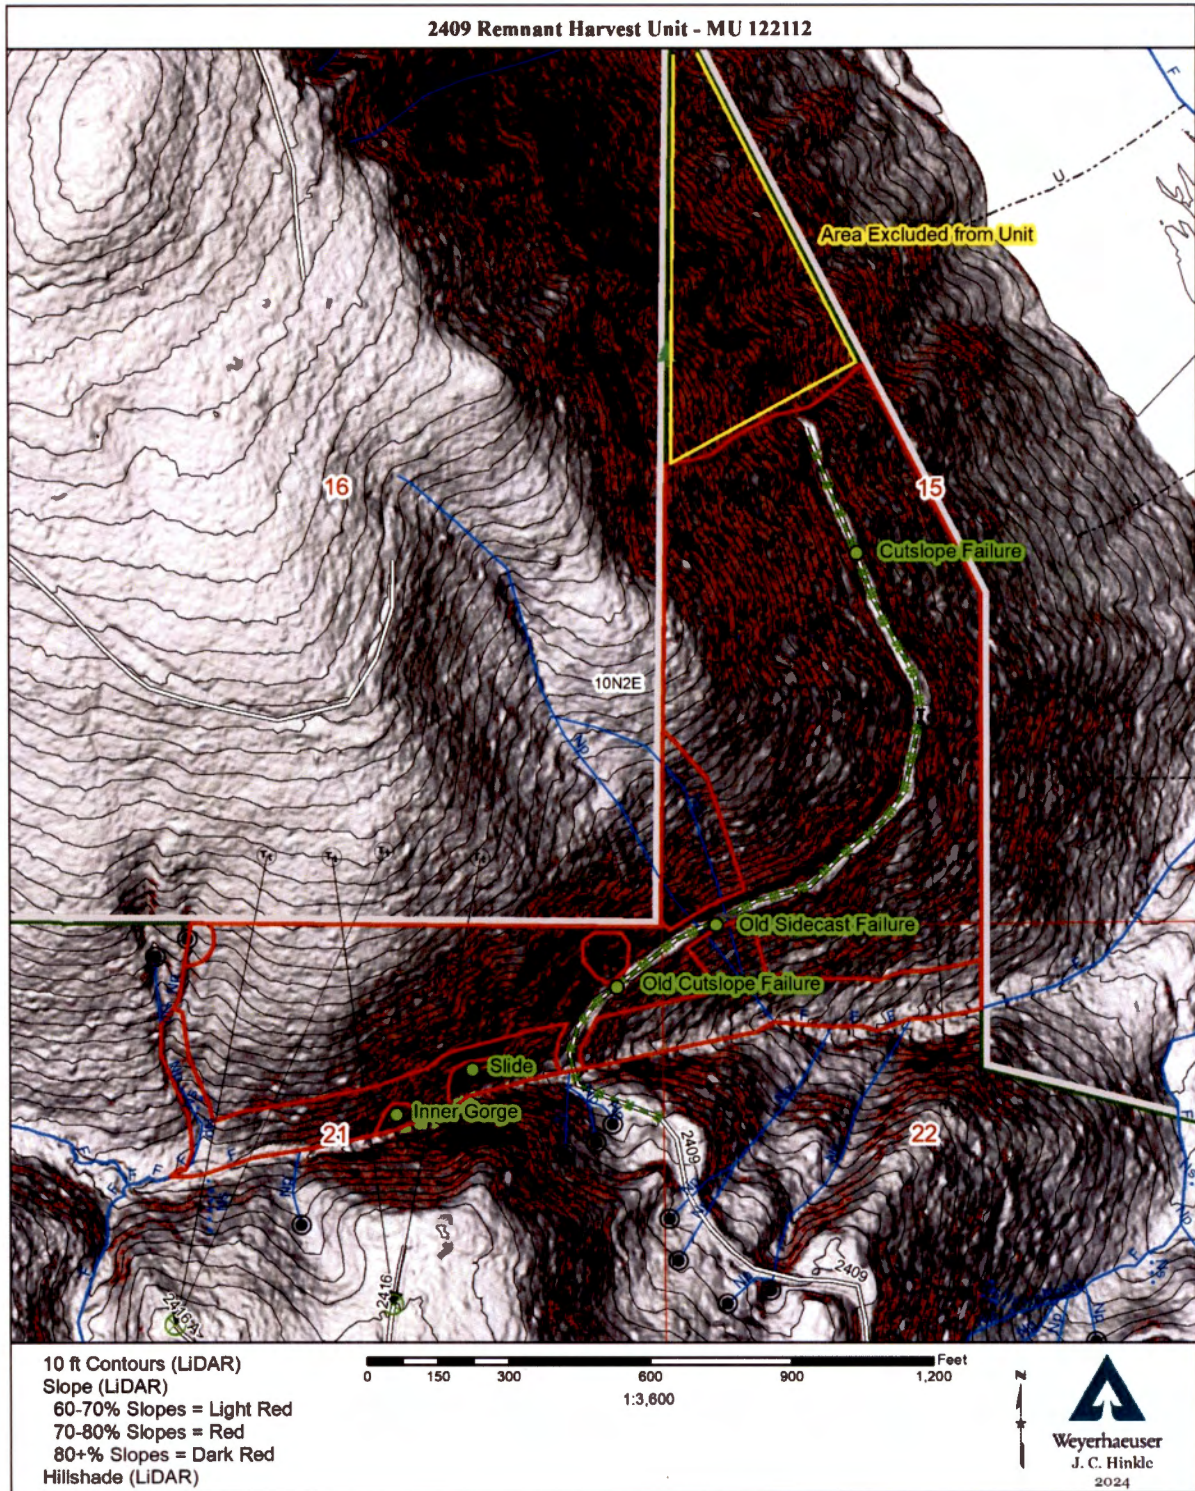
Figure 2: LiDAR 10 ft contours, slopes, and hillshade.

The unit is dominated by moderate to steep (>60%) slopes above Stitz Creek (Figure 2). Elevation in the unit ranges from 1040 feet to over 1480 feet above mean sea level.

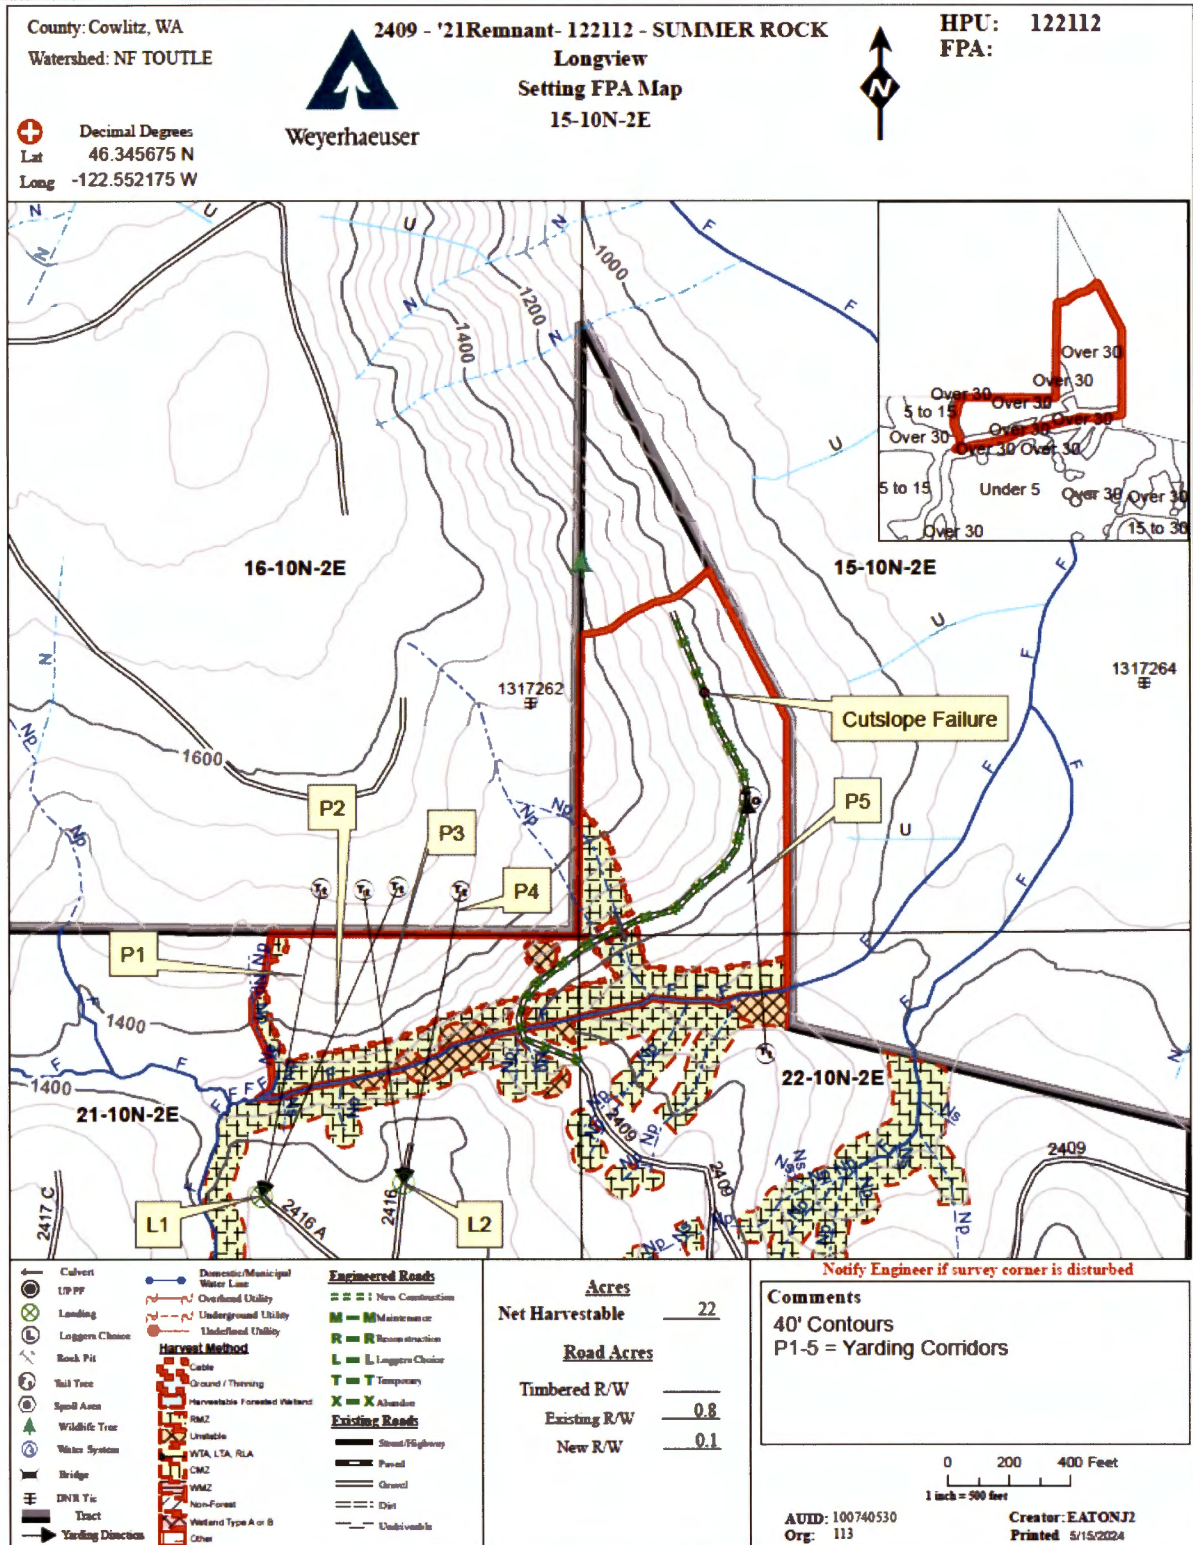
Figure 3: Final unit layout with yarding corridors.

Due to the rugged terrain and relative inaccessibility of the unit, we discussed the necessity of yarding corridors that may need to cross unstable slopes buffers (Figure 3). The forest practices application will be filed as a Class IV Special accordingly.

Corridors #1, #2, and #3 should be able to avoid crossing unstable slopes buffers. Corridor #4 will likely have to cross an inner gorge buffer (Figure 4). Corridor #5 will only require hanging lines through/over an inner gorge buffer, but no yarding through/over the buffer will be necessary. We discussed utilizing the following options to mitigate and/or minimize any impacts to the slopes and leave trees in the buffers:

- Avoid crossing buffers as much as feasible.
- Utilize natural openings in the canopy to avoid impacts to leave trees.
- Maximize lift in the yarding system as safe to do so.

- Buck logs on the slope to minimize the yarded log length (only as necessary and safe to do so). Logs may not necessarily be bucked in this situation. Whole trees allow for greater reach with less yarding corridors necessary.

- Operate the carriage slowly as it passes through the canopy in the buffers.
- Maintain full suspension as much as feasible during yarding to avoid ground disturbance.

- Landing #2 has been moved back on the 2416 spur from the end of the spur to reduce the impact to stream shading from cutting corridors #3 and #4. By moving the landing back, the corridors will be more spread out at the RMZ to resemble something more like a thinning strip through the RMZ rather than a larger continuous block of trees removed from the top of the RMZ where the corridors converge towards the landing.

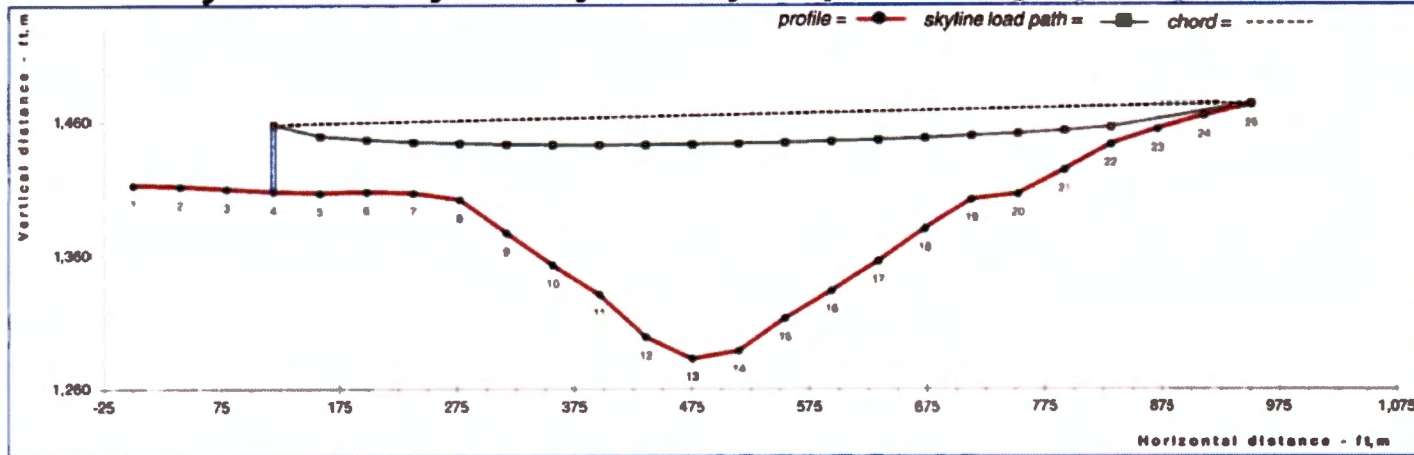
Figure 4: Engineering notes for corridor profile P4.

- Trees will likely need to be felled to maintain a safe corridor at Corridor #4. Full suspension may not be possible in this corridor either. There will be full suspension across the stream and most of the inner gorge, but possibly not all of it. There may only be one-end suspension as logs come across the defining slope break at the top of the inner gorge. Any cut trees will be left within the buffer and will be felled across the corridor, parallel to the stream to provide a buffer or slash mat for the trees being yarded across to rub against instead of being yarded across the ground surface, especially at the defining slope break at the top of the inner gorge.

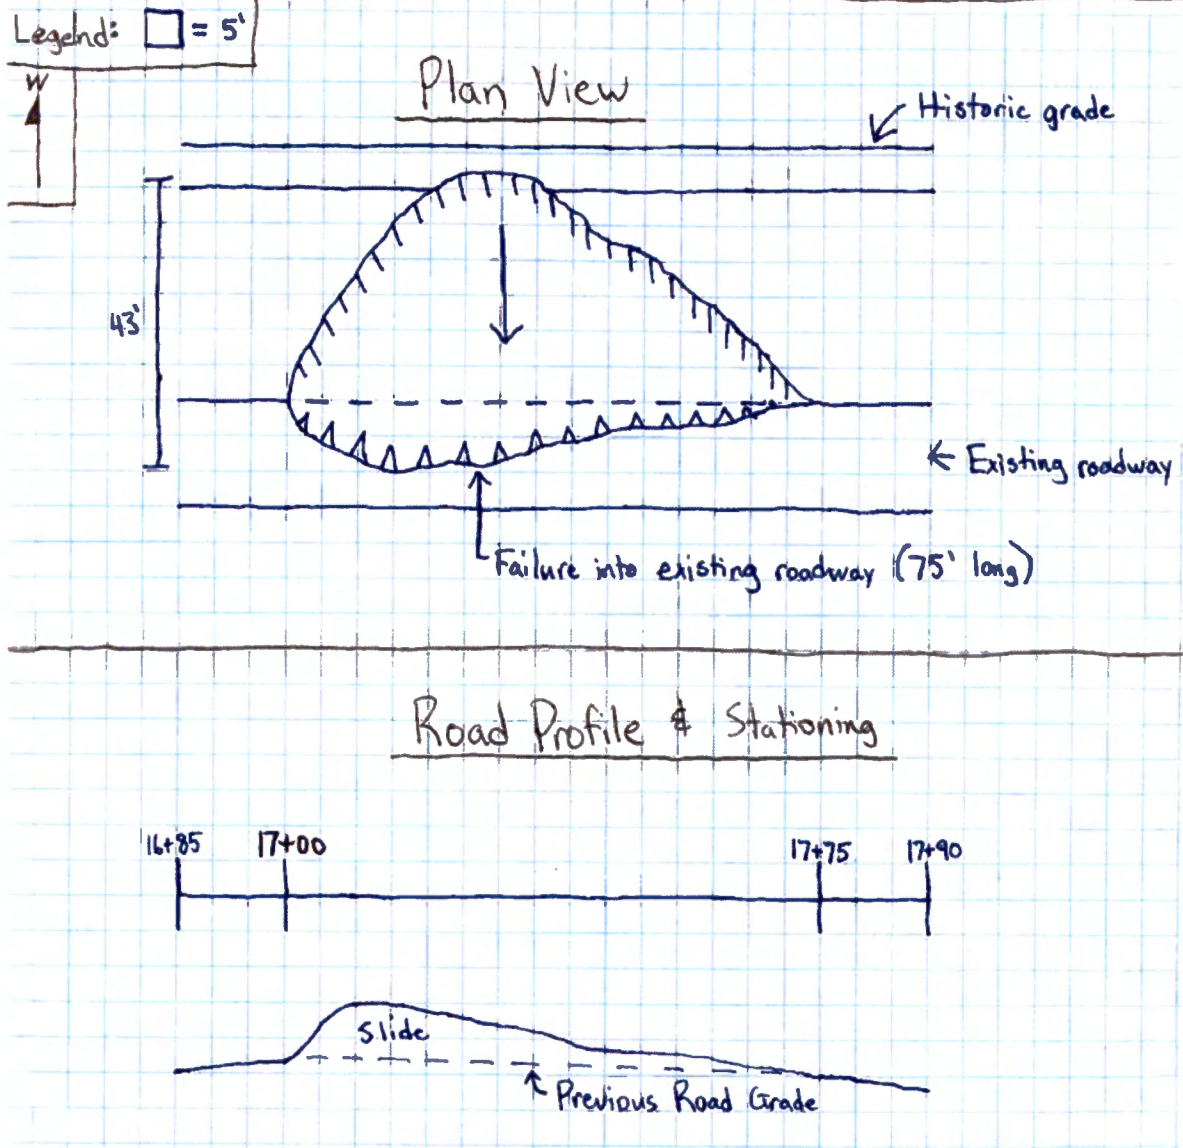
Figure 5. Plan view and profile of reconstruction at cutslope failure.

- Old sidecast failure – Not significantly affecting road grade; Feature buffered.
- Cutslope failure – Scarp in old catroad grade above cutslope in 2409 Road; Slide deposited on 2409 Road; 50-60% slopes on slide mass; 65-70% catroad cutslope; 55-60% slopes above catroad; Conifer and old growth stumps present; Wet site conditions observed in ditch along 2409 Road; No signs of surface water above slide; No other signs of recent slide activity.

The 2409 Road will need to be reconstructed to access the north end of the unit. Most of the old grade is intact and only needs clearing, reestablished ditch-lines and cross-drains, and surfacing. However, the recent cutslope failure has made the road impassable at that location. This will also dictate the need for the forest practices application to be filed as a Class IV Special. The repair should be simple and straightforward. The slide deposit on the road will be excavated and hauled to a stable location. The slope will be laid back and then buttressed with a large rock fill as shown in the engineering notes (Figures 5 and 6). The ditch-line will be reconstructed across the site, reestablishing proper road drainage at the site.
