**REVISED REPORT OF GEOLOGIC HAZARD EVALUATION
GEODESIGN INC., AN NV5 COMPANY
MAY 27, 2020**

Revised Report of Geologic Hazard Evaluation

Naff Pit

Geologic Hazard Evaluation

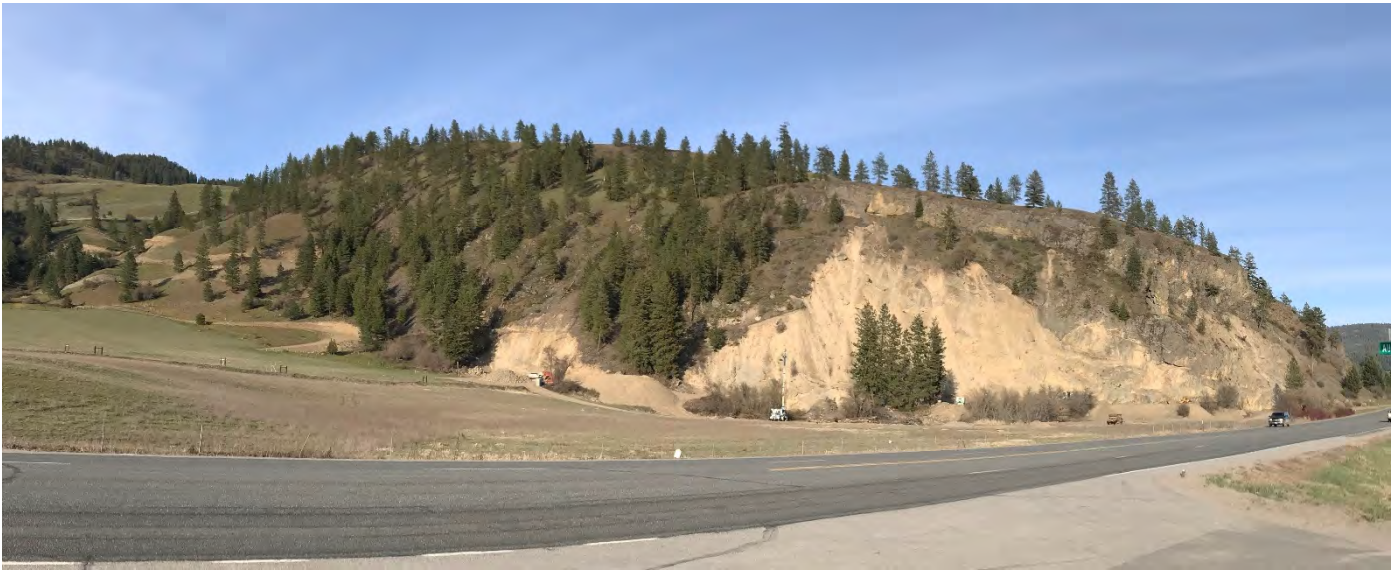
NAFF PIT (RIGHT) AND THE PROPOSED EXPANSION AREA (LEFT OF MINE DISTURBANCE) VIEWED FROM HIGHWAY 20. A RECENT DOZER TRAIL IS LOCATED FURTHER LEFT OF THE EXPANSION AREA. PANORAMIC PHOTOGRAPH TAKEN FACING EAST/NORTHEAST.

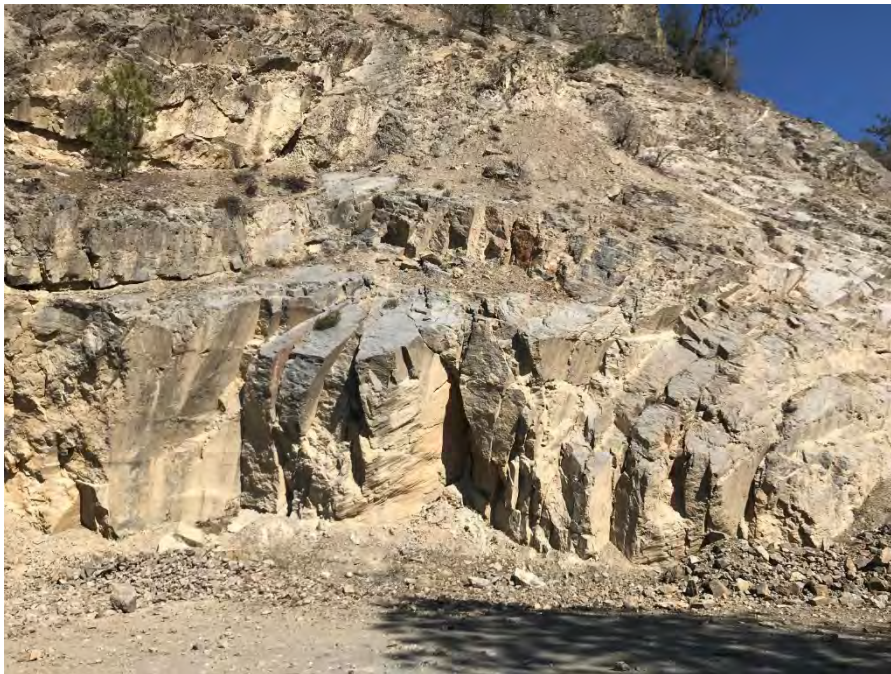
Figures 3 and 4 show photographs of jointed beds in the mined excavation. Similarly oriented joints and planar trends are exhibited in outcrops. These features are visibly aligned where they can be observed together.

SOUTH END OF MINED EXCAVATION INTO BEDROCK (CONGLOMERATE) AT NAFF PIT. BEDDING APPEARS NEAR HORIZONTAL IN THIS VIEW BECAUSE THE PERSPECTIVE FACES UP-DIP TO THE NORTHEAST. STEEPLY DIPPING ROCK JOINTS CROSS-CUT THE CONGLOMERATE BEDS.

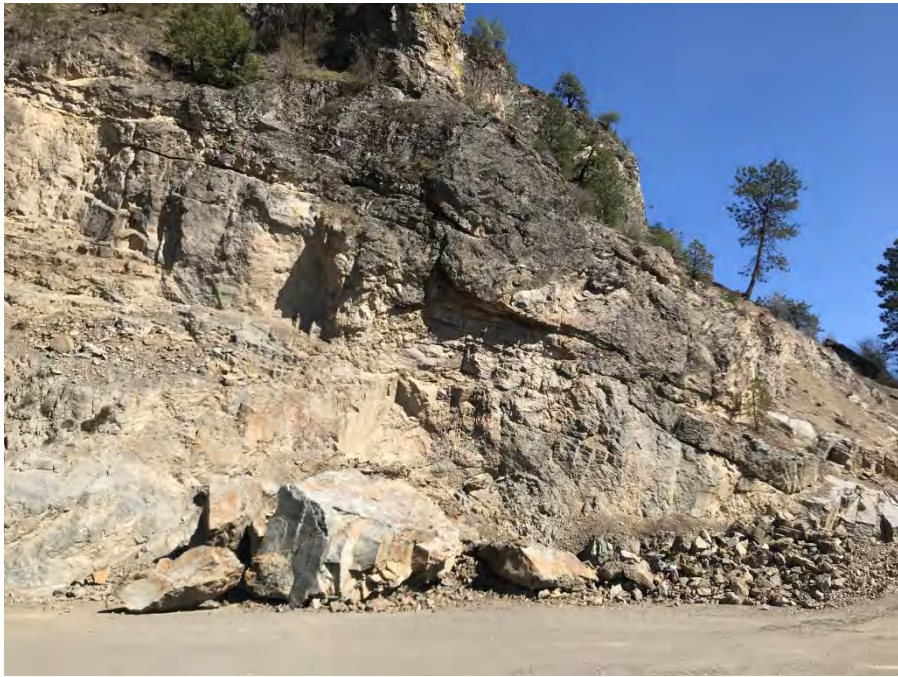
We did observe large, angular boulders on the south floor of the current mine that fell out of the mined bedrock excavation. These boulders are similarly sized in all three dimensions, up to approximately 10 feet in diameter, and have prominently planar faces representing rock discontinuity surfaces. The boulders appear to be defined by two sets of intersecting joints and bedding planes. This mode of failure can result in wedge failures out of exposed bedrock if rock cuts are significantly tall and steeper than the main discontinuity, which is bedding in this case.

MINED EXCAVATION INTO CONGLOMERATE AT NAFF PIT. BEDDING DIPS DOWN AND TO THE RIGHT (SOUTHWEST). ROCKFALL HAS ACCUMULATED AT THE FOOT OF THE HIGHWALL. PHOTOGRAPH TAKEN FACING EAST.

We recommend that the bedrock highwall in the current mine excavation not be advanced farther east into the hillside at the current elevation. The current mine face has experienced some significant rockfall. Continued mining would result in a taller exposure with a greater chance for large rockslides. If further mining of the currently permitted area is not planned, we recommend the operator place a protective berm or consider backfilling the floor and restoring a slope up against the bedrock highwall to protect against potential future rockfall. Backfill should consist of clean, inert soil and weathered, non-saleable rock removed from the expanded mine excavation area. Fill should be placed in horizontal lifts using bulldozers or other heavy equipment and track-compacted into place to a firm, unyielding condition. Lifts should not exceed 2 feet in thickness. Fill should be placed during dry weather or when not excessively above optimum moisture content.

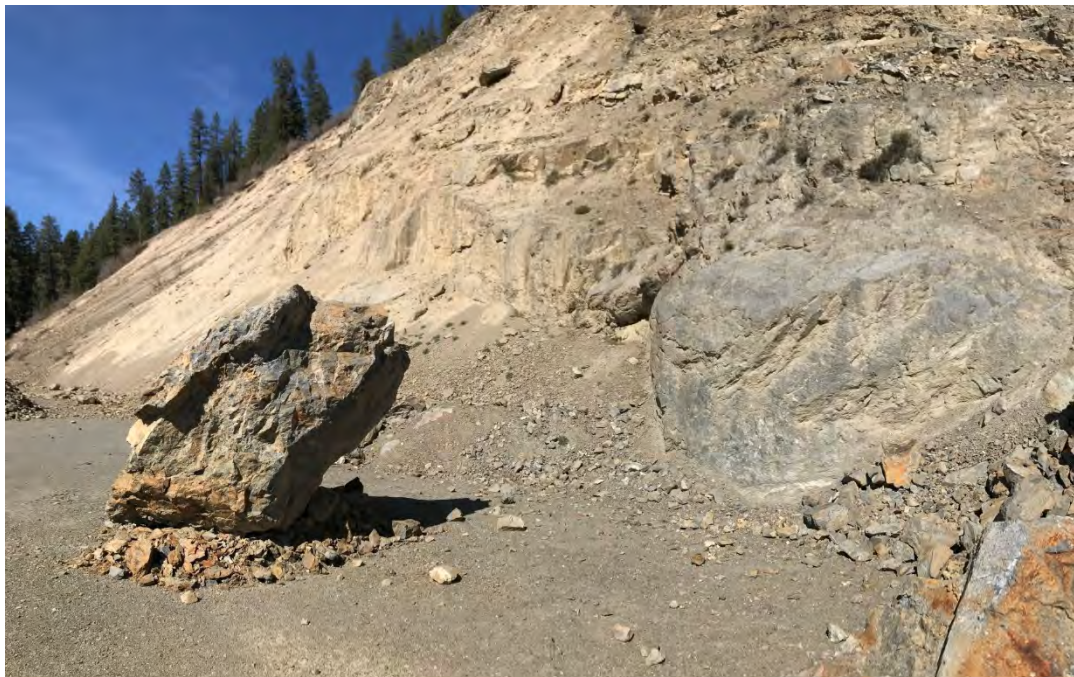
ROCKFALL BOULDER APPROXIMATELY 8 FEET IN DIAMETER. THE MINED SLOPE IN THE BACKGROUND IS MOSTLY FORMED FROM REMOVAL OF TALUS. PHOTOGRAPH TAKEN FACING NORTHEAST.

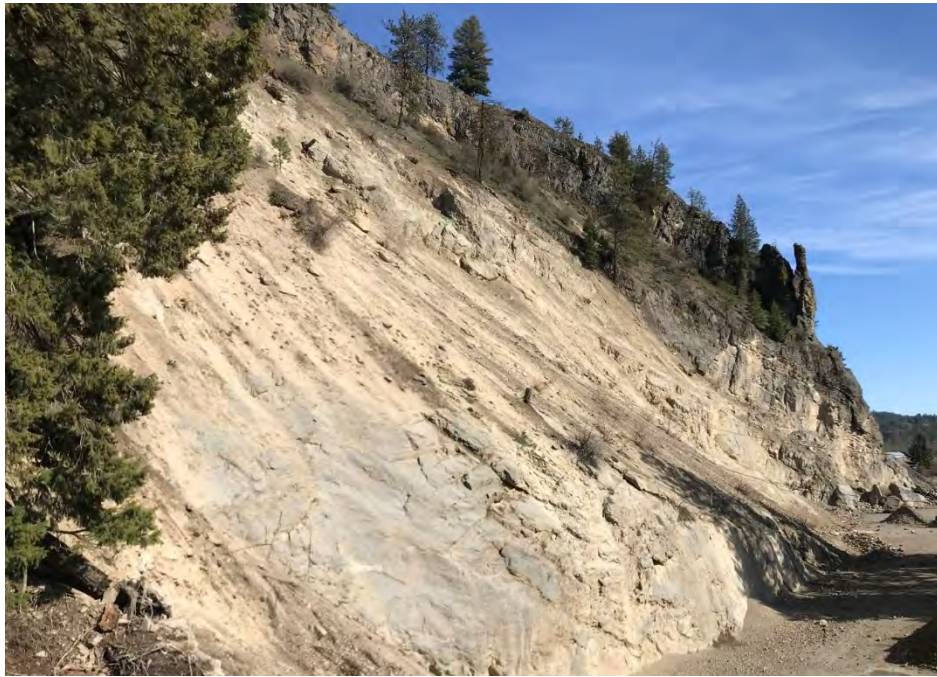
The presence of dipping rock strata out of the slope and cross-cut by high-angle rock fractures presents the potential for slope instability. We did not observe signs of global slope failure or significant rockslides at the site during our reconnaissance. In fact, there are rock features toward the south end of the currently permitted area that appear to be delicately balanced, forming isolated pinnacles from gradual erosion of the surrounding bedrock (Figure 5).

VIEW PARALLEL TO THE MINED EXCAVATION, INCLUDING THE TALUS SLOPE UNDERLAIN BY A BEDROCK CUT IN THE FOREGROUND, AND THE BEDROCK EXCAVATION WITH ROCKFALL IN THE BACKGROUND. PHOTOGRAPH TAKEN FACING SOUTH/SOUTHEAST. NOTE THE NATURAL OUTCROP ABOVE BOTH SLOPES ORIENTED PARALLEL TO THE BEDDING EXPOSED IN THE BEDROCK EXCAVATION. ROCK PINNACLE ALSO VISIBLE AT THE RIGHT END OF THE NATURAL OUTCROP.

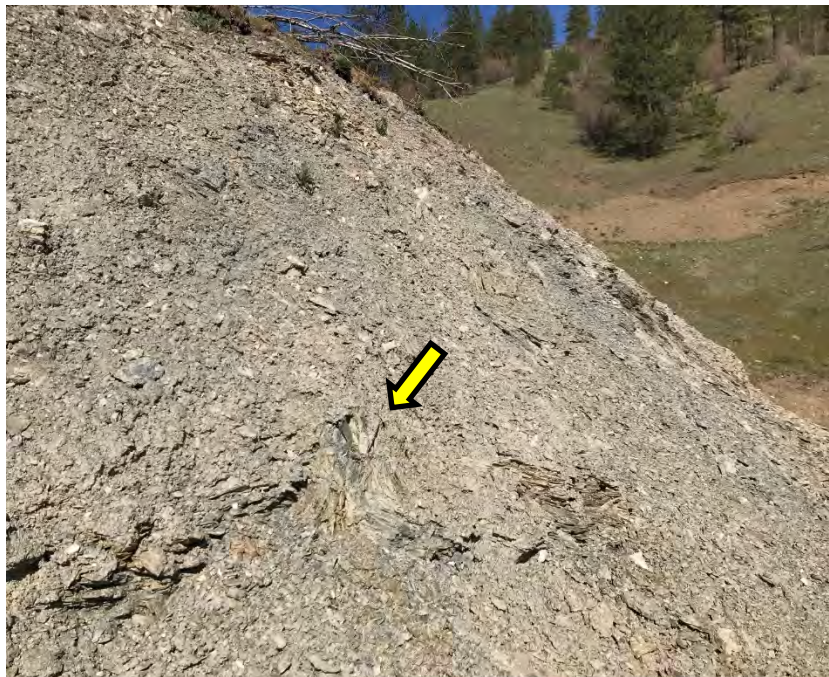
A recently cut dozer trail on the less-steep slope located north of the expansion area has multiple exposures of slate. The slate is gray, fissile, finely laminated, and intensely fractured and contorted (Figure 5). It is impossible to tell the structural orientation of the slate in the outcrops we observed due to the structural disturbance of the original bedding. We interpret the less-steep natural slope gradients north of the expansion area to reflect the slate's lesser resistance to weathering, resulting in more gradual topography with no natural outcrops.

SLATE EXPOSED ALONG DOZER TRAIL NORTH OF THE EXPANSION AREA. YELLOW ARROW POINTS AT THE CONTORTED BEDDING IN THE SLATE. PHOTOGRAPH TAKEN FACING EAST.

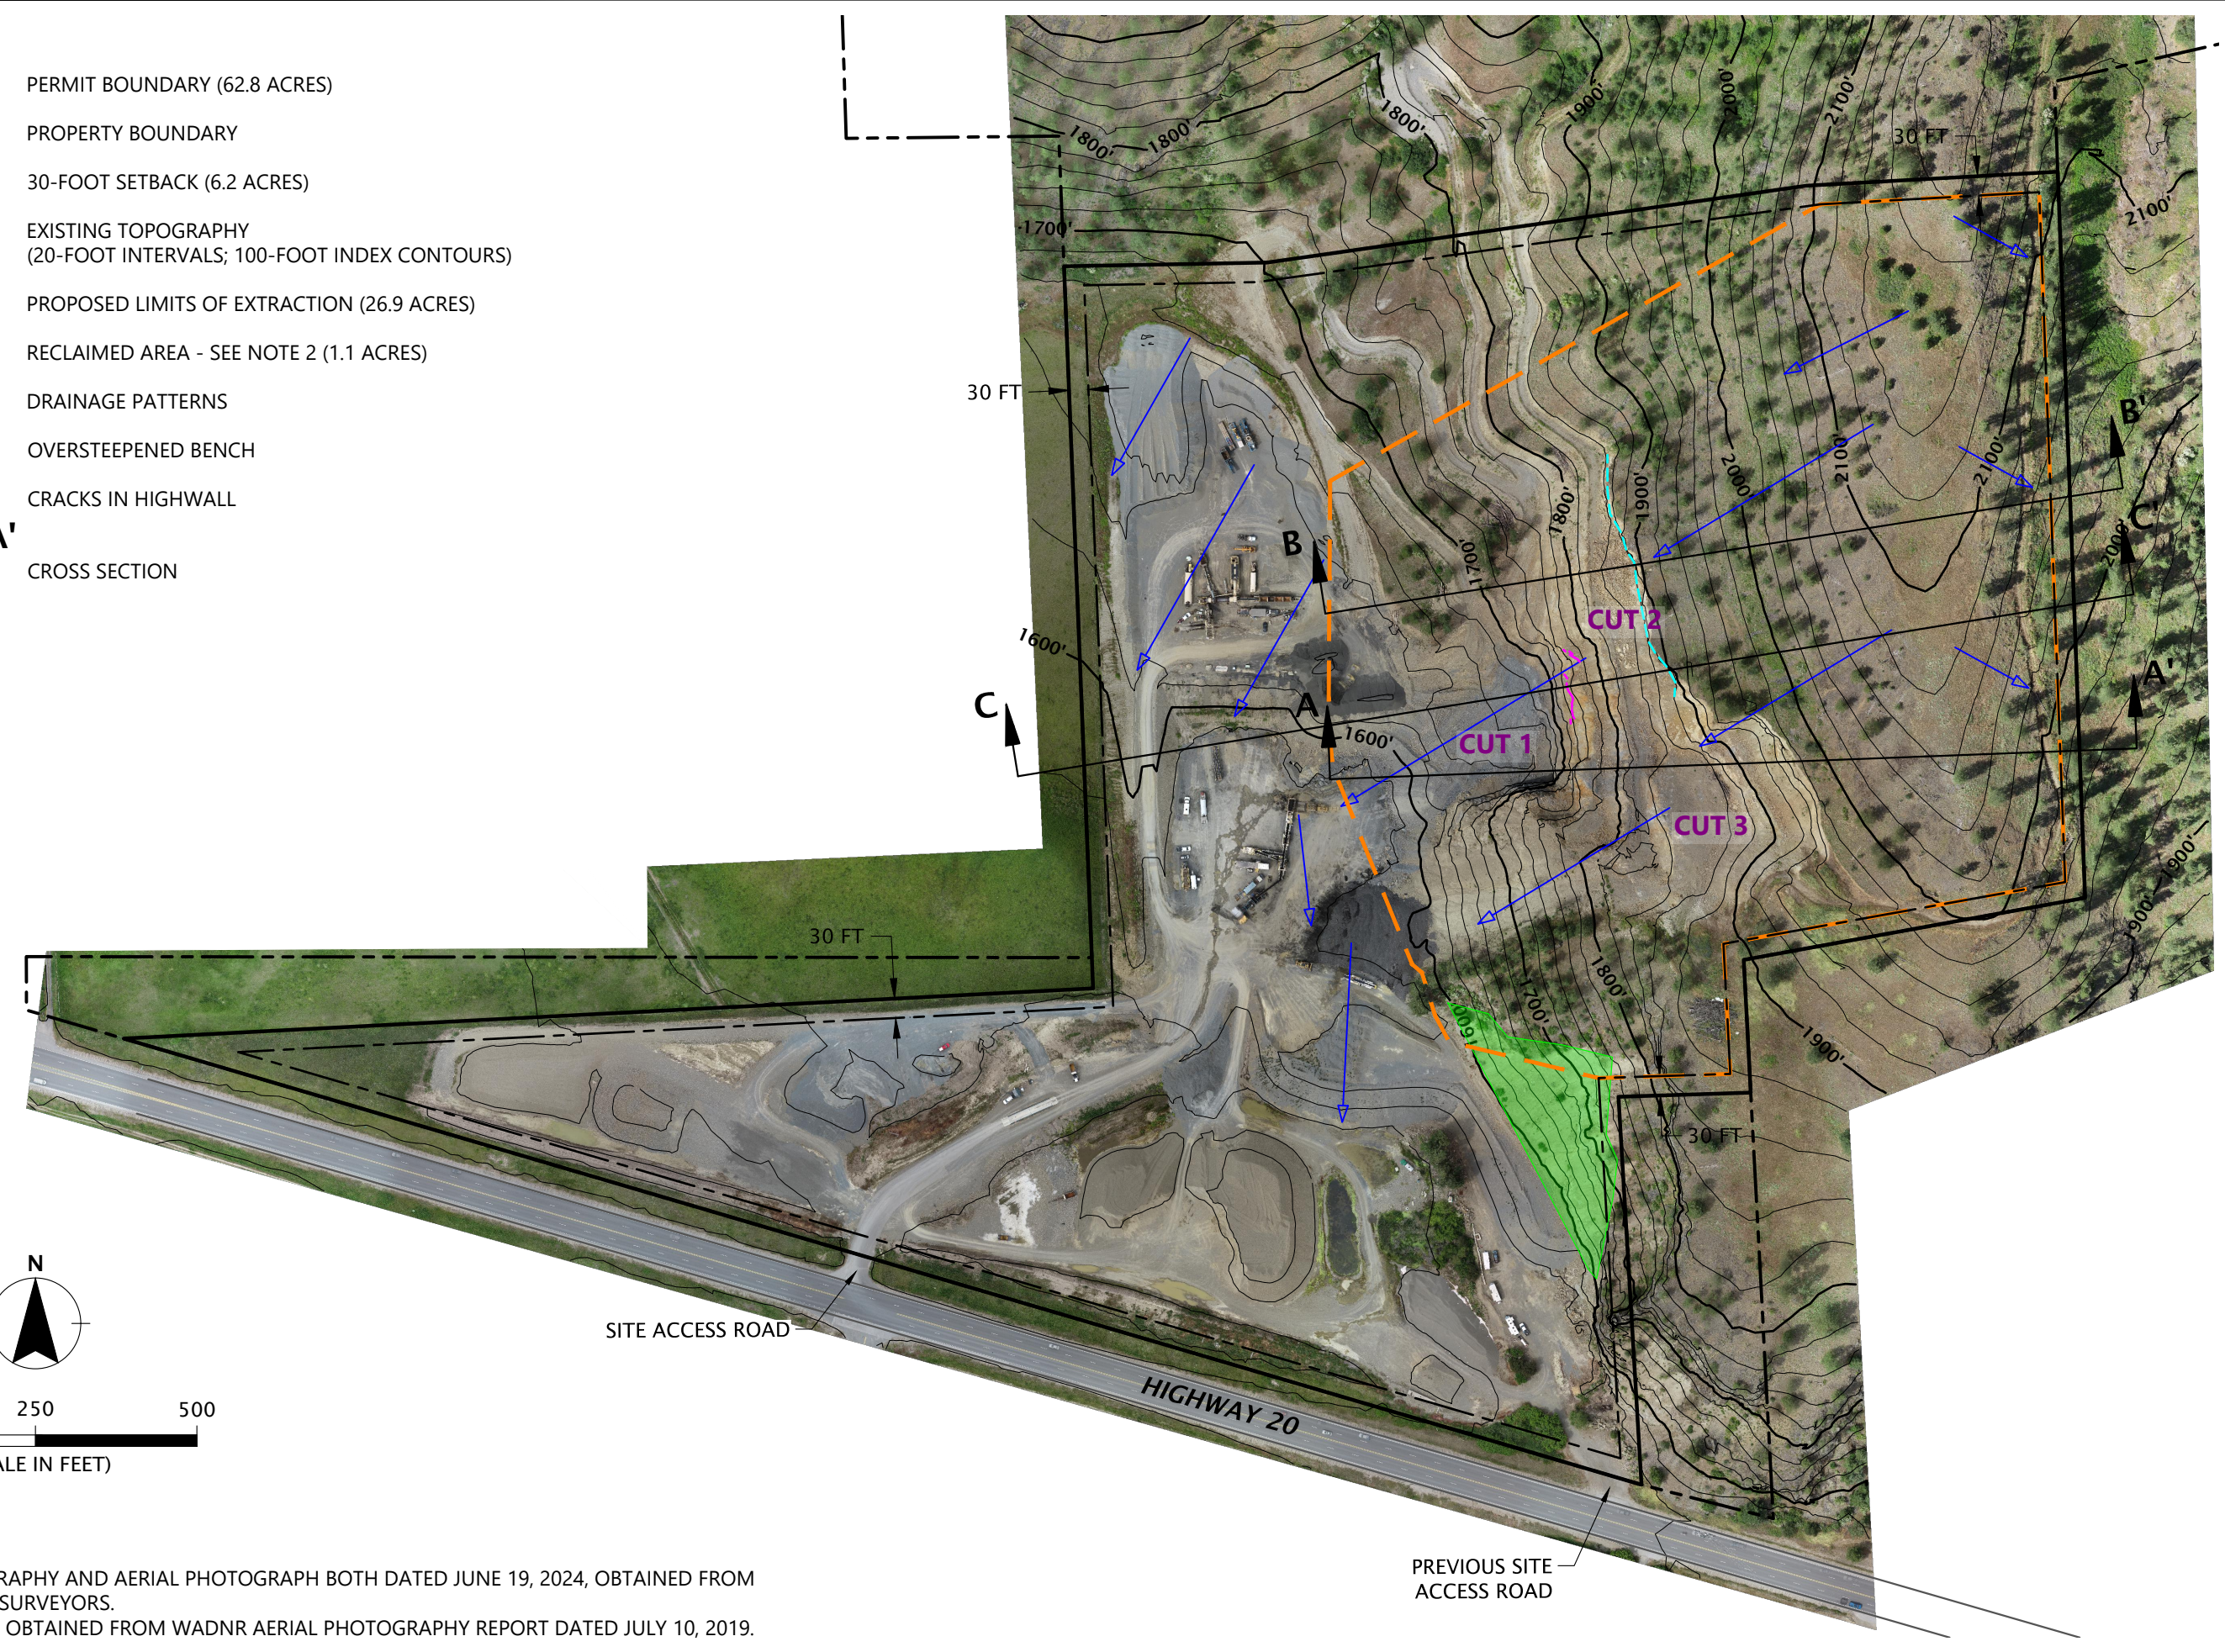
VAAGEN BROTHERS LUMBER, INC. PROJECT 012.01.01 AUGUST 2024	AERIAL SITE MAP NAFF PIT - GEOLOGIC HAZARD EVALUATION STEVENS COUNTY, WA SECTIONS 25 & 26, TOWNSHIP 36N, RANGE 38E W.M.	FIGURE 2

The expanded mine conditions are presented on Figures 2 and 3 using the June 2024 UAV aerial imagery and topographic survey. A multi-use property access road extends north and east of the mine and was widened and graded with additional switchbacks to ascend the north slope. Two internal haul roads extend south from the switchbacks to access benches cut into the west hillside at elevations of about 1,770 and 1,830 feet above mean sea level (msl). An additional haul road is located at 1,690 feet msl.

The June 2024 UAV imagery indicated the presence of bedrock cracks forming in the mid-slope of the northeast part of Cut 1. These cracks are mapped on Figures 2 and 3 and located along cross section C-C'. The cracks are not accessible on foot. Indication of possible cracking was noted in one area during Fulcrum's April 2024 reconnaissance, as shown on Figure A-5 in the Attachment. The separation and orientation of these cracks indicate an incipient rock topple failure is forming in the highwall similar to the rock topple in Cut 2, though involving a taller exposure. This presents a significant hazard to mine staff working below the wall. The wall height in this area makes recognition of slope stability hazards difficult in the field without the benefit of overhead/UAV assistance.

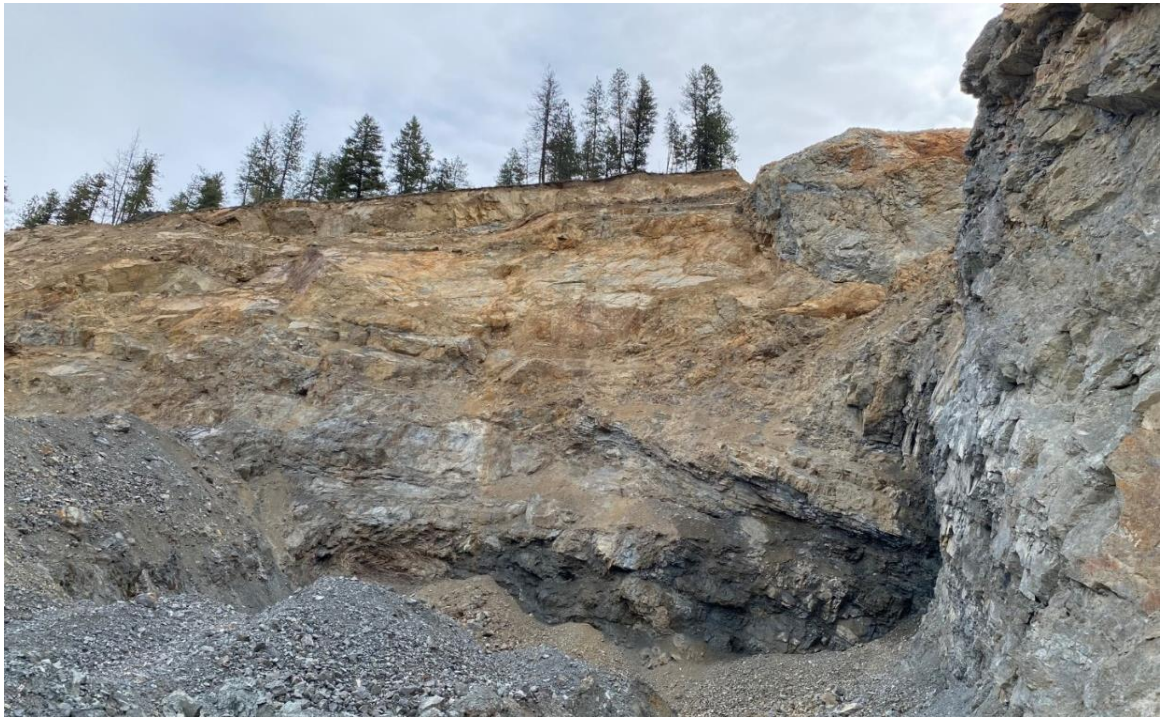
Cut 1 consists of a very tall “box-cut” into the lower hillside, exposing thick conglomerate beds underlain by finer-grained, thin sandstone and slate beds in the east wall of the cut. Refer to Figures A-1 and A-2 in the Attachment. Undulations in the bedding have also resulted in locally steeper dip planes that appear to have caused smaller, localized failure of prior benches. One remnant block from a previous bench, located in the southeastern corner of Cut 1, remains at the top of the cut wall. Refer to Figure A-2. Adjacent areas to the north expose a smoothed, dipping plane that appears to underlie this suspended block, suggesting there were other blocks located along the previous bench that already slid.

VIEW EAST INTO THE "BOX CUT" OF CUT 1. NOTE THE DARKER, FINE-GRAINED STRATA (THIN SANDSTONE BEDS AND SLATE) AT THE BOTTOM OF THE CUT.

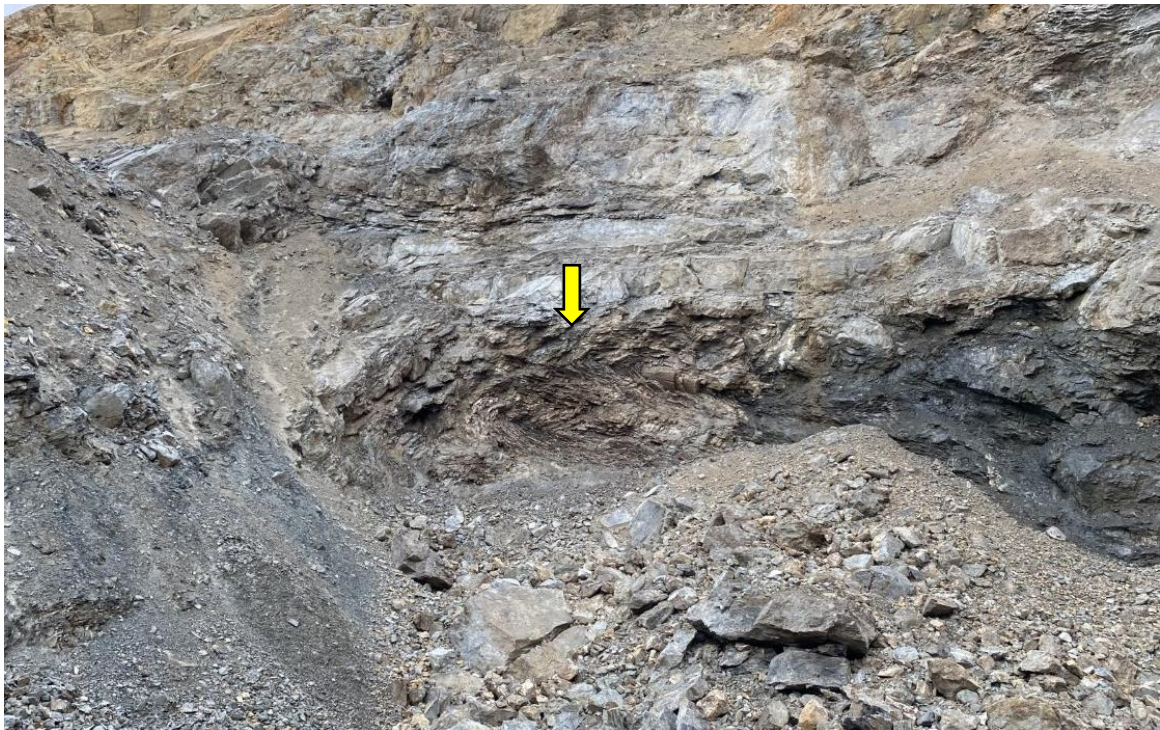
The finer-grained strata – particularly the slate – located at the base of the east wall in Cut 1 is of significant concern. Slate is a much weaker rock than the overlying conglomerate and sandstone, as exhibited along the dozed roadways north of the mine. If Cut 1 were expanded northward or southward from the current box cut into a longer bench, it could lead to a global failure of the ridge, where the overlying conglomerate and sandstone could slide over the exposed slate. Based on the proposed final contours on Figure 4 and cross section A-A' on Figure 5, Cut 1 has been excavated below a final floor projecting at 2H:1V from the east edge of the proposed extraction limits. As such, some of the current Cut 1 may require backfill to achieve the proposed final topography presented on Figures 4 and 5.

CONTORTED BEDDING (YELLOW ARROW) IN SLATE TOWARD THE BOTTOM OF THE EAST WALL IN CUT 1. VIEW IS TO THE NORTHEAST.

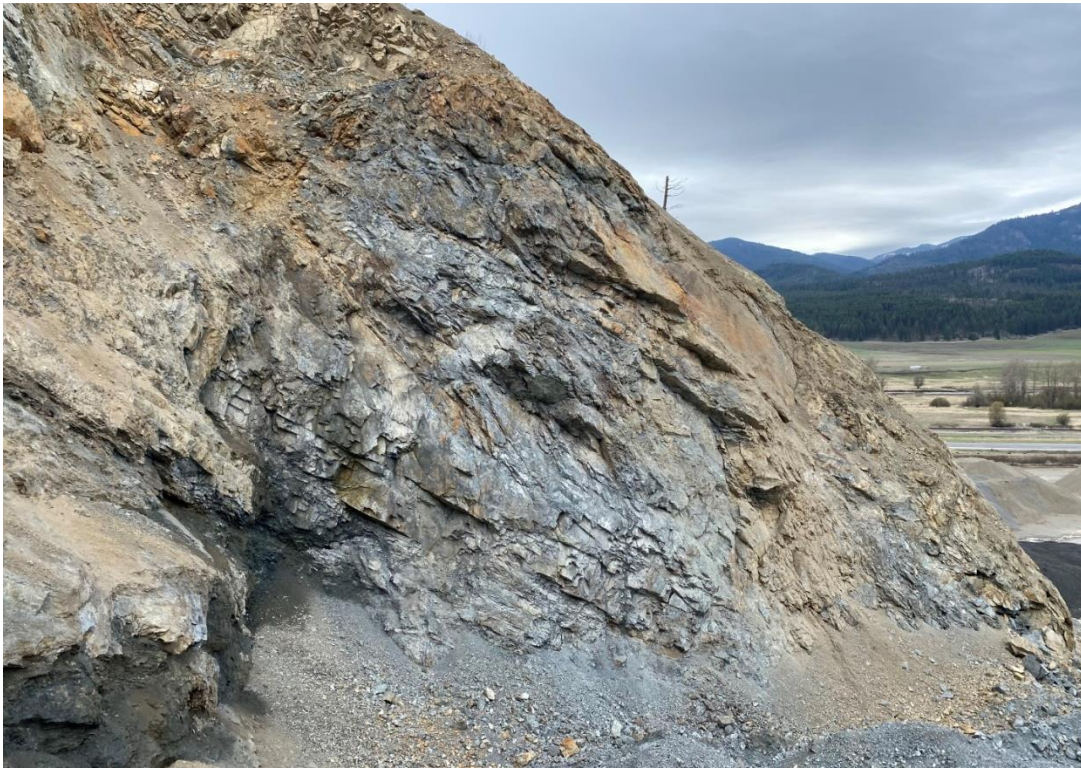
PROMINENT, SOUTHWEST-DIPPING BEDDING IN CONGLOMERATE EXPOSED IN THE SOUTH WALL OF CUT 1. VIEW IS TO THE SOUTH.

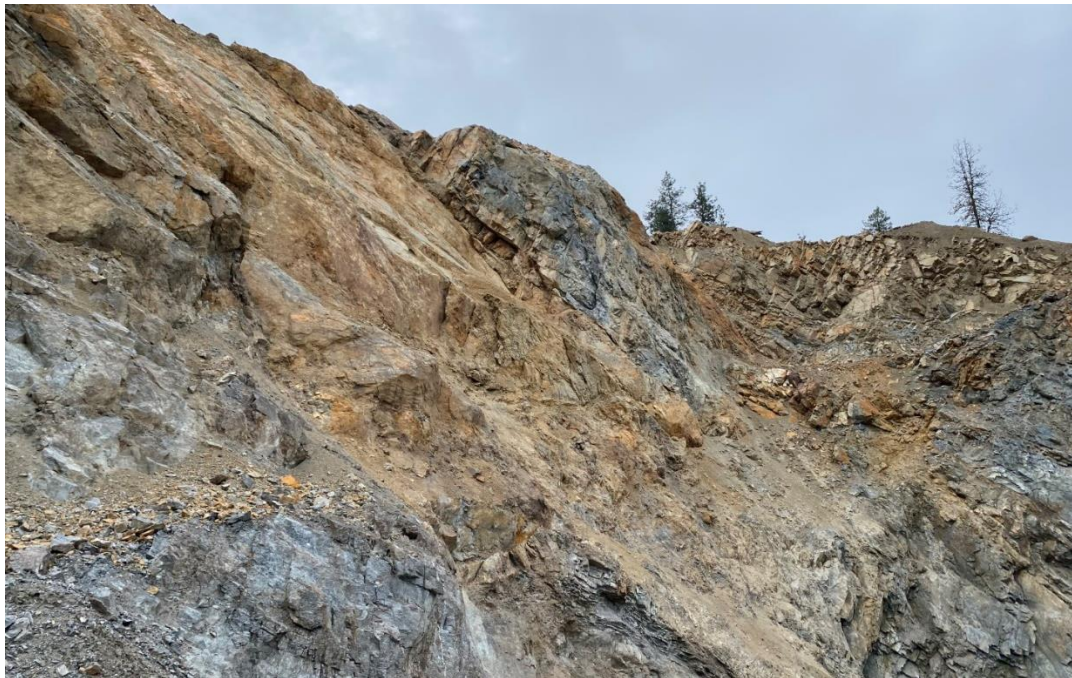
SUSPENDED BLOCK OF CONGLOMERATE (GRAY) IN CUT 1. NOTE THE ORANGE-STAINED, ANGLED BEDDING PLANE IN THE FOREGROUND LEFT OF THE BLOCK, WHICH LIKELY UNDERLIES THE BLOCK. VIEW IS TO THE SOUTHEAST.

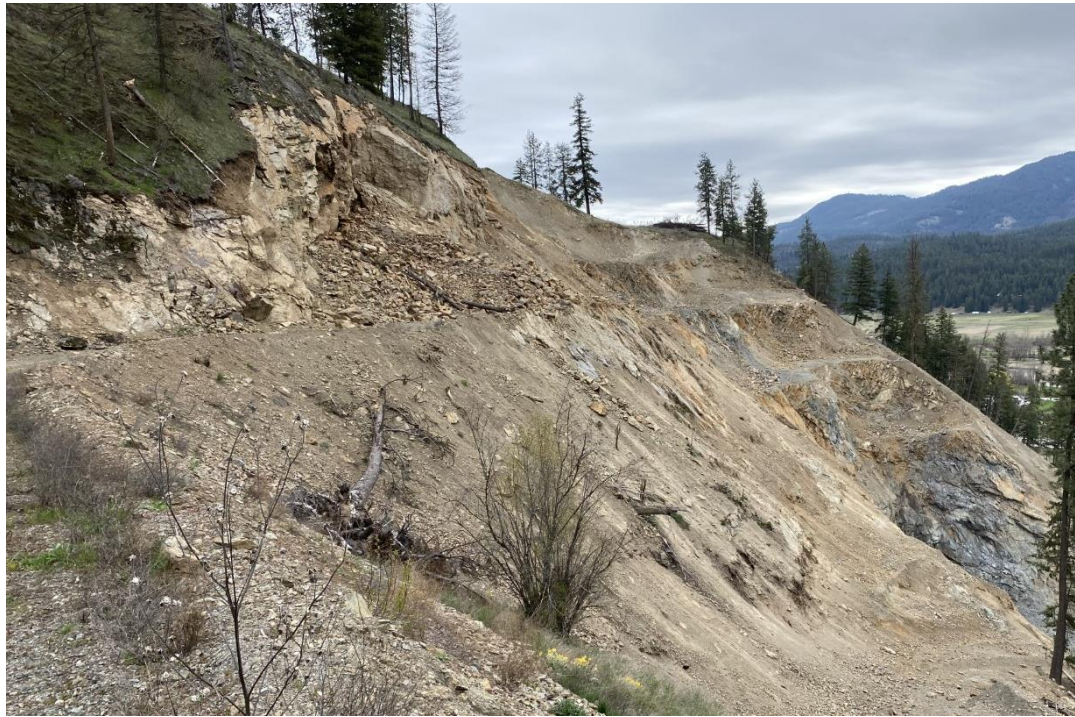
Cut 2 consists of a bench more than 350 feet in length that experienced a bench wall failure over about 200 feet of its length. Refer to Figures A-3 and A-4 in the Attachment. The bench wall is tilted 80 degrees with the top oversteepened westward above the former bench floor. At the time of Fulcrum's reconnaissance and in the June 2024 UAV imagery, there was accumulated rock debris piled across most of the bench width and against the lower part of the bench wall. The inclined wall appears to be a consequence of high-angle rock joints that formed a detachment, allowing dipping rock strata to topple out of the excavated wall. Based on the 2016 topography and current elevations in adjacent areas, the maximum bench height was about 50 feet and bench width about 50 feet prior to failure.

OVERSTEEPENED BENCH WALL AND ROCK DEBRIS IN CUT 2. OTHER BENCHES AND THE TALL SOUTH WALL OF CUT 1 ARE VISIBLE AT RIGHT. VIEW IS TO THE SOUTH.

The bench around Cut 2 served as an effective primary catchment for rock debris that fell from the bench wall and could continue to serve this role as long as there is capacity for debris to accumulate on the bench. The operator should regularly observe this bench to make sure it does not become overfull and could spill material further downslope. If material needs to be cleared for this purpose, we recommend only the outer part of the bench (i.e., the west side) be cleared of debris. Leaving debris in place on the east side serves a benefit to buttress the oversteepened highwall. We recommend the bench only be accessed when needed to clear debris to maintain the catchment.

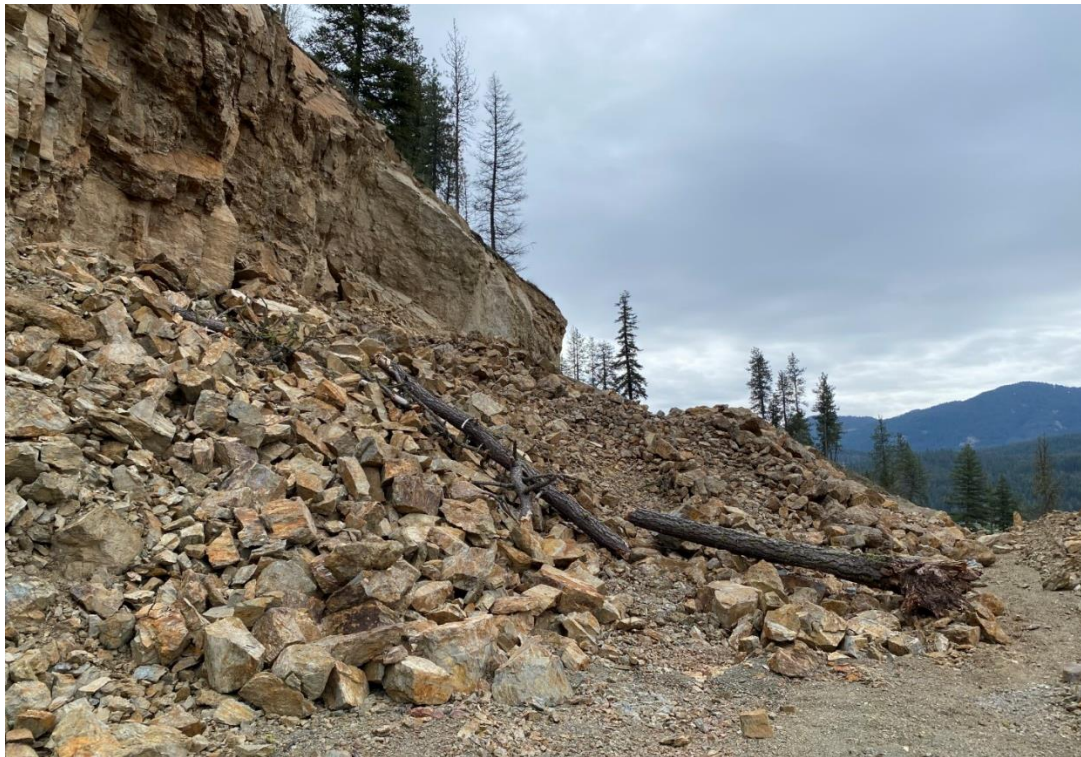
The current wall orientation is still tilted to the west and oversteepened, suggesting additional failure is possible. Accumulated debris at the base of the topple is currently buttressing the base of the wall. Additional failures of the top of the wall could cause the adjacent bench to be overfilled with debris, leading to loose rock material falling past the bench and farther downhill to lower portions of the site.

OVERSTEEPENED WALL AND ACCUMULATED ROCK DEBRIS ON THE BENCH AT CUT 2. VIEW IS TO THE SOUTH.

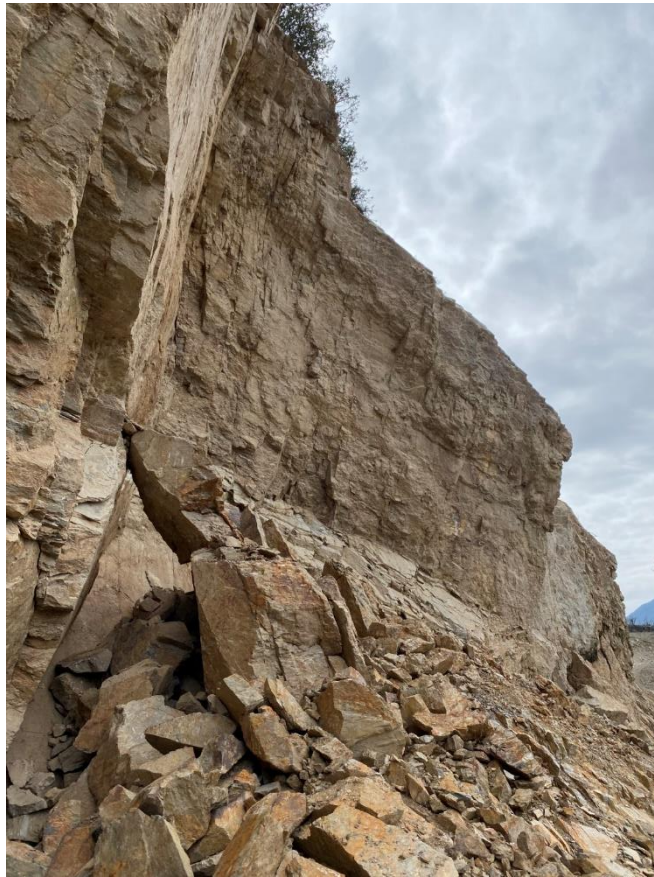
OVERSTEEPENED WALL AT CUT 2. NOTE THE FLAT, TABULAR PARTINGS IN THE BEDROCK FROM HIGH-ANGLE ROCK JOINTS. VIEW IS TO THE SOUTHEAST.

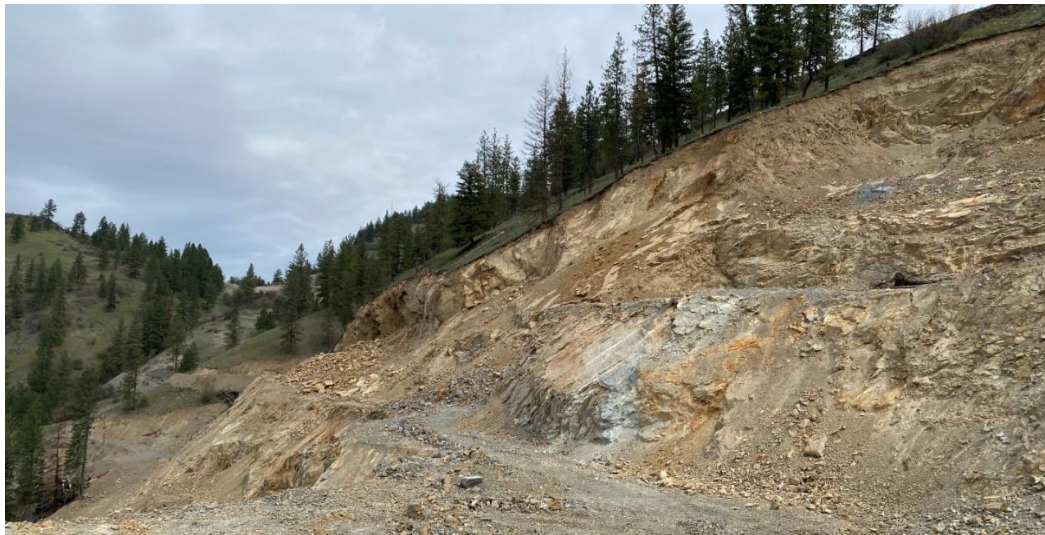
VIEW LOOKING NORTH AT THE TOPPLED ROCK DEBRIS AND OVERSTEEPENED WALL AT CUT 2. THE DETACHED BEDROCK ALONG BEDDING LEFT A PROMINENT PLANAR SURFACE. START OF CUT 3 VISIBLE AT RIGHT.

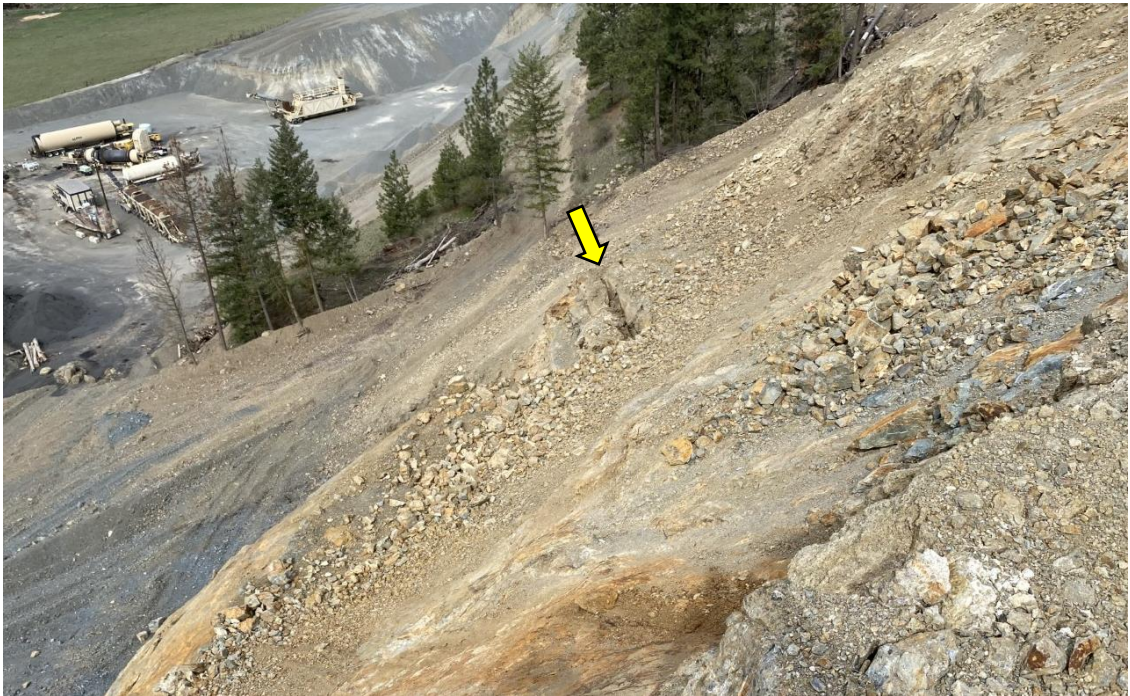
BEDROCK CRACK (YELLOW ARROW) OBSERVED IN THE MIDDLE OF THE HIGHWALL IN CUT 1. THIS CORRESPONDS TO THE CRACK MAPPED FURTHEST NORTH ON FIGURES 2 AND 3. VIEW IS TO THE NORTHWEST.

We expect that future block and topple failures in the mined mid-slope benches and cuts will occur, and the operator should make regular observations for developing highwall cracks or similar signs of incipient failure. This will likely require the assistance of a UAV system to capture images from overhead, such as the cracks mapped on Figures 2 and 3 that were not observable on foot, and to prevent staff from needing to be present in the exclusion zone.

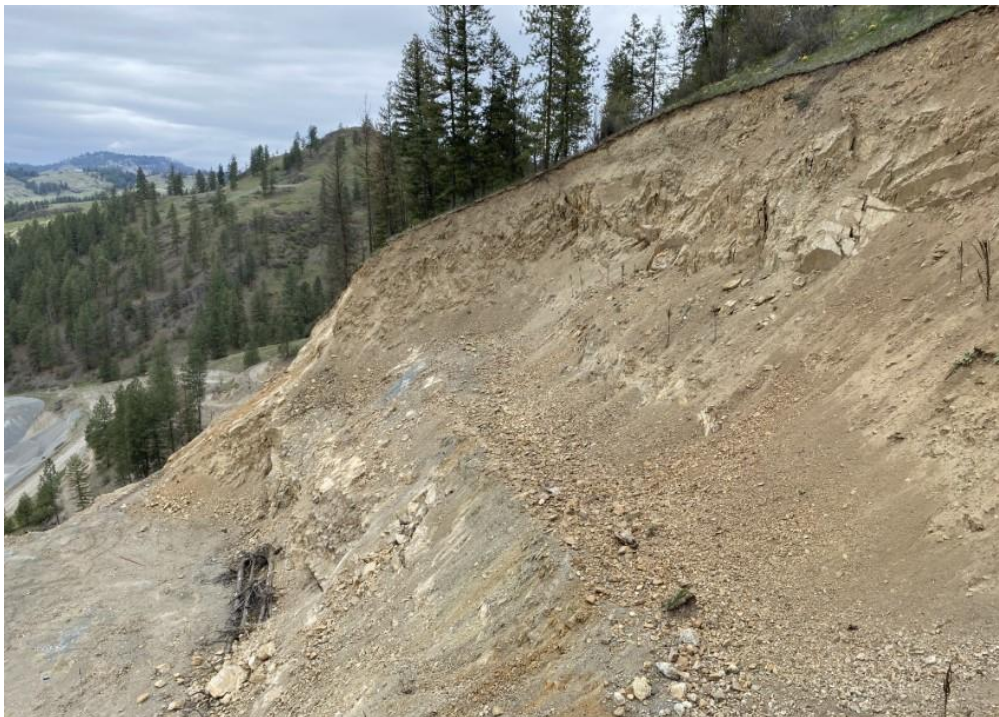
VIEW NORTHWEST OF THE HIGHWALL AT CUT 3. THE HIGHWALL GRADIENT IS LESS STEEP THAN THE OTHER TWO CUTS – THOUGH STILL STEEPER THAN 2H:1V – AND APPEARS TO INCLUDE AT LEAST TWO RELICT BENCHES.

We recommend that future mining follow the top-down strategy recommended by GeoDesign, where future mining would start at the top of the ridge and develop benches gradually down the slope to form a net 2H:1V gradient. As previously recommended, benches should not be more than 30 feet in vertical height. We recommend benching should observe a 2H:1V gradient for both interim and final slopes.
