**DEPARTMENT OF
NATURAL RESOURCES**

October 12, 2021

SUBJECT: Geologic Field Summary for the Sentinel Timber Harvest, Thurston County, Washington

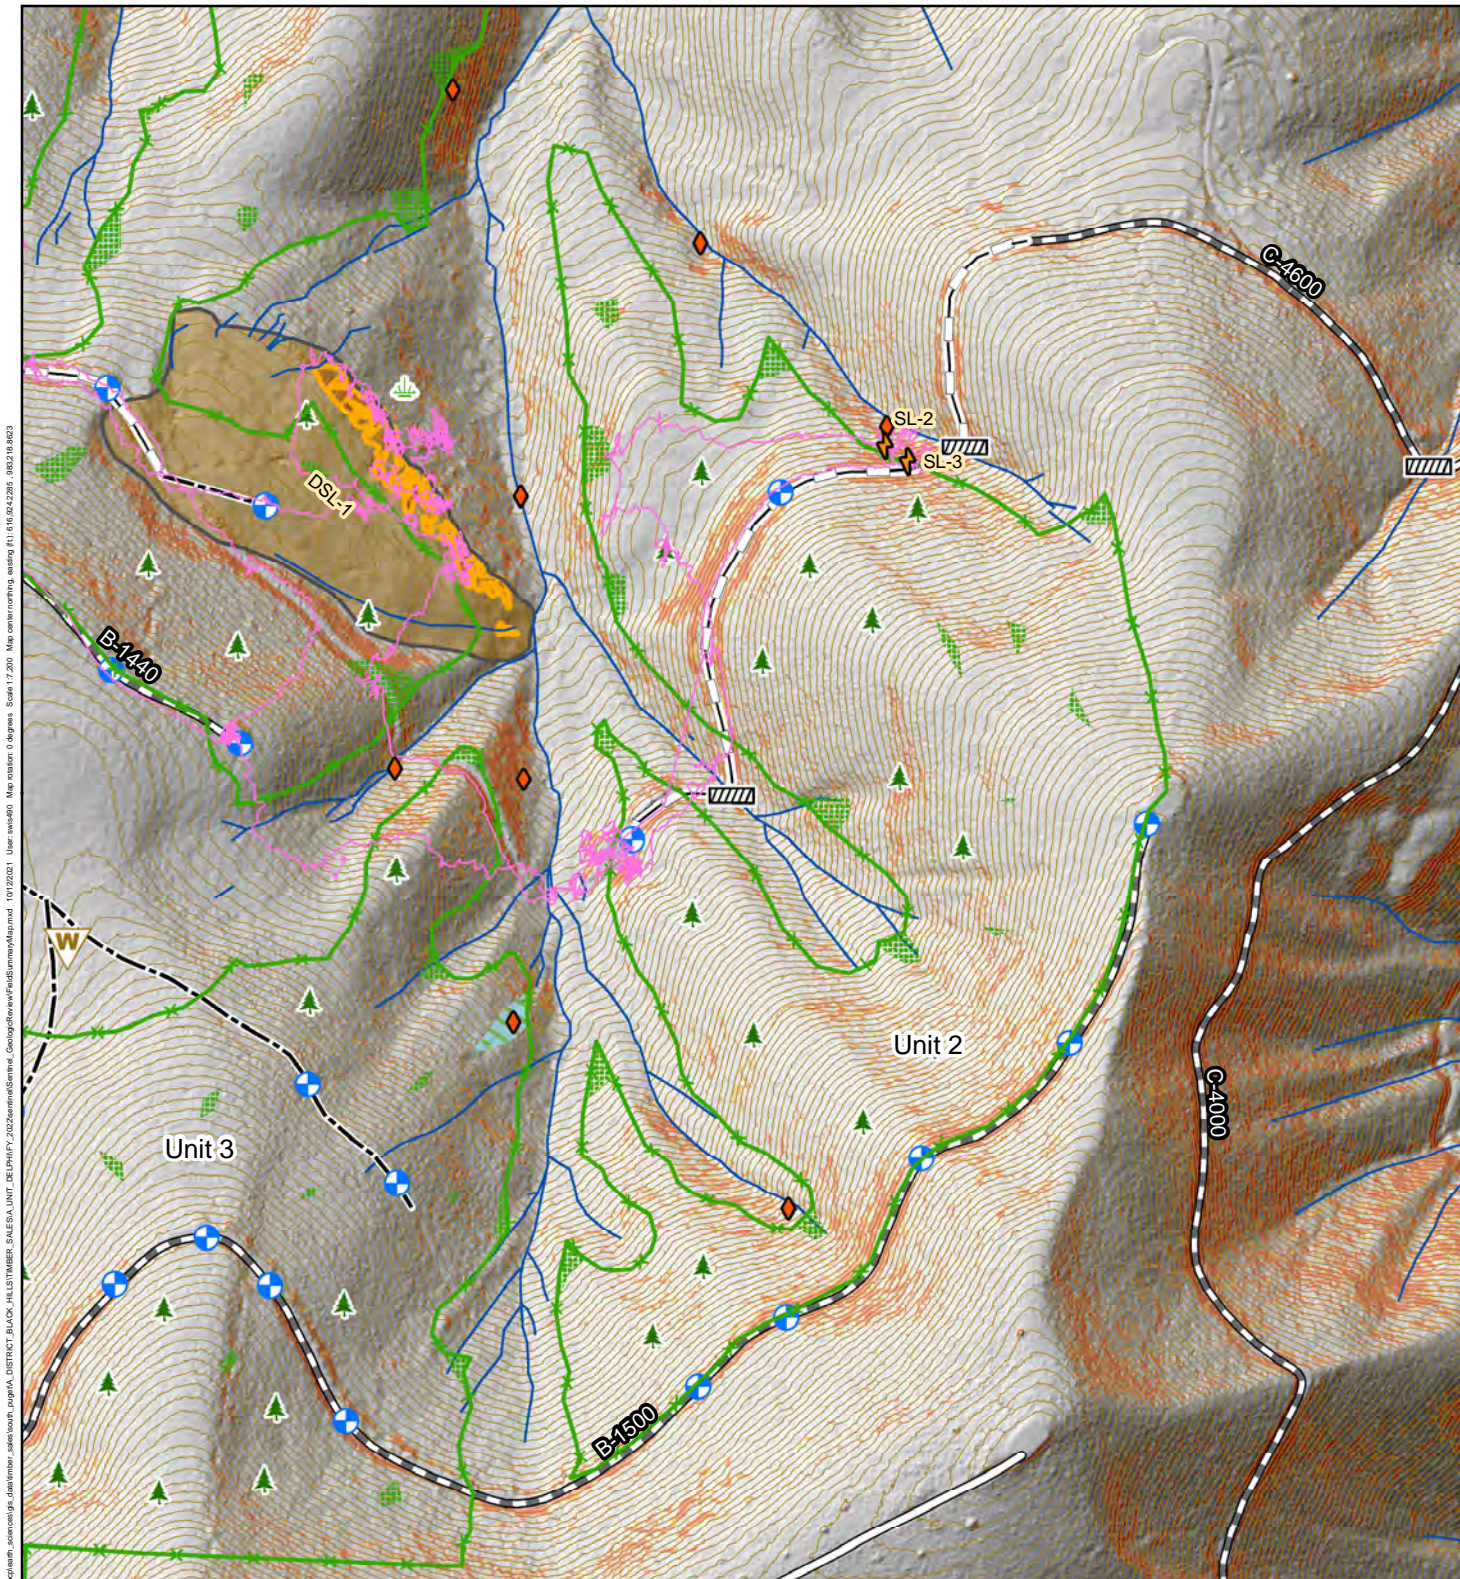
Fig. 1
Sheet 2 of 4

SL-2 and SL-3 occurred below a currently abandoned section of the C-4600 (Figure 1, Sheet 2). SL-2 is approximately 15 feet wide, 1.5 feet thick, and 40 feet long and occurred approximately 75 feet downslope of the road. We did not observe water in this failure. SL-3 is approximately 25 feet wide, 2 feet thick, and 30 feet long. This landslide delivered sediment to the stream below. I did not otherwise observe water in this landslide. SL-3 appeared to be a fill slope-related failure. These landslides have been bound out of the proposed timber harvest other than any trees removed for right-of-way above SL-3.

The road plan proposed reconstructing this stretch of the C-4600 road including the fill where SL-3 occurred. There is no culvert located here currently located or planned above these landslides.

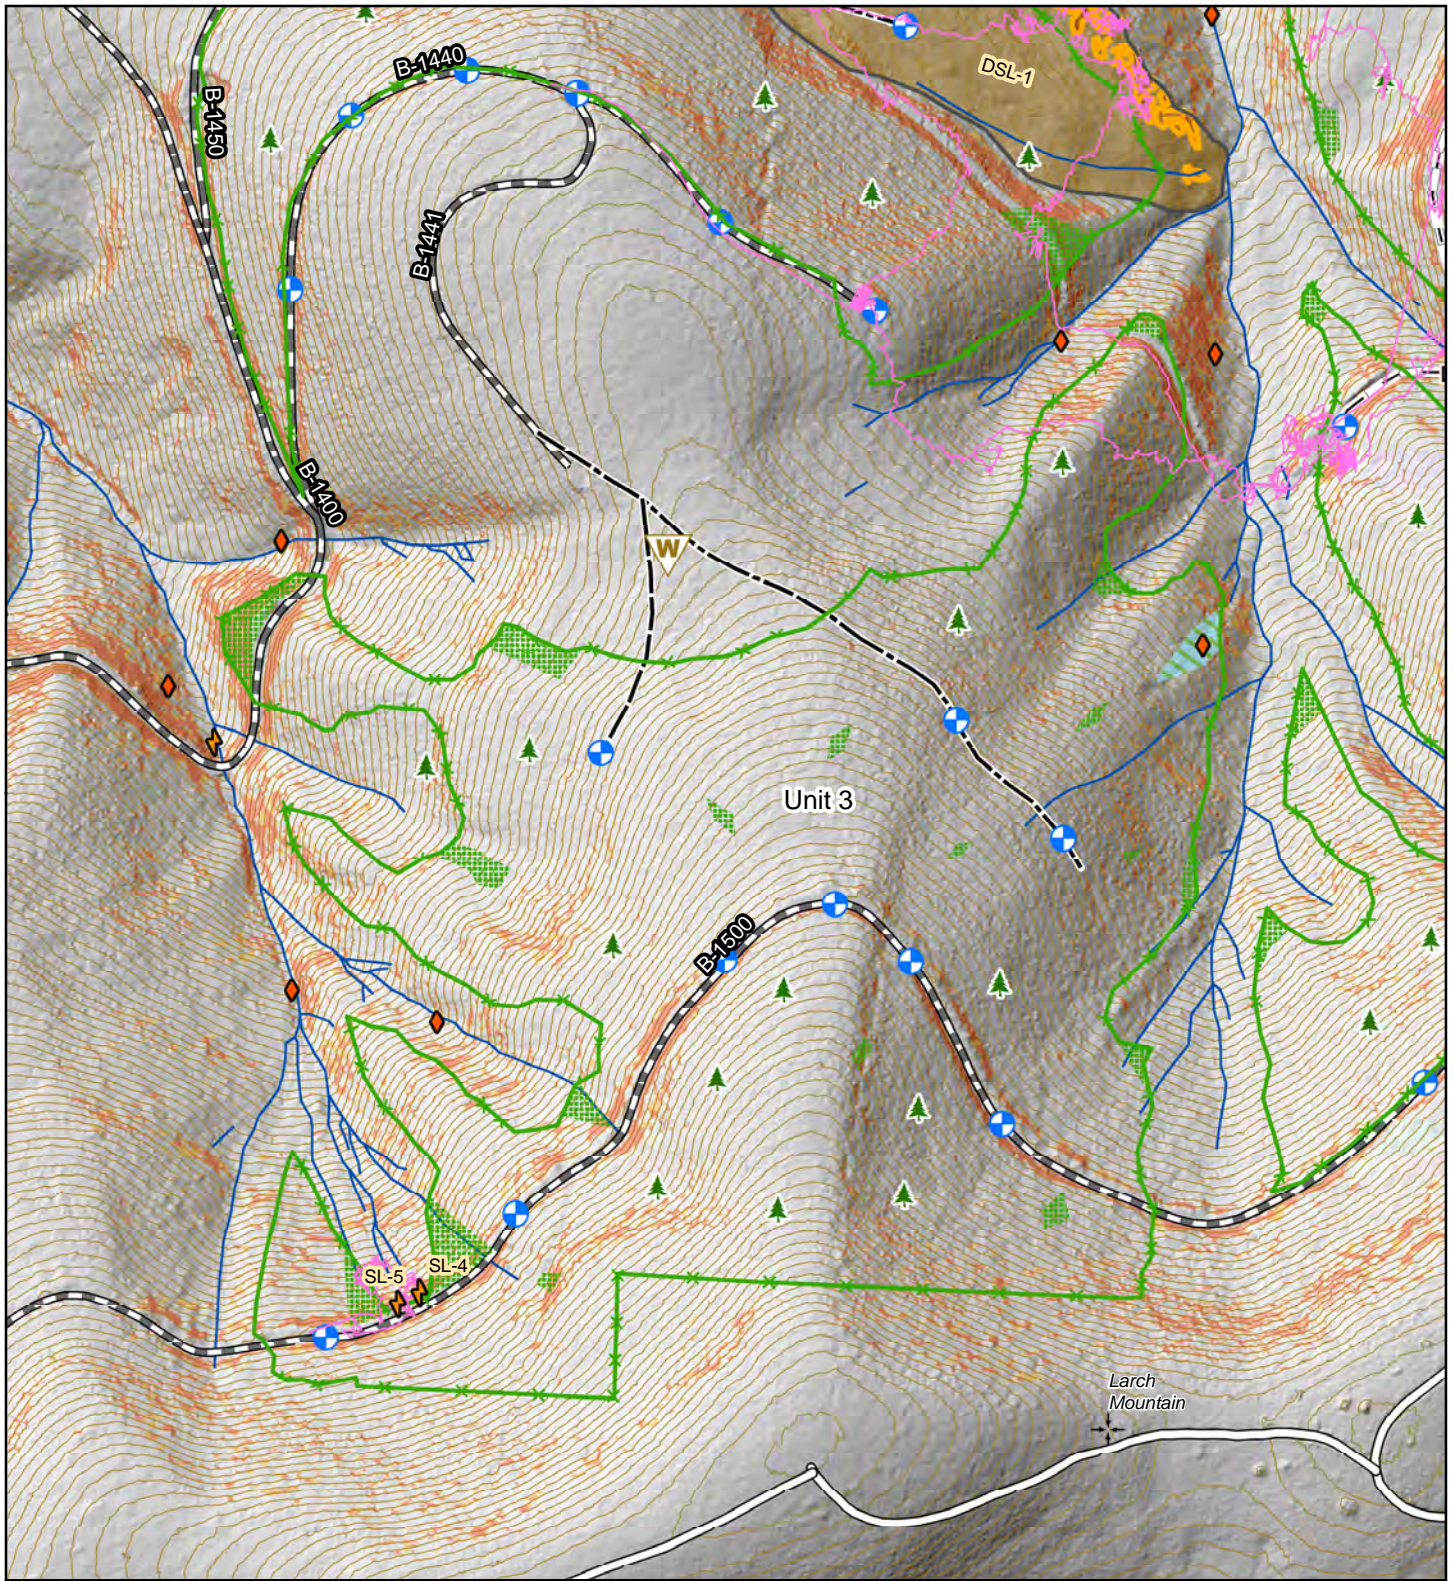
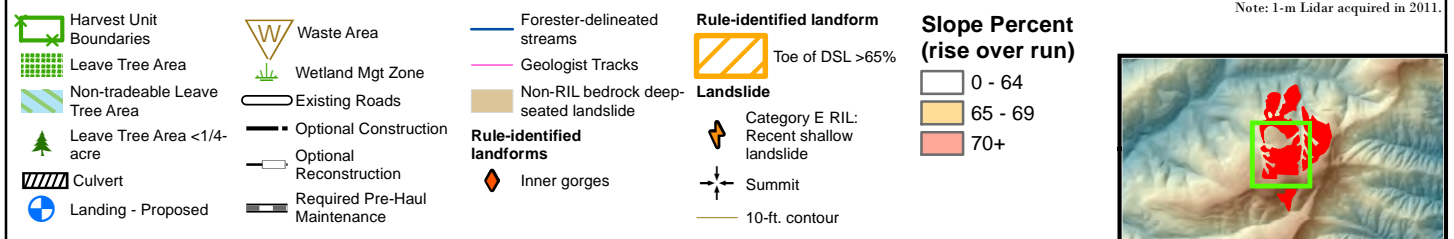
Fig. 1
Sheet 3 of 4

SL-4 and SL-5 are fill slope failures off the currently active B-1500 road that appeared to occur from the historic 2007 rain-on-snow storm event (Figure 1, Sheet 3). SL-4 is approximately 35 feet wide, 5 feet thick, and 40 feet long. SL-5 is approximately 40 feet wide and 3 feet thick. I did not observe water in these landslides at the time of my visit. In the 2008 orthophotograph, SL-5 appears to have traveled approximately 1,600 feet downstream to and just beyond the B-1400 (Figure 2). These landslides have been bound out of the harvest. Additional leave trees are placed along the boundaries east and west of the landslides (Figure 1, Sheet 3).

I worked collaboratively with Jacob Gross, the State Lands Engineer to develop road plan mitigation measures. The road plan includes grading, shaping, and cleaning and reconstruction of ditches along the B-1500 road. The road will be moved into the slope approximately 2 to 3 feet to avoid these failures. There is no culvert currently located or planned above these failures. The forester will include a note to the contract administrator to monitor this road during wet conditions. The State Lands heavy equipment crew may complete some of this road work prior to the sale. In this case, I recommend the State Lands Forester or Engineer monitor any work in wet conditions.

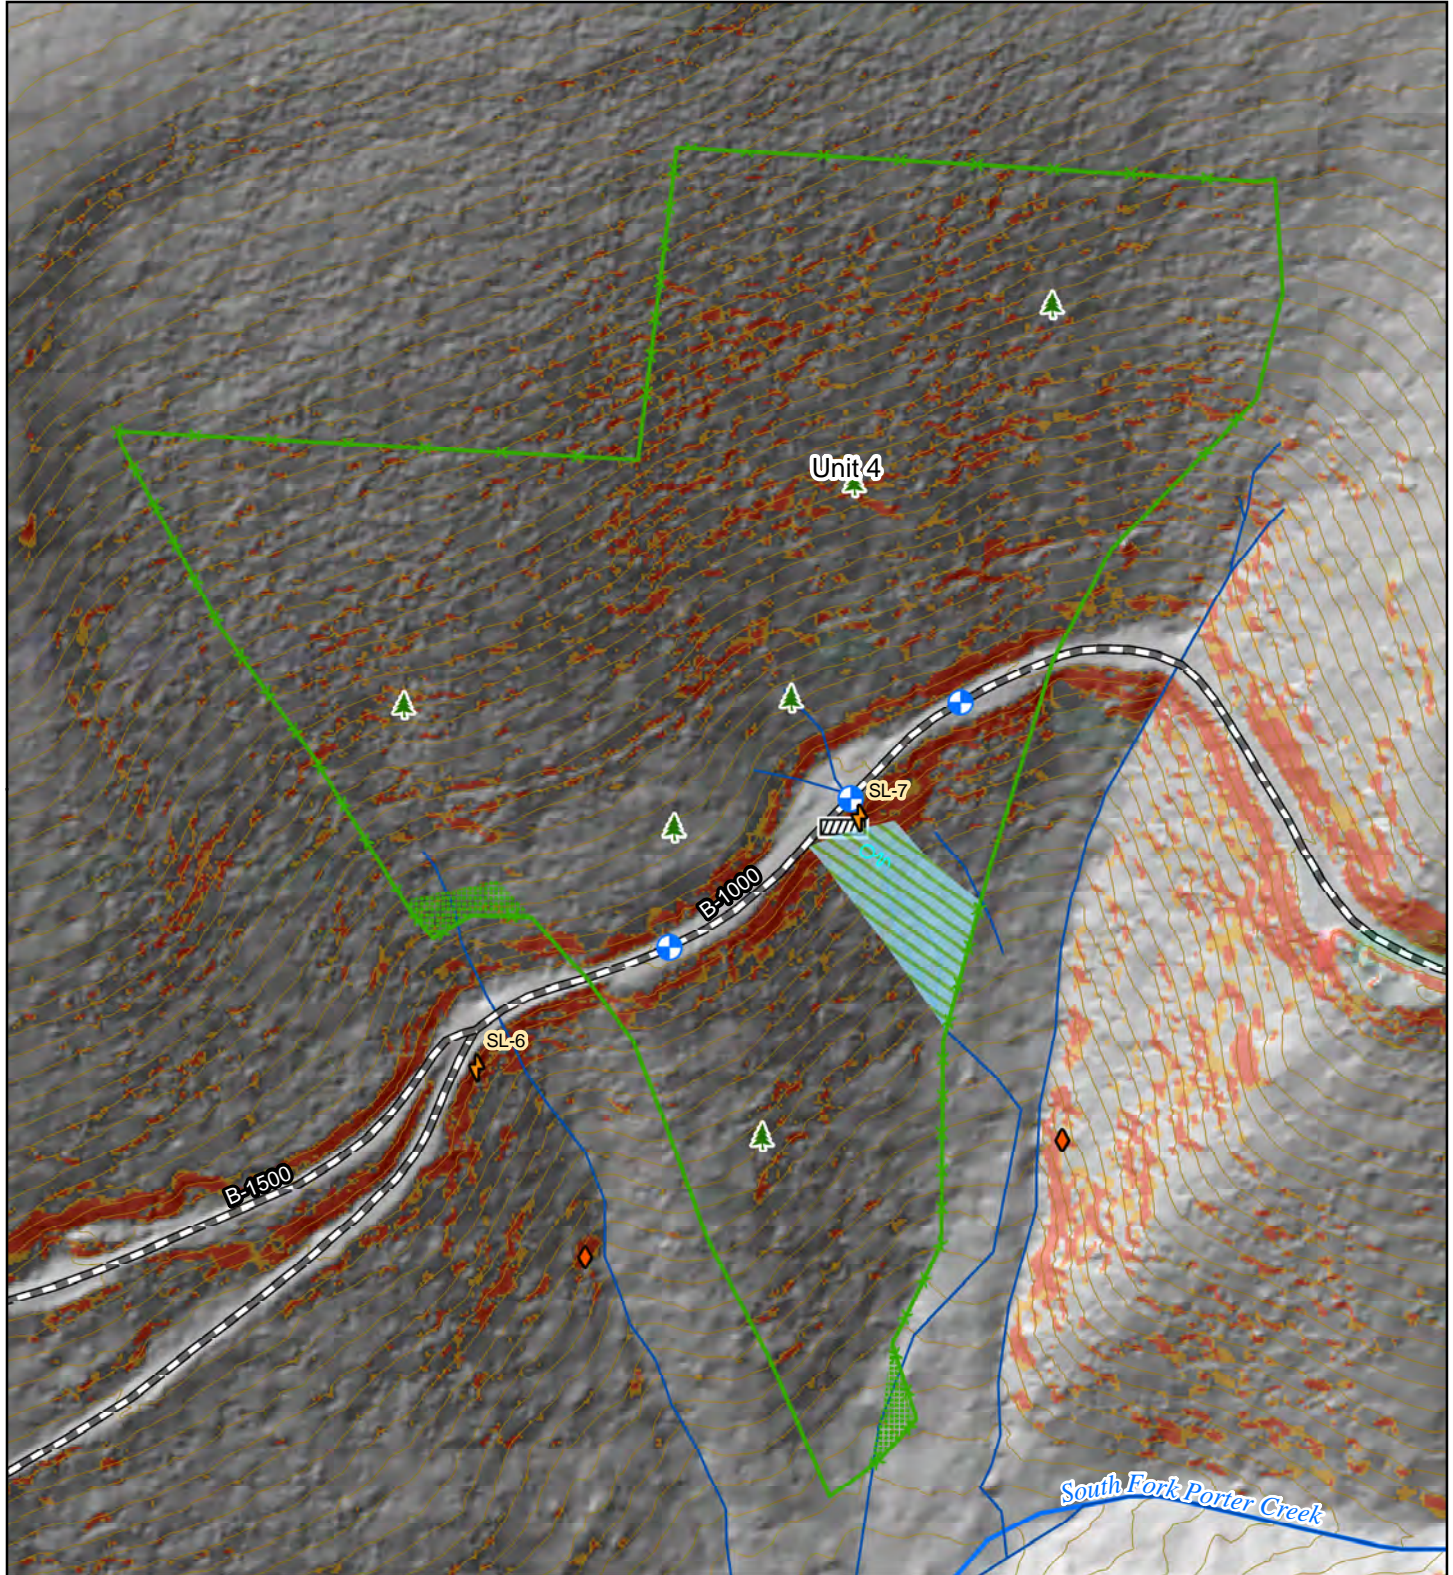
Fig. 1
Sheet 4 of 4

SL-6 is a fill slope failure off the currently active B-1000 road (Figure 1, Sheet 4). SL-6 is approximately 4 feet wide, 1 foot deep, 7 feet long, and did not appear to deliver sediment to the stream below. Although dry at the time of my visit, I observed a subtle depression and rilling in the road grade. I interpret this to be from water flowing down the B-1000/B-1500 Y-intersection, across the B-1000, over this fill.

SL-7 is another fill slope failure off the B-1000 road (Figure 1, Sheet 4). SL-7 is approximately 20 feet wide, 5 feet deep, and 75 feet long. This failure occurred at a culvert outlet and a second initiation occurred downslope where a Type 5/NS stream initiates approximately 15 feet below the fill. Approximately 4 to 5 trees will be cut above SL-7 to allow for safe operational space while reconstructing the fill. Below these upper right-of-way trees, the landslide initiation and runout area below the existing fill is protected with a non-tradeable leave tree area.

I worked collaboratively with Jacob Gross, the State Lands Engineer to develop road plan mitigation measures along this stretch of the B-1500 and B-1000. The road plan includes ditching, re-grading, and adding an extra cross-drain on the B-1500 to reduce water running down to the Y-intersection above SL-6 (Figure 1, Sheet 4). The State Lands heavy equipment crew may complete some of this work prior to the sale. In this case, I recommend the State Lands Forester or Engineer monitor any work in wet conditions.

Above SL-7, the road plan includes reconstructing the fill and replacing the pipe with a 24-inch diameter, 50-foot long pipe above SL-7. The reconstructed fill will be comprised of rip rap and topped with quarry spalls. The rip rap will serve as an energy dissipater at the culvert outlet, reducing the likelihood of future fill slope failures. The grade above will become a landing area for the unit. The ditch area here contains the Type 5/NS stream that appears to go subsurface below the road and initiates again approximately 15 feet below the fill slope. Installing the new pipe at a steeper angle will help identify the subsurface water and capture this stream thereby helping prevent saturation of the road prism. The timber sale includes logging restrictions to dry seasons to help protect the Type 5/NS stream.
