# WILDFIRE-ASSOCIATED LANDSLIDE EMERGENCY RESPONSE TEAM REPORT

## 2024 Pioneer Fire

Chelan County, Washington

WASHINGTON  
GEOLOGICAL SURVEY  
WALERT Report  
September 2024

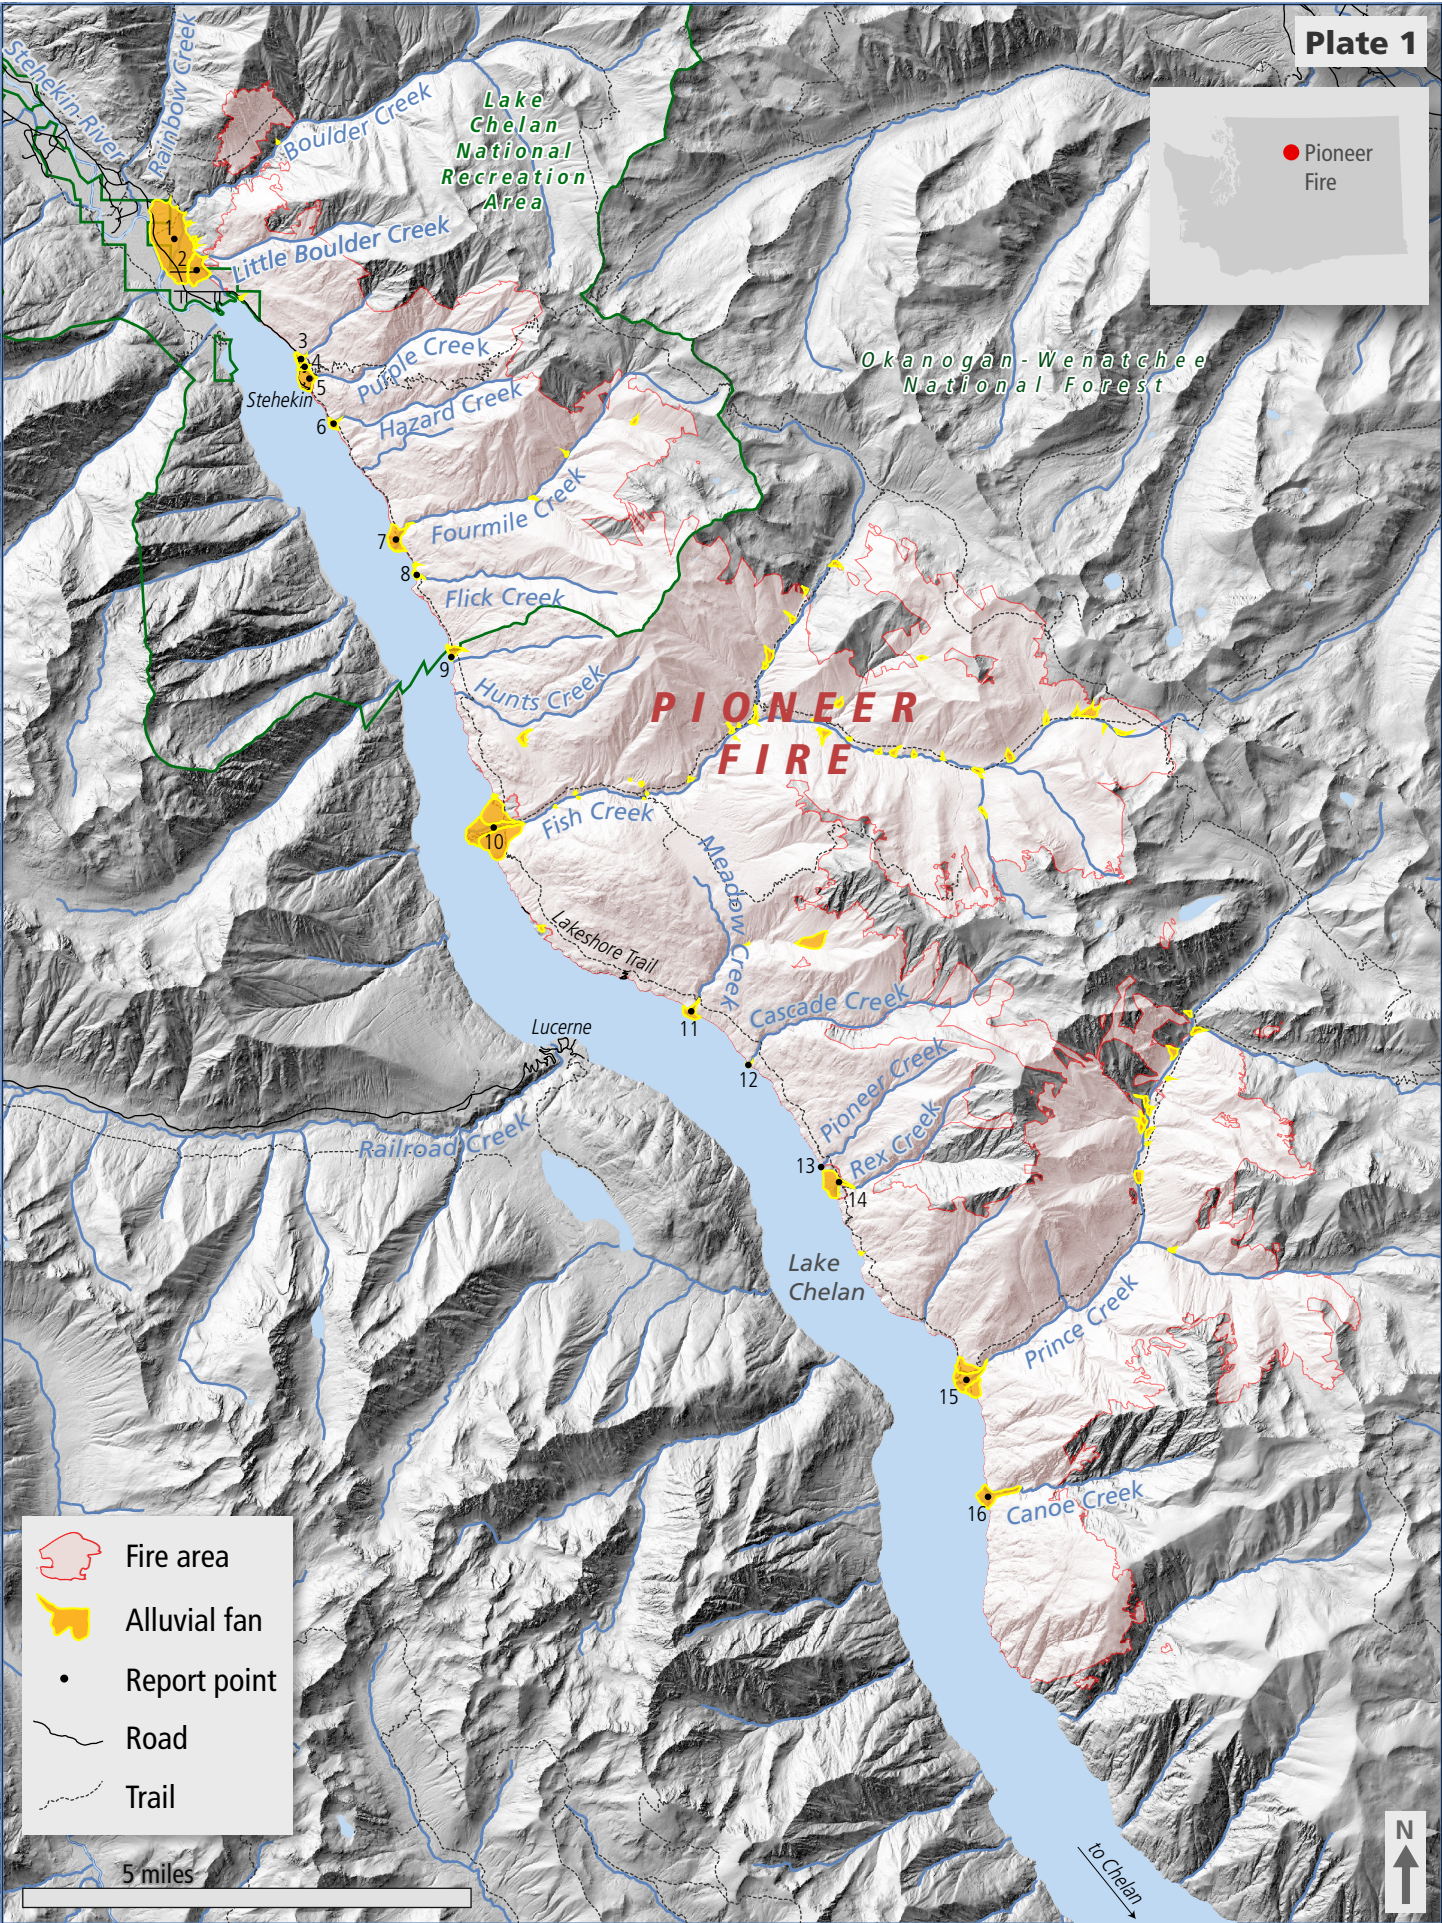
**Plate 1.** Highlighted locations mentioned in this report for the Pioneer Fire

#### **UNNAMED STREAM (POINT 9 ON PLATE 1)**

#### **FISH CREEK/MOORE POINT (POINT 10 ON PLATE 1)**

#### **MEADOW CREEK (POINT 11 ON PLATE 1)**

### **CASCADE CREEK (POINT 12 ON PLATE 1)**

### **PIONEER CREEK (POINT 13 ON PLATE 1)**

### **REX CREEK (POINT 14 ON PLATE 1)**

### **PRINCE CREEK (POINT 15 ON PLATE 1)**

### **CANOE CREEK (POINT 16 ON PLATE 1)**

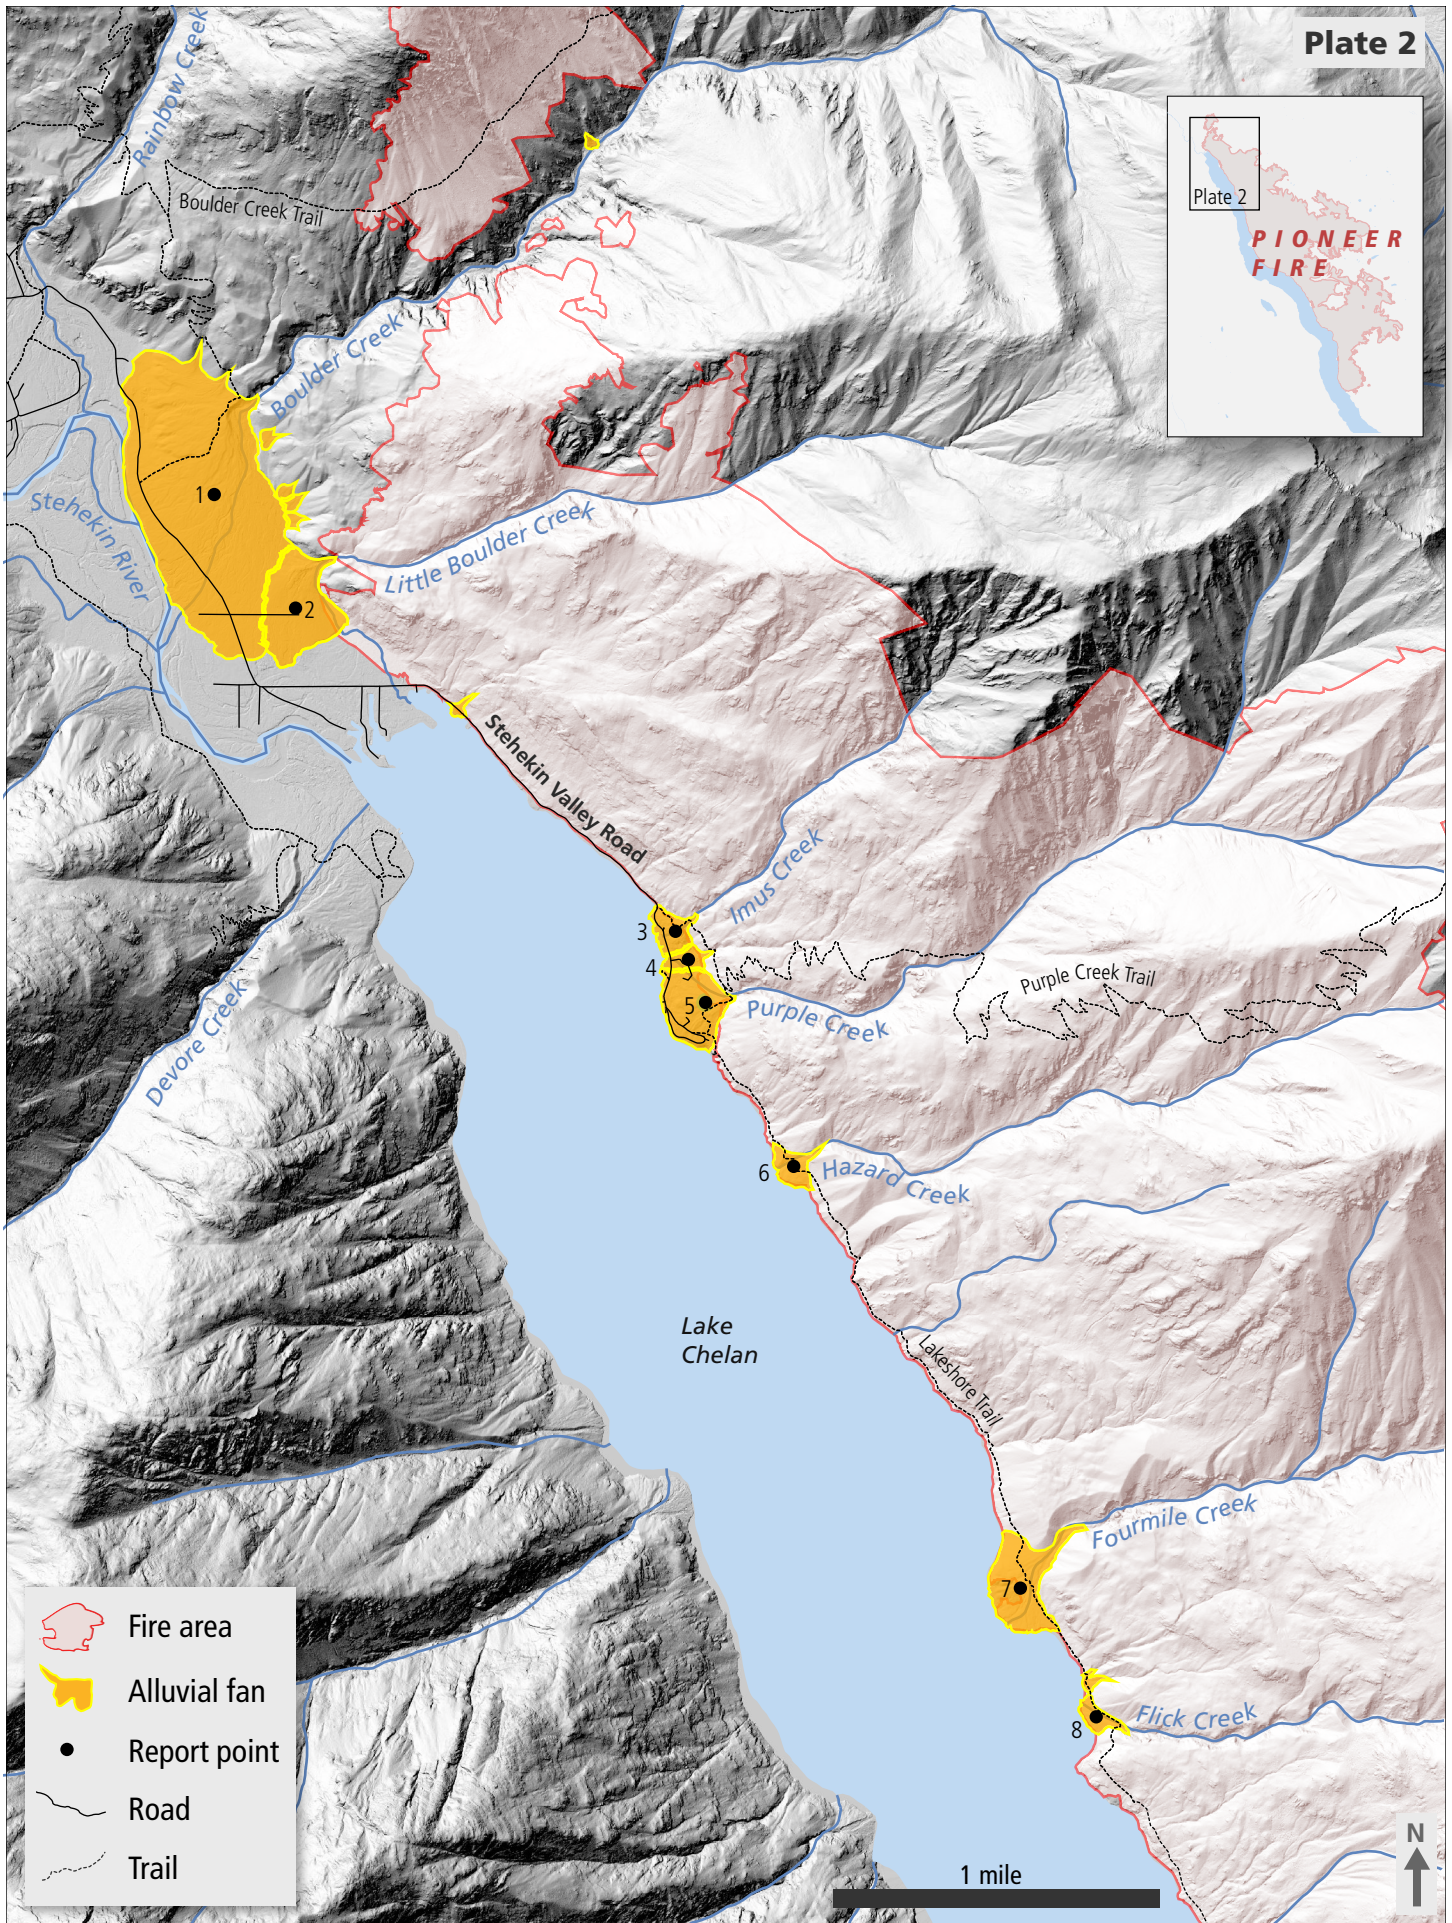
**Plate 2:** Highlighted locations along northern shore of Lake Chelan near Stehekin

### **BOULDER CREEK (POINT 1 ON PLATE 2)**

### **LITTLE BOULDER CREEK (POINT 2 ON PLATE 2)**

### **IMUS CREEK (POINT 3 ON PLATE 2)**

### **UNNAMED CREEK (POINT 4 ON PLATE 2)**

### **PURPLE CREEK (POINT 5 ON PLATE 2)**

### **HAZARD CREEK (POINT 6 ON PLATE 2)**

#### **FOURMILE CREEK (POINT 7 ON PLATE 2)**

#### **FLICK CREEK (POINT 8 ON PLATE 2)**
