WILDFIRE-ASSOCIATED LANDSLIDE EMERGENCY RESPONSE TEAM REPORT

2024 Easy Fire

Skagit and Okanogan Counties, Washington

WASHINGTON
GEOLOGICAL SURVEY
WALERT Report
October 2024

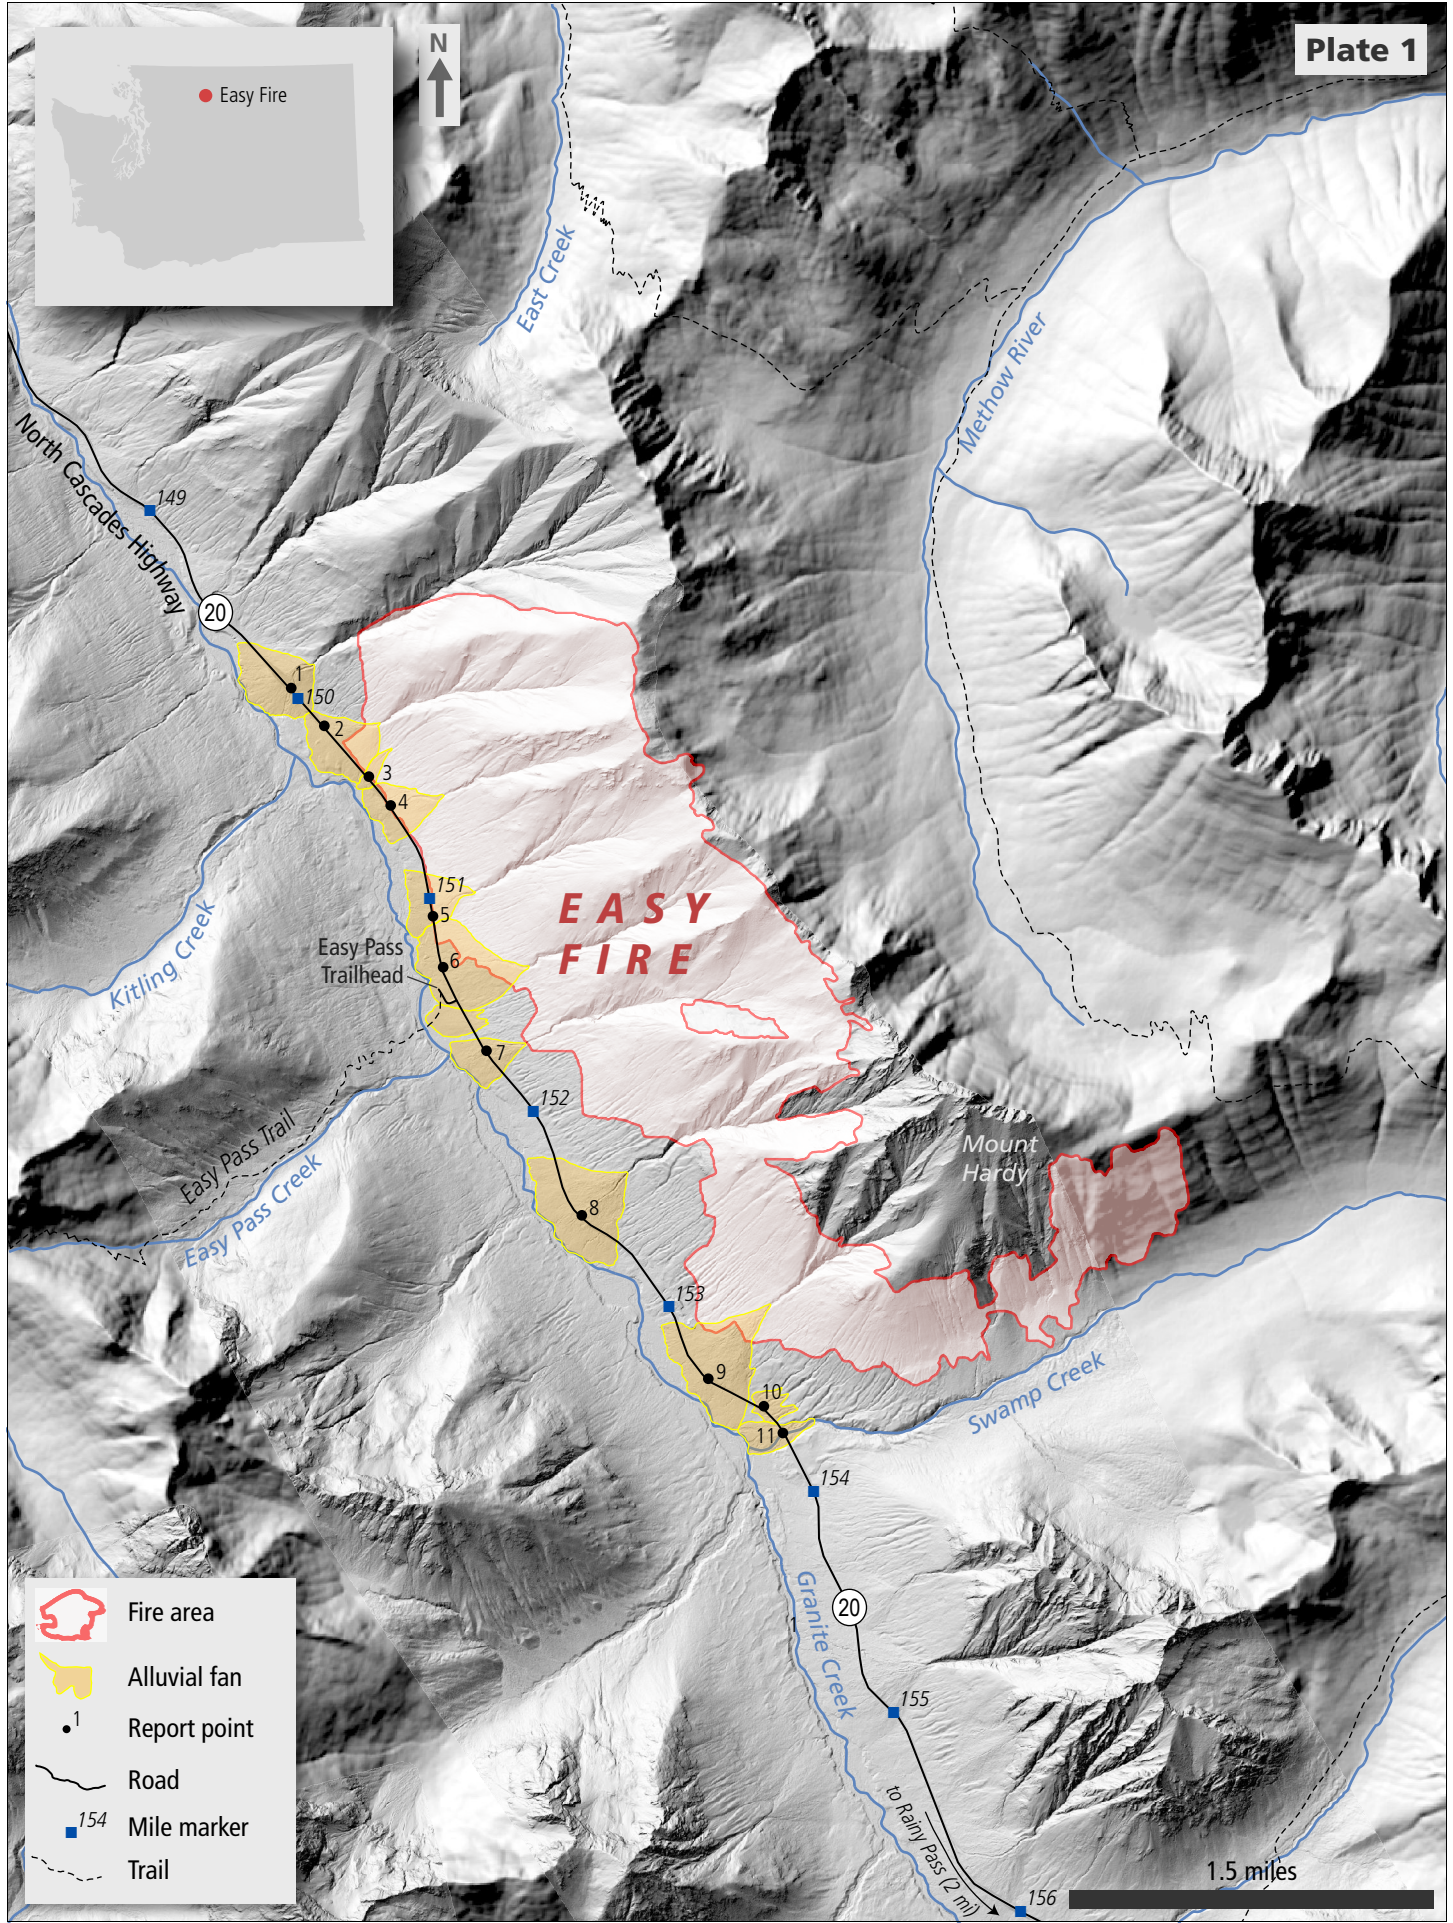
Plate 1. Highlighted locations mentioned in this report for the Easy Fire

Much of the terrain burned during the Easy Fire is located on steep mountain slopes to the northeast of and directly above a section of SR 20 between MP 149.7 and 153.8 (see Plate 1). The drainages on these southwest-facing slopes are typically long, steep, and straight. These drainages direct water and debris onto alluvial fans before feeding into Granite Creek on the west side of SR 20. Our remote and field observations revealed that some of these alluvial fans have experienced debris flows and flooding in the past, consistent with prior work in the same area (Allen and Smith, 2014). Source area proximities, mountain slope gradients, size of transported material (large boulders), and general channel characteristics (relatively straight and confined) suggest that debris flows have the potential to reach SR 20 quickly and with little warning. Where mature conifer forests remain unburned on alluvial fans, energy dispersion by trees can reduce the debris flow hazard to SR 20.

The contributing basin above the alluvial fan at MP 149.9 was modeled by the USGS as a Moderate debris flow hazard. Considering that this fan and its basin experienced debris flow events in 2004 and in 2013, and that a portion of this basin burned in the Easy Fire, we expect debris flow events to occur here in the future. SR 20 was constructed as a through cut into fan deposits such that much of the fan's surface upstream is located 60 to 70 ft above SR 20. The main (active) alluvial fan channel is oriented to the southwest near the apex of the fan, but a channel diversion was constructed to redirect the channel nearly 90 degrees to the southeast near the base of the fan close to where it crosses the east side of SR 20 (Allen and Smith, 2014, p. 3). Remote review indicates that the main channel is incised approximately 10 ft below the top of the channel berm. This channel was not field reviewed during our site visit in August 2024; however, such a shallow depth of incision would be prone to being overtopped by material entrained in a debris flow. If this were to occur, SR 20 could be impacted, putting public safety at risk. It is our understanding that the portion of the main channel near SR 20 has been engineered (post 2013 event) to convey flow to the southeast in attempts to reduce potential debris flow impact to SR 20.

The contributing basin above the alluvial fan coincident with MP 150.2 was modeled by the USGS as a Moderate debris flow hazard. All the contributing basin and part of the alluvial fan were burned during the Easy Fire. Historic aerial photos display a swath of the fan's surface missing conifer tree cover. This swath extends from the fan's apex to near SR 20. The missing vegetation coincides with a distinct zone of hummocky terrain displayed in lidar and is likely associated with past debris flow activity. Remote review indicates that main channel confinement is mostly lost and potential for avulsion (i.e. reoccupation of abandoned channels or formation of new channels) is present between the fan's apex and SR 20. Future avulsion is not easy to predict, though typically occurs during flooding and (or) debris flow events when channel pathways get blocked by log jams or debris. If debris flow activity occurs because of post-fire conditions, entrained material egressing from the basin appears to have the greatest potential to mobilize down the northern portion of the alluvial fan and possibly reach SR 20. This potential may increase where tree cover is absent or reduced due to fire activity.

WALERT mapped a relatively small alluvial fan between MP 150.4 and 150.5. This fan also has a small contributing basin. However, the contributing basin above the fan was modeled by the USGS as a Moderate debris flow hazard and contains a straight channel in relatively close proximity to SR 20. Historic evidence of debris flows was not identified at this location but the potential for a debris flow event to impact the mapped fan and possibly to impact SR 20 is present.

The contributing basin above the alluvial fan coincident with MP 150.6 was modeled by the USGS as a Moderate debris flow hazard. All the contributing basin and most of the alluvial fan upslope of SR 20 were burned during the Easy Fire. Historic aerial photos display a swath of the fan's surface missing conifer tree cover. This swath extends from the fan's apex to within 500 ft of SR 20. The missing vegetation coincides with lobate terrain on the fan just downslope from a channel bend and may be associated with past debris flow activity overtopping the channel. If debris flow or flood activity occurs because of post-fire conditions, entrained material egressing from the basin appears to have potential to possibly reach SR 20. This potential may increase where tree cover is absent or lost or reduced due to fire activity.

The contributing basin above the alluvial fan coincident with MP 151.1 was modeled by the USGS as a Moderate debris flow hazard. Almost all of the contributing basin and the majority of the alluvial fan upslope of SR 20 were burned during the Easy Fire. Aerial photo review indicates a swath of the fan's surface is missing conifer tree cover. This swath extends from the fan's apex to within 350 ft of SR 20. We interpret the missing tree cover to be associated with past debris flow activity. Considering that this fan and its basin experienced a debris flow event in 2013, that evidence of historic debris flow activity predates the 2013 event, and that a Moderate debris flow hazard is modeled, we anticipate post-fire debris flow activity to occur on this fan in the

The basin above the alluvial fan coincident with MP 151.3 was modeled by the USGS as a Moderate debris flow hazard. Much of the contributing basin and the upper portion of the fan was burned during the Easy Fire. Aerial photo review shows that the fan's apex is mostly void of mature conifer tree cover. We interpret the missing tree cover to be associated with past debris flow activity. We understand this alluvial fan experienced a debris flow in 2013 that mostly arrested upslope of SR 20 due to various debris dams and channel shifts. However, material from the 2013 event did reach SR 20, filling portions of its ditch. WALERT anticipates that smaller debris flow events reaching the fan in the future may self-arrest before reaching SR 20 but that larger events may reach and impact the highway. A parking lot associated with the Easy Pass Trailhead and the Easy Pass trail are present on the west side of SR 20, farther from the fan's apex.

The basin above the alluvial fan coincident with MP 151.7 was modeled by the USGS as a Moderate debris flow hazard. This alluvial fan experienced a debris flow both in 2013 and in 2024. The fire burned the majority of the contributing basin to the fan's apex but left vegetation on the fan unburnt. During our site visit, we observed that the August 2024 debris flow event deposited large boulders, sand and gravel, and abundant burned trees and snags. The deposit spread across the forest floor, reached SR 20, and traveled down ditch lines and across the road surface. At least 5 ft of debris were deposited on the SR 20 roadway, with fine sand and wood particles filling the ditch and overtopping into the forest on the downslope side of the highway. This event occurred while this section of SR 20 was closed. If a debris flow event of this magnitude occurs again while the road is open, the risk to public safety would be considerable.

The USGS modeling indicates the drainage associated with the MP 152.5 alluvial fan has a Moderate debris flow hazard. The well-defined fan is located at the base of a steep, rocky drainage. A debris flow emanated from this drainage and buried a section of SR 20 in at least 10 ft of debris on August 11–12, 2024. Large granitic boulders, some more than 8 ft in diameter, were deposited by the debris flow. Two of these boulders were large enough that WSDOT was forced to blast them into smaller pieces to move them off the roadway and out of the immediate channel.

This alluvial fan was impacted by a debris flow event in August 2024, soon after some of its basin burned. The drainage basin that feeds this fan is modeled as a Moderate debris flow hazard. The Easy Fire burned the lower third of the drainage basin with patchy moderate to high soil burn severity. The main channel in the basin is steep and relatively straight. Where it emerges onto the fan, the primary channel flows along the fan's southern edge in a southerly direction. However, there are numerous abandoned channels that start at the fan's apex and are oriented in a SW-NE direction across the middle of the fan. The presence of these secondary channels as well as the observed roadside position of debris flow material from the August 2024 event indicate that flooding and (or) debris flows occasionally avulse in a southwest direction away from the primary channel. The general lack of primary channel confinement suggests much of the fan's surface is subject to channel shifting and inundation by water and debris. However, the active debris flow history and the USGS modeling implies this alluvial fan will likely continue to be impacted by debris flows, some of which may reach SR 20.

The basins above this mapped fan are modeled to have Moderate debris flow hazards. The drainage areas above this fan are much smaller than the alluvial fans to the west, described above. The mapped alluvial fan is also smaller and appears less active, as well, based on the lack of hummocks or secondary channels. However, if a debris flow occurred along one of these channels, debris flow material could impact SR 20 where it intersects the alluvial fan.

The Easy Fire burned approximately two miles up the Swamp Creek drainage along southeast-facing slopes of Mt. Hardy. Collecting flow from numerous small, steep streams emanating out of the Easy Fire burn, Swamp Creek is the largest, near-fire tributary stream to Granite Creek. The small, steep channels that feed into Swamp Creek drain basins that are modeled as having Low or Moderate debris flow hazards. However, all those basins in closest proximity to SR 20 are Moderate hazards. As westward-draining Swamp Creek nears SR 20, its low gradient alluvial fan surface intersects the base of SR 20's road prism. Considering the distance from the steep slopes and the size of the Swamp Creek basin, the part of the Swamp Creek fan at SR 20 appears to be less likely to be impacted by debris flows than the previously described points above, though may be susceptible to flooding.

We recommend that both westbound and eastbound lanes of SR 20 as well as the Easy Pass Trailhead and associated parking lot be signed to warn the public of flash flood and debris flows at appropriate, highly visible locations. We recommend that landowners and land managers evaluate the hazards detailed herein and determine forms of mitigation that will act to reduce the potential for debris flows and flooding to impact SR 20. Landowners and land managers may choose to take action to prevent excessive soil erosion and promote revegetation to help mitigate flooding and debris flow hazards and to meet their management and economic goals. The soil burn severity map created and field-validated by the USFS BAER team can be a useful tool to evaluate areas for re-planting. We are willing to help direct users to this map product or provide the data in various formats as needed.
