Clayton Beach Eelgrass and Dredge Hole Investigation

A Nearshore Habitat Survey for the Northwest Straits Foundation

Washington Department of Natural Resources
NWSF Contract No. 2023-09-DNR
DNR Contract #93-105096

June 26, 2025

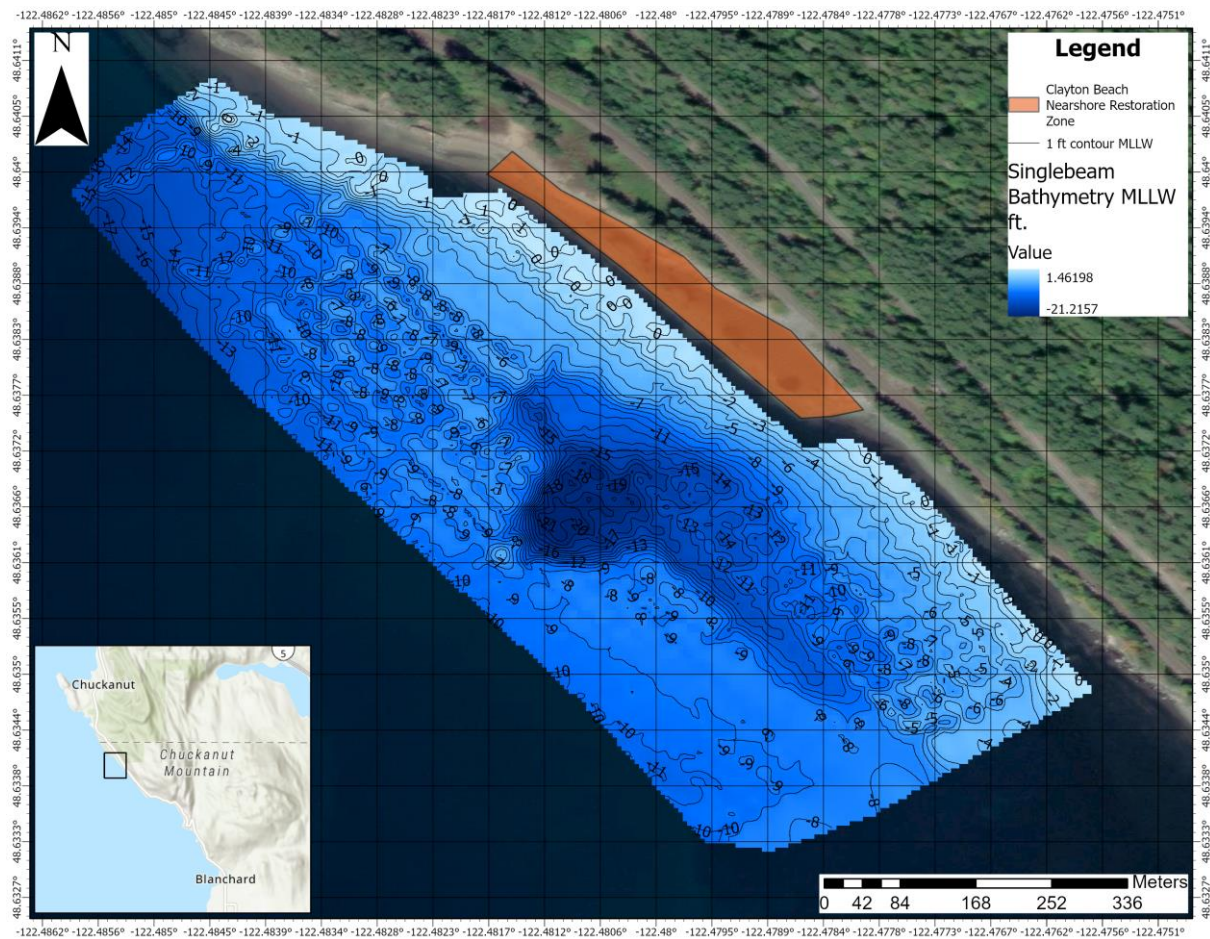
Bathymetry from single beam depths was interpolated and is represented in (Figure 11). This surface has a low resolution of approximately 20 m², however, it indicates that in general, the sites' surface slopes steeper north of the nearshore restoration zone than it does southeast of it. To the north, the bathymetry falls from 0 ft MLLW to -8 ft. MLLW in 300 ft, is flat for 330 ft, then steeply descends out of frame (Figure 11). South of the divot, the seafloor appears to slope offshore at a shallower angle for 450 ft, falling from 0 ft. to -8ft. MLLW across that distance. The seafloor then flattens and remains at a constant depth of -9 to -10 ft. MLLW (Figure 11).

Figure 11. Bathymetric surface interpolated from single beam sonar data at Clayton Beach, Skagit County, WA.

The surface of the seafloor just offshore from the Clayton Beach riprap wall (at 0ft MLLW) follows a shallow slope of 0.9 degrees between the -2 and 0 ft. MLLW contour. This surface slope is more gradual than the seafloor just south of the Nearshore Restoration Zone, which slopes steeper at 1.1 degrees (Figure 11). This slope can be attributed as an influence from

the unvegetated dredge hole, as past this and at the edge of where data was collected, the slope returns to a shallower form (Figure 11).

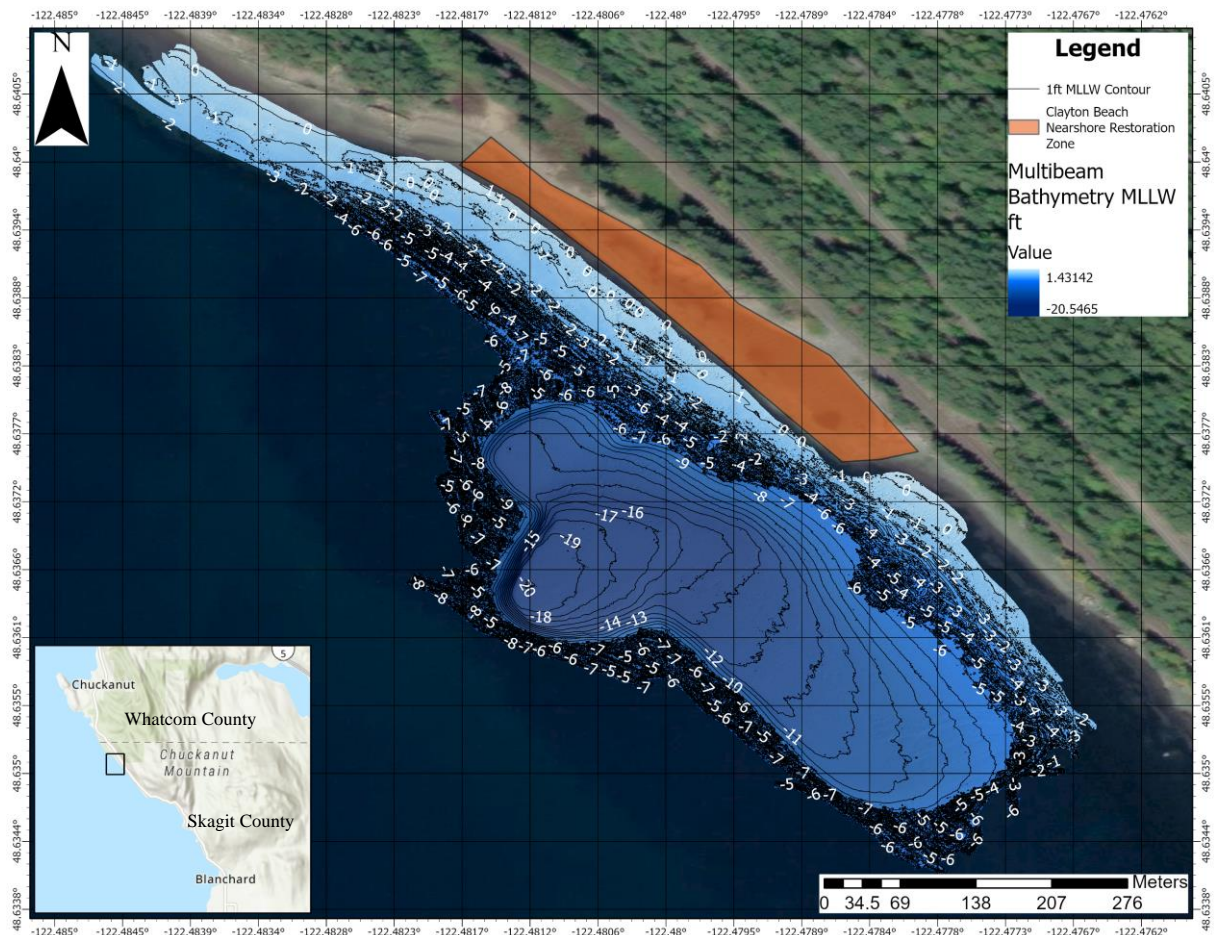
Figure 12. Bathymetry collected and produced by multibeam sonar at Clayton Beach, Skagit County, WA

Figure 12 is a surface that has been produced from multibeam sonar data. This surface accurately displays the shape and depth of the unvegetated dredge hole which is obvious as a deep depression south of the Clayton Beach nearshore restoration zone. At a resolution of 0.25 m², this surface gives a more accurate value of depth where vegetation is sparse or absent compared to the interpolation from single beam data in Figure 11. Where eelgrass was dense however, the multibeam sonar is unable to detect the true bottom depth.

Zones that are bare have a standard deviation of only 1 – 2 cm, whereas locations with eelgrass have up to 70 cm of error. In these zones, the single beam generated bathymetry surface can be used as a replacement for seafloor depth. Both bathymetric surfaces corroborate the maximum depth of the divot as -20 ft. MLLW and show that it is deepest at its northwest extent, becoming gradually shallower as one moves to the southeast. It appears to be completely void of any rock, boulder, or large feature.

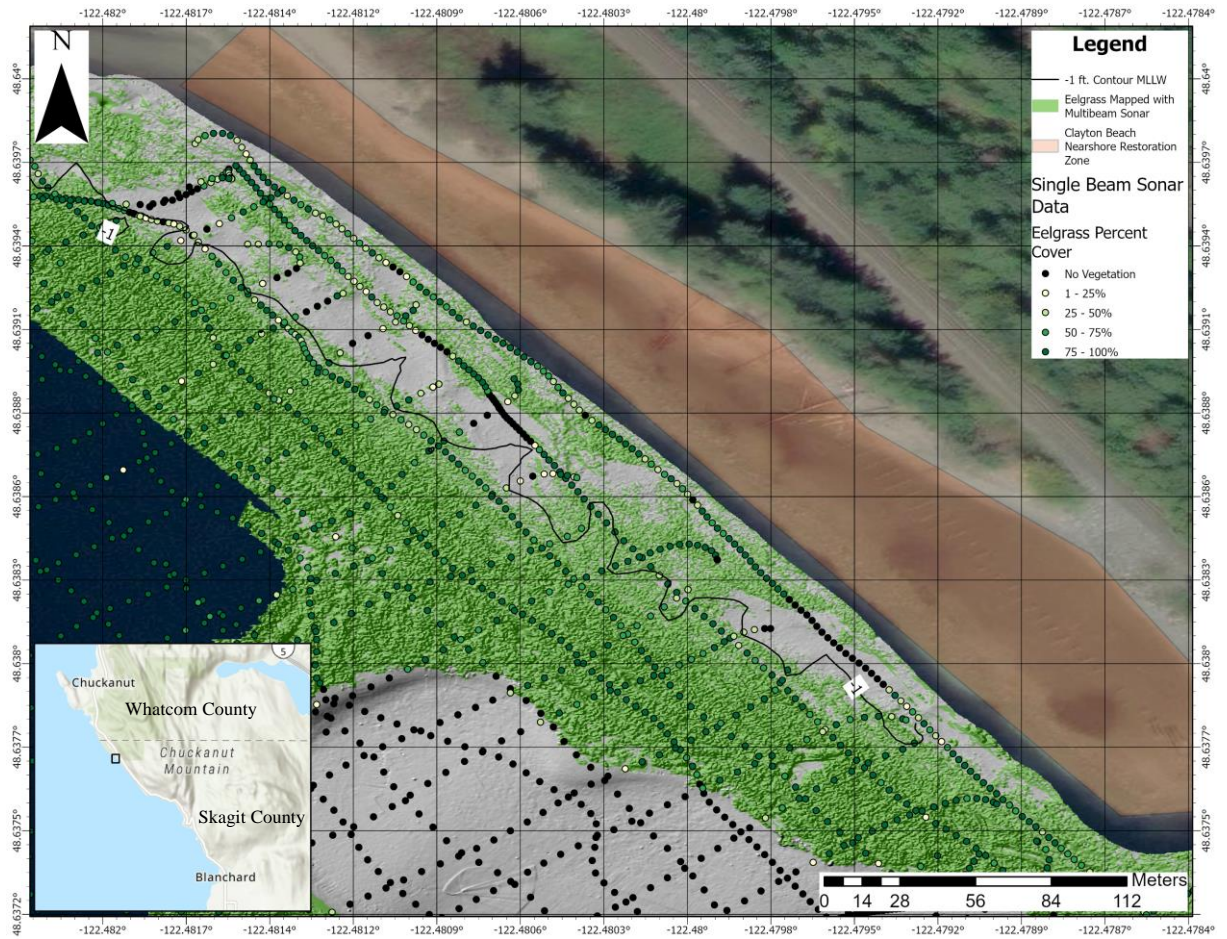
Closer to the restoration zone, Eelgrass is patchily distributed within a buffer of approximately 130 ft. from the riprap wall, where large unvegetated patches are present and obvious in both multibeam and single beam data (Figure 17). These unvegetated patches sum to approximately .68 acres of unvegetated bed-land. The eelgrass offshore from armoring and out to approximately -1 ft. MLLW has an average percent cover of 55.4 ± 36.6 (SD). The patchy framework extends to this point (-1 MLLW ft), and deeper than this (dredge hole excluded) it becomes a more continuous bed.

Figure 15. Eelgrass distribution offshore the Clayton Beach restoration zone.

Our surveys detected large patches (~ .68 acres) of unvegetated seafloor in front of the trestle (riprap) restoration zone. These large patches are not evident in locations without shoreline armoring. The absence of eelgrass in localized patches could be due to several reasons, with some that are related to the presence of the current trestle. Thom et al. (2011) notes that while the impacts to eelgrass from armoring are not well studied, eelgrass will eventually be negatively affected by substrata changes associated with the reduction in fine sediment delivery to the beach. In the case of Clayton Beach, the absence of fines could be due to a scouring effect of finer sediments related to increased wave energy on the armored wall. We were not able to collect sediment samples at the base of the armored wall, and so a confirmation of this hypothesis cannot be tested. If true, the removal of armoring and recontouring of the seafloor could promote natural restoration of fine sediments back into the unvegetated patches that currently exist, making these patches more suitable for eelgrass.

This eelgrass bed was found to extend relatively high into the intertidal (up to 0 ft. MLLW), and down to -10 ft MLLW at its deep edge. Because eelgrass grows up to the riprap restoration site (at 0 ft. MLLW), it is possible that after removal and re-grading of riprap, pilings, and sediment, that eelgrass will move into this newly restored zone. Based on bathymetry and the certainty that eelgrass will grow up to 0 ft. MLLW, this may be more successful if the newly restored zone is designed like the surrounding natural shoreline and graded to remain flat until meeting the steep beach.

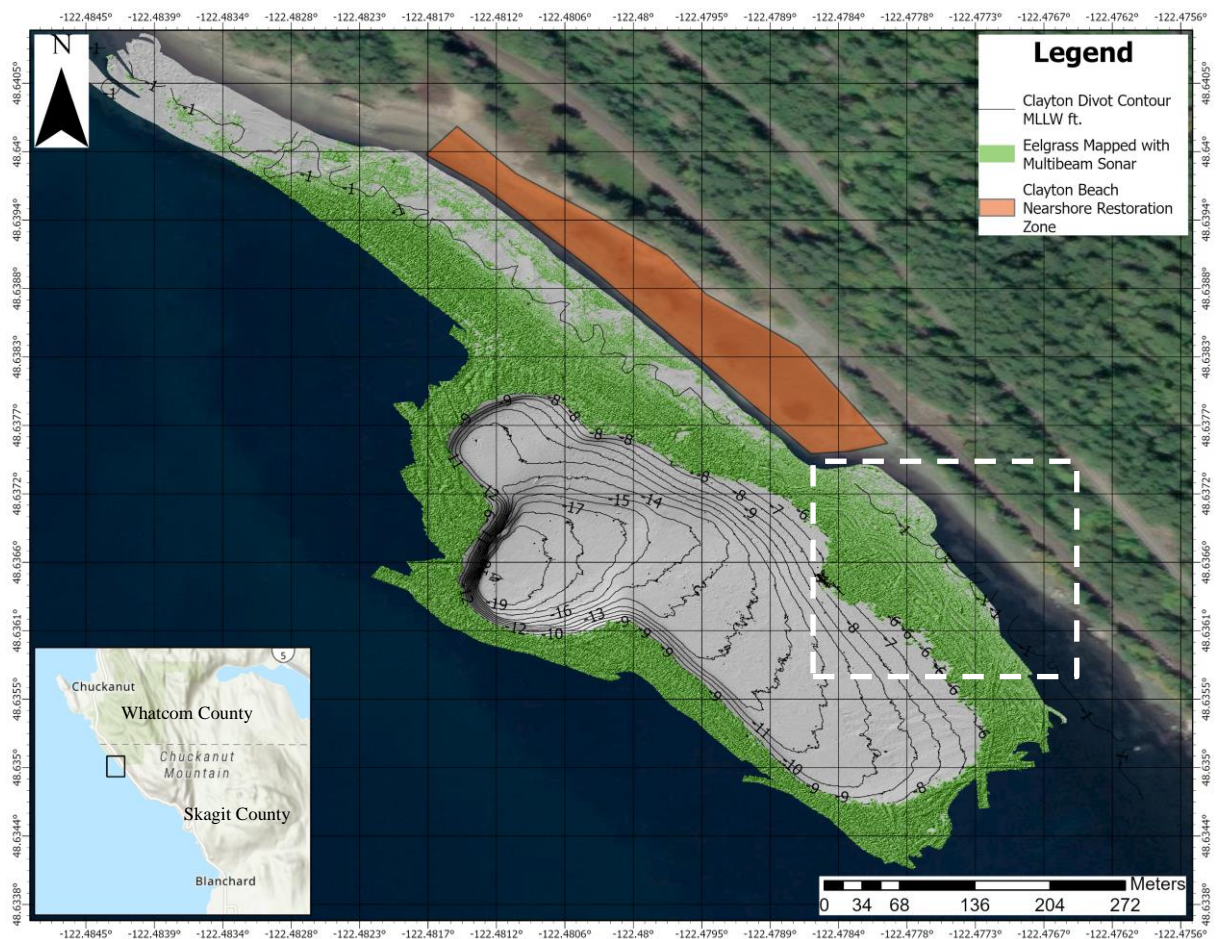
The dredge hole yields 13.9 acres of unvegetated bed-lands, surrounded by dense eelgrass on all sides (Figure 17). Figure 18 **Error! Reference source not found.** A – D are cross sections of the divot taken from multibeam data. Eelgrass canopy appears obvious in these images as a “spiked” surface after moving from a smooth non – vegetated divot. Apparent in these cross sections is that eelgrass grows to different depths at different locations along the edge of the divot. In some locations (shallow southeast edge), it ceases to grow at approximately -5 or -6 ft. MLLW, whereas in other locations (western deep edge), eelgrass ceases to grow at the -9 ft. interface. These images corroborate previous figures and show that the divot is more steeply excavated on its west side compared to the east side (Figure 17 **Error! Reference source not found.**).

Figure 17. Bathymetry of the dredge hole and surrounding eelgrass at Clayton Beach, Skagit County, WA. Patchy eelgrass bed exists shallower of -1 ft. MLLW, whereas the eelgrass bed grows more continuous to a depth of approximately -10 ft (MLLW). The hashed white box indicates a section of the survey that was completed in front of unarmored shoreline.

In addition to this new shoreward expansion, the Clayton Beach divot presents a unique opportunity to restore 13.9 acres of eelgrass to Puget Sound. This aligns with the Statewide Kelp Forest and Eelgrass Meadow Health and Conservation initiative to conserve and restore 10,000 acres of kelp and eelgrass habitat by the year 2040 (WADNR 2023). To restore the original seafloor slope at the divot, it is estimated that approximately $71,246 \text{ m}^3 \pm 119 \text{ m}^3$ (93,186 yd³) of sediment will be needed. While it is not currently known where this large quantity of fill will come from, data from large scale dredged capping projects will identify important considerations for this restoration. A primary factor in divot restoration success will be to work around the consolidation time of deposited sediments. After sediment deposition, it will be important to allow consolidation time for successful eelgrass shoot plantings. Depending on the void ratio (the volume of voids in any sediment relative to the volume of solids) of the fill, and the total depth of deposit, the deposited sediment will consolidate

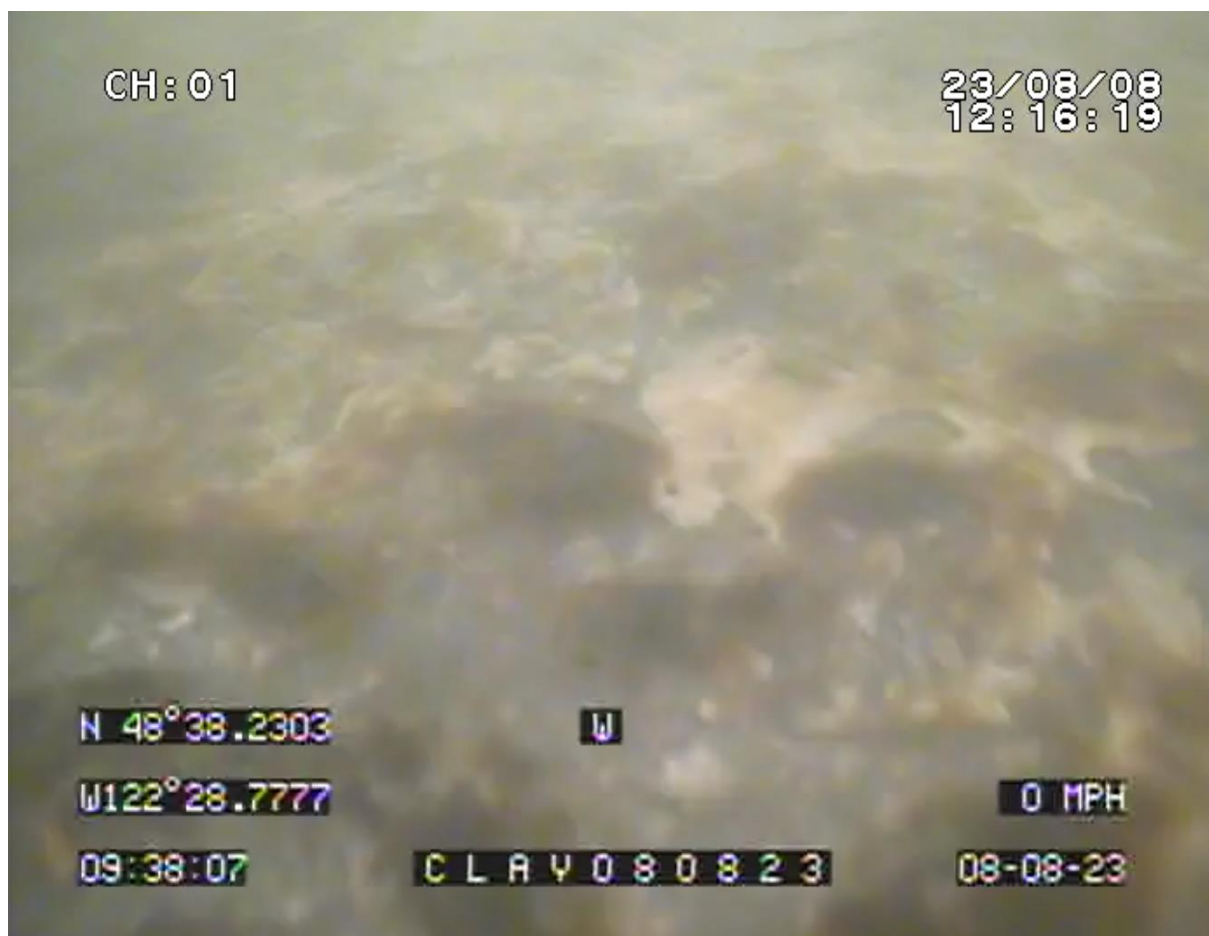
Video used to “truth” single beam and multi beam sonar identified a thin algal mat inside the dredge hole (which appeared to be decomposing at the time of this late summer survey). It is likely that the dredge hole acts as a sink for seasonal decomposition during the summer, accumulating algae and detritus (Figure 20 and Figure 21).

Figure 20. Video from within the Clayton Beach dredge hole, Skagit County, WA.

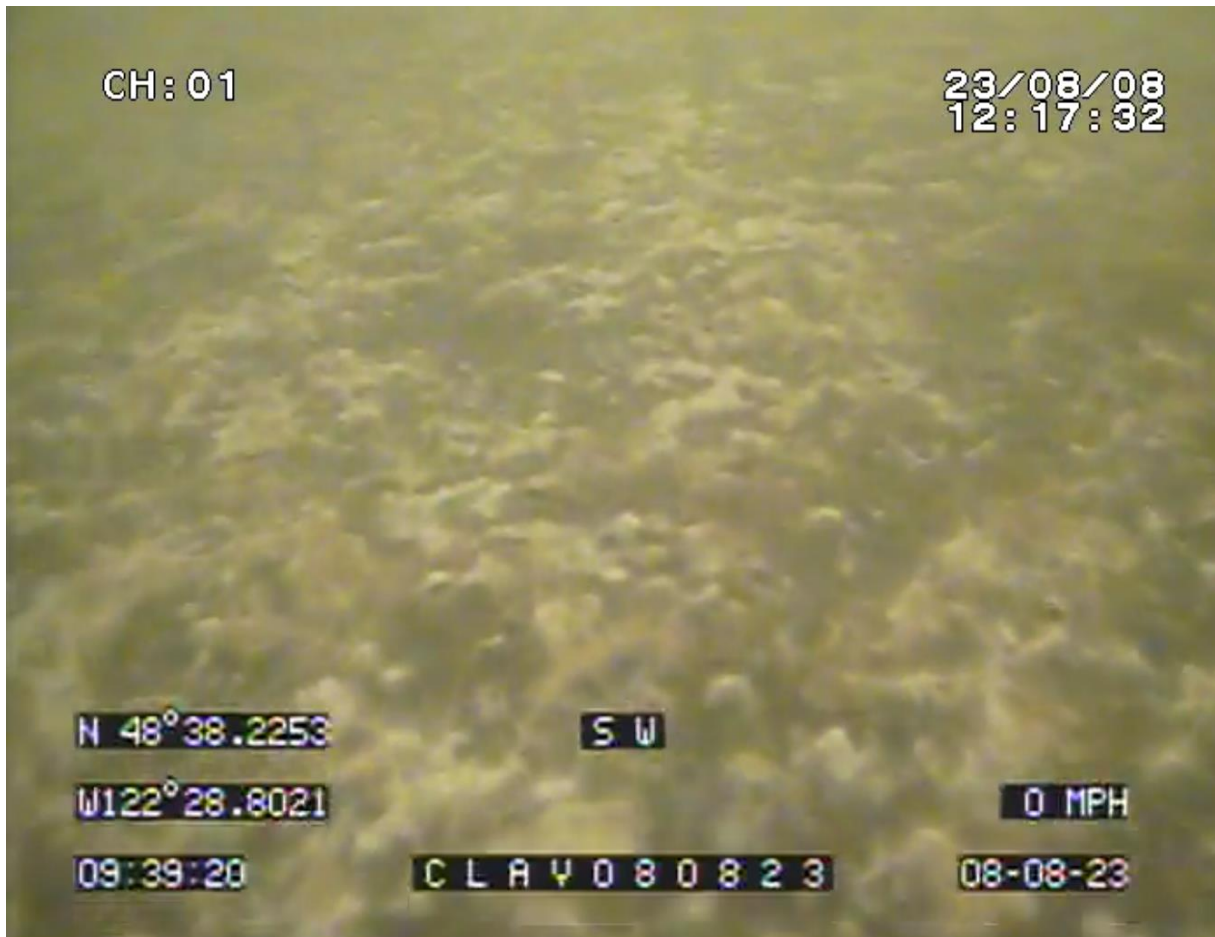
Figure 21. Video from within the Clayton Beach Divot, Skagit County, WA.

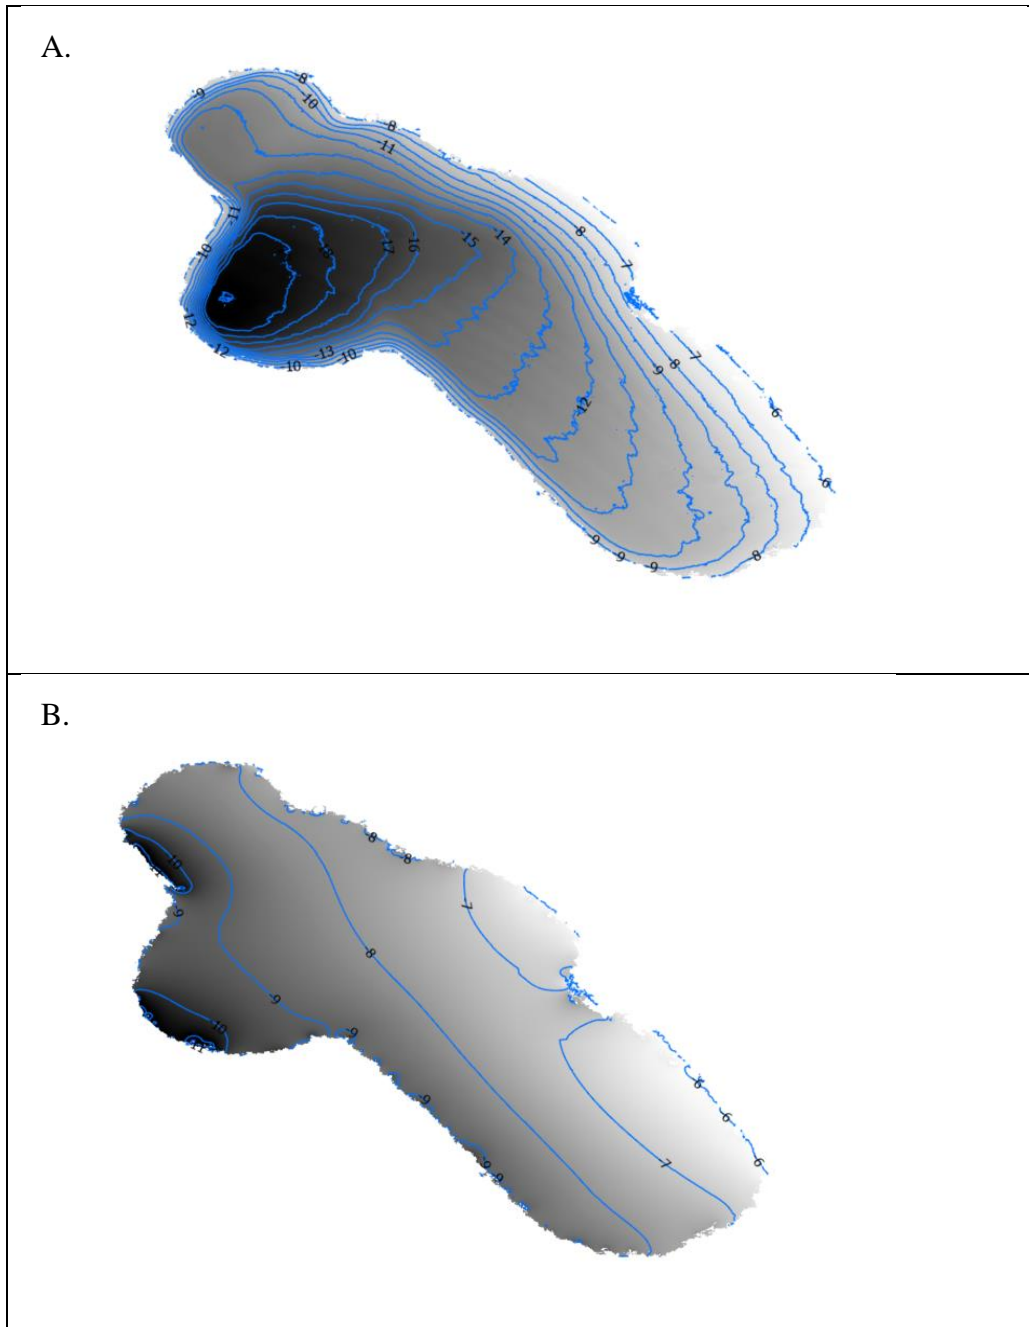
Two raster surfaces were used to calculate the total volume of the divot. The first was an unaltered 0.25 m² resolution raster of bathymetry for all unvegetated portions of the divot (Figure 22A). The second was an interpolated surface that estimated a natural slope profile as if the divot did not exist (Figure 22B).

The volume between these two surfaces was calculated as 71,246 m³ ± 119 m³ (93,186 yd³). This is the total quantity of fill needed to bring the seafloor up to a suitable height for eelgrass restoration. For reference – this equates to roughly 97 full size school busses needed to fill the hole.

Figure 22 A. Current Clayton Beach Divot Bathymetry. Contours in MLLW ft.

Figure 19 B. Interpolated bathymetry of filled Clayton Beach Divot. Contours in MLLW ft.

substantially. Based on data from the US Army Corps of Engineers, fill may continue to consolidate for an extended period. A report on consolidation time for different sediment void ratios indicates that subsistence and settling of material will continue for approximately 3000 days (8.2 years) post deposit regardless of sediment void ratios. Over this time, a surface may subside anywhere from 2 to 5 feet or more (Rollings 2000).

In addition to settlement time, it will be important to ensure a uniform seafloor surface is restored within the divot. Eelgrass is light limited, and the surface depth of new material should uniformly slope across the current depression at a constant from -6 to -9 ft. MLLW. It must not exceed -10 ft. MLLW in depth (the natural deep edge extent of eelgrass at the site). If a uniform slope is not achieved, a patchwork may occur where depressions in the surface exist, instead of a dense meadow of successfully restored eelgrass.
