WILDFIRE-ASSOCIATED LANDSLIDE EMERGENCY RESPONSE TEAM REPORT

2025 Wildcat Fire

Yakima County, Washington

WASHINGTON
GEOLOGICAL SURVEY
WALERT Report
December 2025

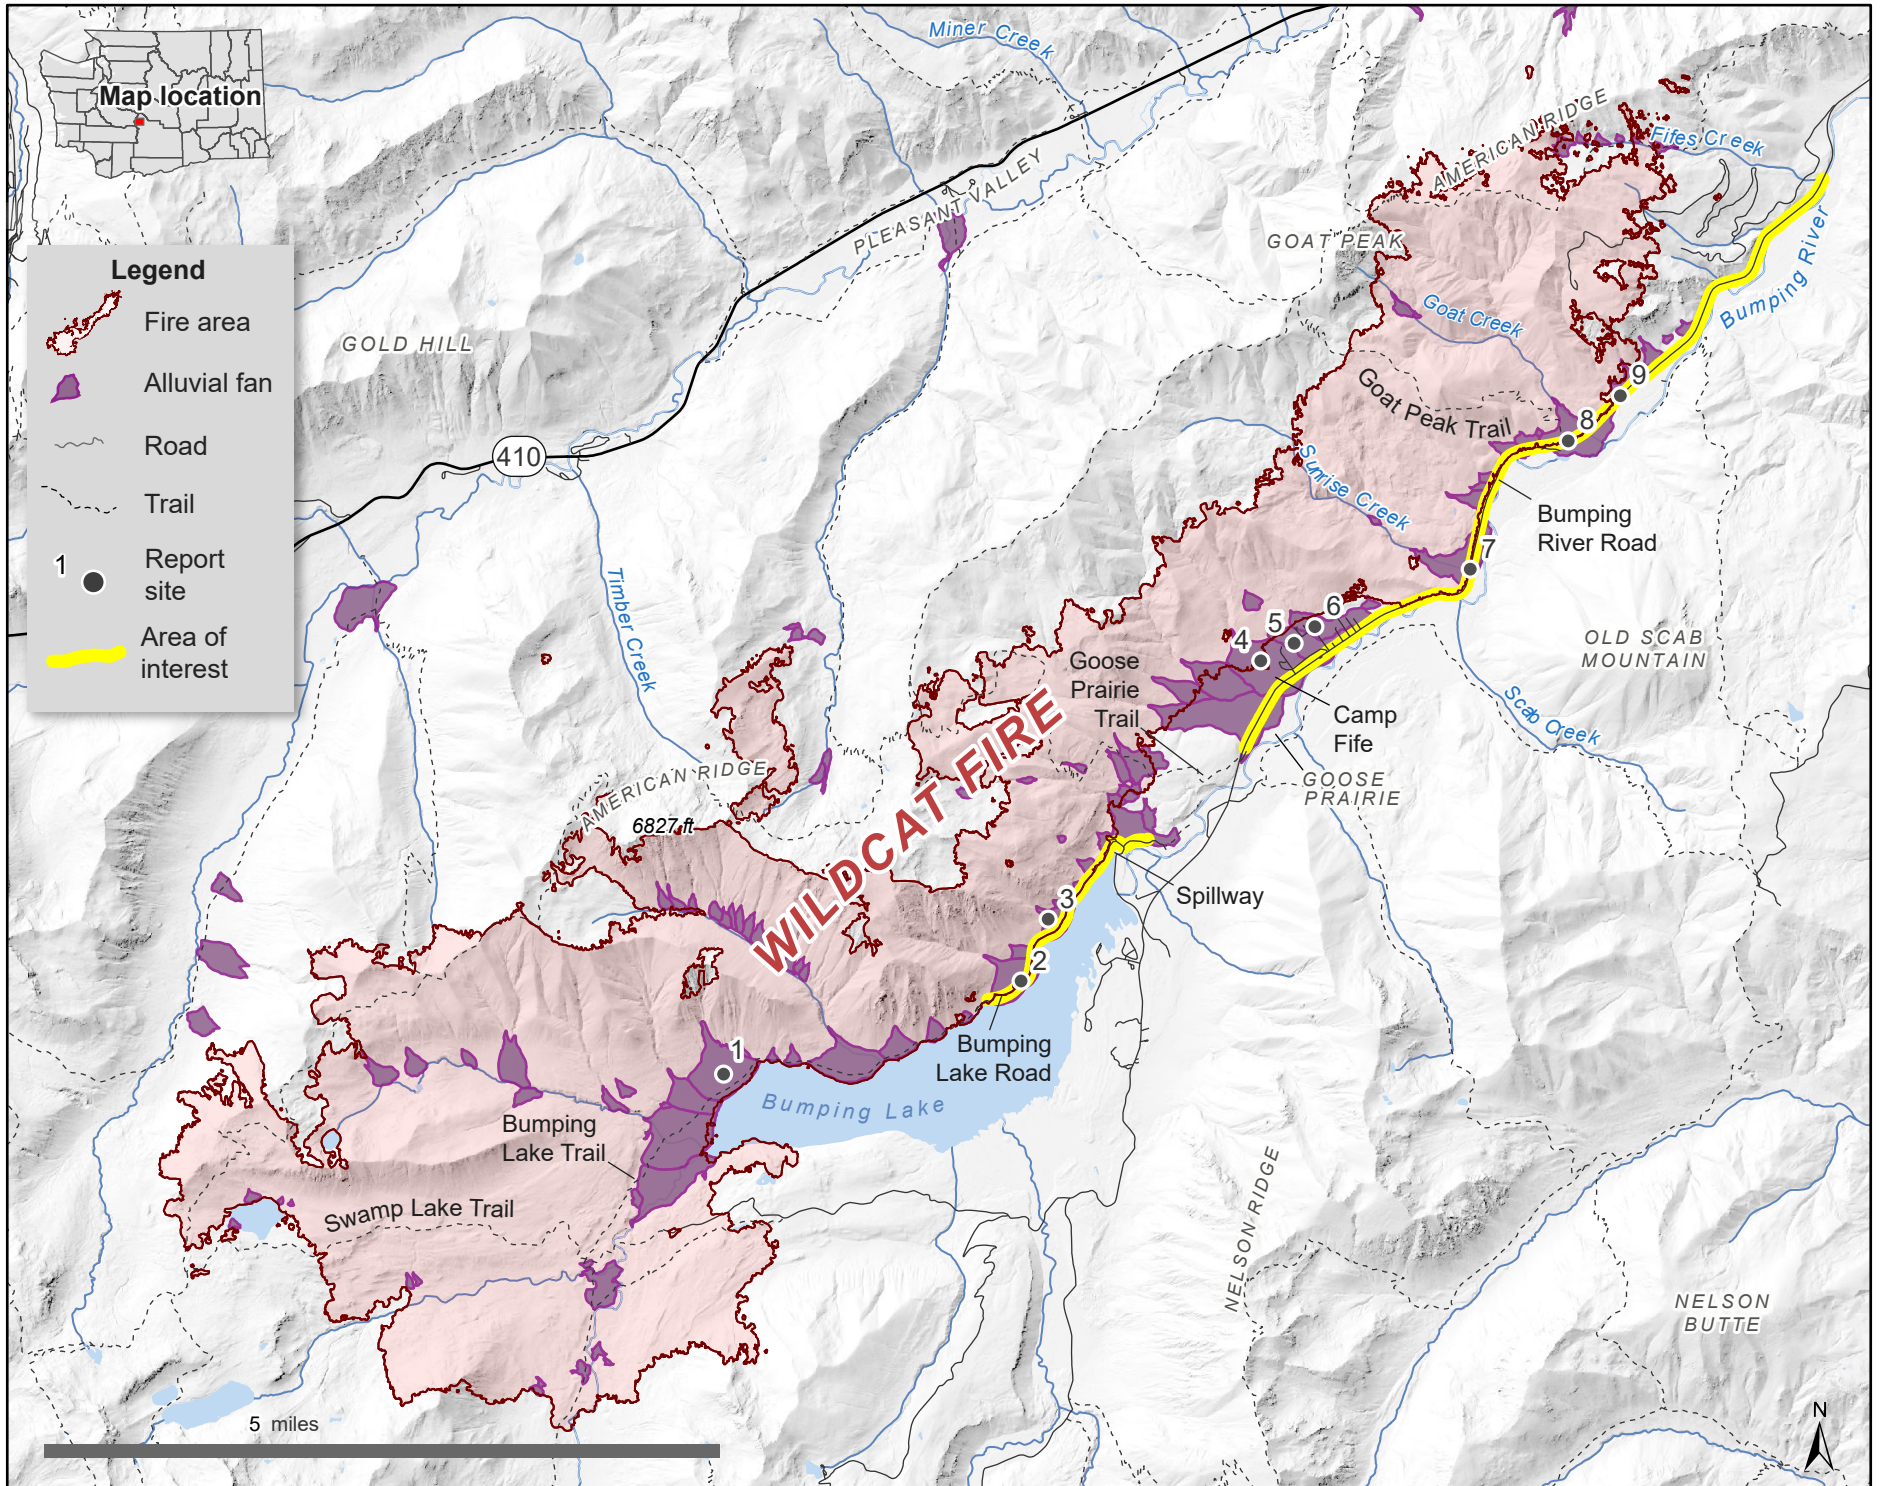
Plate 1

Plate 1. Highlighted locations mentioned in this report for the Wildcat Fire

We evaluated the fan surface near the apex and along active and abandoned channels to assess potential hazards to the residential structures located on this fan surface (Plate 1). The fan is characterized by a hummocky surface that is well vegetated with a mixture of tree species of varying ages. The active stream channel flows roughly southward down the fan surface, and under Bumping Lake Road in a 3-ft-wide culvert. There are two, slightly less incised, abandoned channels on this fan that lack vegetation, suggesting somewhat recent flow. Near the fan's apex and upstream of Bumping Lake Road, we observed that the active channel was incised roughly 5 ft deep and composed of primarily angular to sub-rounded cobbles and small boulders. Midway up the fan along the active channel, we observed a recent avulsion where a fallen tree partially redirected flow out of the channel. In remote review, we observed debris flow activity as a swath of bare soils at the apex of this fan that likely occurred between collection of 1959 and 1970 aerial imagery. The swath of bare soil (apparent in 1975 and 1985 aerial imagery) coincides with an area of distinctly younger trees than the mature conifer trees growing on immediately adjacent slopes.

We observed three potential flow paths on this fan surface. At the time of our visit on Nov. 3 there was no flow in the main channel (along the western edge of the fan). However, we observed fine sediments in the channel that appeared to have been deposited by recent stream flow. We observed 1 ft boulders, large woody debris in the active channel, and debris lobes along channel margins. Boulders up to 5 feet wide, and abundant mature conifer trees were observed on other parts of the fan's surface. There is an 18–24 in. culvert beneath Bumping Lake Road associated with this channel. Downslope of Bumping Lake Road, the active channel opens into a swale terminating at the lake shore, where a significant amount of large woody debris (logs, felled trees, and branches) are situated within the swale between the road and lake. Should a large flux of water or material come through this system, much of this debris may be delivered into Bumping Lake.

On the fan near Camp Fife (point 4) we observed a stream channel incised 4–5 ft into the fan surface with subrounded cobbles on the channel bed. On the surface of the fan's apex, we observed angular boulders up to 4 ft diameter. Abundant angular boulders, hummocky slopes, and apparent avulsion channels on the fan's surface is indicative of past debris flow activity. Unmarked walking trails traverse steeper sections of the fan near the apex, driveways and structures occupy the flatter mid-fan sections, and Bumping River Road crosses over the very distal edge. The debris flow modeling indicates low combined hazard for this fan.

On the fan at point 5 (Plate 1), we observed 1–2 ft angular boulders near the apex. Two distinct channels drain in different directions away from the fan apex, with pebble to cobble sized sediment on the channel beds. Multiple channels and angular boulders suggest past flooding or debris flow processes on the fan. The fan at Point 6 showed similar evidence of past debris flow activity in the form of hummocky surfaces and clusters of 1–3 ft boulders near the apex. However, the channel on this fan appears to be much less incised and only a small trickle of flow was observed in the shallow channel. The stream channel associated with this fan appears to flow through landside deposits roughly 500 ft above the fan apex. Material disturbed by this apparent landslide may be relatively easy to erode during high flows or floods. The cabins and structures on these fans are exposed to increased risk of flooding and debris flows during intense rain, rapid snowmelt, or rain-on-snow until vegetation recovers to pre-fire conditions. The basins above Goose Prairie (Points 4–6) have low and moderate debris flow hazard according to the USGS modeling (Plate 2).

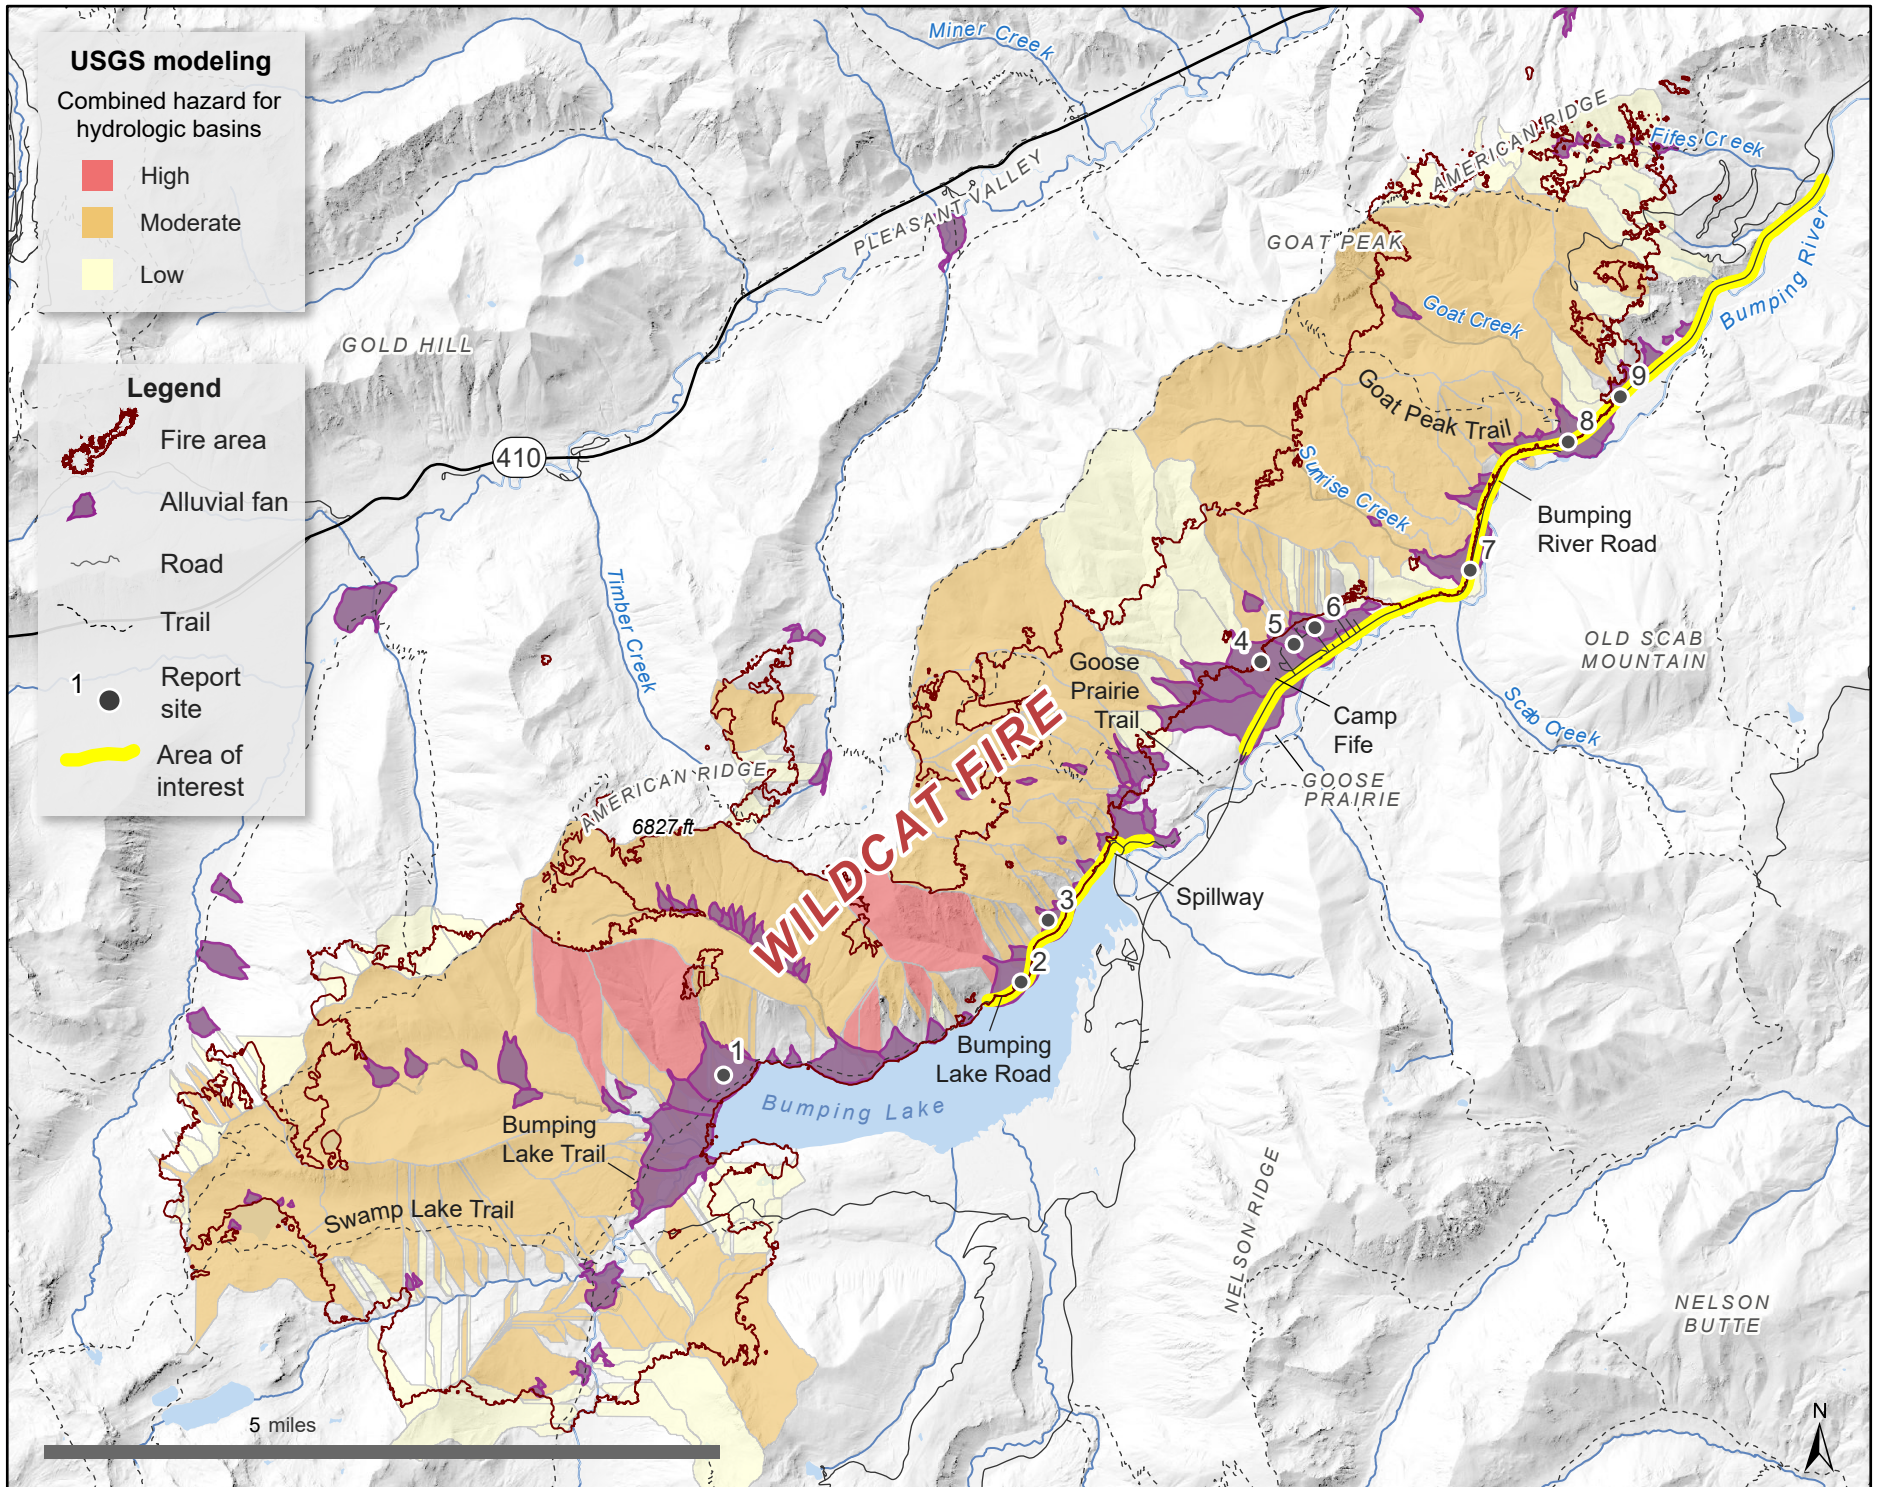
Plate 2

Plate 2. USGS post-fire debris flow hazard modeling for 24 mm/hr rainfall rate for hydrologic basins impacted by the Wildcat Fire

Future events have potential to reactivate much of the fan's surface based on a shallowly incised stream channel at the uppermost portion of the fan that could be filled or plugged by debris, initiating channel avulsions. Structures built within or adjacent to the active channel, abandoned channels, and (or) swales where water and (or) hyperconcentrated flows may become channelized, may be at elevated risk. The basin above this fan is modeled as high combined hazard, suggesting that it is at elevated risk of debris flows following the Wildcat Fire (Plate 2).

Based on our remote and field assessment of this fan, structures may be at elevated risk of flooding or debris flows. Future events have potential to reactivate much of the fan's surface based on a shallowly incised stream channel at the uppermost portion of the fan that could be filled or plugged by debris, initiating channel avulsions. The hydrologic basin above this fan is modeled with a moderate combined debris flow hazard (Plate 2). As such, structures built within or adjacent to the active channel, abandoned channels, and (or) swales where water and (or) hyperconcentrated flows may become channelized, may be at elevated risk of debris flows following the Wildcat Fire (Plate 2).

The community of Goose Prairie is located on several alluvial fans that drain from hydrologic basins modeled with moderate and low combined debris flow hazard (Plate 2). The Goose Prairie community consists of Camp Fife and several residential structures on the eastern half of the prairie. During our field assessment, we traversed three of the fans that underlie the Goose Prairie community (points 4–6). We observed flowing water in channels on all three fans, as well as alternate stream flow pathways on the fan surfaces from past avulsion and channel migration. There are four other alluvial fans in Goose Prairie that we did not visit in the field. Remote review reveals similar morphological features and surface textures in lidar for two of the fans (south of point 4). These fans have larger contributing basins and more incised stream channels, but no recorded structures on the fan surfaces. On the southernmost fan in Goose Prairie, multiple channels coalesce into one main stem before crossing Bumping River Road at the fan's distal edge. This fan has a moderate debris flow combined hazard rating according to the USGS modeling. At the north end of Goose Prairie, there is one structure on a smaller fan that has a smooth surface texture, no discernable channel in the lidar, and for which the modeling indicates a moderate debris flow hazard for the small, contributing basin (Plate 2).

The Sunrise Creek fan has developed several inset fan surfaces over time in response to erosion of its lower slopes by the Bumping River. The modern fan surfaces have multiple incised channels with varying depths, and the portions we visited in the field are vegetated with abundant, mature conifers. Where Sunrise Creek crosses Bumping River Road (Point 7) there is a ~3-ft-diameter concrete culvert. We observed some pooling of water in the channel downstream of the road. Upslope of the fan, Sunrise Creek traverses several landslide deposits apparent in remote review of the lidar. Landslide deposits can be more erodible than in-place bedrock during high flows or floods. The USGS modeling indicates a moderate debris flow hazard for the Sunrise Creek basin (Plate 2).
