McNeil Island Habitat Restoration Project Feasibility Report

July 2015

Washington Department of Fish and Wildlife

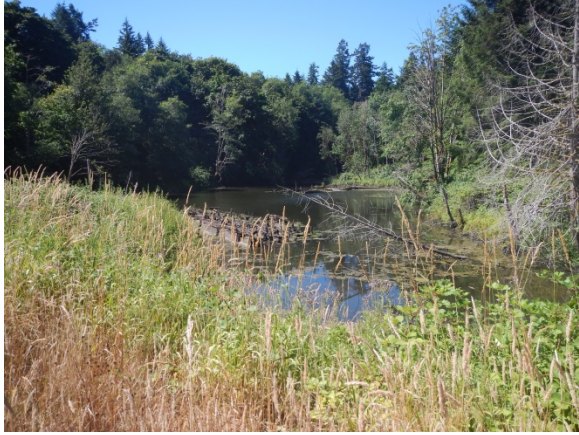
Impounded Pond and Debris

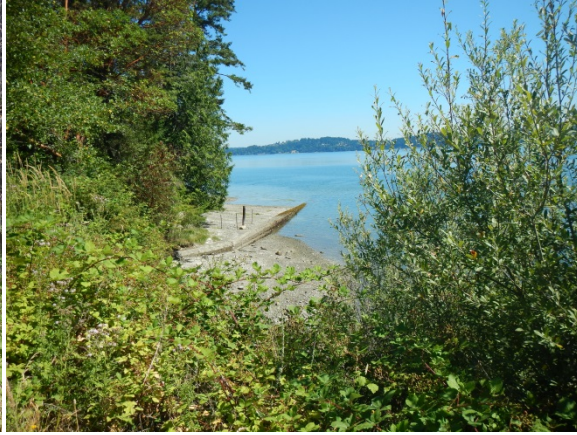
Milewa Creek Site Shoreline and Groin

The road at Milewa Creek acts as a dam and the perched culvert reduces tidal inundation of the Milewa Creek Estuary, impacting approximately 2.5 acres of marsh. The existing road embankment was constructed after 1965 and replaced a 300 foot long bridge that was originally constructed at an unknown date. Due to the debris placed at the culvert outlet, and the pond elevations at the time of survey this culvert was not visible and was not surveyed or documented. Some tidal exchange may be taking place with this culvert or it could be completed buried and non-functional. A second 18" metal culvert directly above was surveyed and is described in the drawings below. This culvert is well above Mean Higher High Water (MHHW) and likely serves as an overflow during high flows. Additionally, a 2 foot wide by 180 foot long concrete groin extends from the existing culvert outlet location into the intertidal zone. The groin follows the slope of the beach, but the beach to the north is 3 feet above the beach on the south side of the groin. The footing for this groin is approximately 1 foot below the beach on its south side. The groin extends to +6.6 MLLW at the north, and +3.6 MLLW south. The current seawall/embankment is armored with a combination of concrete debris and submarine netting around the culvert. The orientation and condition of the culvert was difficult to observe due to overhanging banks and heavy vegetation. Within the impounded pond there are remnants of 2 barges and other concrete and construction type debris.

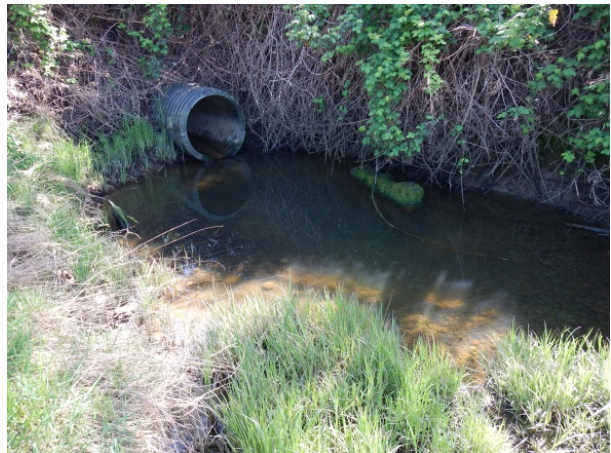
Outlet of Culvert Drain.

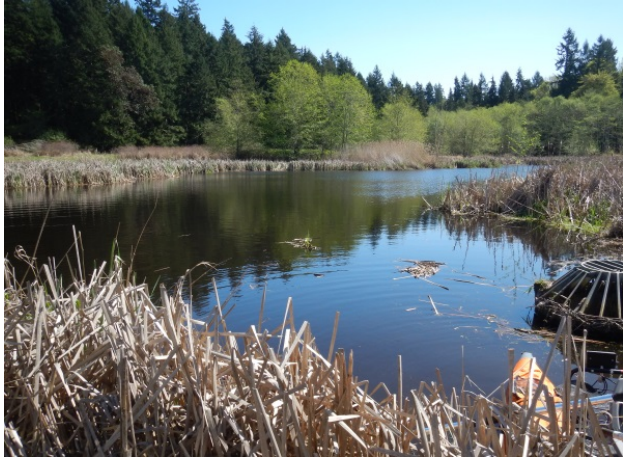
Ponded Creek and Control Structure

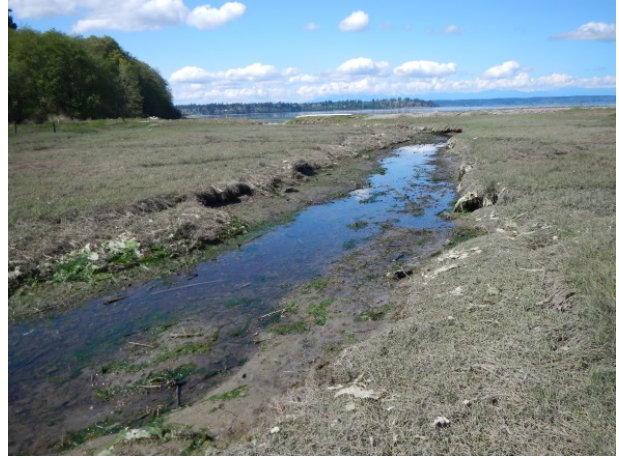
Tidal channel at outlet

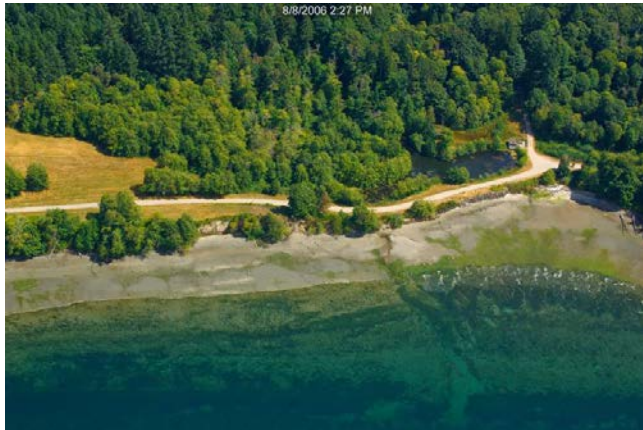
The road embankment and perched culvert along Floyds Cove has blocked the tidal inundation of approximately 0.5 acres at MHHW. The existing pond bottom is assumed to have aggraded significantly since the embankment was constructed. Field crew indicated that the substrate was covered in about a foot of loose fine sediment over more solid substrate throughout much of the pond. The existing culvert is a 24" concrete pipe culvert that is perched above the beach and has one or more sections that separated. The pump house and diversion are not in operation at this

The culvert was assessed as a complete barrier for fish passage due to the outfall drop of 0.2 to 2.5 meters at high tide (Till and Caudill 2003, WDFW 981753). Four small streams flow into the impoundment but are limited for potential fish use due to small stream length (less than 200 meters) and low flows (Till and Caudill 2003).

Floyds Cove Embankment from Boat Survey

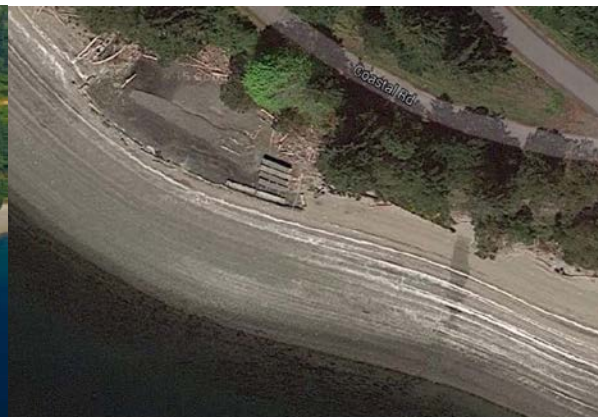
Site Debris as observed from Shoreline Survey

Description: Remove all of the debris from the beach. Dispose of all concrete debris off site and remove the quarry spalls from the upper landing area. Expose existing beach material and regrade the beach to match the profile of the adjacent stretches of beach. Some backfilling of the beach after removal of crushed gravel and quarry spalls may be necessary to reach grade level. Remove the concrete boat launch and similarly regrade the beach. Pull all of the log pilings and dispose of at an approved landfill. Leave or reposition the logs with rootwads. The cost of this option is estimated at \$20,000-\$40,000

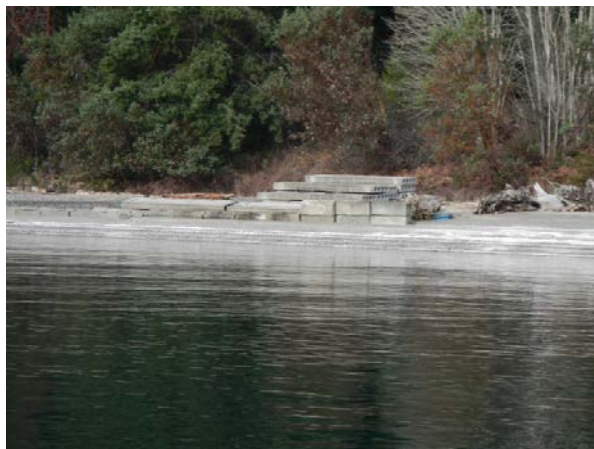
Voided slabs and anchored rootwads at the site
