Weyerhaeuser
Western Timberlands Operations Support

GEOLOGIC REPORT FOR THE 1880 HARVEST UNIT

December 15, 2023

Harvest Unit Name: 1880
HPU Number: 415920
Watersheds: Chehalis Headwaters
Location: Lewis County, Washington
Section 29 T11N R5W, W.M.

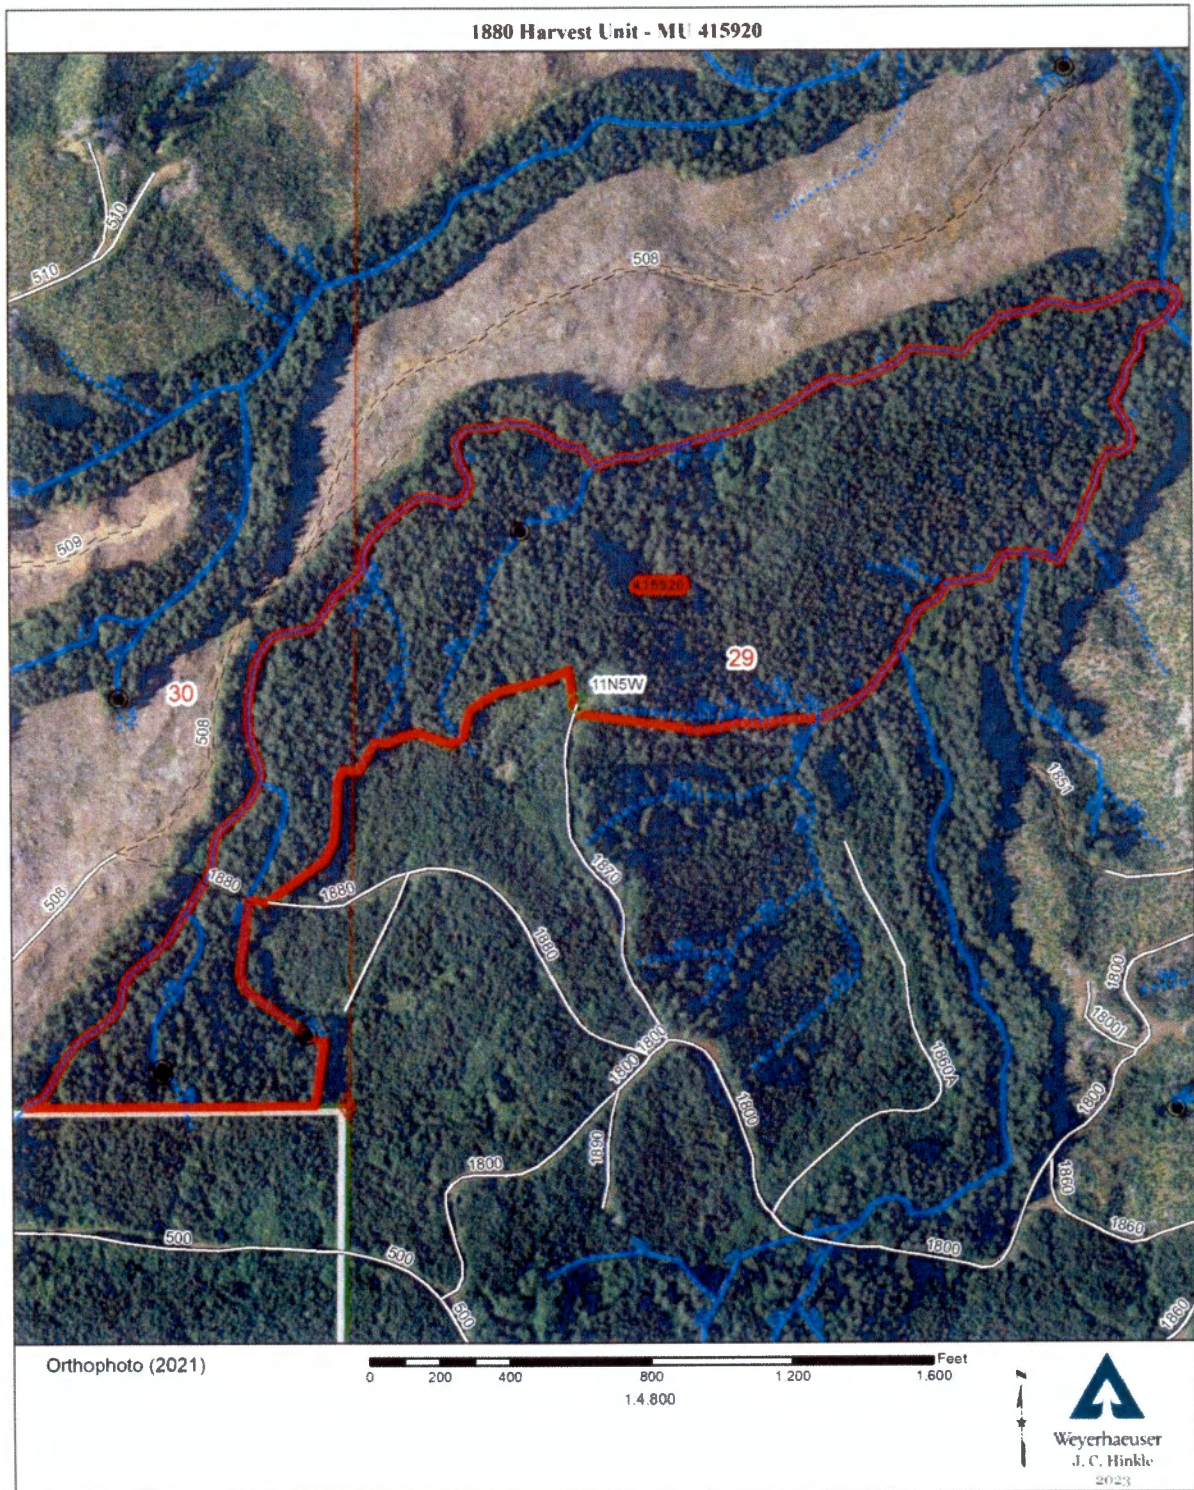
Figure 1: 2021 Orthophoto.

The harvest unit consists of several stand types dominated by 51 to 55 year old second-growth Douglas fir with western hemlock, and other species in places (Figure 1).

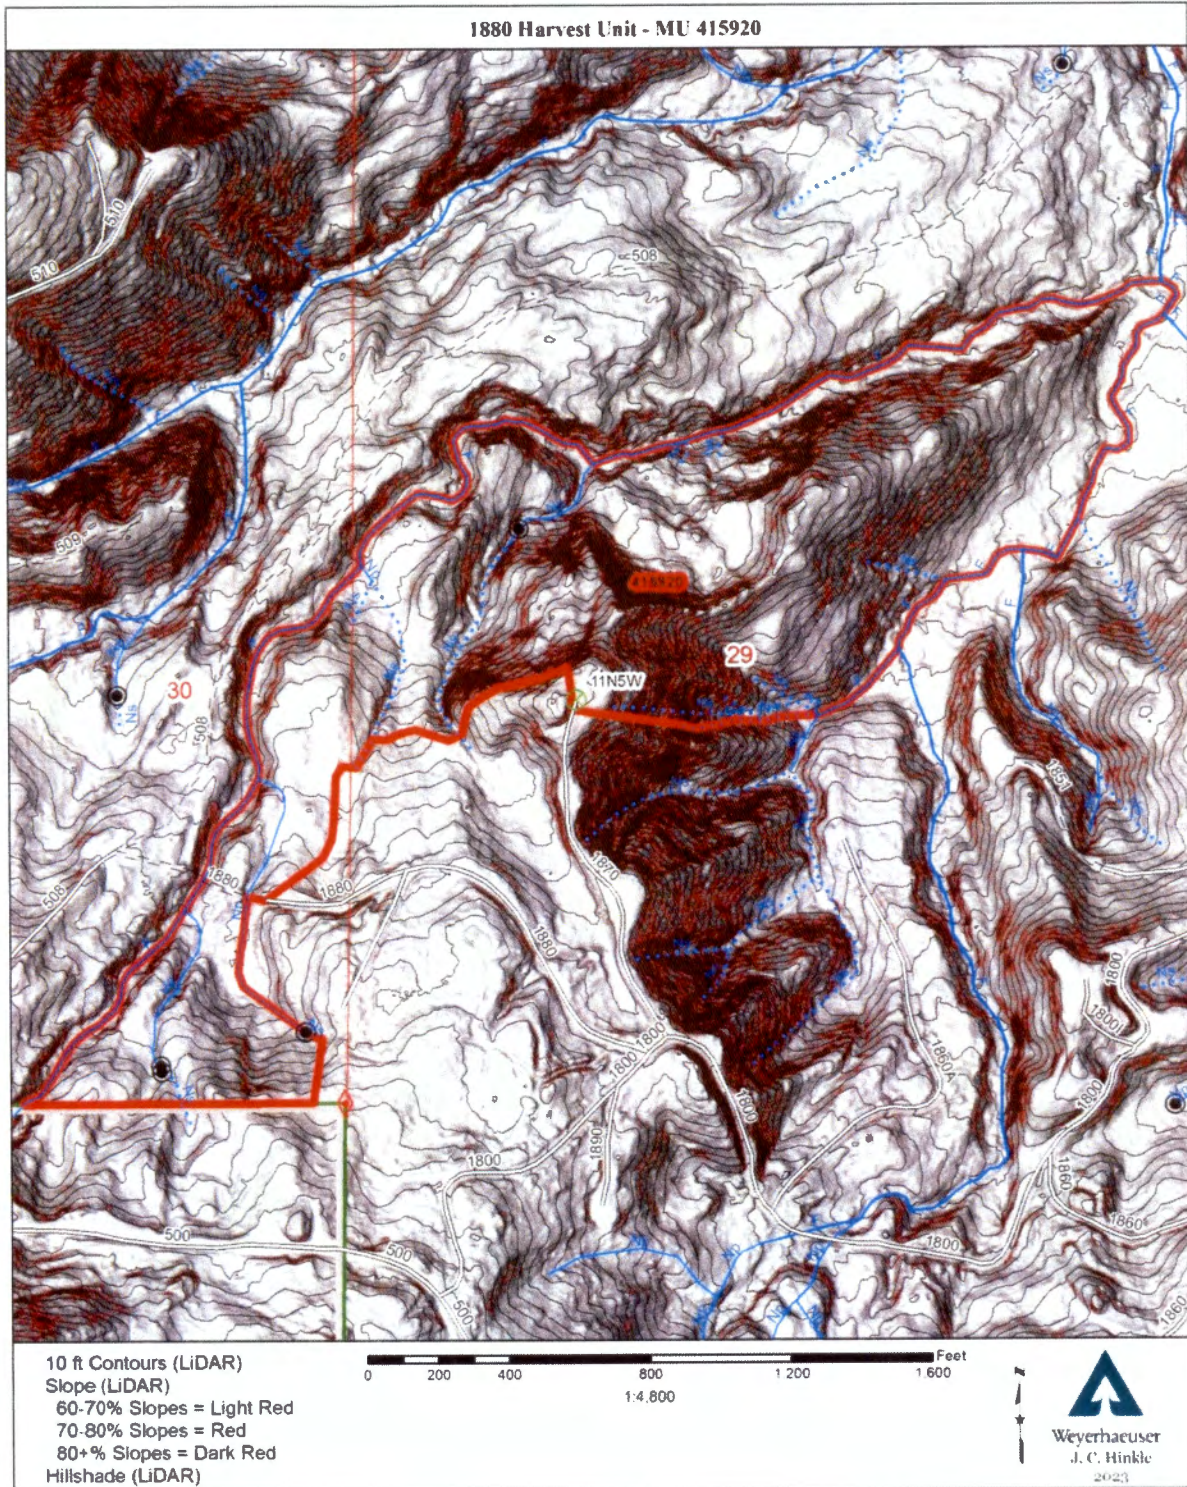
Figure 2: LiDAR 10 ft contours, slopes, and hillshade.

The harvest unit straddles a low ridge in the headwaters of the West Fork of the Chehalis River. The unit is dominated by gentle (<40%) dormant-indistinct to relict deep-seated landslide terrain. Moderate to steep (>60%) slopes occur along scarps and along streams incised into the otherwise gentle terrain (Figure 2). There is also an area of steep (>60%), moderately dissected slopes in the south-central portion of the unit. Elevation in the unit ranges from 1440 feet to over 1880 feet above mean sea level.

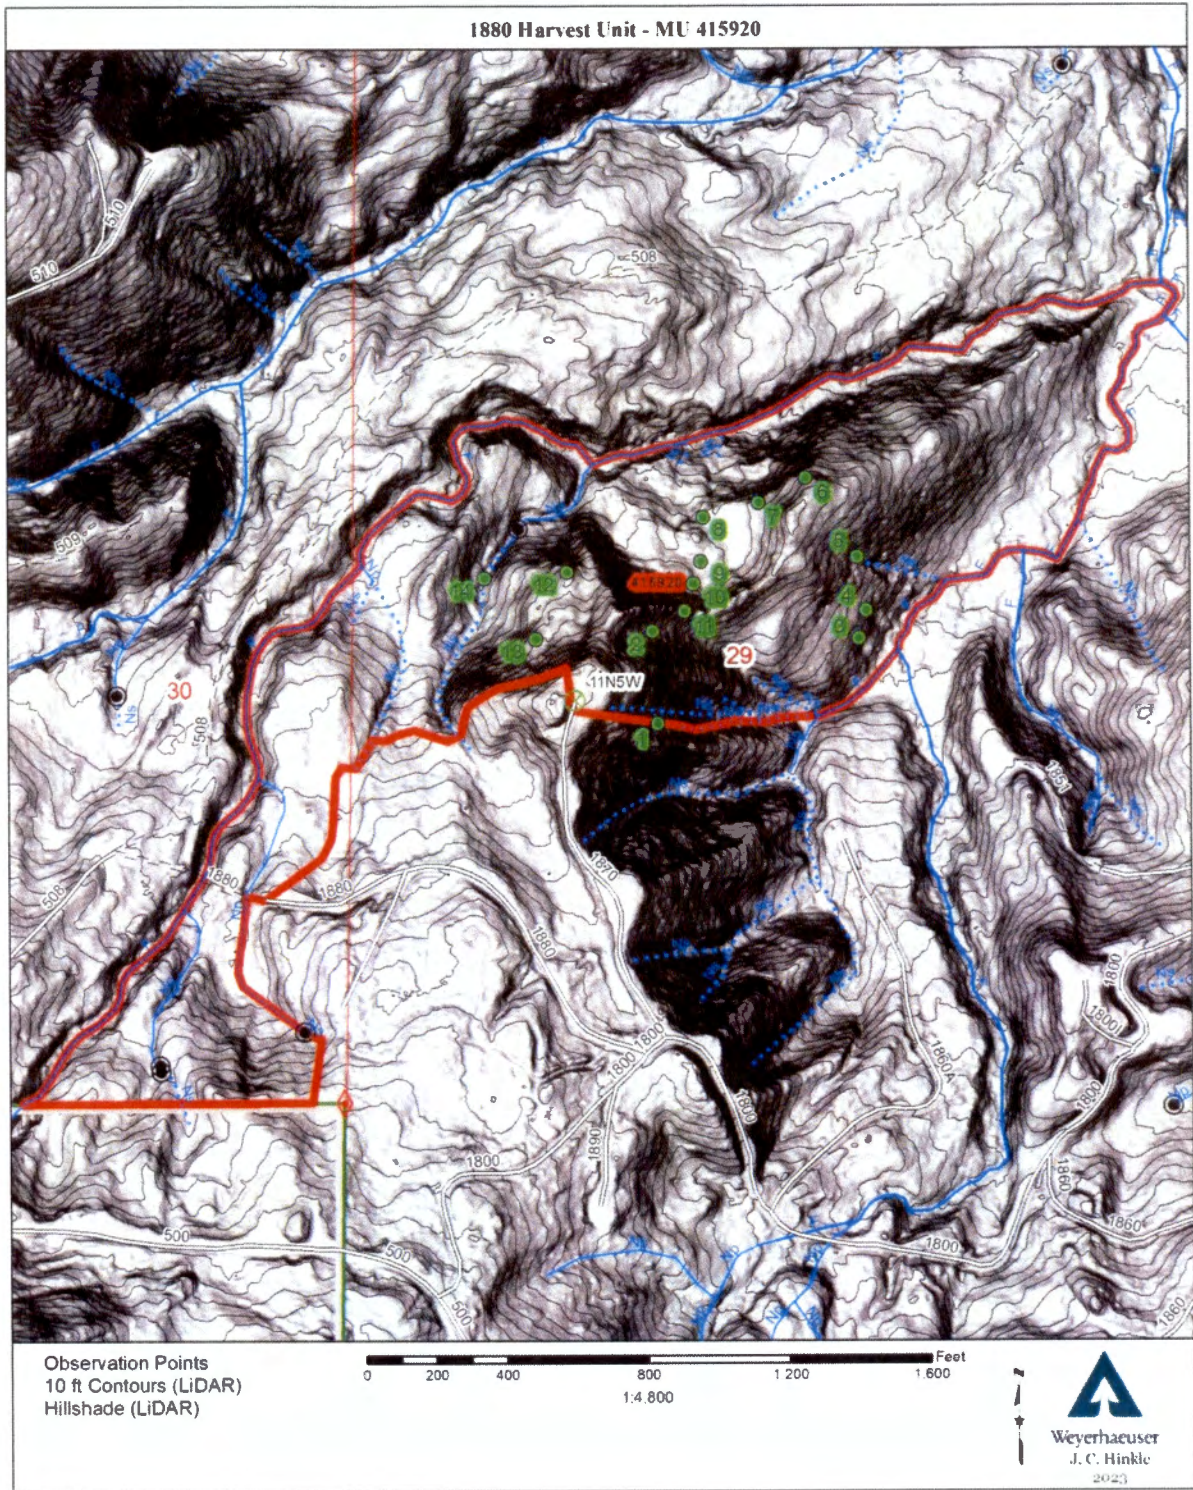
Figure 3: Observation points.

We made the following observations during our field review (Figure 3):

Point	Observations
1	Slide; 85% slopes; Deep seated; Mixed stand with brush; Old growth stumps; Wet site conditions; Ns channel; Sweep in large conifers; Recommend buffer
2	Swale; 50% slopes; Steeper side slopes and head; Convergent to broadly convergent slopes; Conifer; Old growth stumps; No signs of surface water; No signs of recent slide activity

3	Old slide scar; Slope break; 45% slopes above break; 75% slopes below break; Conifer; Old growth stumps; Back rotated trees; Recommend expanding RMZ to protect feature
4	Old slide scar; Slope break; 45% slopes above break; 75% slopes below break; Brush in scar; Conifer adjacent; Old growth stumps adjacent; Recommend expanding RMZ to protect feature
5	Deep seated slide; 2007 storm; Scarp; Lower portion mobilized; 45% open slopes; Young mixed stand and brush in scar; Conifer adjacent; Old growth stumps; No signs of surface water
6	Old slide scar; Slope break; 45% slopes above break; 95% slopes below break; Conifer; Old growth stumps; Back rotated trees; Recommend expanding RMZ to protect feature
7	Active deep-seated slide; 2007 storm; Slope break 15% slopes above; 85% slopes below; Back rotated trees below break; Recommend buffer
8	Active deep-seated slide; Activity extending downslope towards stream

9	Active deep-seated slide; Apparent right margin of activity
10	Active deep-seated slide; Smaller secondary failures on headscarp deposited on bench
11	Active deep-seated slide; Headscarp; Exposed soil; Near vertical slopes; Back sweep in large conifer on slide bench below; Buffer flagged along slope break up around scarp
12	Steep slopes below knob; 90% slopes; Open slopes; Conifer; Old growth stumps adjacent; No signs of surface water; No signs of recent slide activity
13	Deep seated slide; Dormant distinct; 25-55% slopes; Conifer; Old growth stumps; No signs of surface water; No signs of recent slide activity
14	Inner gorge buffered per engineer's notes

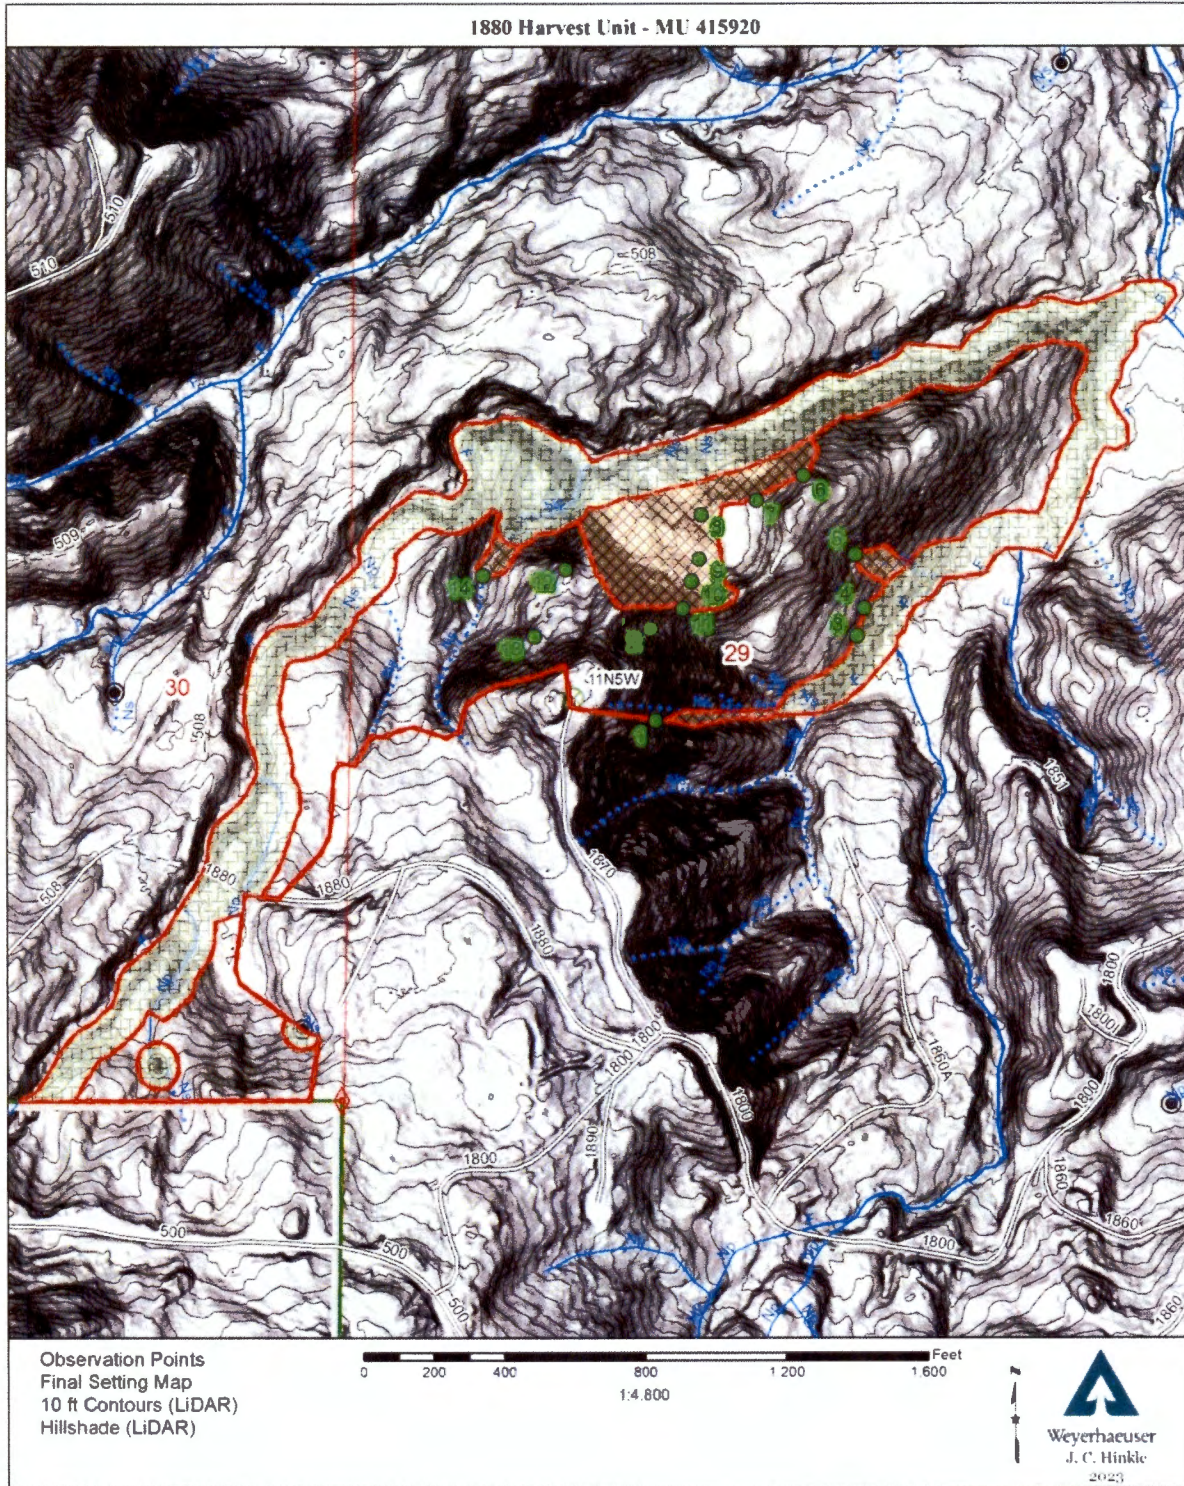
Figure 4: Final unit layout.

The harvest unit has been laid out to avoid harvesting the areas with the highest landslide hazard and risk of sediment delivery to streams (Figure 4). Slope stability protection measures are summarized below:

- The slide at Point #1 will be protected in a UNS buffer.
- The old slide scars at Points #3 and #4 will be protected within the RMZ.
- The recently active deep-seated landslide at Point #5 will be protected with a combination of UNS and RMZ buffers.
- The active deep-seated slide that includes Points #7, #8, #9, #10, and #11 and the adjacent area of historic landslide activity at Point #6 will all be protected with a combination of UNS and RMZ buffers.
- The inner gorge at Point #14 will be protected in a combination of UNS and RMZ buffers.
- Sections of inner gorge elsewhere in the unit will be protected within RMZ buffers.

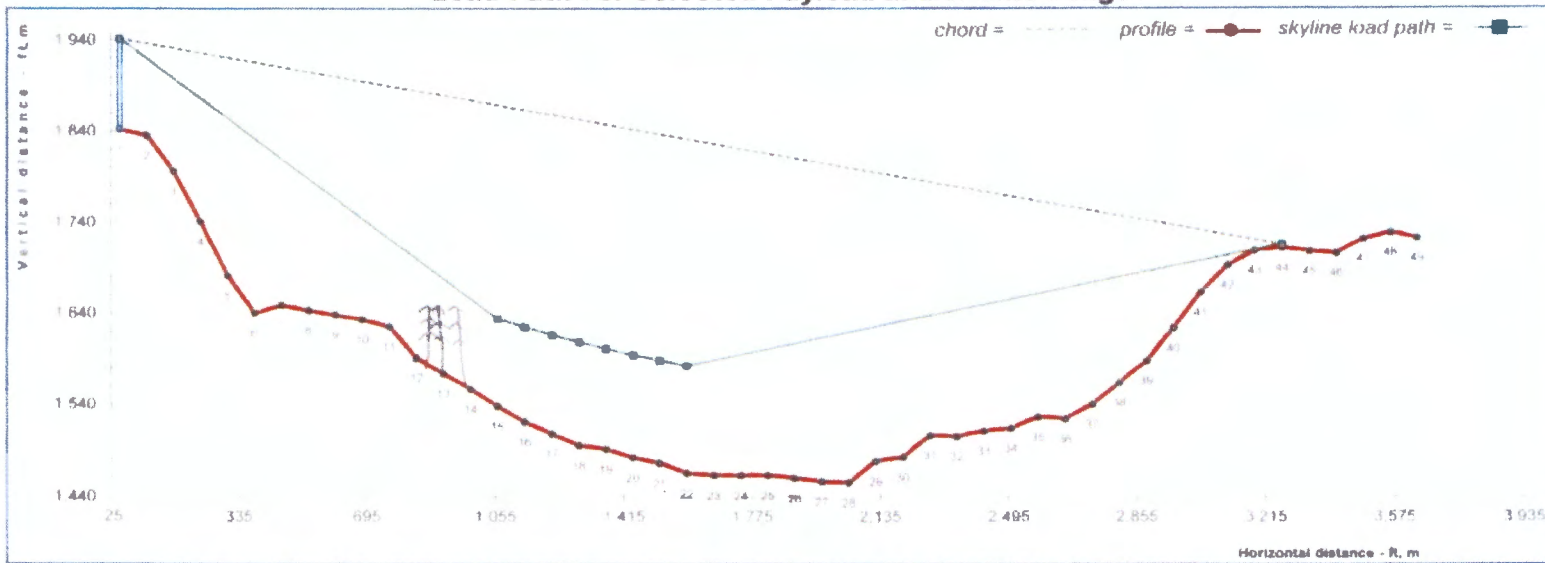
Figure 6. Yarding profile for corridor A.

the temporary road does not work out, the forest practices application will be filed as a Class IV Special to address the option of yarding corridors across unstable slopes buffers. Your analysis of the yarding skyline profiles indicates that yarded logs will have full suspension, but trees may need to be cut in some of the corridors to safely operate. I have included the yarding profiles you provided for the corridors (Figures 6 and 7).

- Avoid crossing buffers as much as feasible.
- Utilize natural openings in the canopy to avoid impacts to leave trees.
- Maximize lift in the yarding system as safe to do so.
- Buck logs on the slope to minimize the yarded log length (only as necessary and safe to do so).
- Operate the carriage slowly as it passes through the canopy in the buffers.
- Maintain full suspension during yarding to avoid ground disturbance.
