GEORESOURCES

September 5, 2024

Geological Report
Proposed Surface Mine Expansion
Hoh Mainline
Jefferson County, Washington
PN: 612032001
Doc ID: JJCResources.StRegisPit.RG

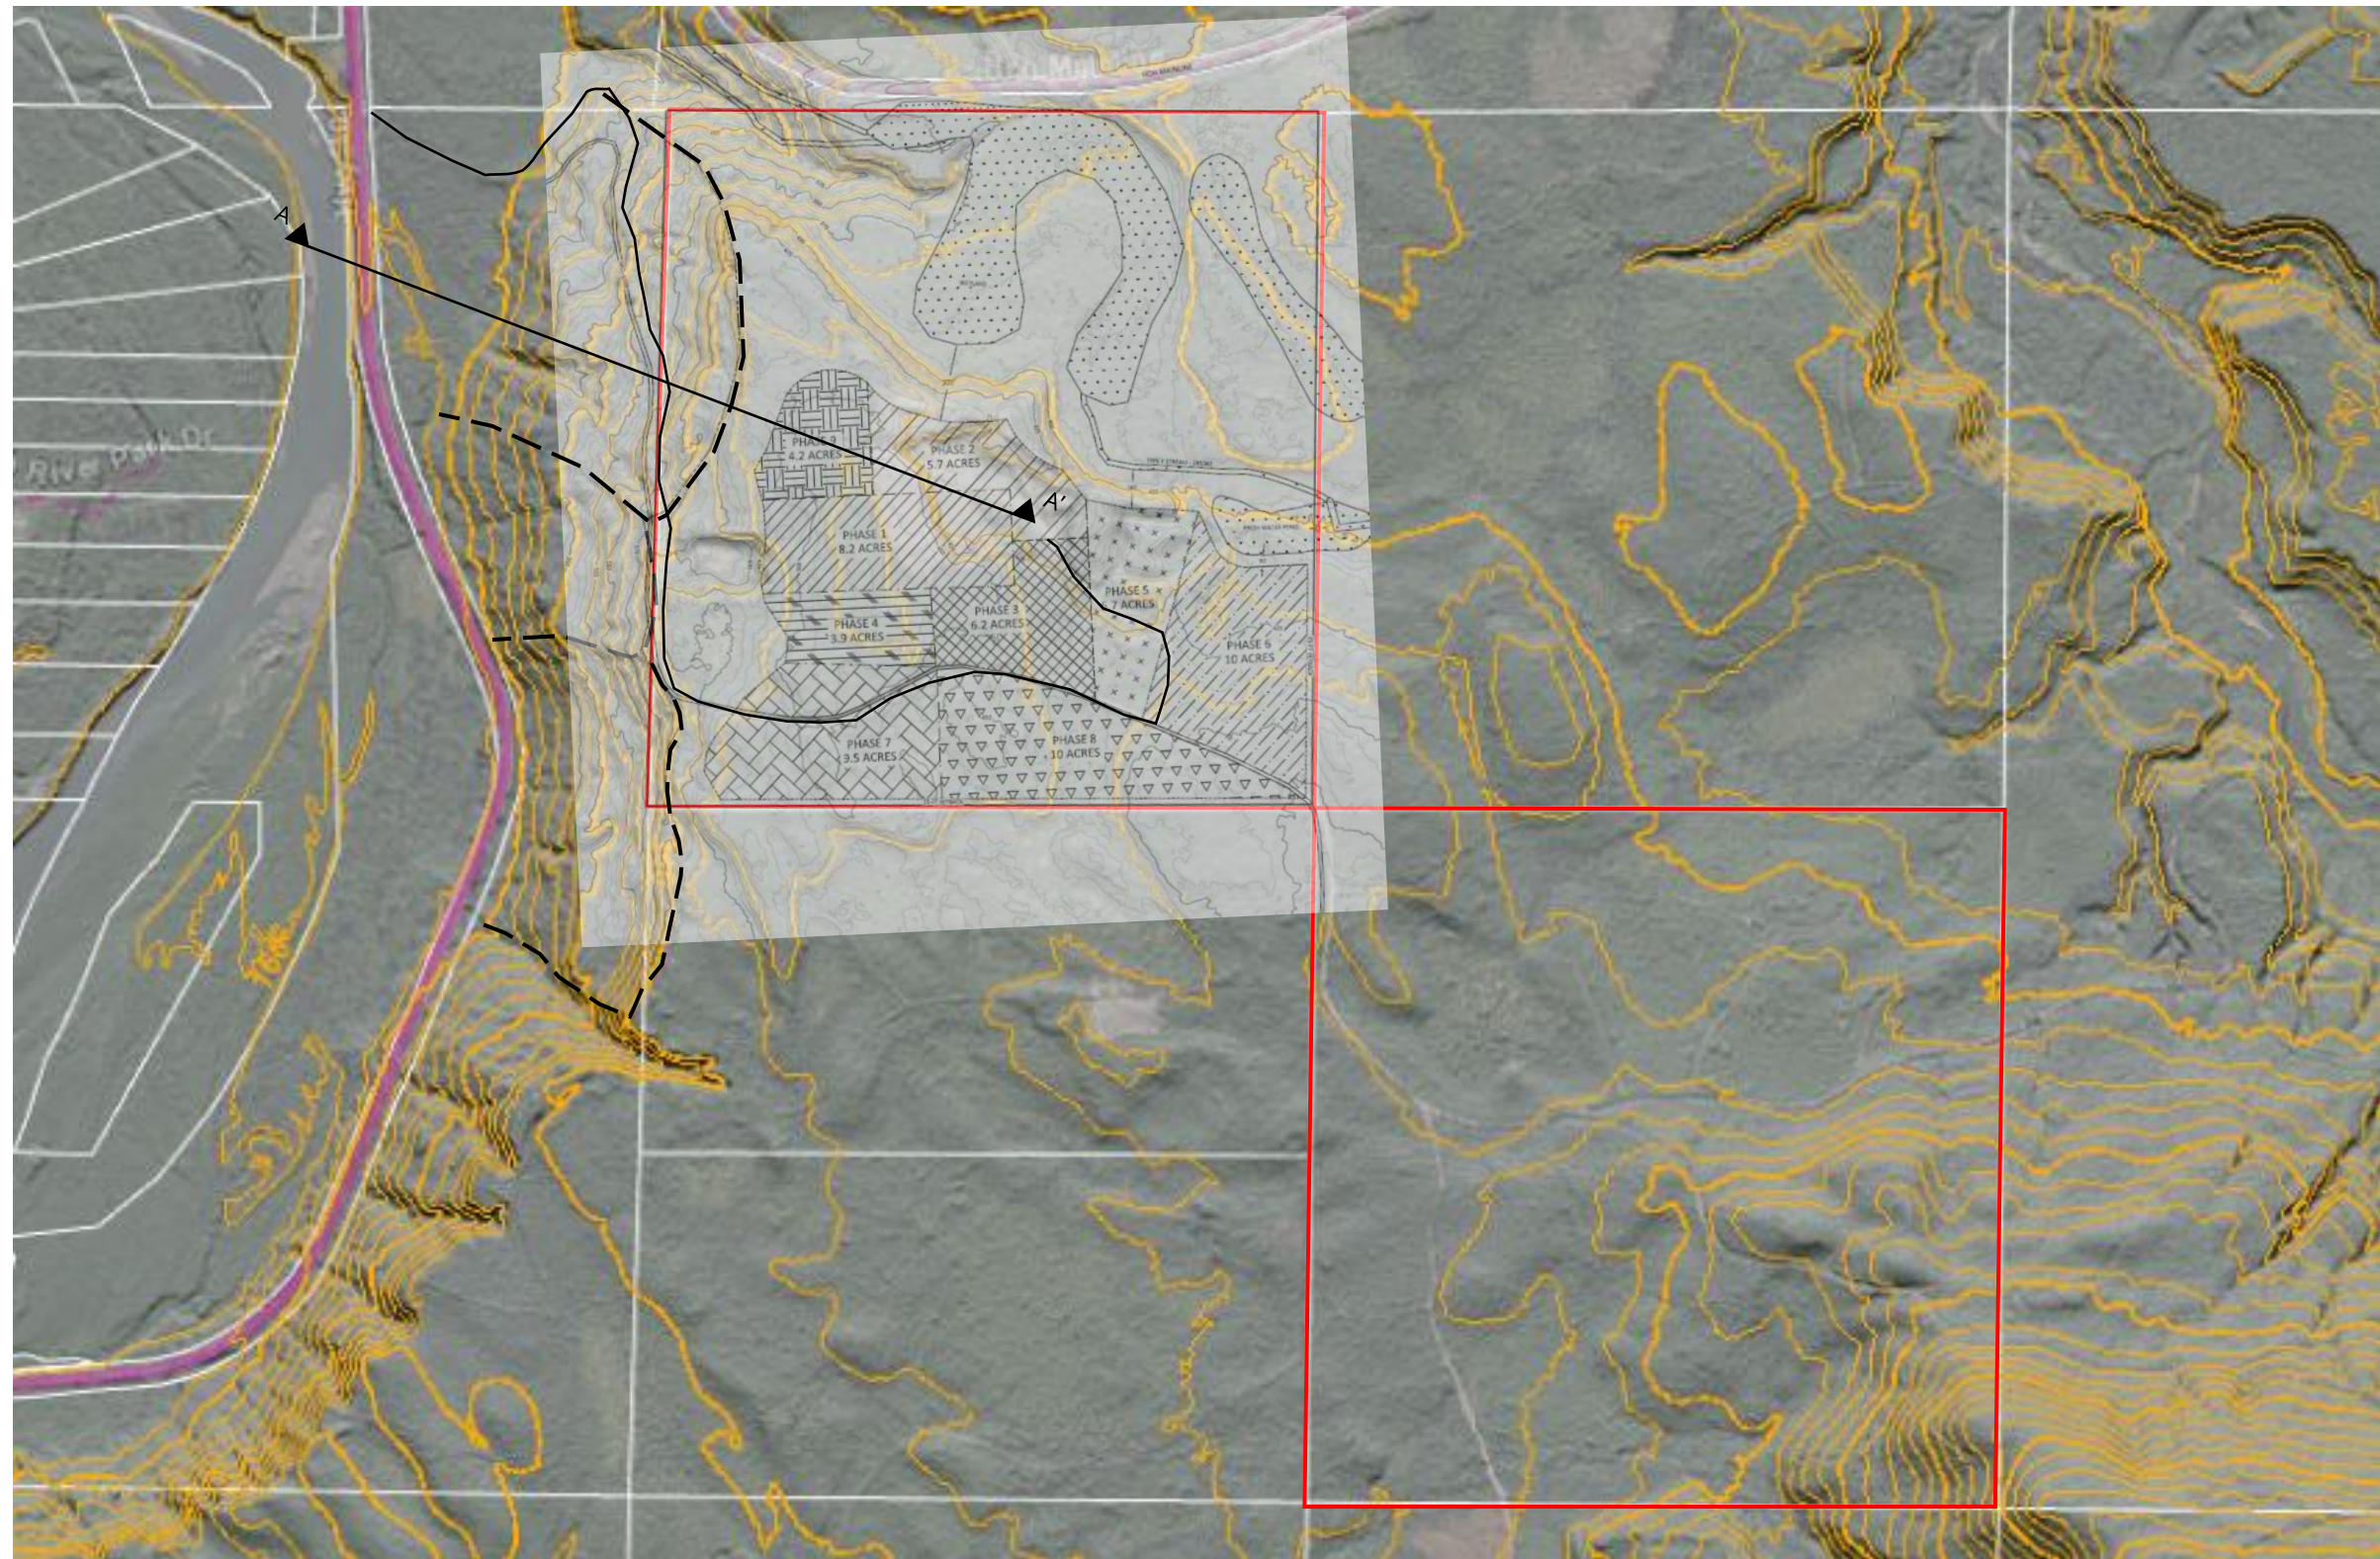
Figure 2

The site appears to have two of the above listed indicators of a landslide hazard area as defined by Jefferson County Code 18.22.510 (slopes steeper than 40 percent with more than 10 feet of vertical relief, and landslide deposits on or near the site). Based on our site reconnaissance and literature review, it is our opinion that a landslide feature is present on the western portion of the site. This feature is readily identifiable on LiDAR imagery for the site, as shown on Figure 3. During our site reconnaissance, we observed areas of sparsely vegetated, over steepened soils along the observed head scarp, also visible in LiDAR imagery. Additionally, we observed a feature consistent with a back-rotated bench and hummocky terrain below. Hummocks were not pronounced and most of the anticipated runout appears to have been removed via erosion and sediment transport. Our interpretation of the approximate limits of the landslide feature and additional notes regarding the feature are included in Figure 2.

Given that we characterize the landslide feature as dormant, and the toe of the feature is relatively well protected by the US Highway 101 grade, it is our opinion that the likelihood of remobilization of the landslide feature is relatively low, provided our recommendations included below are appropriately incorporated into the design and operation of the mine. However, without additional analysis, a buffer should be included in the reclamation plans to provide protection against the potential for remobilization.

We recommend that no site disturbance is allowed within the primary GWRA, leaving a vegetated buffer in place. By avoiding disturbance of the primary GWRA, it is our opinion that the potential for increased groundwater recharge and associated pore water pressures within the slide deposit is negligible. In concurrence with the previous reports referenced in our literature review, maintaining or reducing pore water pressure levels within the landslide deposit is likely the most critical factor in promoting stability of the landslide deposit.

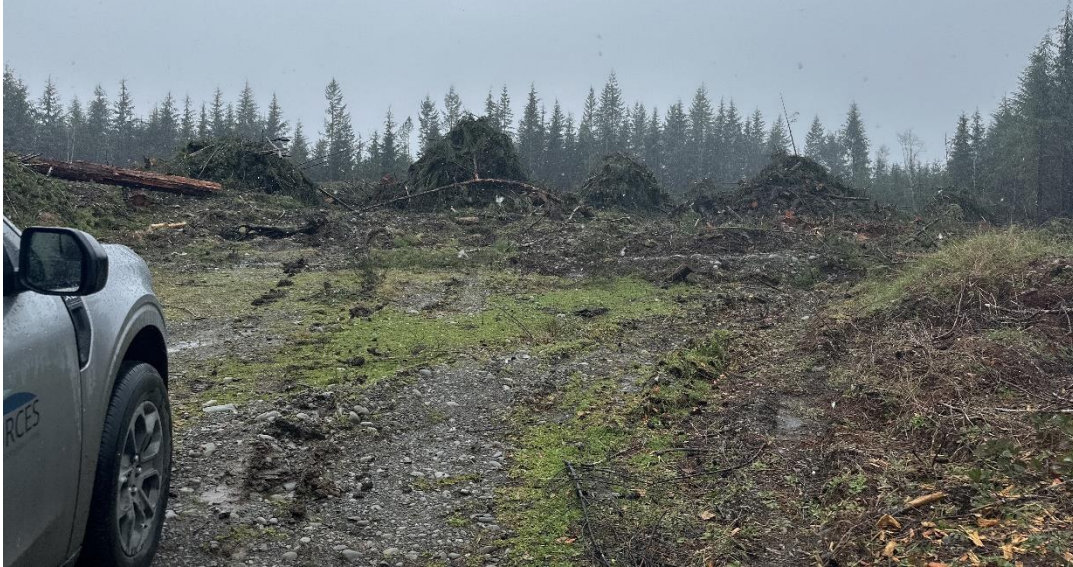
Image 1. Tree clearing in area of proposed mine expansion.

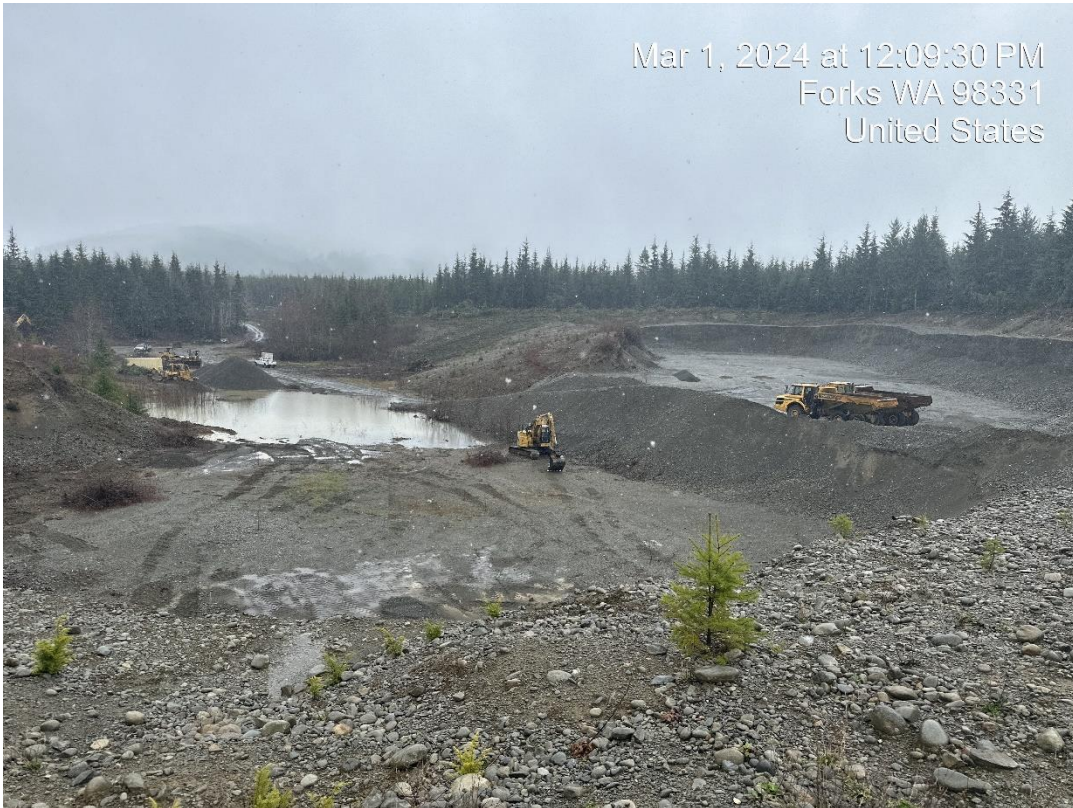
Image 2. Active mine operation area.

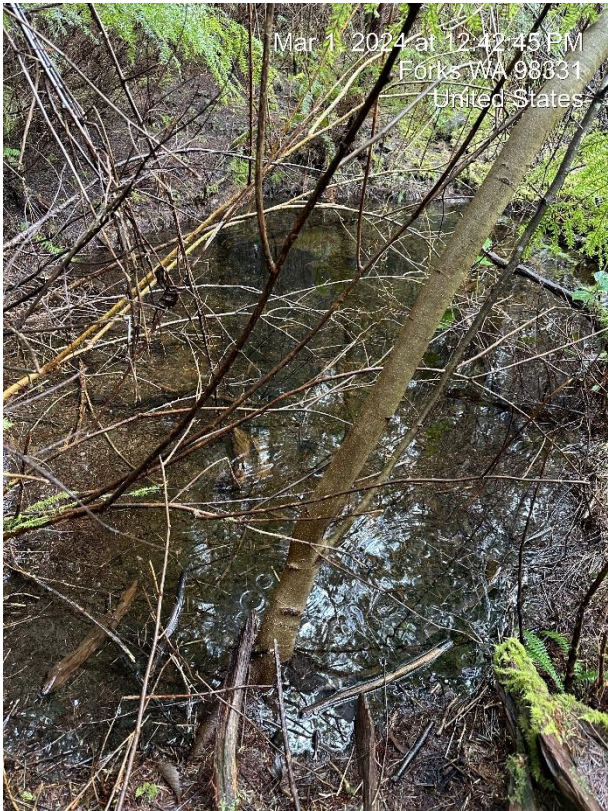
Image 3. Standing water in upland area, perched on glacial till

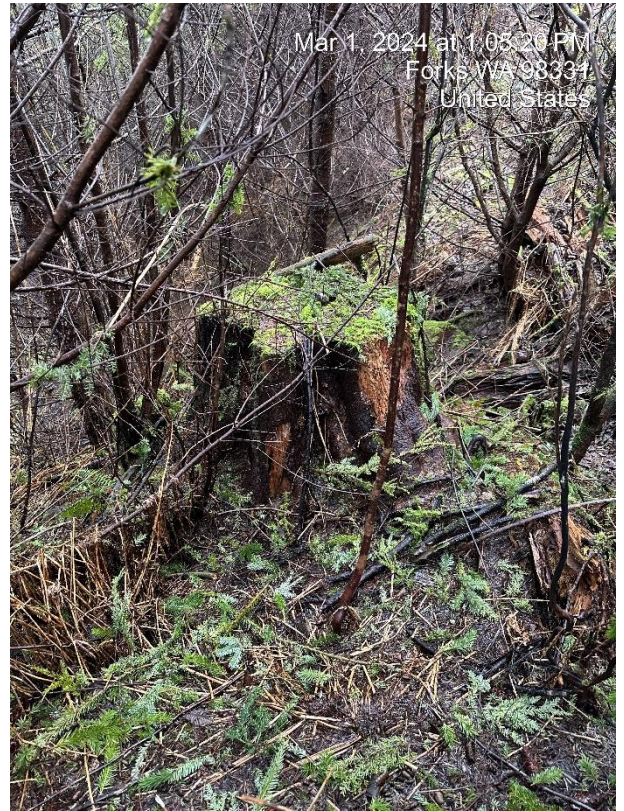
Image 4. Upright second growth stump on head of slide

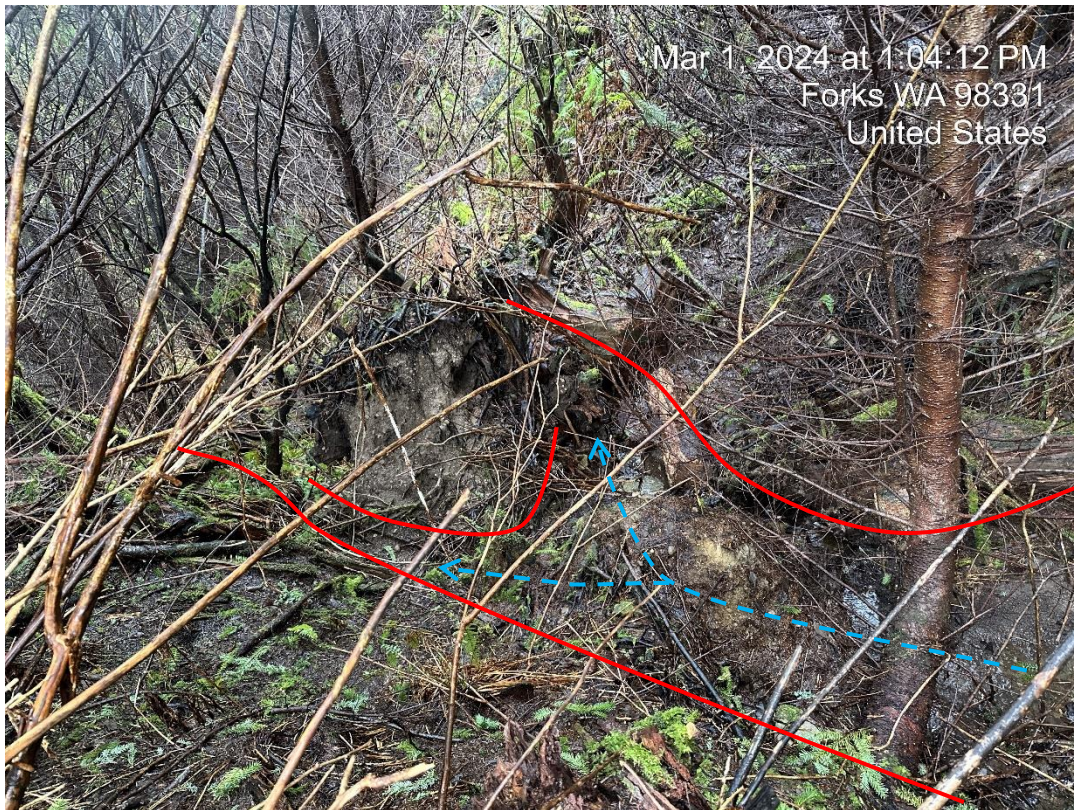
Image 5. Channel and flow path draining from upland over crown of slide

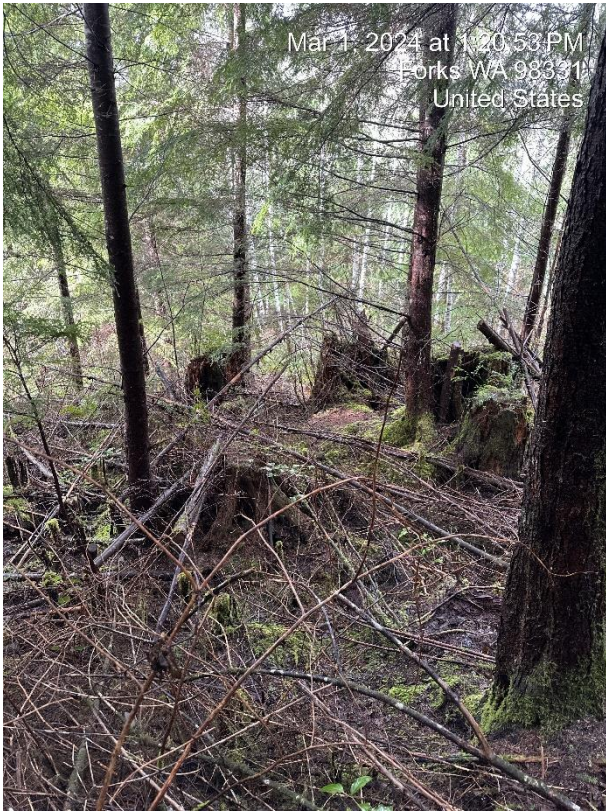
The presence of upright old growth stumps observed on the landslide deposit and a lack of other field evidence that would indicate more recent movement, as described above in the “**Site Reconnaissance**” section, further supports the characterization of the landslide as dormant. Based on our review of aerial photographs, timber was harvested from a significant portion of the landslide deposit between September 1952 and July 1955. The age of the harvest provides an age constraint on the most recent movement of the slide deposit. Accordingly, the most recent movement of the landslide deposit, based on available evidence, is likely in excess of 50 years ago.

Image 6. Upright second growth stumps on landslide deposit

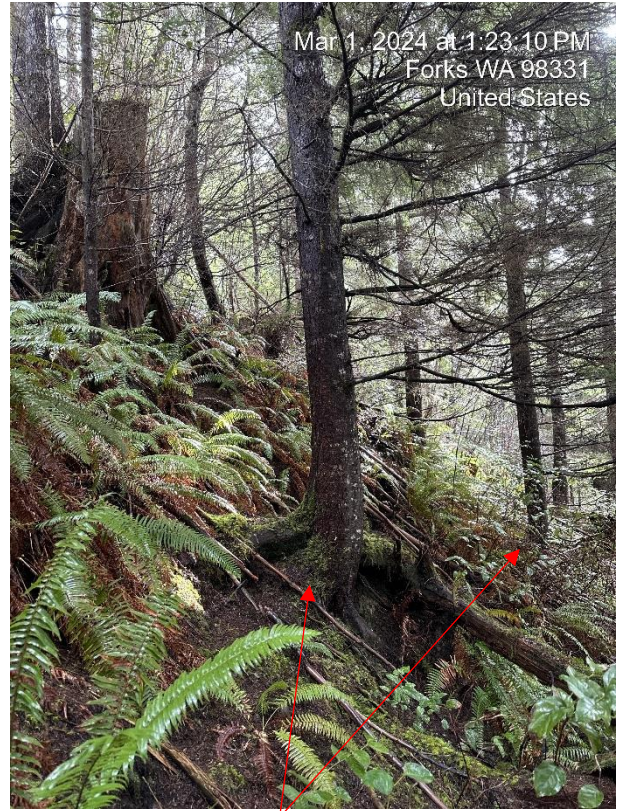
Image 7. Pistol butted immature trees on landslide deposit

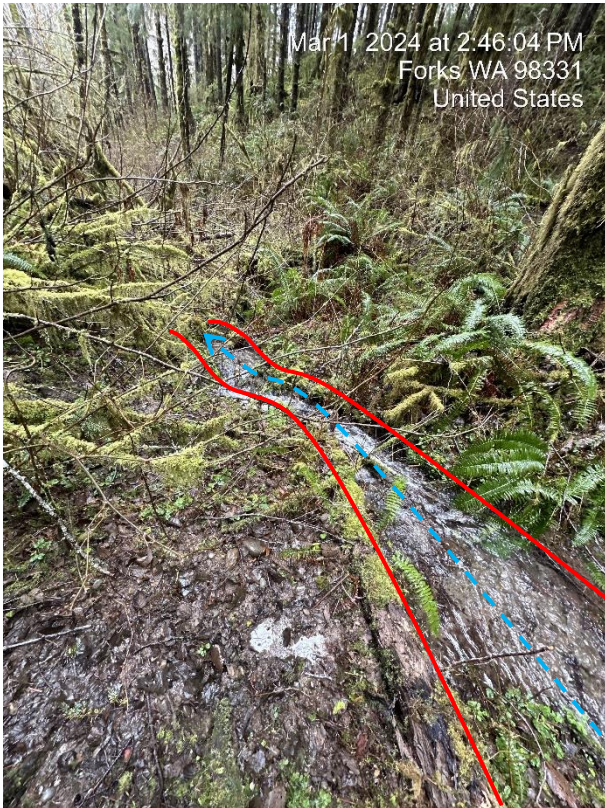
Image 8. Channel and flow path on DNR parcel, downstream from seep zone at approx. el. 360 feet

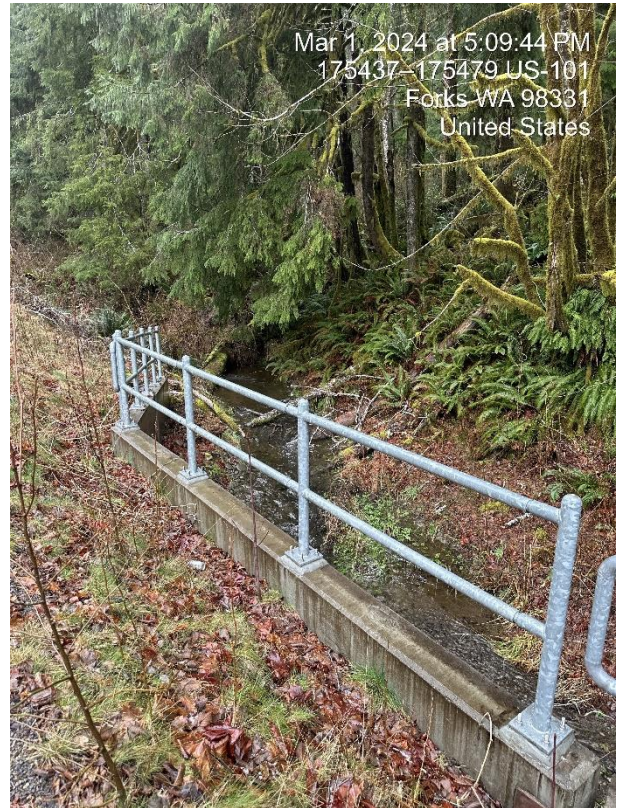
Image 9. Culvert at toe of slope near HWY 101

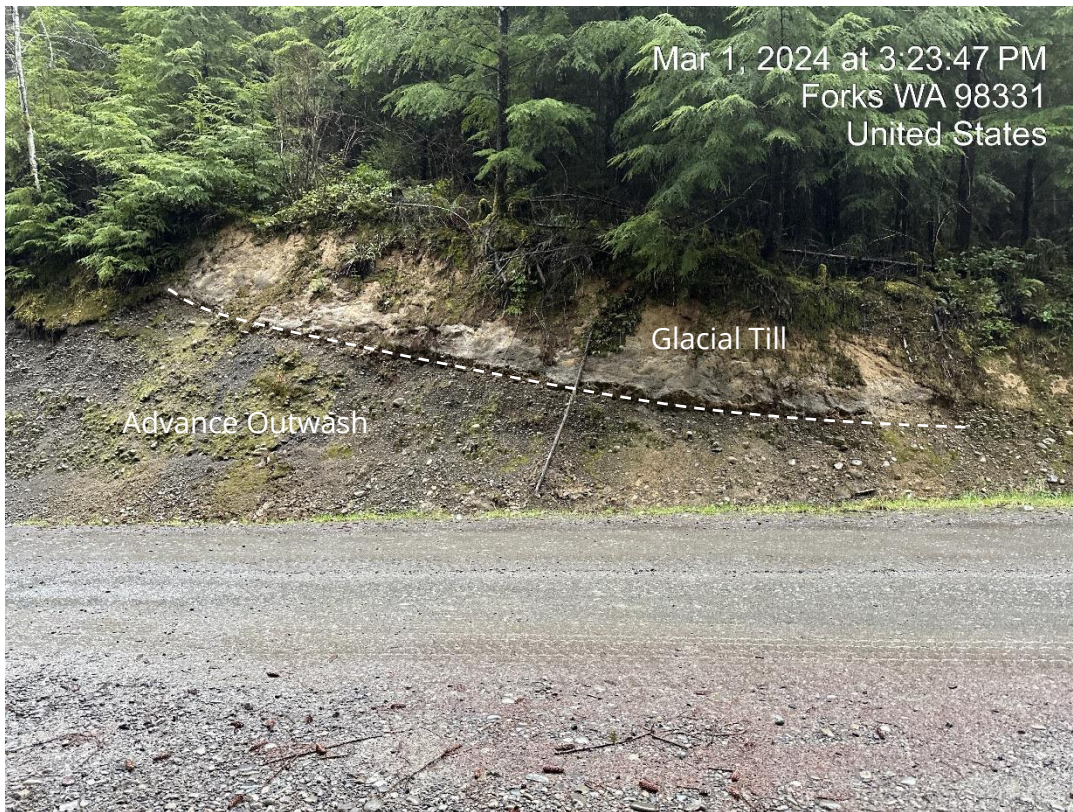
Image 10. Roadcut showing backrotated contact in the head of the landslide
