# Restoration and Monitoring Report Eelgrass (*Zostera marina*) Restoration in Puget Sound, WA

**February 2018**  
**12059-05**

**Prepared by**

Hart Crowser, Inc. and

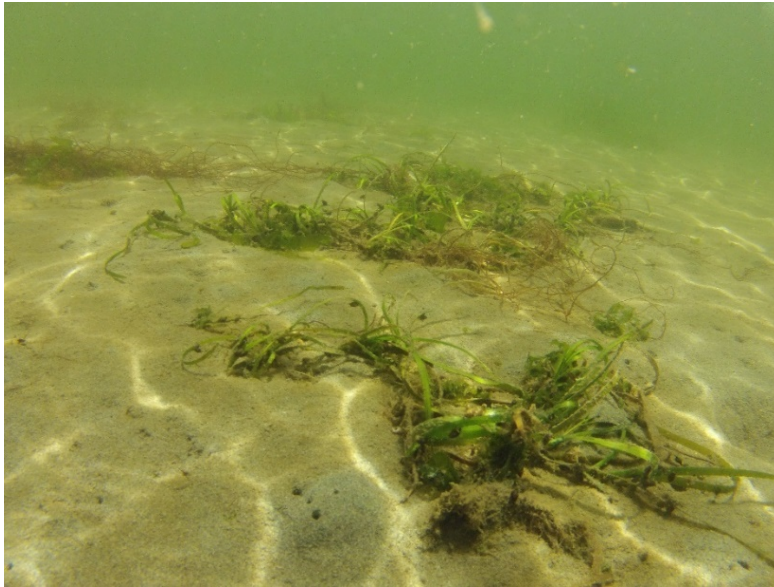
*Photograph 2. Eelgrass test-transplants at Joemma Beach State Park using the burlap strip method (2016)*

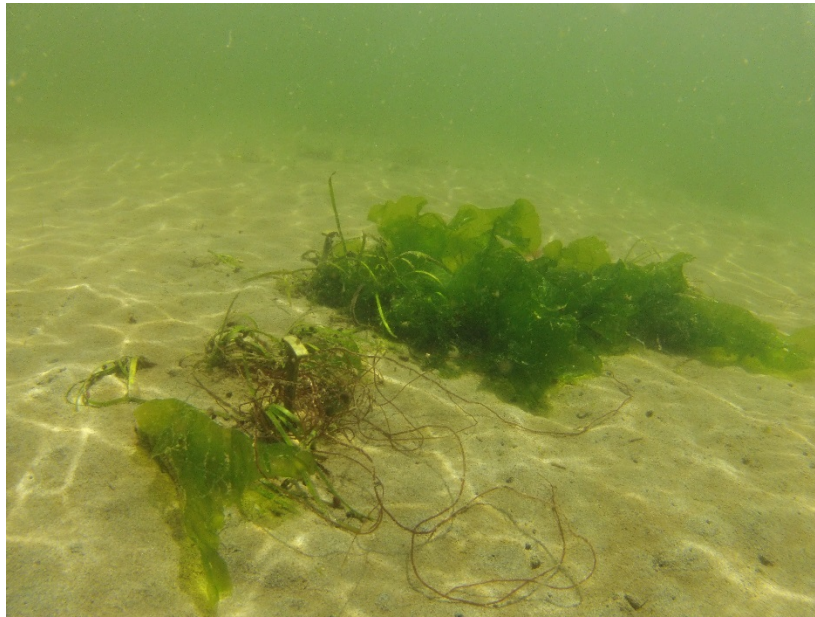
Photograph 3. Visible sod stake accumulating drift algae at Joemma Beach State Park North (2016)

Transplants at Joemma Beach State Park North (2016) did not appear healthy enough to justify a large-scale transplant but the transplanting was not considered unsuccessful. Joemma Beach State Park North (2016) had evidence of tampering and liquefied geoduck harvest holes throughout the area. There was also evidence of drift *Ulva* accumulating on the staples used to hold the burlap strips in place (Photograph 3). To further explore the transplant potential at Joemma Beach State Park North (2016), two additional test-transplant sites were completed in May 2017 (Table 11). All test-transplant sites at Joemma Beach State Park North were monitored in July 2017. Survival at the three sites ranged from 25-44% with an overall average of 34%.

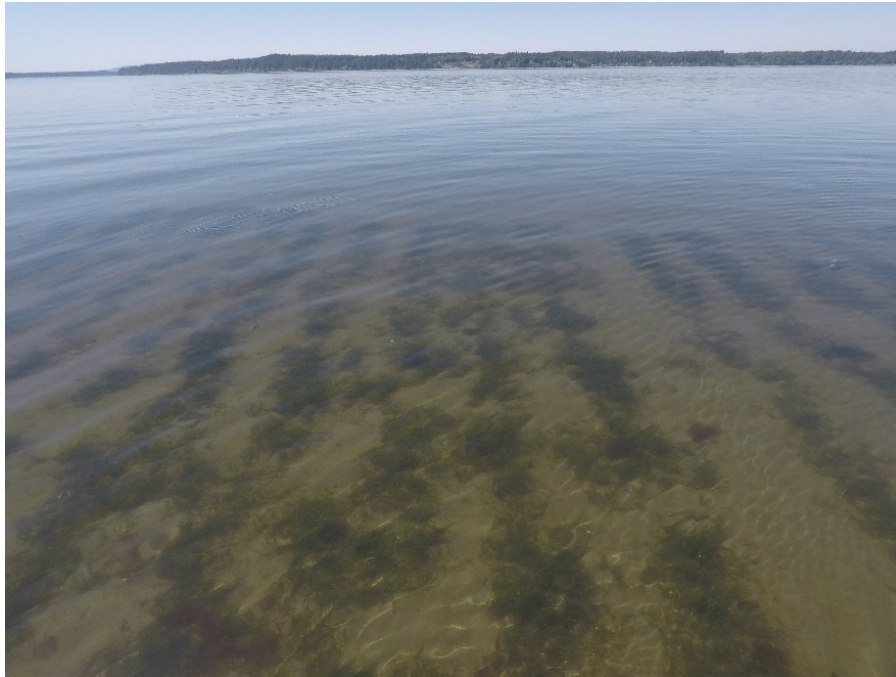
*Photograph 4. Large-scale eelgrass transplant site at Joemma Beach State Park 1 planted in 2016. Original transplant shoot density was 504 shoots  $m^{-2}$  and measured shoot density in 2017 was  $674 \pm 34$  shoots  $m^{-2}$ .*

A quantitative survey of the Joemma Beach State Park 1 (2016) large-scale transplant was completed on June 27, 2017. Thirty-two (32) random 0.25  $m^2$  quadrats were sampled throughout the 160  $m^2$  transplant area. Average shoot density was  $674 \pm 34$  shoots  $m^{-2}$  compared to the original transplant density of 504 shoots  $m^{-2}$ . There was no evidence of eelgrass growing outside the original 160  $m^2$  transplant area but it was clear the eelgrass was expanding and the transplanted rows of plants were coalescing through vegetative growth (Photograph 4).

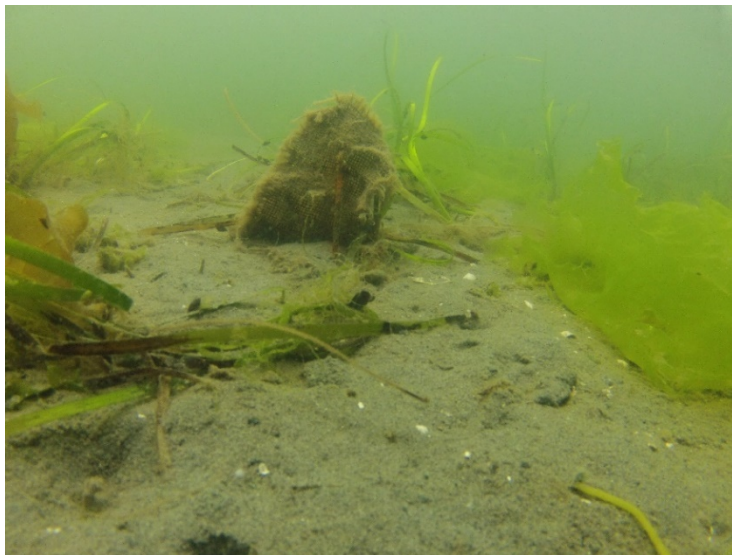
*Photograph 5. Delano Beach 2016 large-scale eelgrass transplant site with evidence of disturbance to the burlap strip planting unit. Photograph taken in July 2016, one month after transplanting.*

A qualitative monitoring effort at the Delano Beach (2016) large-scale eelgrass transplant site was conducted on July 19, 2016. The transplants were present with some evidence of disturbance to the burlap strips and the presence of filamentous algae (Photographs 5 and 6). At the time, the disturbance to the burlap strip planting units and the presence of algae did not suggest major factors that would inhibit transplant success as observed in 2017. In April 2017, the Delano Beach (2016) large-scale site was revisited to determine presence of eelgrass that would support efforts to establish two more large-scale sites for transplanting in 2017. A qualitative assessment in April 2017 found sparse eelgrass and very little presence of algae, typical of early spring conditions. Two additional sites were established for transplanting later in 2017.

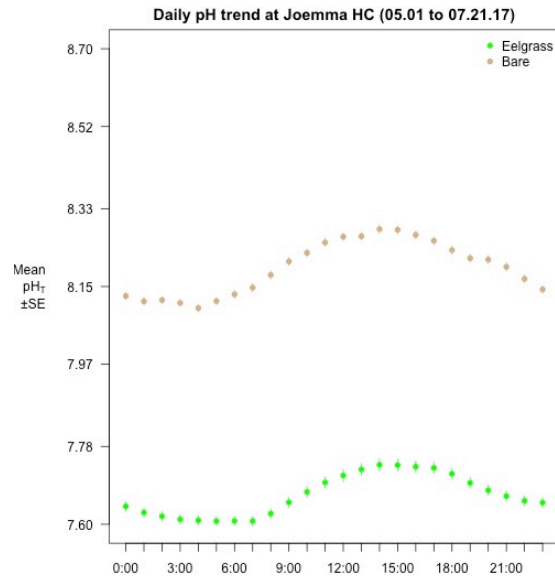
Figure 13. Mean ( $\pm$  se) hourly pH averaged for the period from May 1-July 21, 2017, at Joemma Beach State Park 1. The sensors were deployed in eelgrass at the Joemma Beach State Park 1 large-scale eelgrass transplant site and in an adjacent bare substrate.

The average hourly pH for each deployment period at the two sites at Joemma Beach State Park was inconsistent with expected trends, with more acidic values (lower pH) related to the eelgrass habitat compared to the bare substrate (Figures 13 & 14). In addition, the average daily pH values in eelgrass and bare substrate at Joemma HC and Joemma PNNL were lower than observed values at Delano HC (Figure 12).

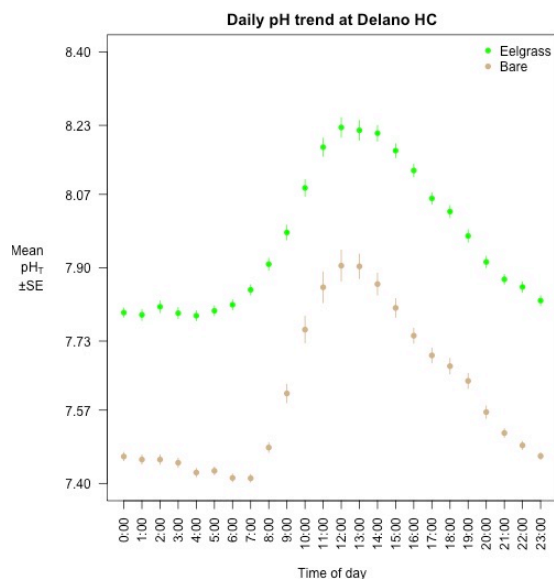
Figure 16. Mean ( $\pm$  se) hourly pH averaged for the period from July 24 – August 19, 2017, at Delano HC (Delano Beach 2016) large-scale transplant site. The sensors were deployed in eelgrass at the Delano Beach 2016 large-scale transplant site and in an adjacent bare substrate.

The second pH sensor deployment extended from July 24 through August 19, 2017, and all sensors functioned properly. The average hourly pH for each deployment period at Delano HC, Joemma HC and Joemma PNNL in eelgrass and bare habitat types was consistent with expected values with the observed pH values in eelgrass were consistently higher than in bare habitats (Figures 16, 17, & 18).

Preliminary results suggest that eelgrass beds may influence local water chemistry due to high amounts of photosynthesis (Figures 12, 16, 17 & 18), but the results were not consistent across the sites during the May through July sampling (Figures 13 & 14). Surprisingly, the site with the greatest observed difference in pH between habitat types during both periods of photosynthesis and respiration was Delano HC (Delano Beach 2016), a site that had very little eelgrass at the beginning of the deployment and none at the end (see section 4.3.2). It is possible that a green algae bloom around the pH sensor deployed in eelgrass at this site triggered a response in pH similar to the presence of eelgrass (Van Alstyne et al. 2015). To improve data quality, minimize lost data due to sensors malfunctioning and improve data uncertainty, future deployments should consist of multiple sensors at the each site with routine cleaning. The addition of dissolved oxygen (DO) sensors could provide a proxy for photosynthesis in the eelgrass compared to bare substrate.

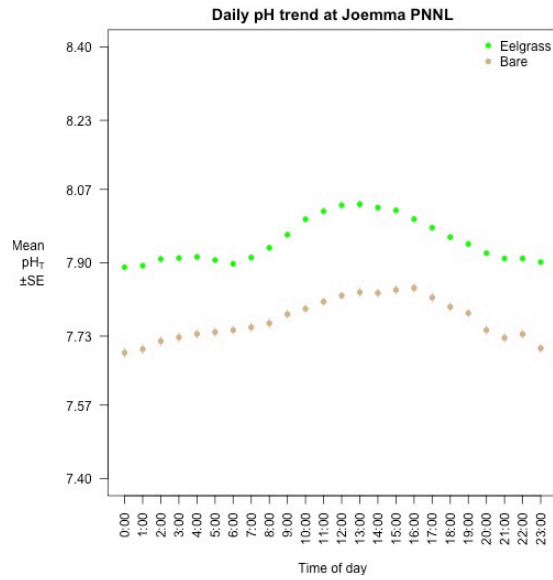
Figure 18. Mean ( $\pm se$ ) hourly pH average for the period from July 24 – August 19, 2017, at Joemma PNNL (Joemma Beach State Park 2013 test-transplant site). The sensors were deployed in eelgrass at the Joemma Beach State Park 2013 test-transplant site and in an adjacent bare substrate.

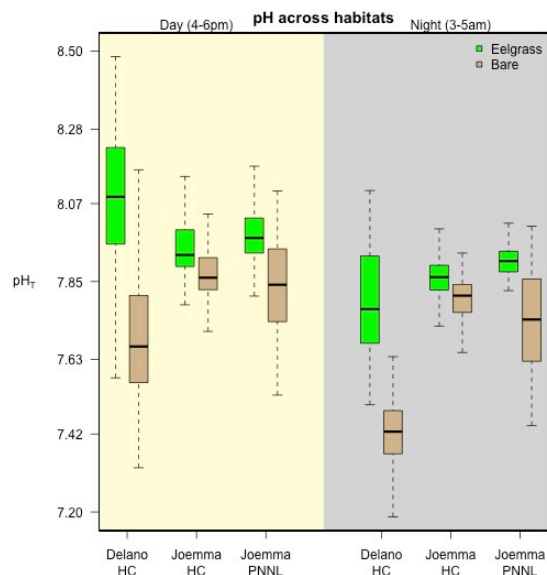
Figure 19. pH across eelgrass and bare habitat from July 24 through August 19 at three eelgrass restoration sites (Delano HC, Joemma HC, and Joemma PNNL) during periods of photosynthesis (Day 4-6 PM) and respiration (Night 3-5 AM). Delano HC (Delano Beach 2016) and Joemma HC (Joemma Beach State Park 1) were planted in 2016 as part of this project, and Joemma PNNL was planted in 2013 (Thom et al. 2014).

The average pH values across eelgrass and bare habitat types during periods of photosynthesis (daylight, 4-6 PM) and respiration (nighttime, 3-5 AM) were not significantly different at Joemma HC (Joemma Beach State Park 1) and Joemma PNNL (Figure 19). There was a significant difference in average pH observed between the eelgrass and bare habitat types during the day and night at Delano HC (Delano Beach 2016, Figure 19).

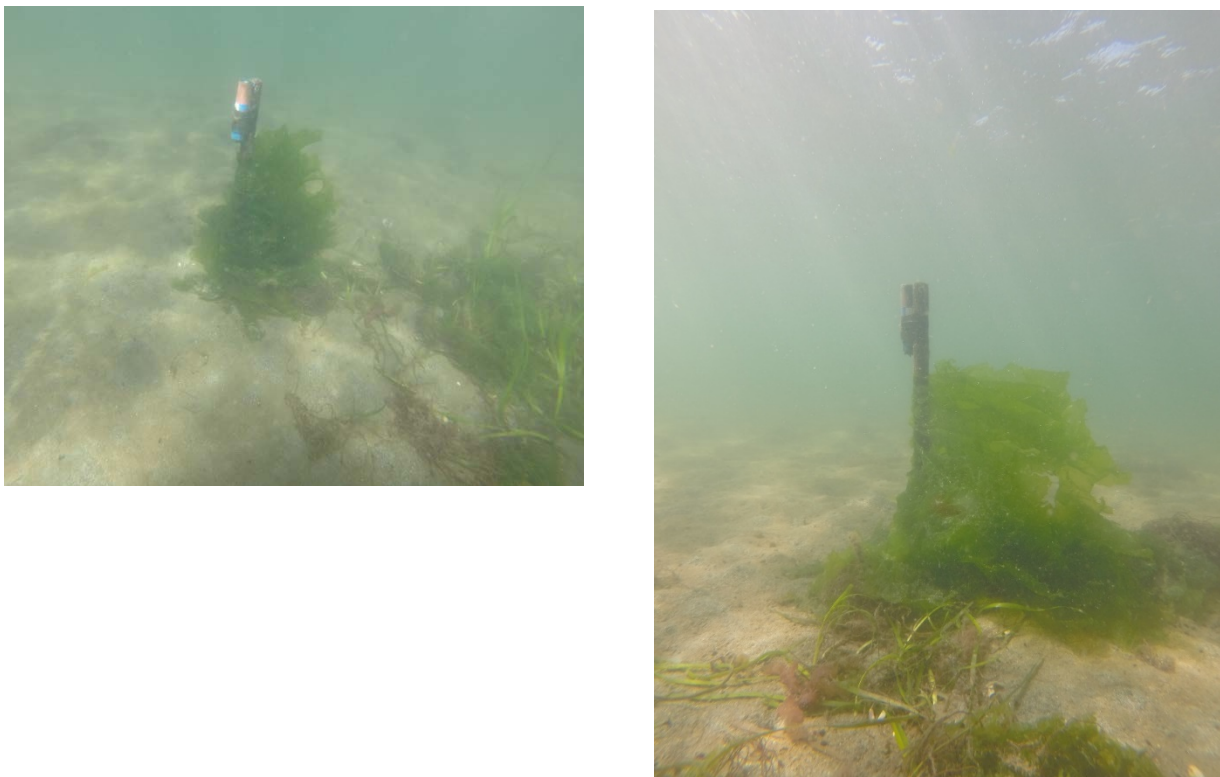
*Photograph 8. Photographs of the PAR sensors that show the bottom sensor fouled by green algae (ulvoids). The low PAR values recorded when a sensor was fouled creates an unrealistically high attenuation value ( $K_d > 5$ ).*

mol m<sup>-2</sup> d<sup>-1</sup>) values and is likely a result the bottom sensor fouled with algae (Photograph 8). With the exception of the last two weeks of sensor deployment (July 3 - July 20), light attenuation was typically below 2 K<sub>d</sub> m<sup>-1</sup>, with most values closer to 1 K<sub>d</sub> m<sup>-1</sup>. The light attenuation coefficient values (K<sub>d</sub> m<sup>-1</sup>) observed are within the range of values calculated in other eelgrass meadows throughout its range (Dennison et al. 1993).

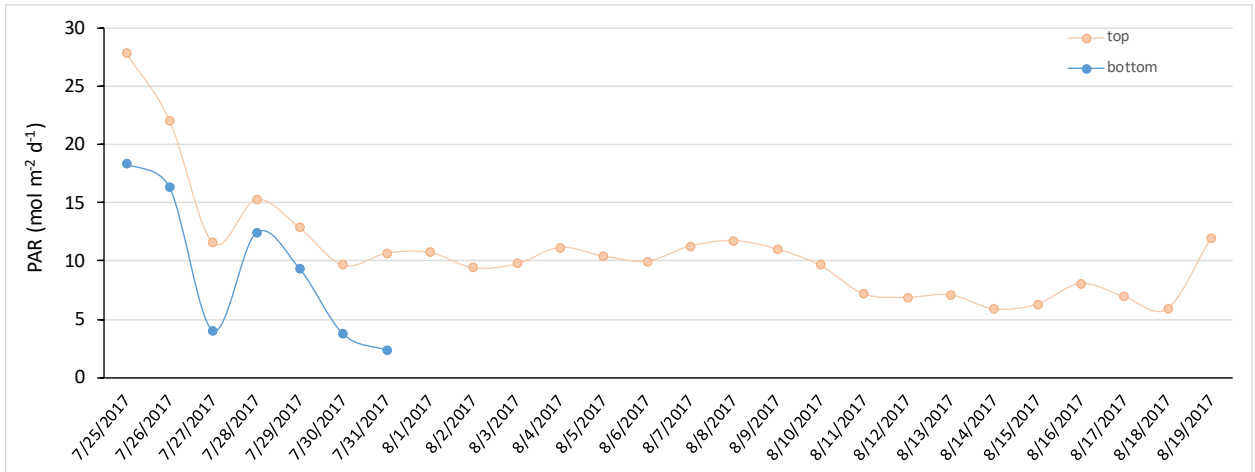
Figure 25. Photosynthetically Active Radiation (PAR) measured 15 cm (bottom) above the sediment surface between July 25 to August 19, 2017, at an eelgrass test-transplant plot at Joemma Beach State Park. The bottom sensor failed to record data consistently after July 31, 2017, therefore, these data are not presented.

For the seven (7) days the bottom sensor recorded data during the second deployment at Joemma Beach State Park, PAR values were in excess of the minimum light requirements (3 mol m<sup>-2</sup> d<sup>-1</sup>). On last day (July 31), the average daily PAR was 2.3 mol m<sup>-2</sup> d<sup>-1</sup>, however, this low reading could be an anomalous reading due to a faulty sensor. Prior to July 31, the bottom sensor recorded PAR measurements from as early as 5:30 AM through 9:15 PM. This period of light was also observed in the data recorded on the top PAR sensor. However, after July 31, the bottom sensor failed to record consistently beyond 11:00 AM.

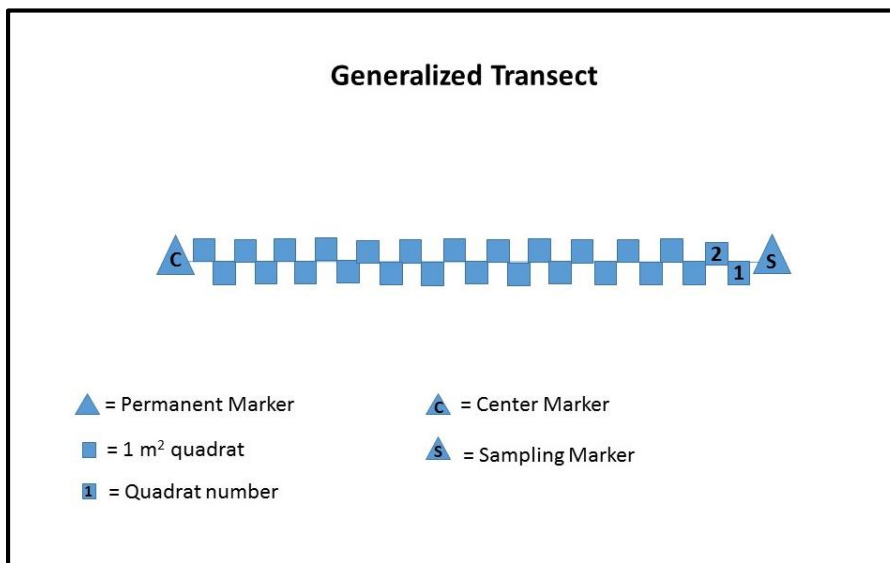
Figure 2 – Generalized monitoring transect placed within harvest portion of donor bed and in control area

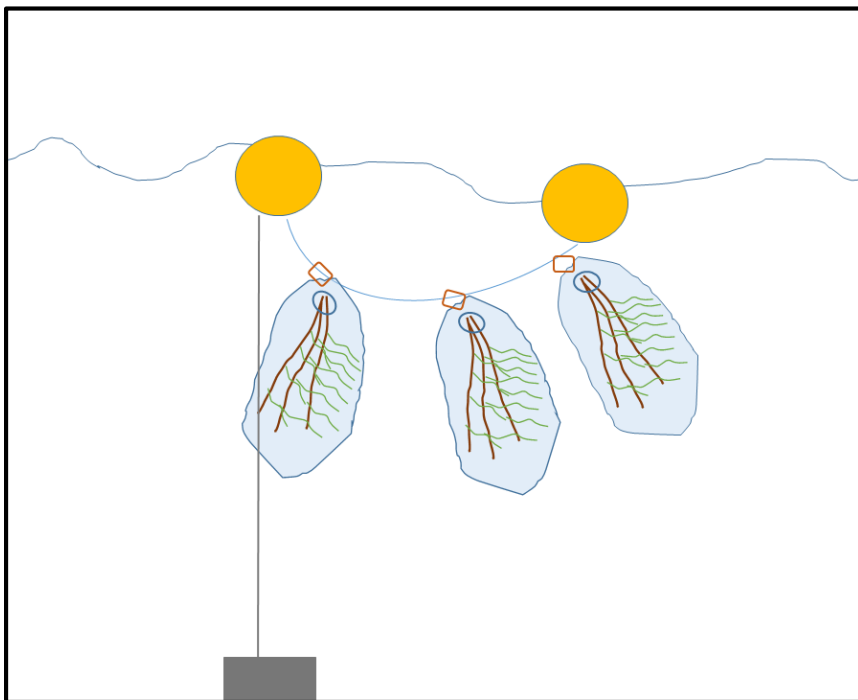
Figure 3 – Buoy system with attached purses and planting units

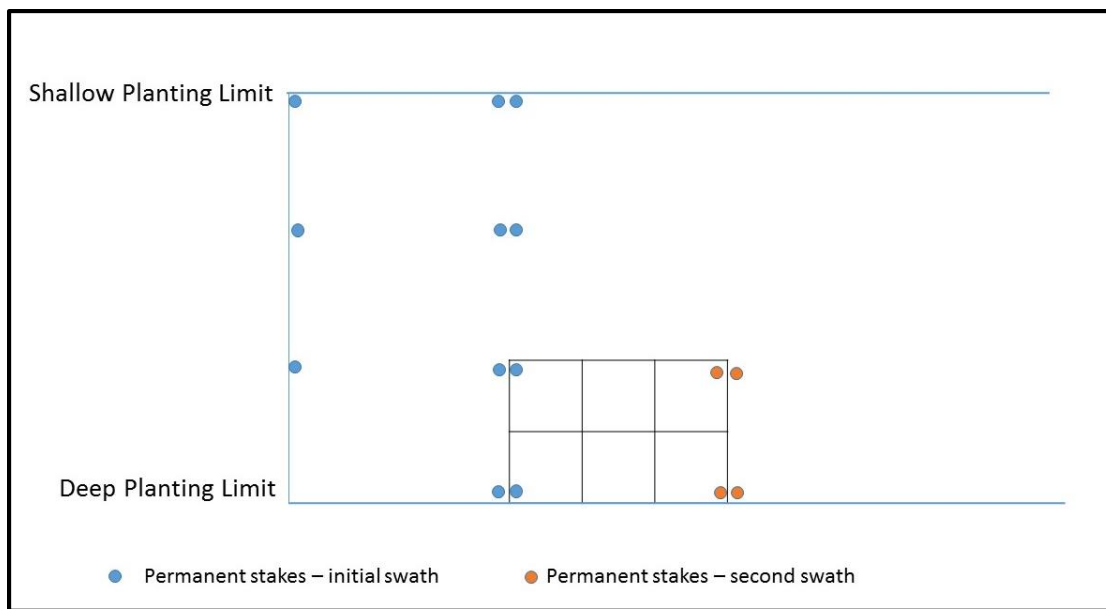
Figure 5 – Transplanting schematic for the second swath

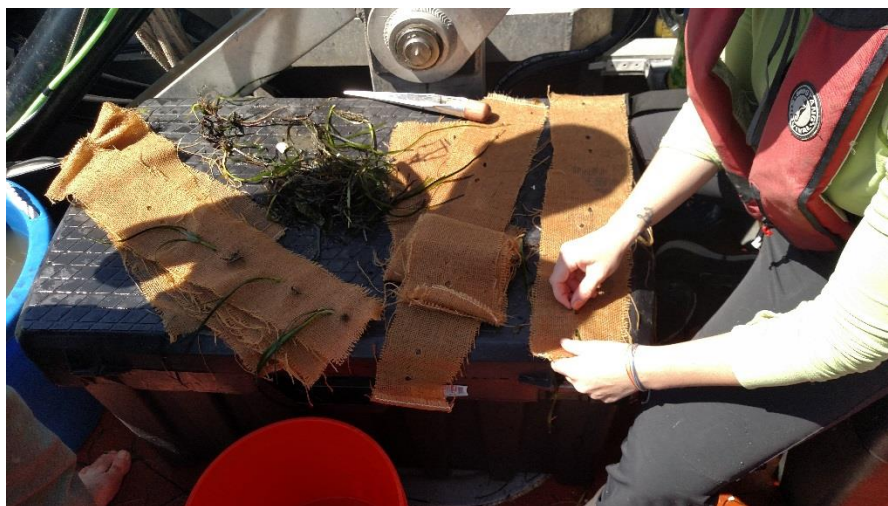
Photograph 1. Creation of a planting unit by weaving eelgrass shoot into burlap strip

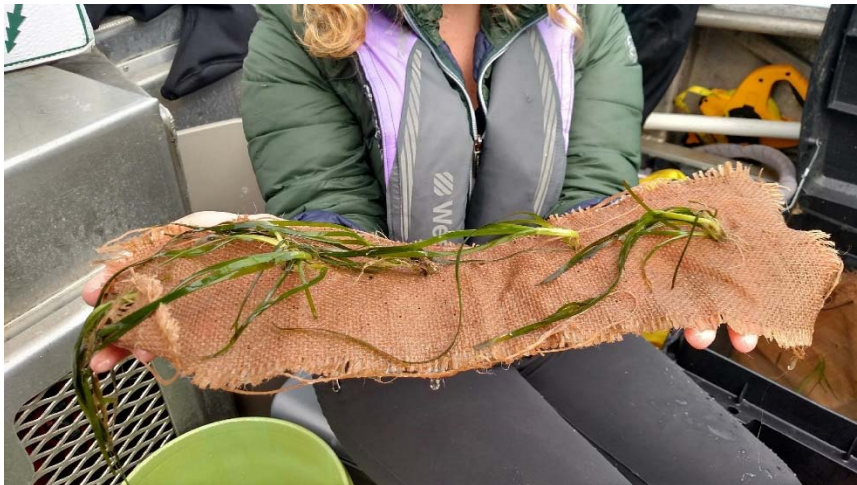
*Photograph 2. Modified installation of eelgrass within burlap – no weave*

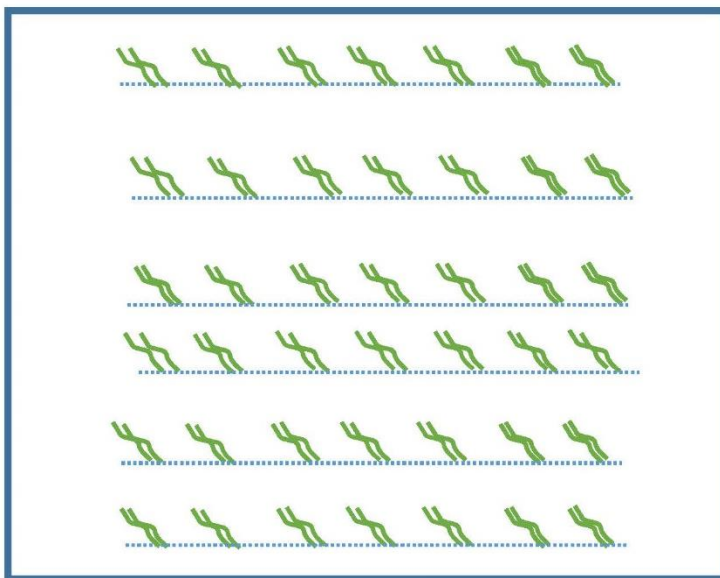
Figure 2. Example of planted 1 meter quad with 6 PU's (strips of burlap with eelgrass)
