# Supplemental Material - Mapping Puget Sound's Artificial Reefs: Identifying Automobile Tires for Removal

*August 16, 2023*

Aquatic Assessment and Monitoring Team  
Aquatic Resources GIS Team  
Aquatic Lands Restoration Program

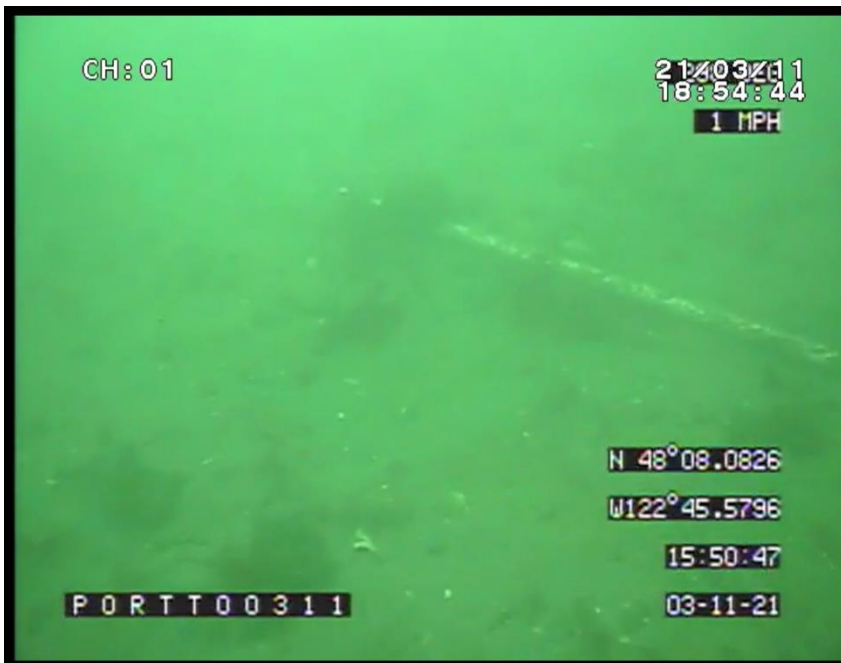
Figure 7. Metal pipe found lying on sediment.

The second most numerous material found at this site were rock piles situated throughout the extent of the delineated reef. The majority of these rock piles were found in the northern portion, where concrete structure was the most abundant. Rock piles ranged in size, from 5 ft. by 5 ft. to 40 ft. by 30 ft. The boulders found in these piles are likely 1-2 person sized or larger (Figure 4 and Figure 5). A few metal poles interspersed within the rock mounds and concrete structures, were observed in the towed video survey, as seen in Figure 7.

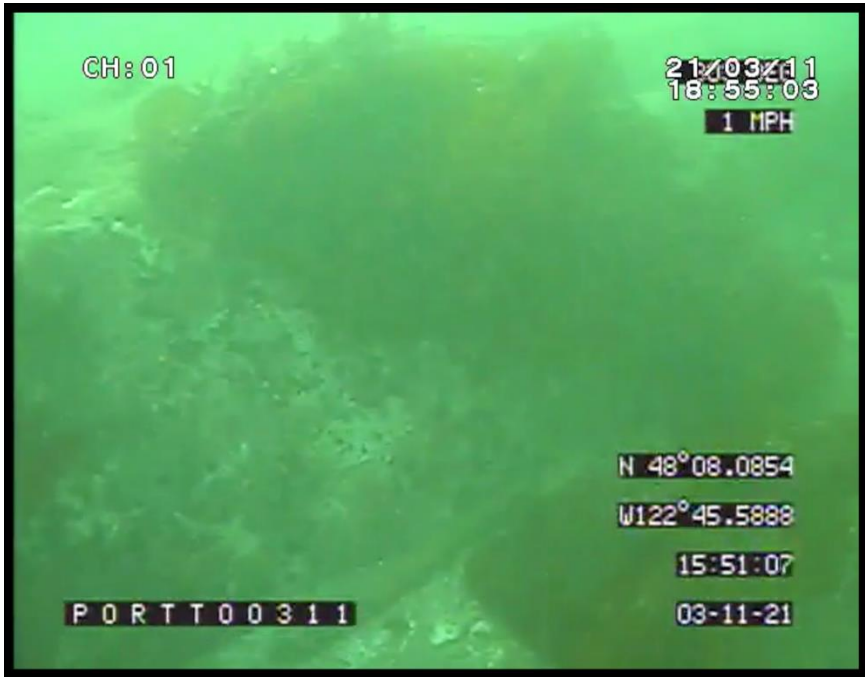
Figure 9. Large rocks found among reef piles at the northern end of the PT Reef.

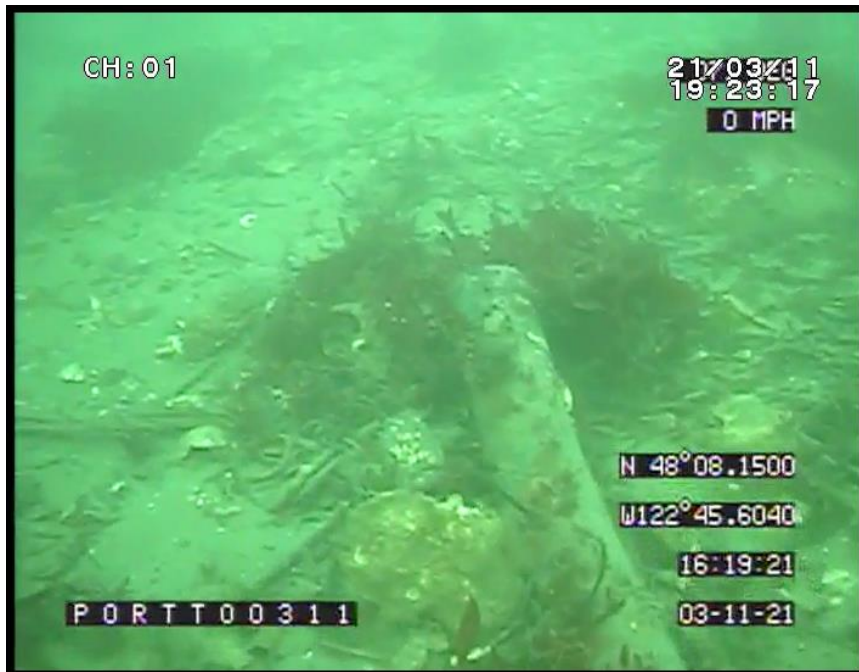
Figure 10. Concrete piling buried in sediment at reef site

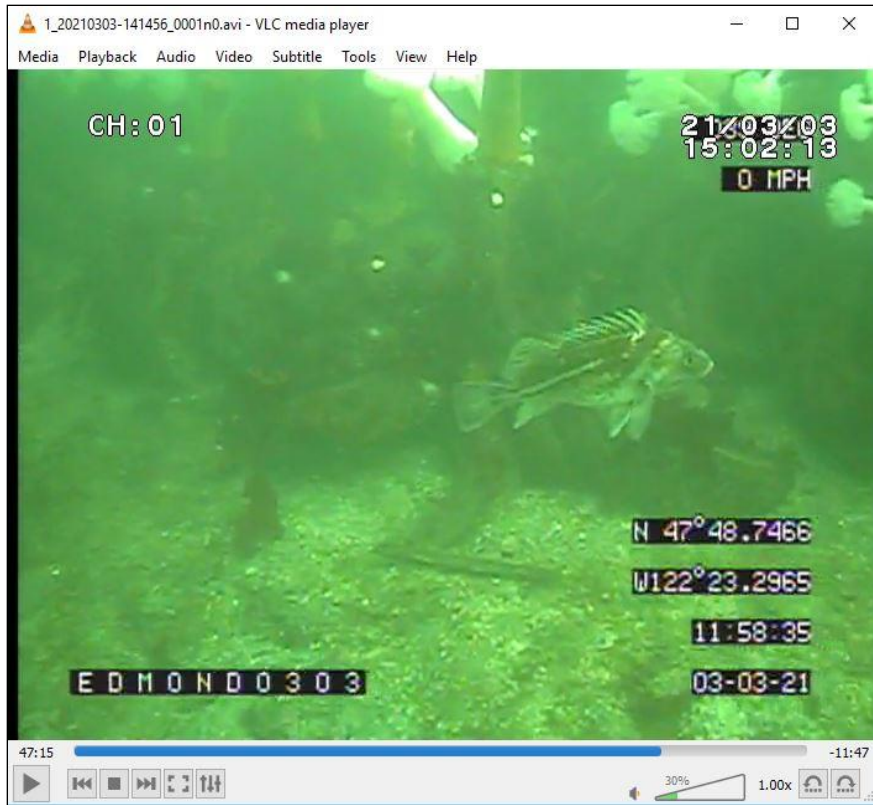
Figure 23. Copper rock fish (*Sebastes caurinus*) among loose piled tires

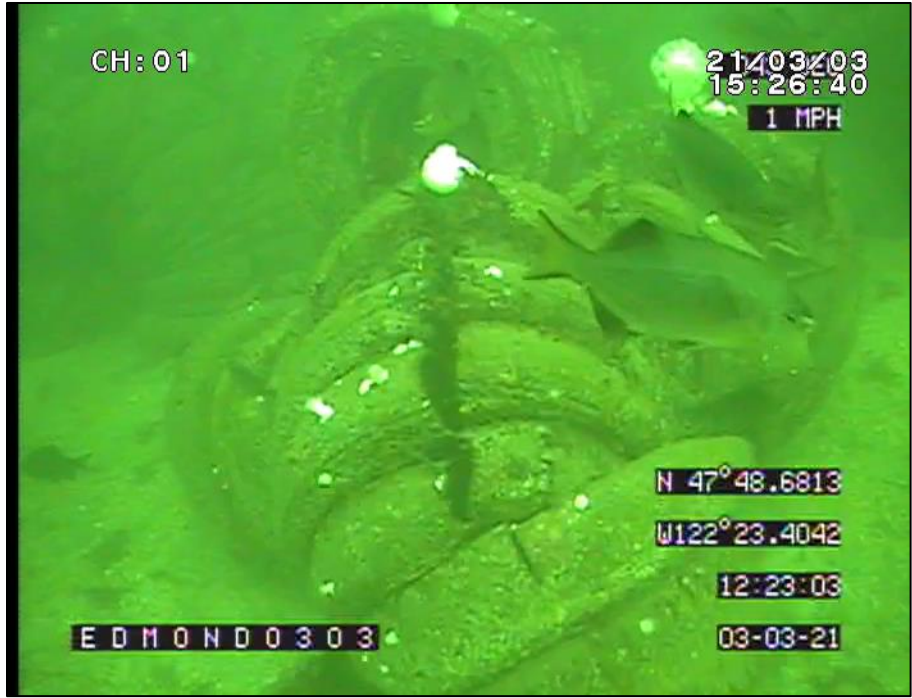
Figure 27. Pile perch observed swimming amongst tires at the site. Air slits are present in many of the tires at the site.

The Edmonds reef includes a variety of different tire features and forms that run approximately 370 meters long and 40 meters wide in front of the Edmonds fishing pier (Figure 15). Many different configurations of tire features have been added over time at this location. Other than the documented grid feature, we found tire feature types at the Edmonds Reef to include loose stacked, horseshoe, and barrel all joined with polypropylene line. The majority of the tires used in this reef appear to be standard passenger car tires. A very large loosely stacked grouping of tires to the north of the gridded feature was composed of tires raised only 10 cm off the surface (likely partially buried) with a footprint of ~400 m<sup>2</sup> (Figure 15 and Figure 16). There were also seven large piles of tires organized in stacks within the middle of the reef which are raised up to 2 m above the seafloor (Figure 16). It is possible that these piles could be stacked 3 to 4 tires high. In addition to these more organized features, it appears that a number of tires have been haphazardly arranged on the seafloor within the larger reef footprint. Features at the south end of the footprint are more spread out and have a higher chance of being mixed within large boulders from the marina jetty (Figure 15). Many of the bottom tires within larger features are partially (up to 50%) or entirely buried (Figure 25 and Figure 28). While some tires remain whole and in good shape, many are cut through the side wall and tread (Figure 27).

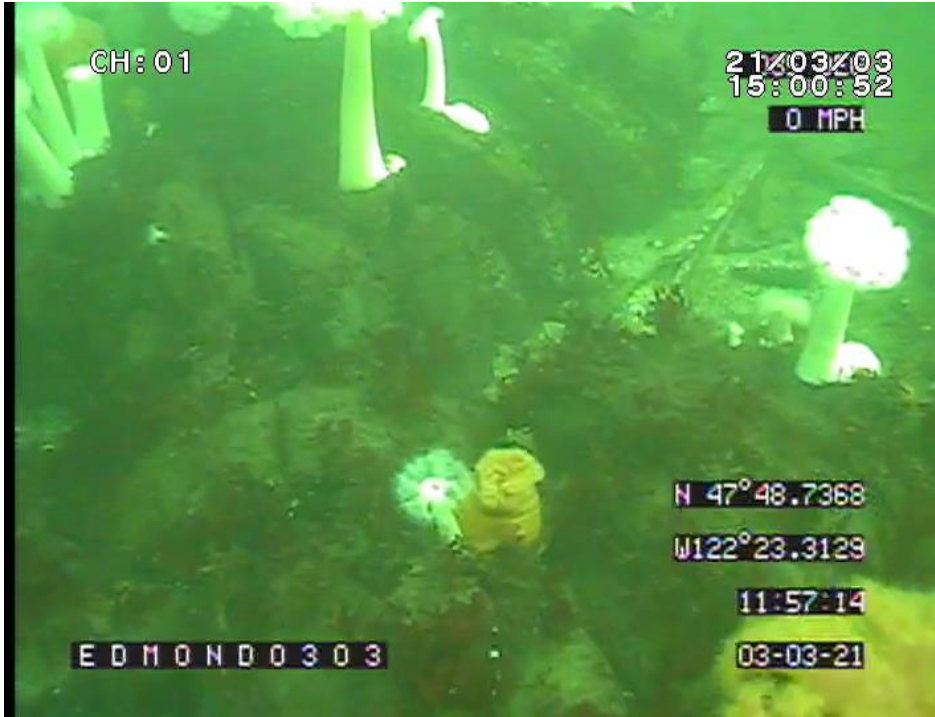
Figure 28. Tires almost completely buried at the Edmonds reef.

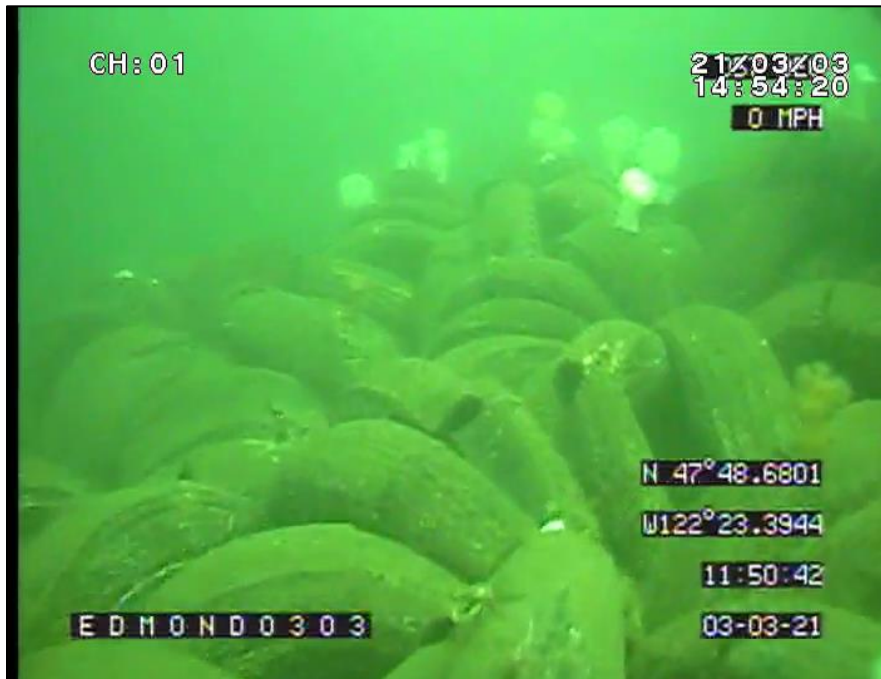
Figure 30. Large loose piled tire feature within the Edmonds tire reef. See Figure 1 for position within the reef.

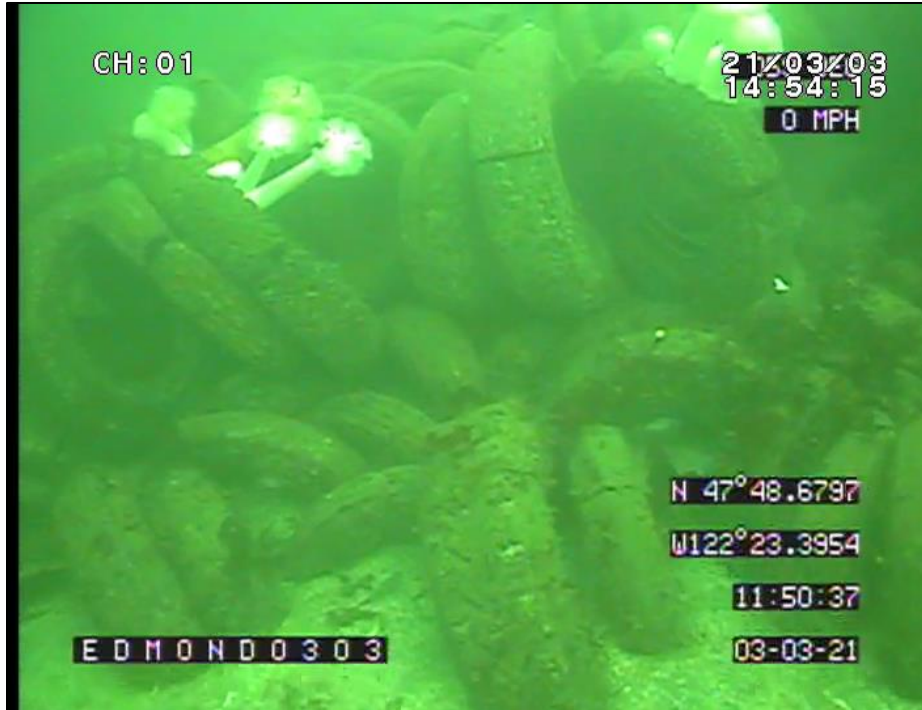
Figure 31. Unorganized tire pile at the Edmonds site. The tires in the bottom row in this feature are buried up to 50% into the sediment.

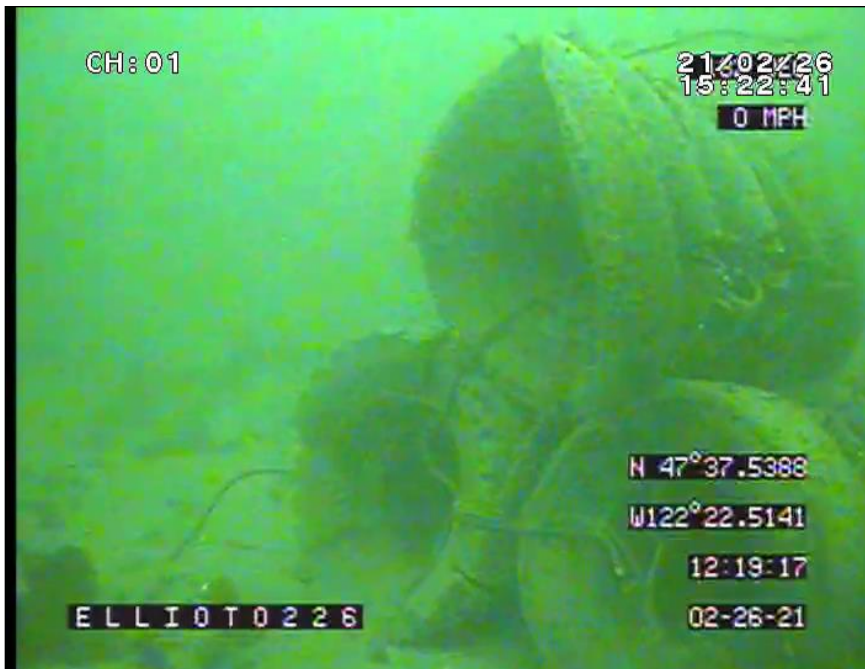
Figure 43. Pyramid of tires at the Elliott Bay site. Line that bands the tires is broken around the tires within this bundle.

The majority of tire features at the Elliott Bay fishing pier reef are barrel joined into rows of 7 to 8 tires and stacked into pyramid configurations with 21 to 24 tires per pyramid. These tires appear in poor condition - many tires have been sliced open upon placement, and tires within barrel groupings have been compressed together over time becoming thinner (Figure 42 and Figure 45). Two main tire groupings to the west and east are separated by a large boulder zone between them (Figure 36). The east grouping of tires is more spread out than the west (Figure 36). Many of the tires at the site were found no more than 10% buried into fine sediment, but some – like those at the bottom of pyramid or barrel features – were found buried up to 20% into the sediment (Figure 38).

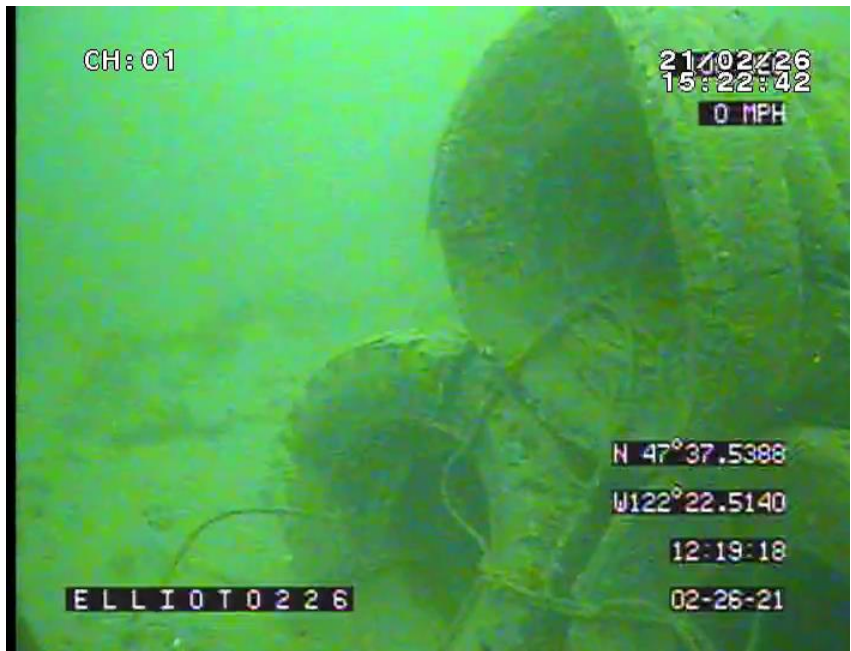
Figure 44. A closer view of broken line around the tire bundles at the site.

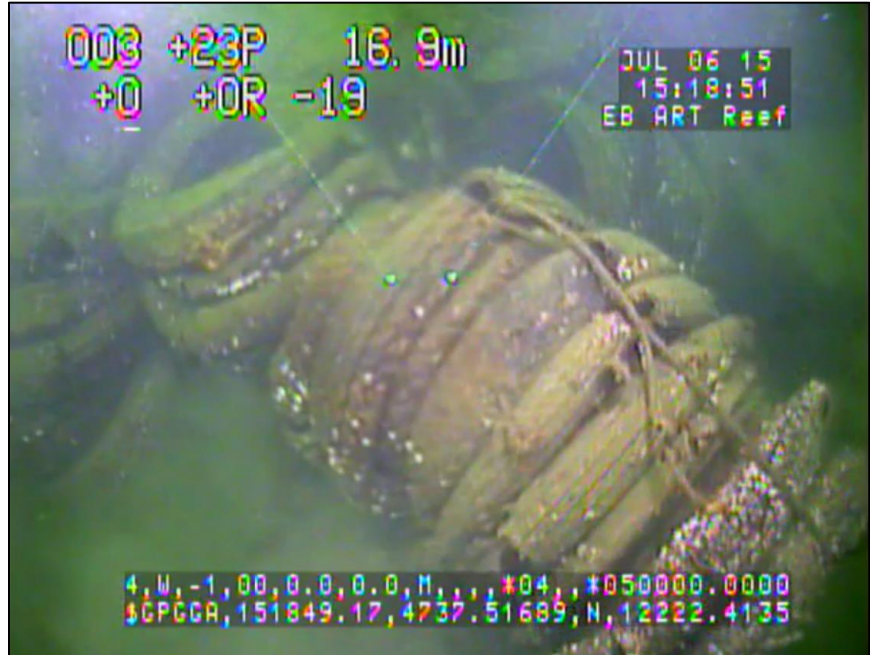
Figure 45. ROV footage from the Department of Fish and Wildlife. A barrel of eight tires is present in foreground.

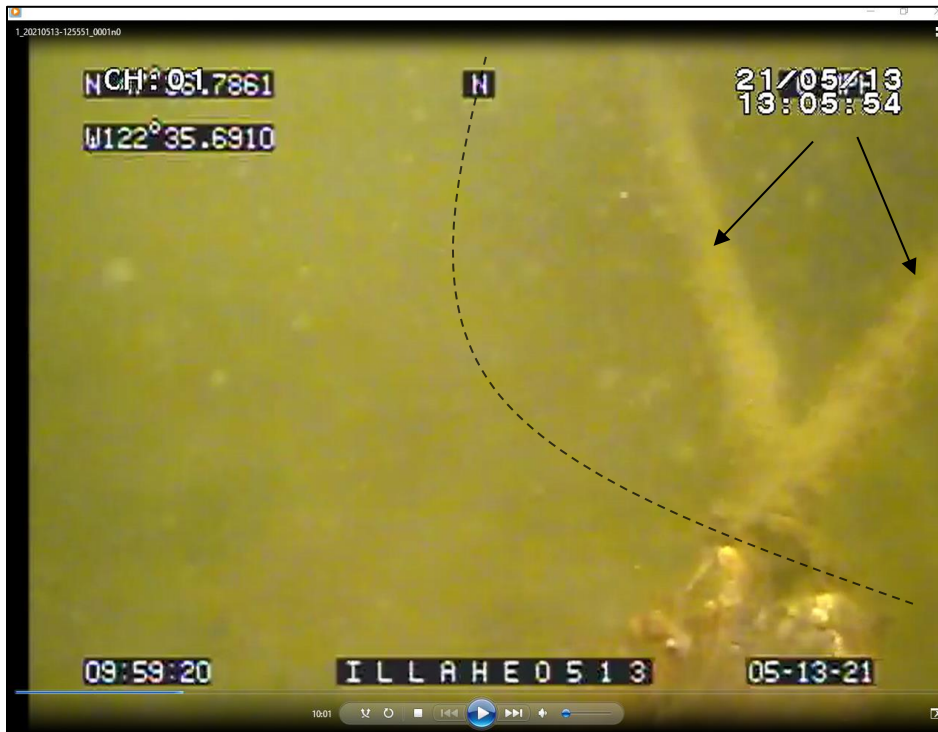
Figure 2. Rope bridal (indicated with arrows) observed attached to a grouping of tires. The nearest tire is delineated with a hashed line.

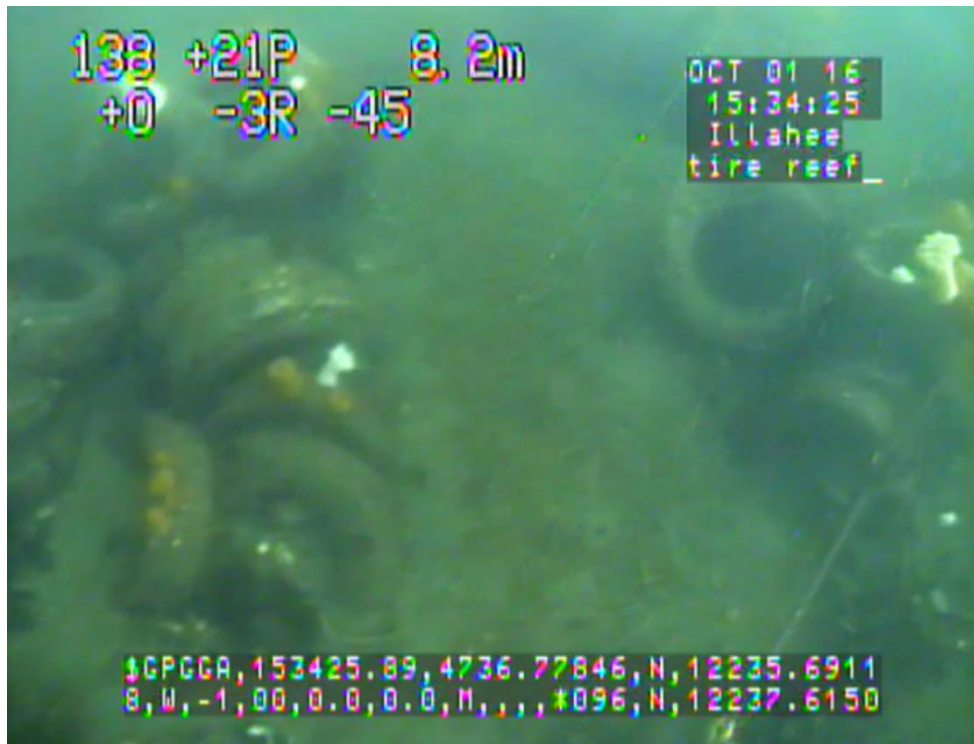
Figure 57. Image from 2016, captured with WDFW ROV. Tires at the site appear to be buried up to 1/2 in fine sediment and strewn haphazardly in loose piles.

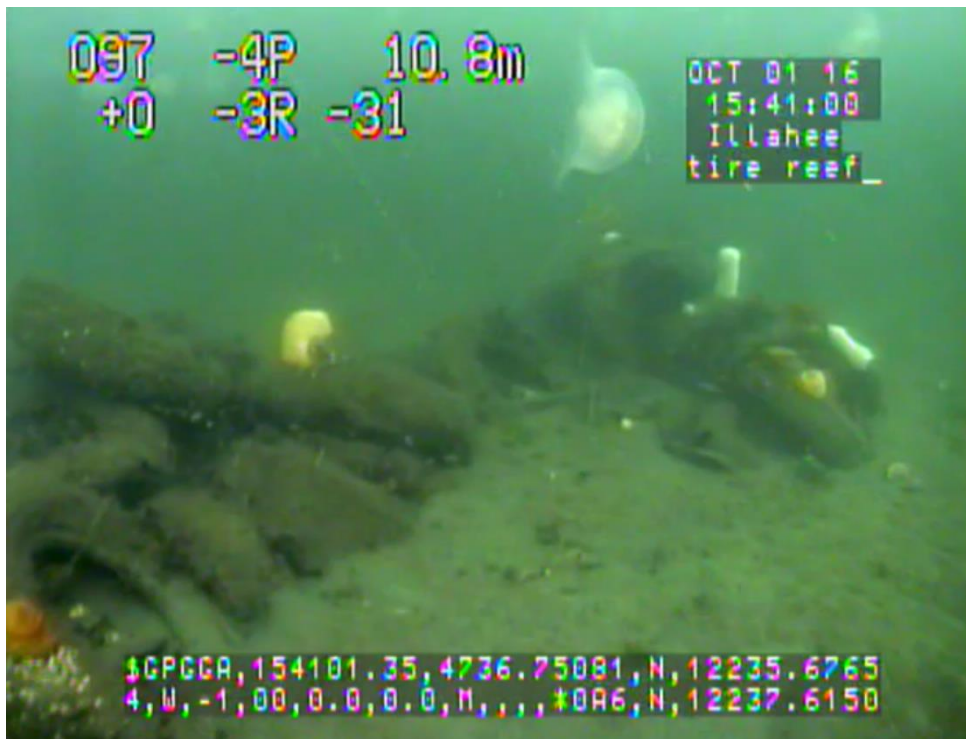
Figure 59. Image from 2016, captured with WDFW ROV. Single layers of tires buried up to 1/2 were present throughout the Illahee reef.

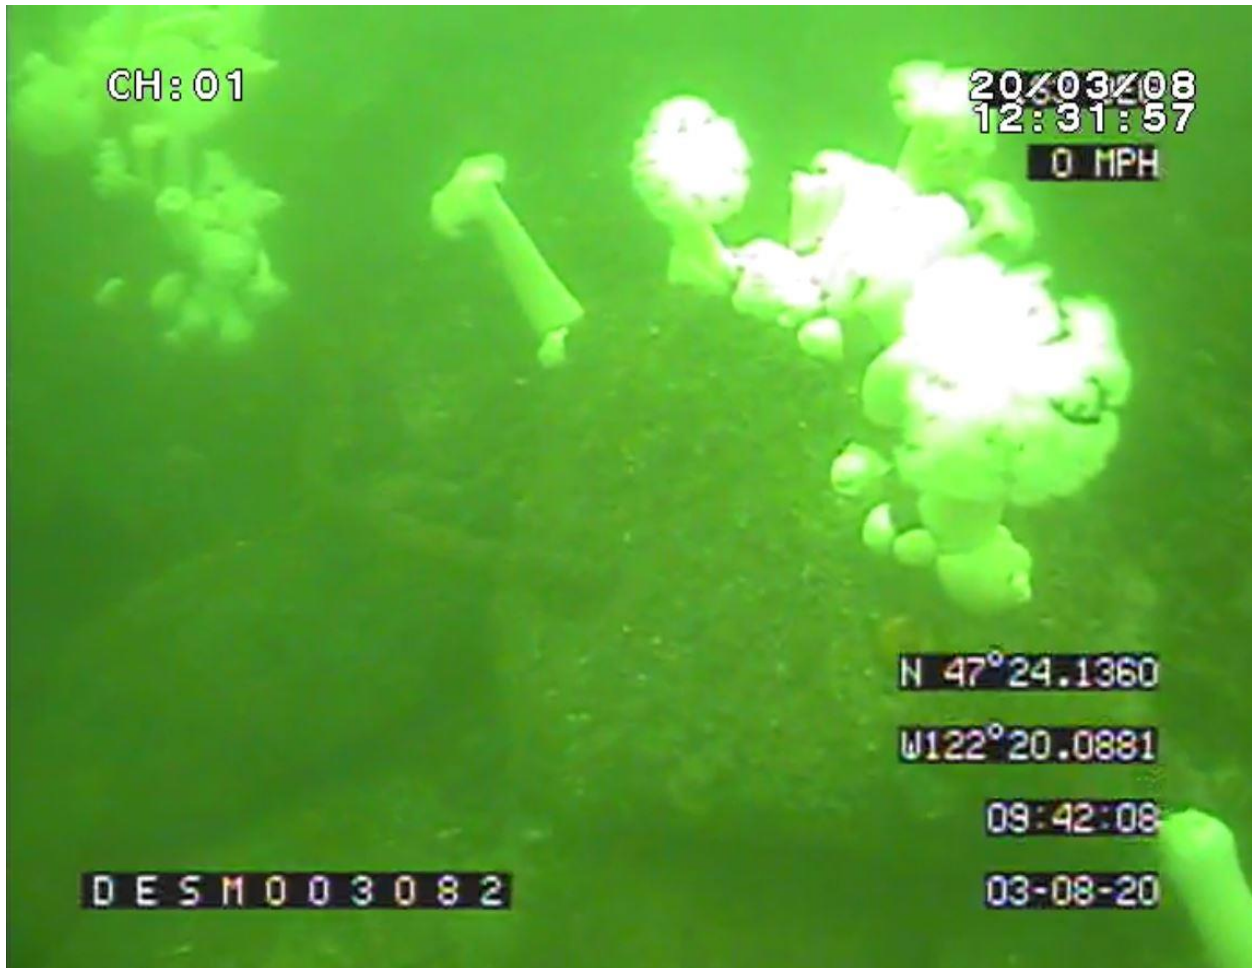
Figure 73. Two person-sized boulders make up many of the boulder mounds found at the Des Moines artificial reef. This photo is from the boulder mound at the Western edge of the reef.

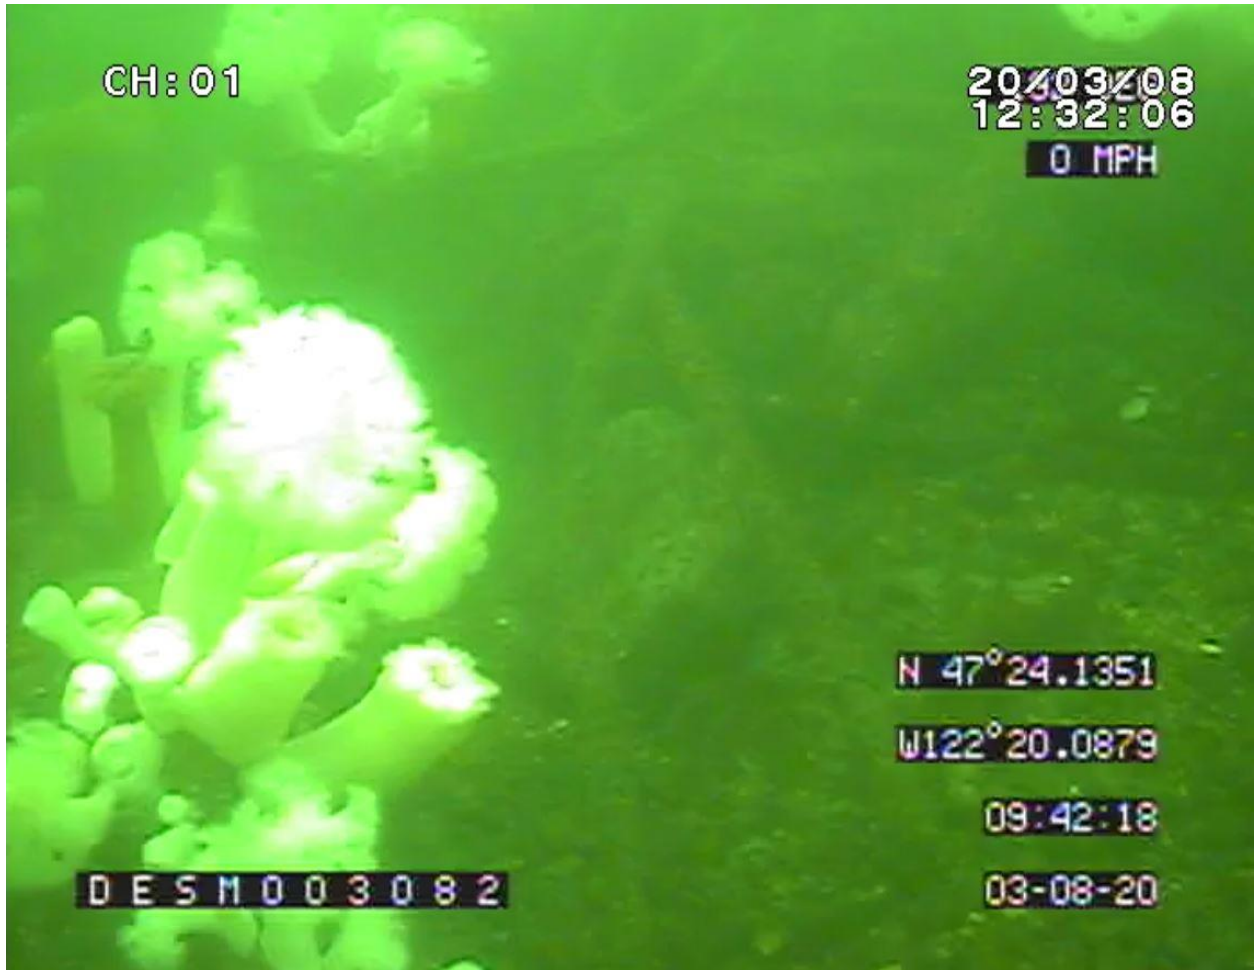
Figure 74. Steel rebar was identified as interspersed throughout the reef. Here it was found lying on the boulder mound at the Western edge of the reef.

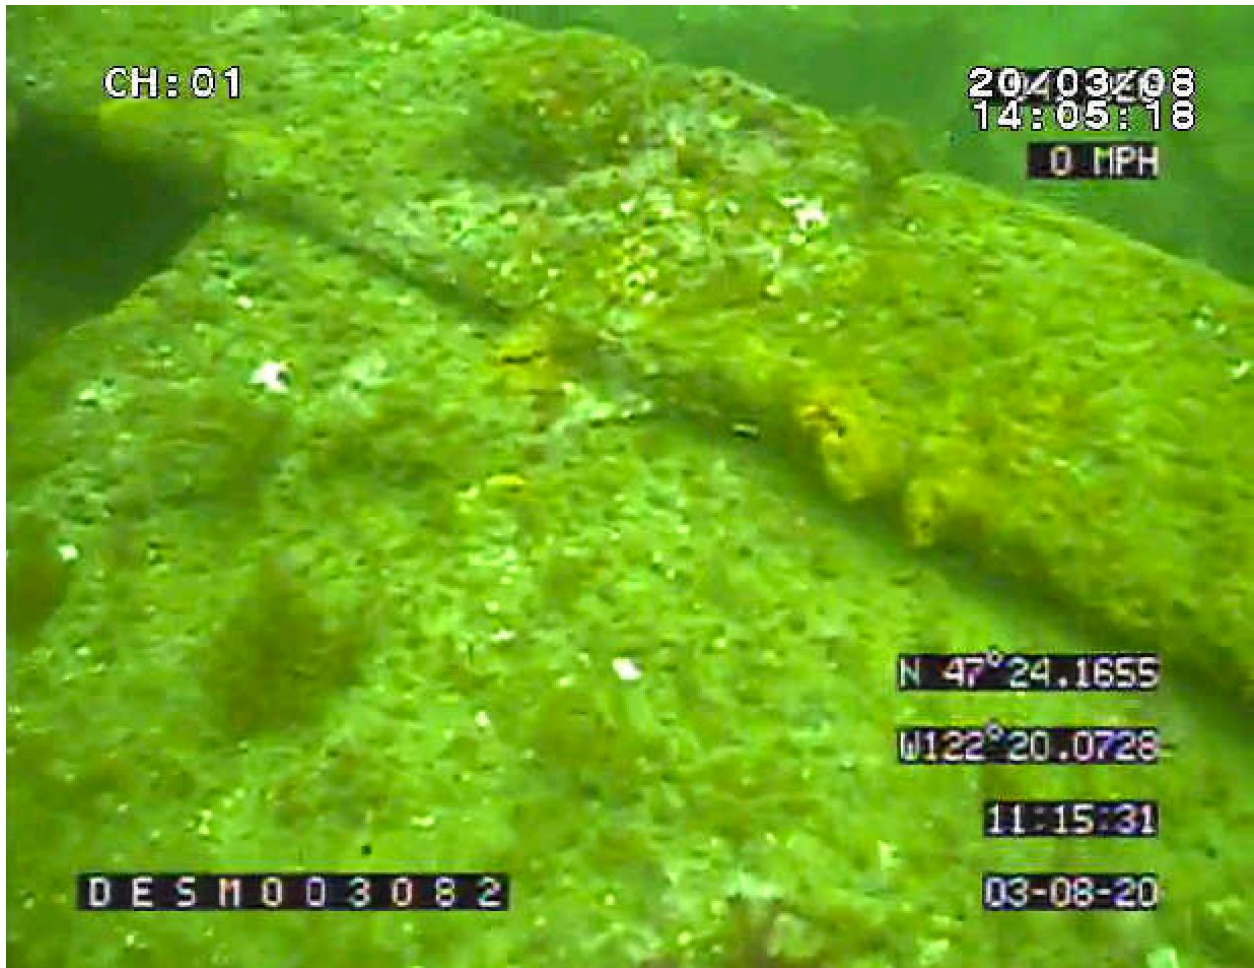
Figure 77. The edge of one of five large concrete or metal dock structures found at the northern portion of the artificial reef (refer to figure 1).

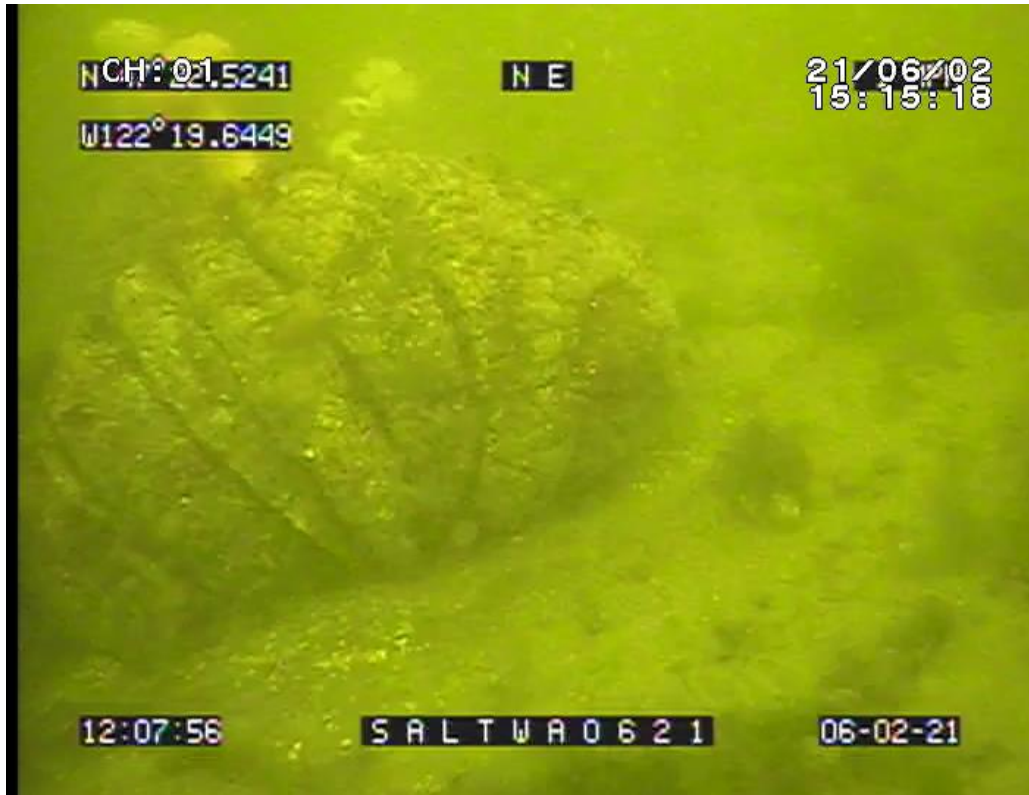
Figure 90. A barrel jointed example of eight tires at the Saltwater State Park reef. Tires at the site are covered by anemones and encrusted with barnacles.

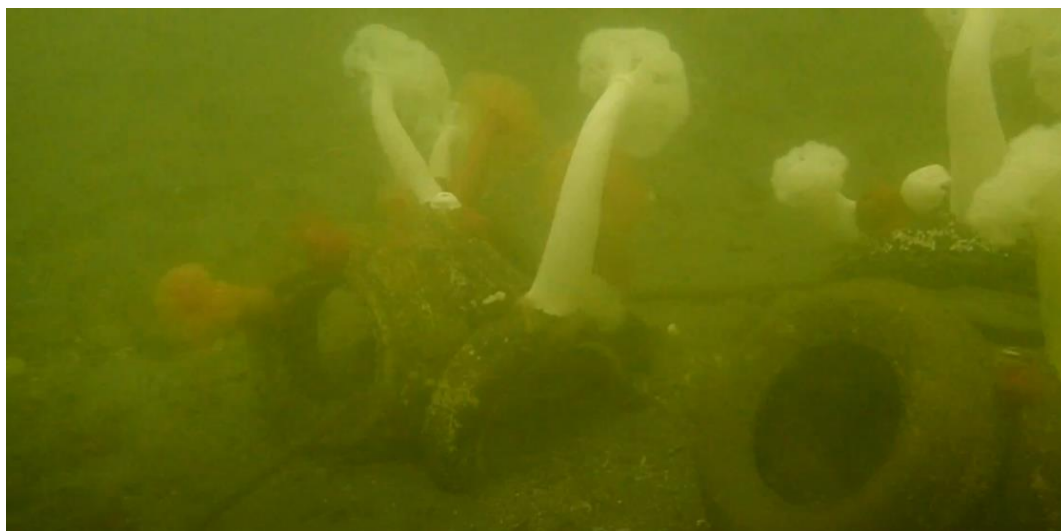
Figure 91. Tires that appear to have broken from their banding, and now lay jumbled and buried up to 1/3 in sediment.

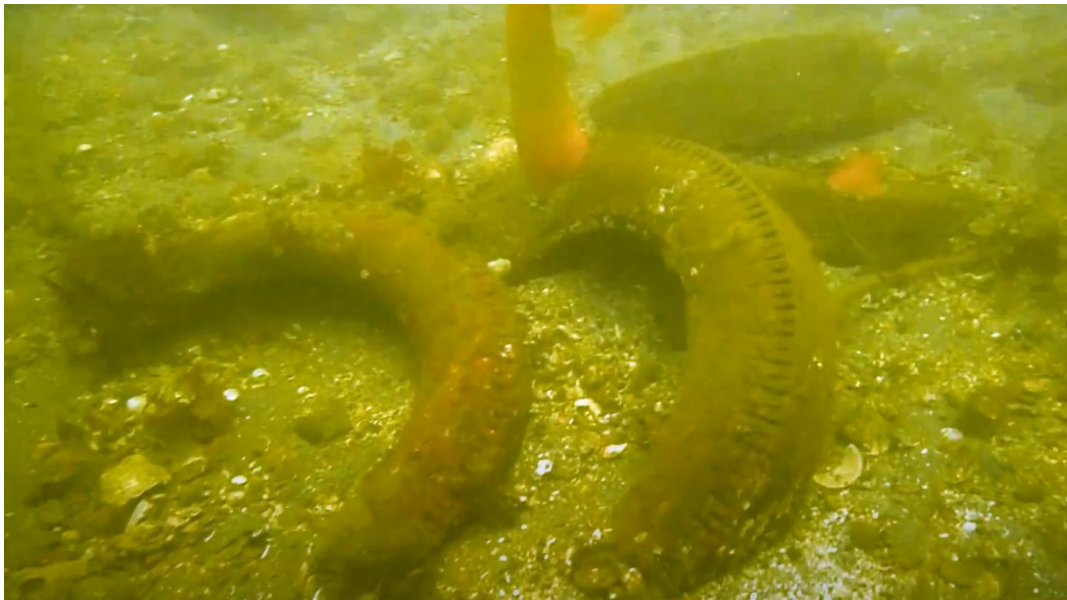
**Figure 95. Degraded and/or buried tires. These tires appear to have broken from their barrel formation long ago.**

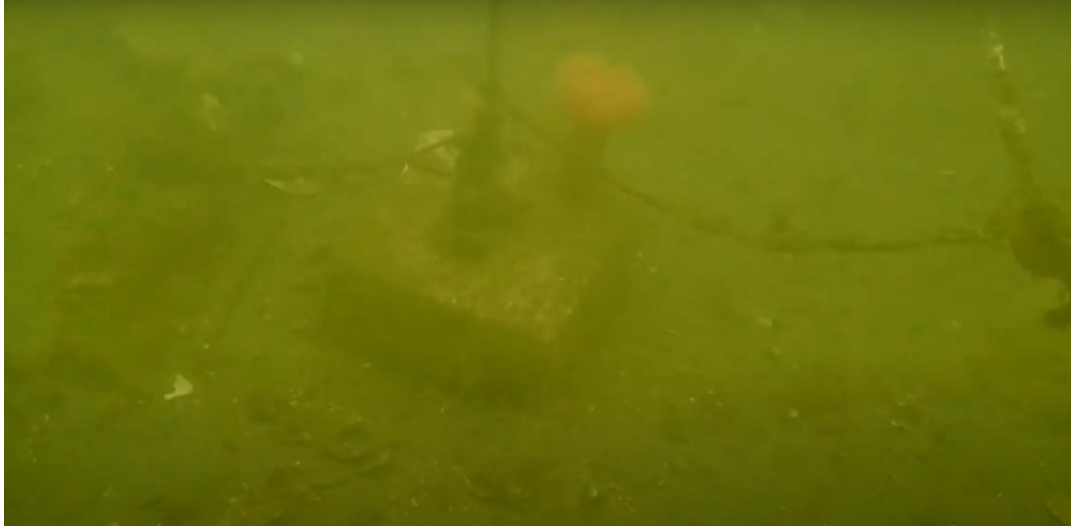
**Figure 96. Concrete anchor found in the vicinity of the tire reef. It is unclear whether this was placed to anchor tires, or as part of a buoy system delineating the corners of the engineered reef.**

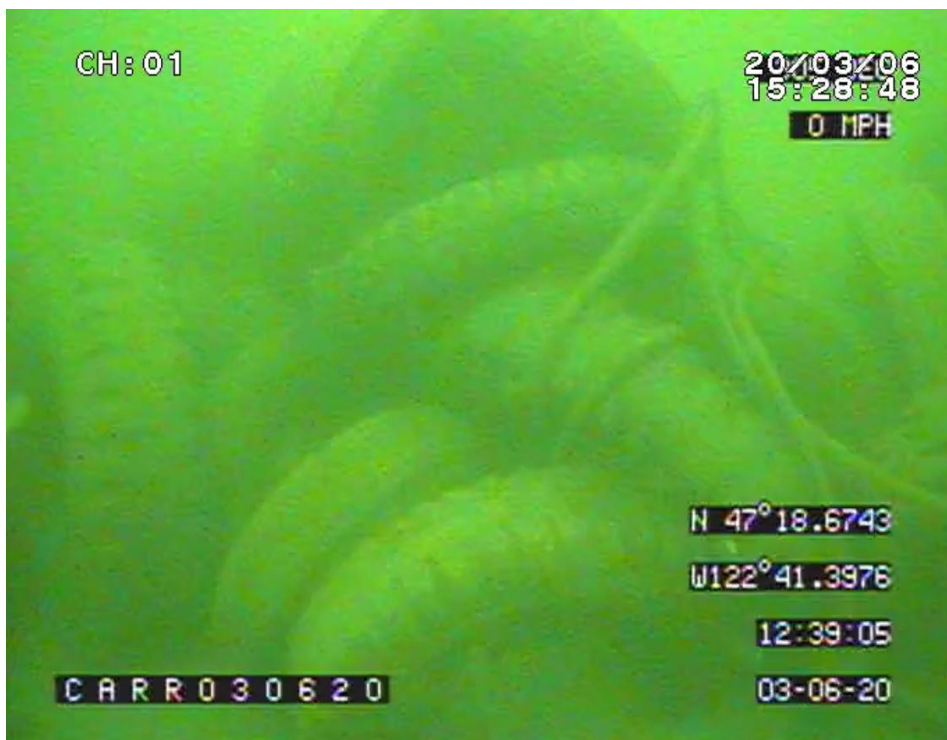
Figure 114. Tire bundles. In this photo, the bundle appears to have broken apart.

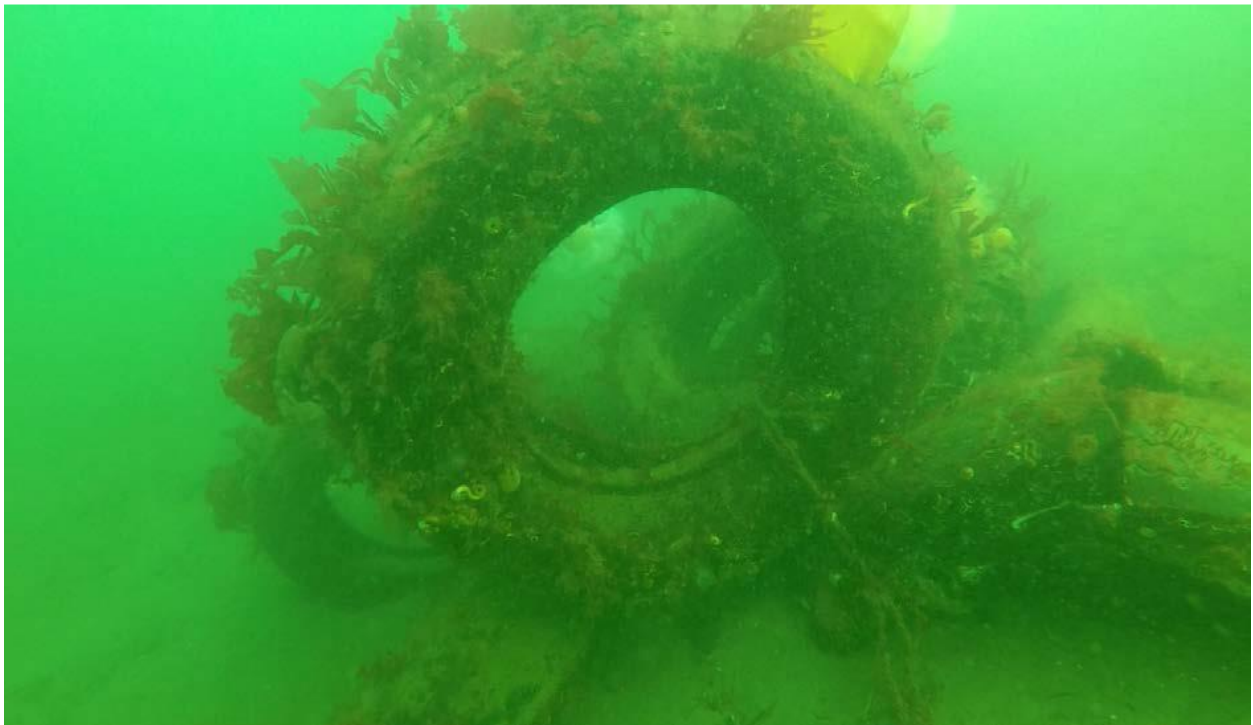
**Figure 135. DNR diver survey: while tires were likely deployed in banded barrels, many groupings have broken from their ordered banding, and are less organized.**

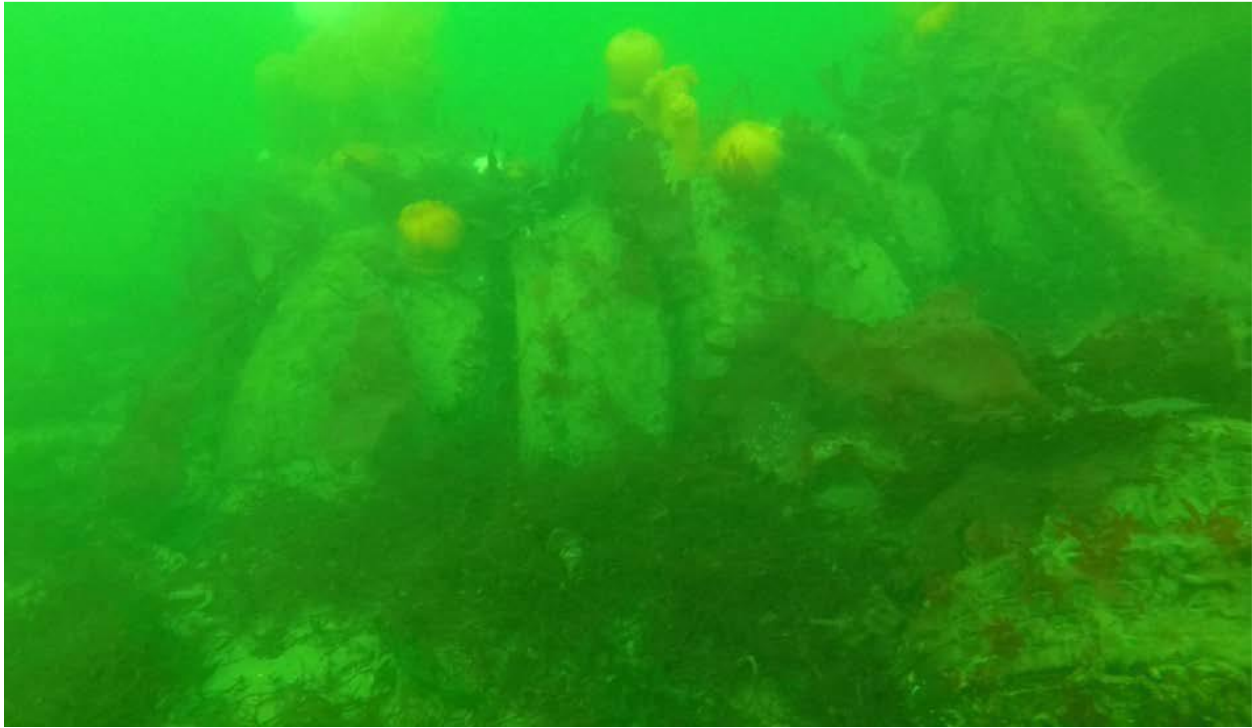
**Figure 136. DNR diver survey: barrel-grouped tires that are buried up to 50% in sediment**

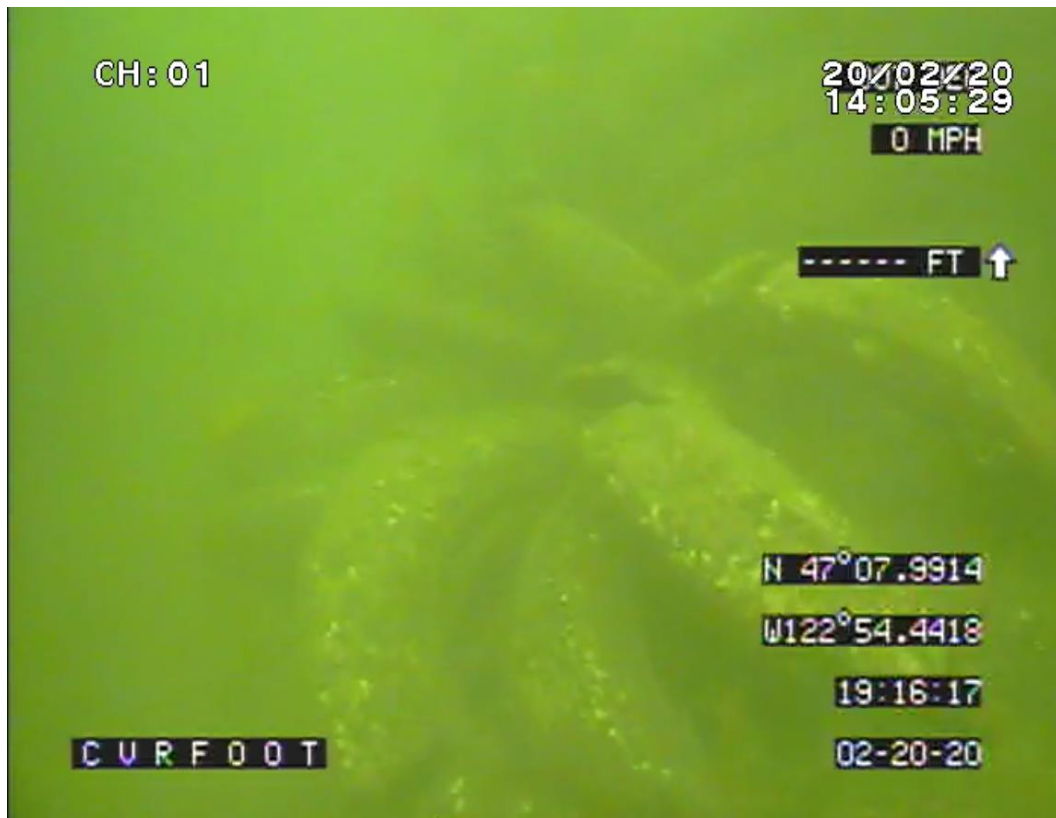
Figure 155. Tires that have broken apart from their bundles.

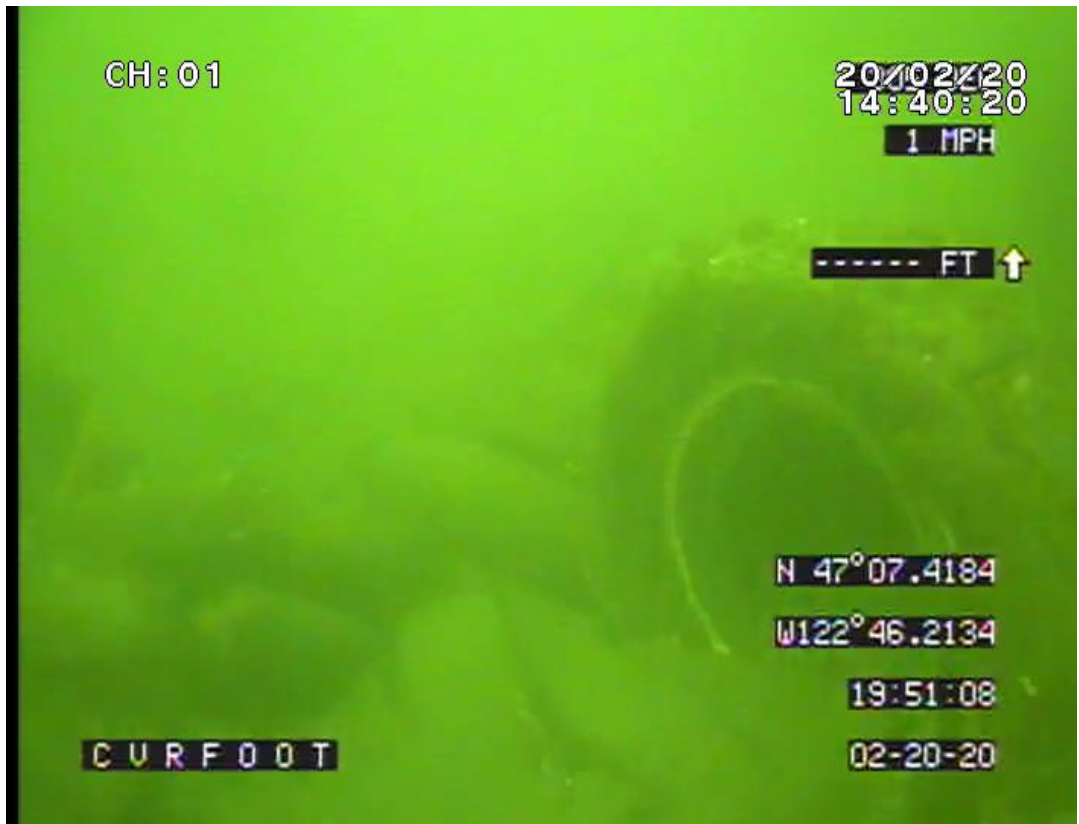
Figure 156. Tires that are buried up to 95% at the Burfoot County Park tire reef

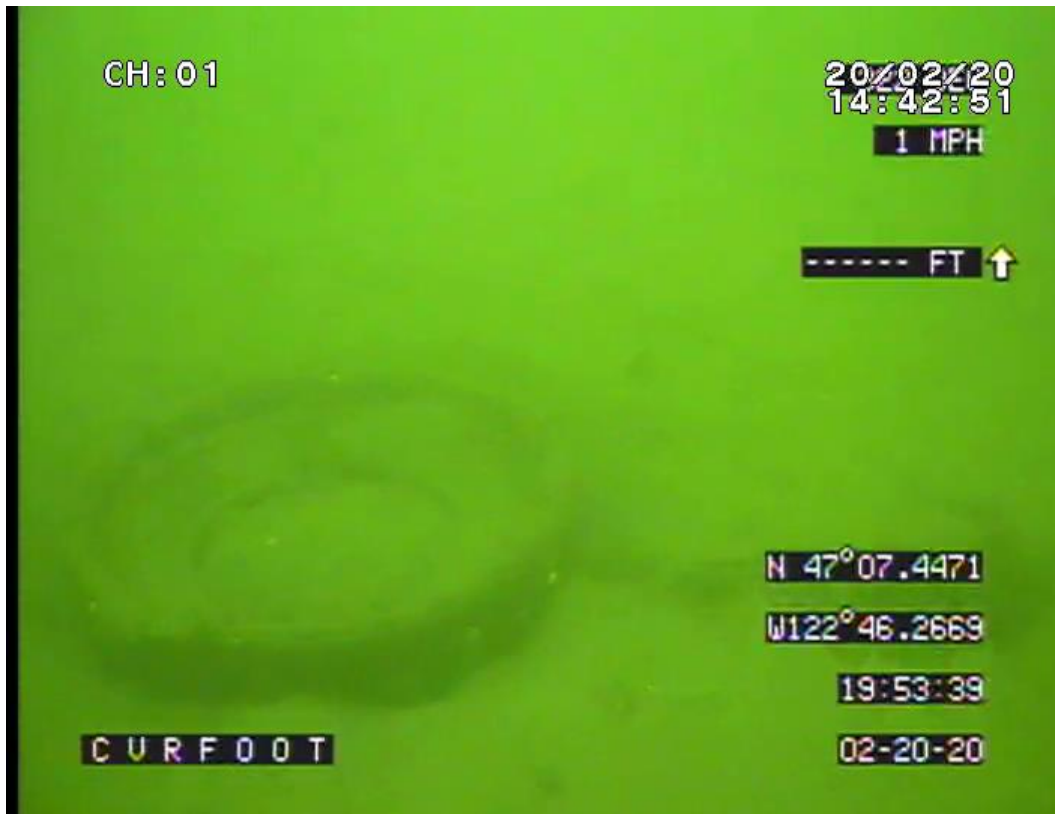
Figure 160. Tire condition was moderate to poor at Burfoot County Park. This is an example of a tire that appears to have split in half widthwise at the site.

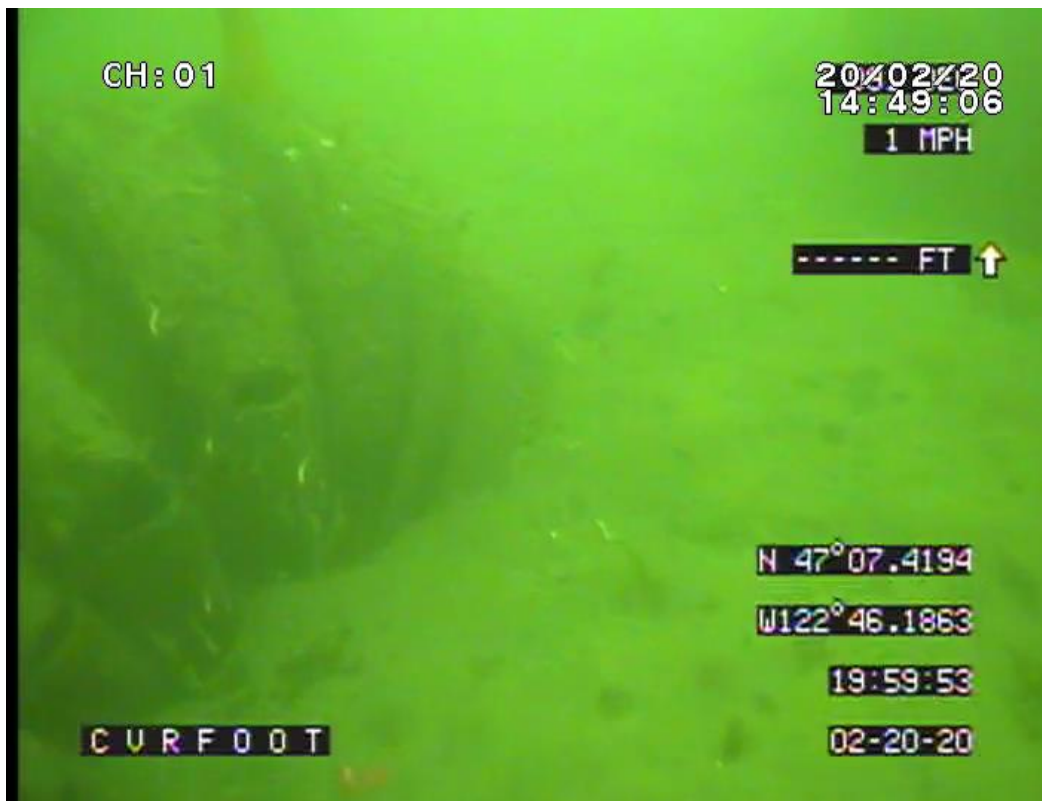
Figure 161. Tires buried up to 25%. Tires at the site appear to have air escapement slits like these.
