# Supplemental Material - Mapping Puget Sound's Artificial Reefs: Identifying Automobile Tires for Removal

*August 16, 2023*

Aquatic Assessment and Monitoring Team  
Aquatic Resources GIS Team  
Aquatic Lands Restoration Program

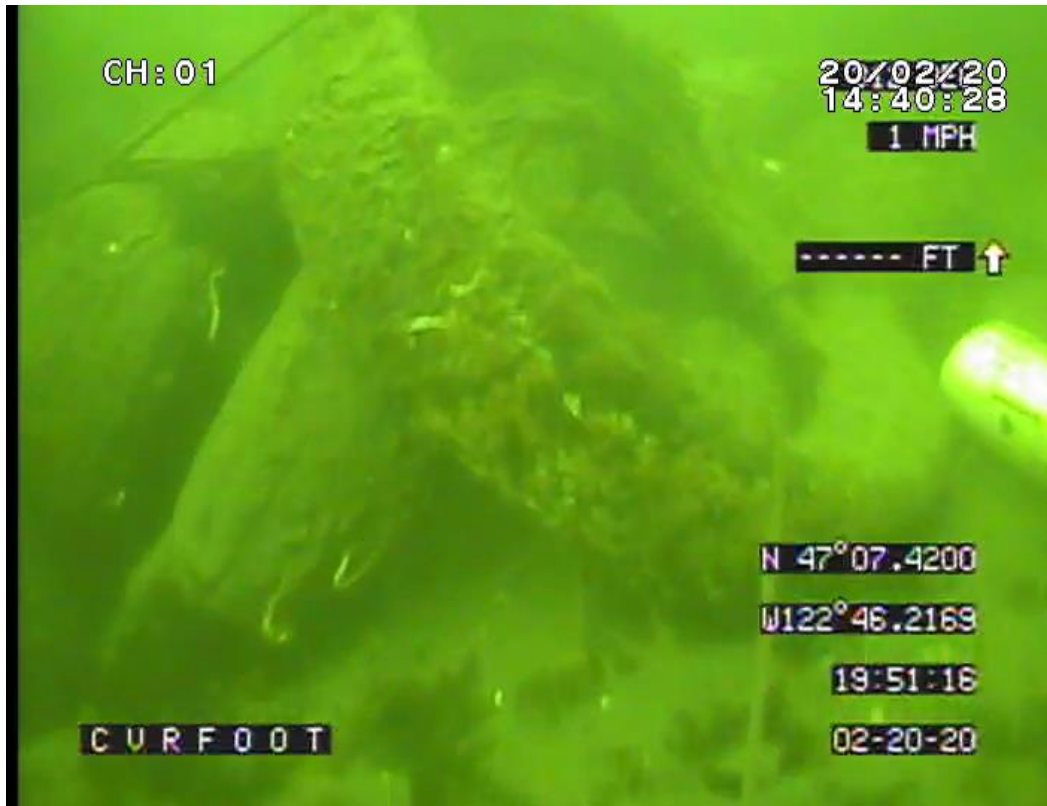
Figure 163. One of many groupings of tires where rope banding has broken, allowing tires to fall apart.

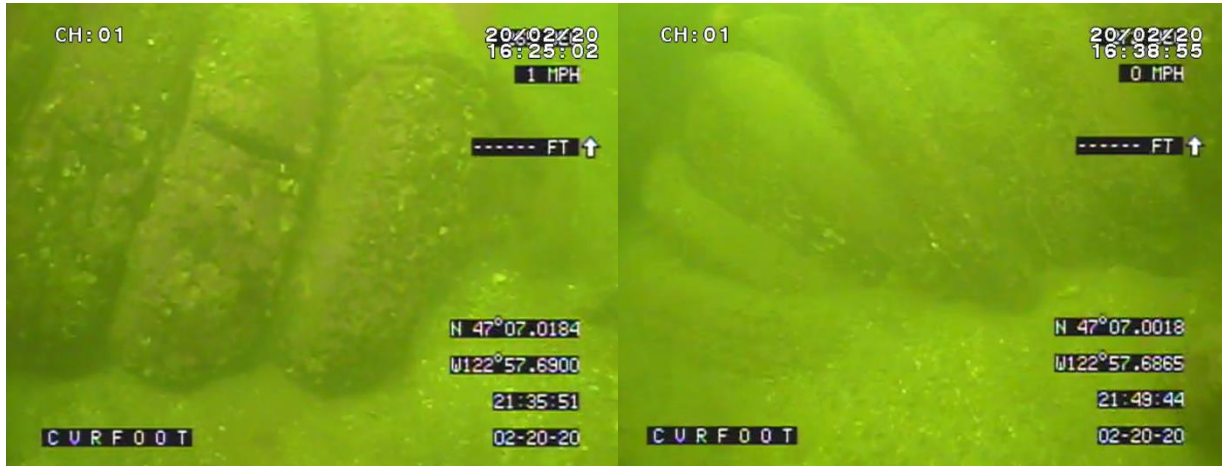
Figure 170. Eld Inlet tire bundles that represent tire bundling, burial levels, and tire degradation typical of the nodes/piles found in the reef.

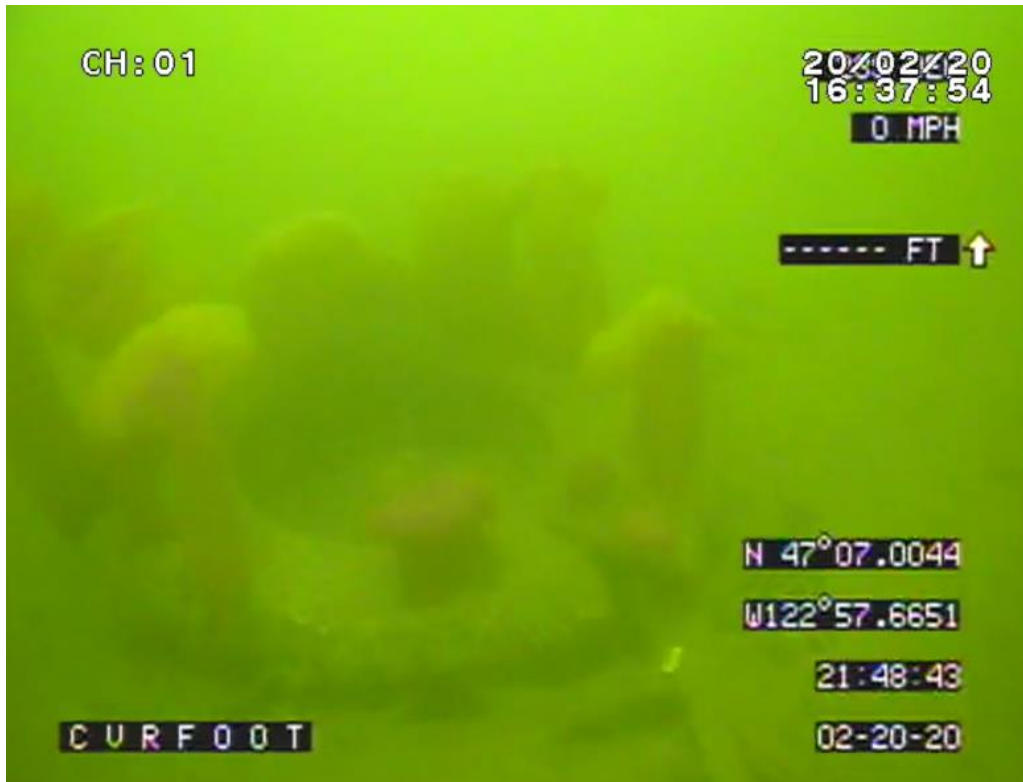
Figure 171. Singular tire identified with video 25 meters to the east of the main tire reef. Tire exhibits degradation typical of the site but is buried deeper than the average bundle. Orange and white sea anemones cover this tire.

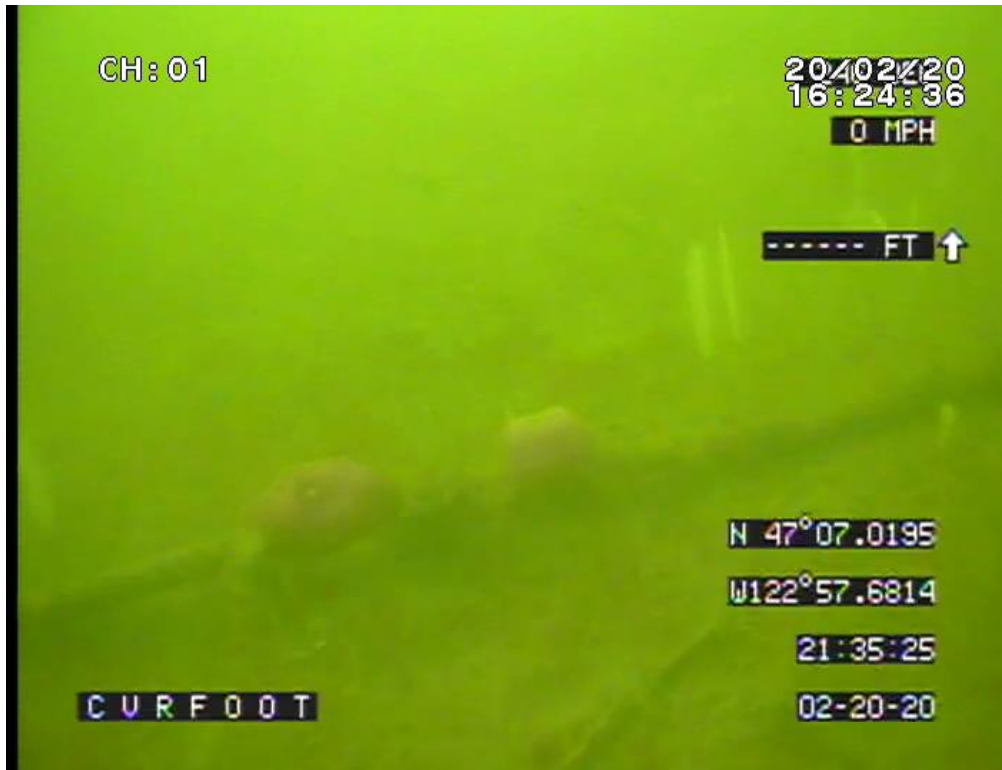
Figure 172. Thick line found to be connecting groupings and bundles of tire.

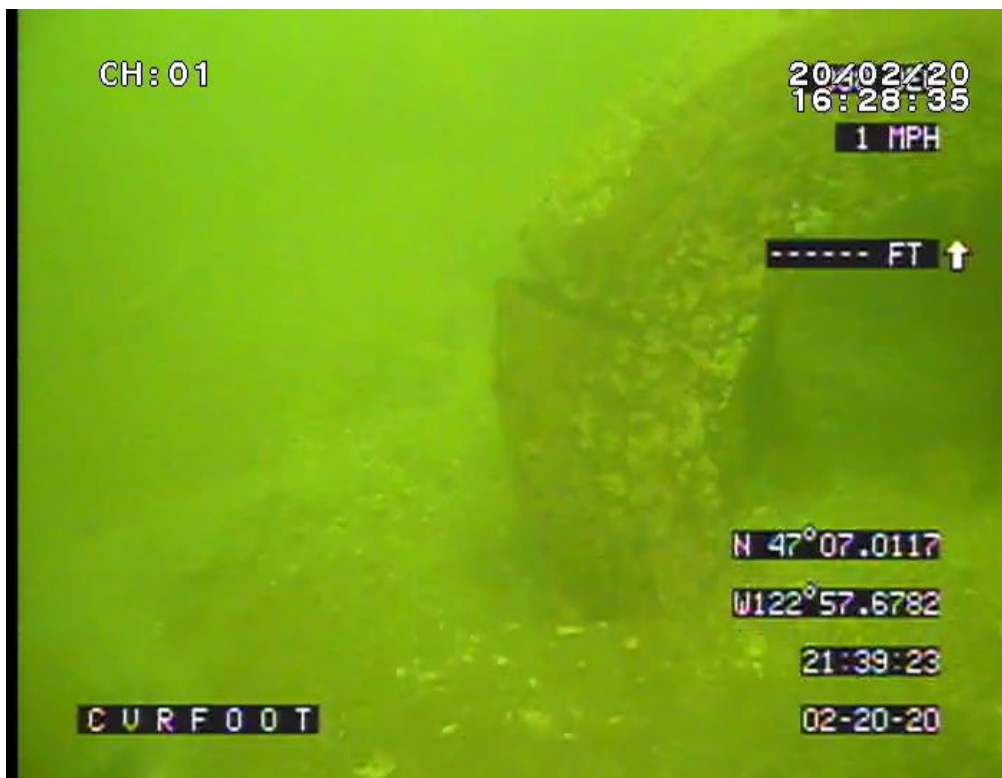
Figure 173. Tires at the Frye Cove reef site are generally in poor condition. This is an example of a tire that is buried ~ 30% in sediment, with slash for air escapement.
