State Trust Lands Implementation Monitoring Report: Implementation Monitoring Report: Implementation of the Roads Component of the Riparian Forest Restoration Strategy

This project represents the final in an initial round of implementation monitoring of the HCP Riparian Forest Restoration Strategy (RFRS). Previous implementation monitoring of the RFRS has included review of restoration treatments in conifer-dominated ([Implementation Monitoring Report published in 2013](#)) and hardwood-dominated ([Implementation Monitoring Report published in 2014](#)) RMZs.

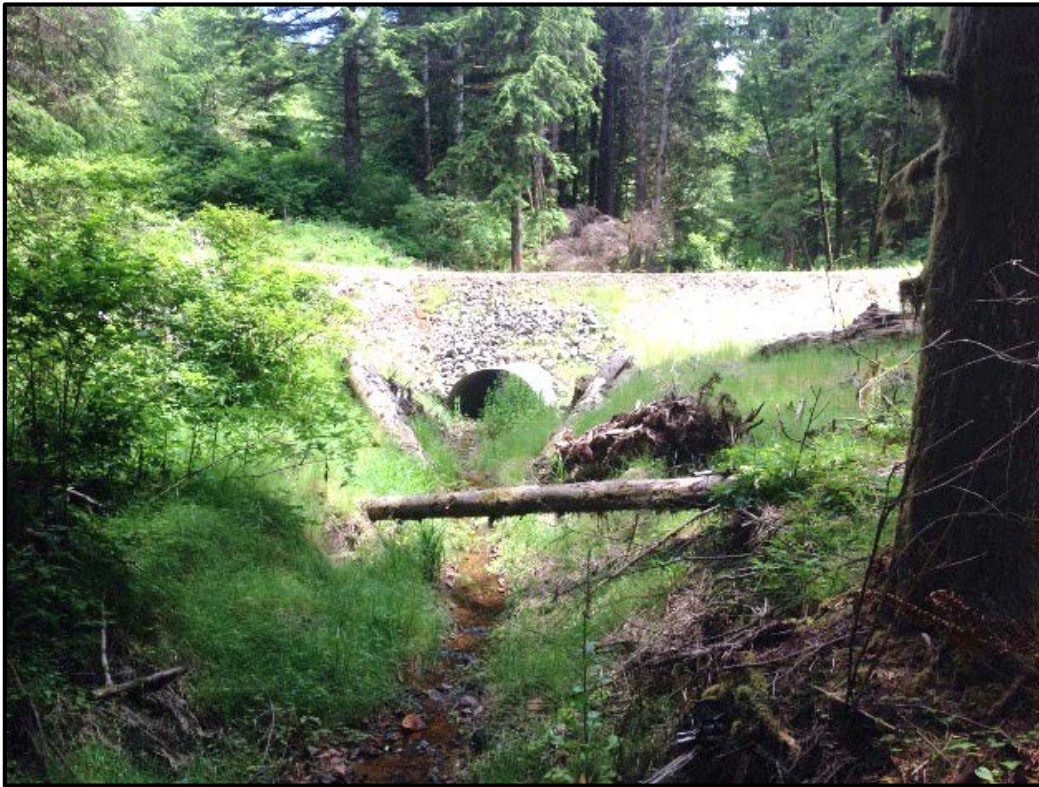
Figure 1. A reconstruction project on a Type 3 stream with placed wood downstream of the crossing. This crossing has a log spanning the stream as well as logs and detached root wads placed adjacent to the stream within the inner zone.

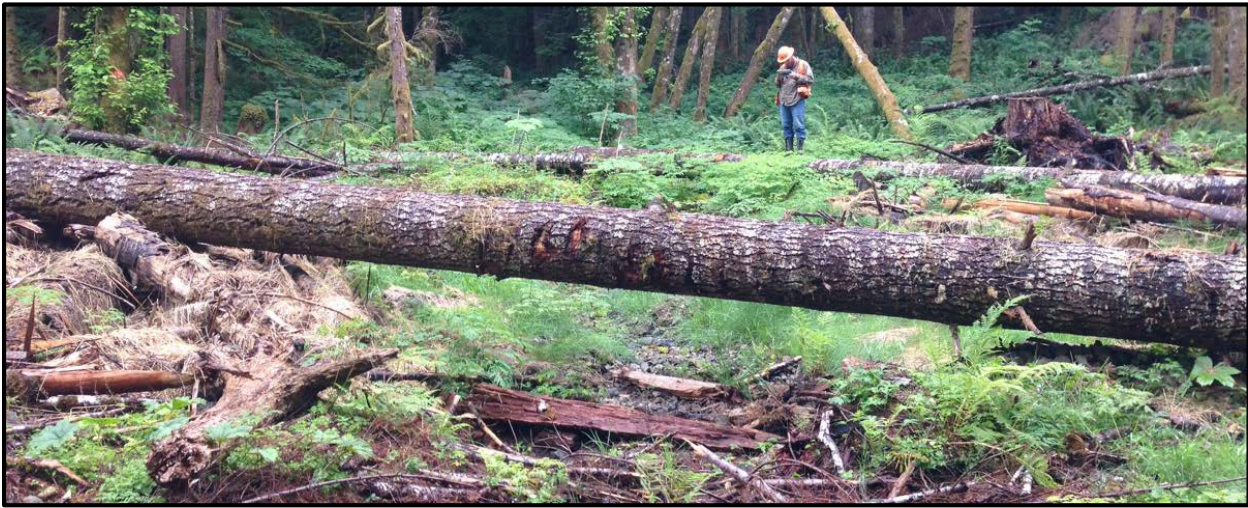
Figure 2. *At this crossing, road construction followed by full abandonment resulted in wood placement throughout the RMZ, including within the road prism. This stream had two branches and some stream-associated wetland so DNR staff elected to place longer logs across the entire feature instead of individual pieces for each crossing.*

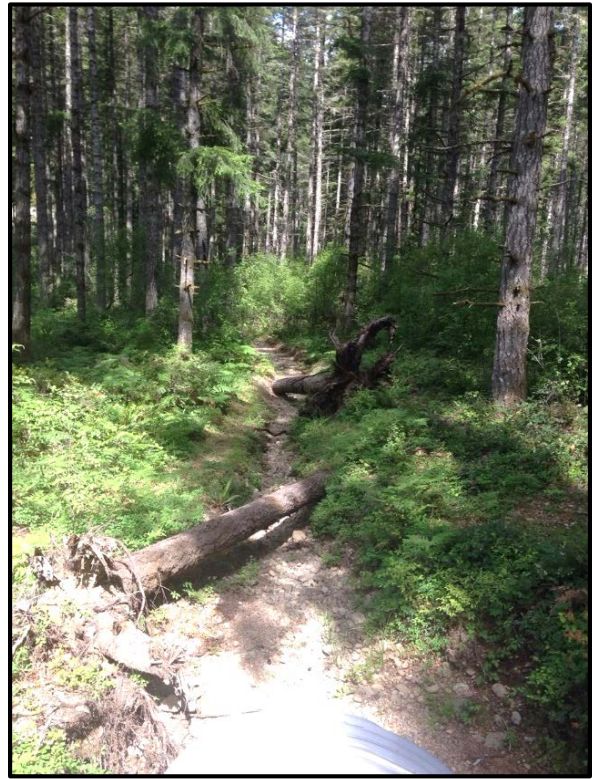
Figure 3. *At this crossing, two logs with attached root wads were placed across the stream on the downstream side of the crossing. It was common for logs with attached root wads to be placed in and adjacent to streams. While the language of the RFRS implementation procedures may imply that placing logs and root wads separately may be a preferred practice, it is acceptable (and potentially preferred) to place logs with attached root wads if operations made this material available, which is common when heavy equipment is used.*

It was common practice for logs with attached root wads to be placed in the stream, with 53% of crossings associated with timber sale contracts and 64% of crossings associated with public works contracts placing logs with attached root wads (Figure 3). To some, the language of the RFRS implementation procedures imply that placing logs and root wads separately is a preferred practice, but in an operational context the method that

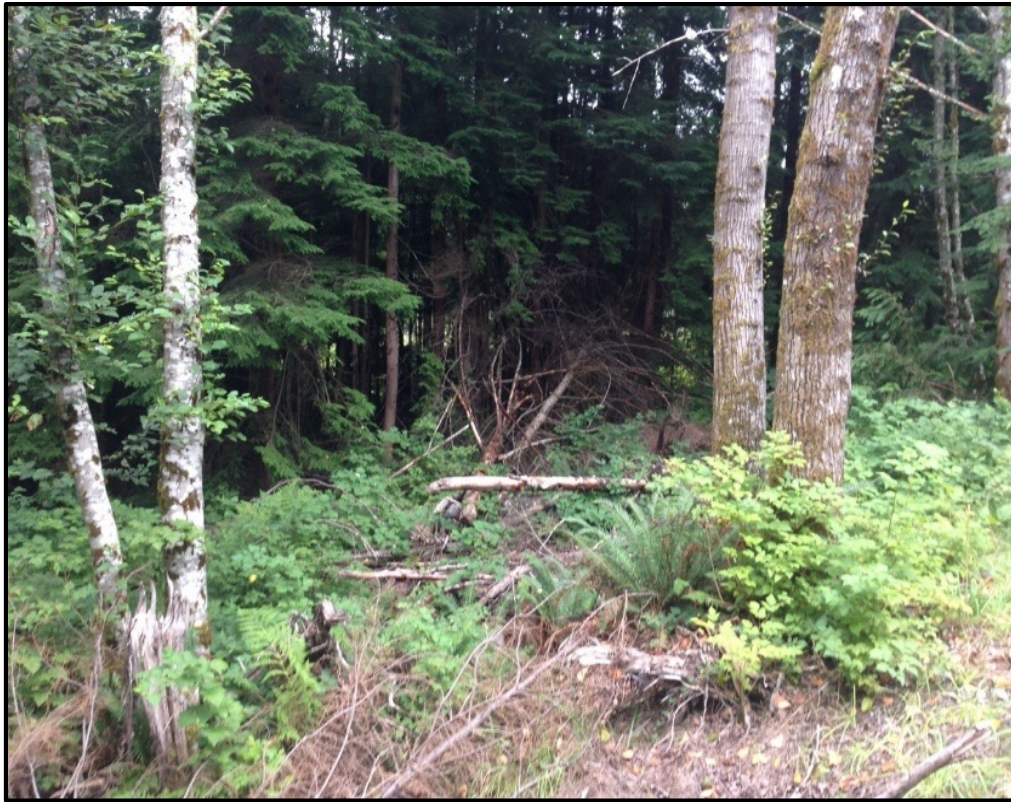
Figure 4. *The RFRS describes placing wood in the middle and outer zones at least 50 feet from the road. In practice, this can be difficult depending on the size and species of the material and the equipment being used to move it. At this crossing, some of the wood placed in the middle zone was less than 50 feet from the road prism.*

The guidance states that excess stumps from the inner zone “shall be placed in a linear fashion at least 50 feet from the road in the middle or outer zone of the RMZ”. At none of the crossings visited by monitoring staff where excess or unsaleable wood was placed in the middle zone, was all wood placed more than 50 feet from the road grade (The RFRS is unclear where this measurement should specifically be taken from; monitoring staff took measurements from the edge of the road prism). At all but one of these crossings logs or puncheon material was placed, both of which can be difficult for

machinery to work with. In practice, placing wood 50 feet from the road is impractical considering that some of the largest machinery used when implementing this type of work can only reach approximately 30 feet (Figure 4). The intent of this guidance was to get extra wood off the side of the road where it could get in the way of road management activities, or potentially be removed from the site during full road abandonment. In practice, it is advised that wood being placed in the middle zone be placed as far off the road as operationally feasible and in a way that

minimizes site disturbance. It is acceptable, and congruent with the intent of the RFRS, to place wood adjacent to the road if it reduces the risk of damaging public resources (e.g., blocking access to off-road vehicles [ORVs]). It is recommended that situations requiring wood placement within 50 feet of the road be described in the site plan in order to assure compliance with the RFRS.

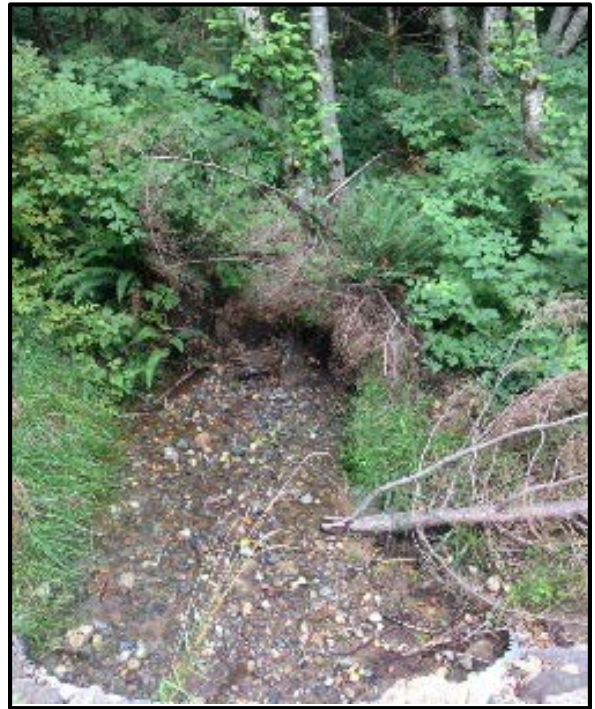
Figure 5. While the RFRS doesn’t prescribe a minimum diameter for wood requiring placement into or adjacent to the stream, DNR staff should use professional judgement as to whether wood placement is stable (i.e., has little risk of moving down stream during high flows) and functional. At this crossing associated with road reconstruction, conifer saplings are placed along the edge of the stream for erosion control in addition to meeting apparent RFRS requirements.

providing additional guidance. In the meantime, DNR staff are advised to place whatever wood is available so long as it is placed downstream of the crossing and poses little risk to resource damage either on site or downstream. The Guidelines for Large Woody Debris Placement Strategies, Section 26 of the FPBM ([Washington State Department of Natural Resources 2013b](#)), require placed wood be at least 12 inches in diameter to count towards large woody debris credit (on applicable projects related to allowing harvest of outer zone trees) on streams with a bankfull width less than 5 feet

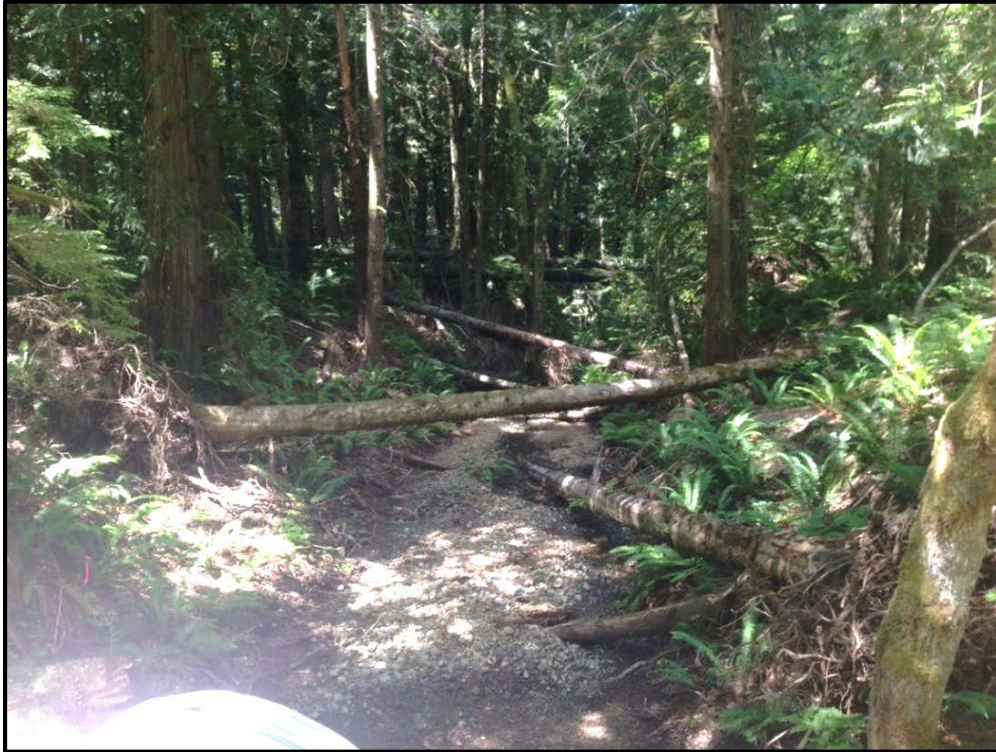
Figure 6. Conifer logs with attached root wads both spanning and within the stream channel. Region staff highlighted how it can be difficult to effectively place wood at crossings with a structurally dense surrounding forest, such as this one.

road pioneering or reconstruction followed by road abandonment or decommissioning. There are situations where placement of wood within the area of the crossing may be best to meet the objectives of RFRS (it is important to document the wood placement plan to assure compliance with RFRS and to assure desired site specific outcomes are achieved). One example of this is when the road project is being implemented in a structurally dense forest where the placement of wood downstream would require a significant expansion of the project footprint and/or unwarranted disturbance to the inner zone downstream of the crossing (Figure 6). Under these circumstances, placing wood

in the area within the crossing is only recommended if the crossing is being fully abandoned and there are no future activities planned that would require reopening the crossing. If the road is being decommissioned, it is recommended that inner zone wood be placed in other parts of the RMZ instead of in the stream channel where it would require removal when the road is re-commissioned. Another situation that may warrant placement of wood within

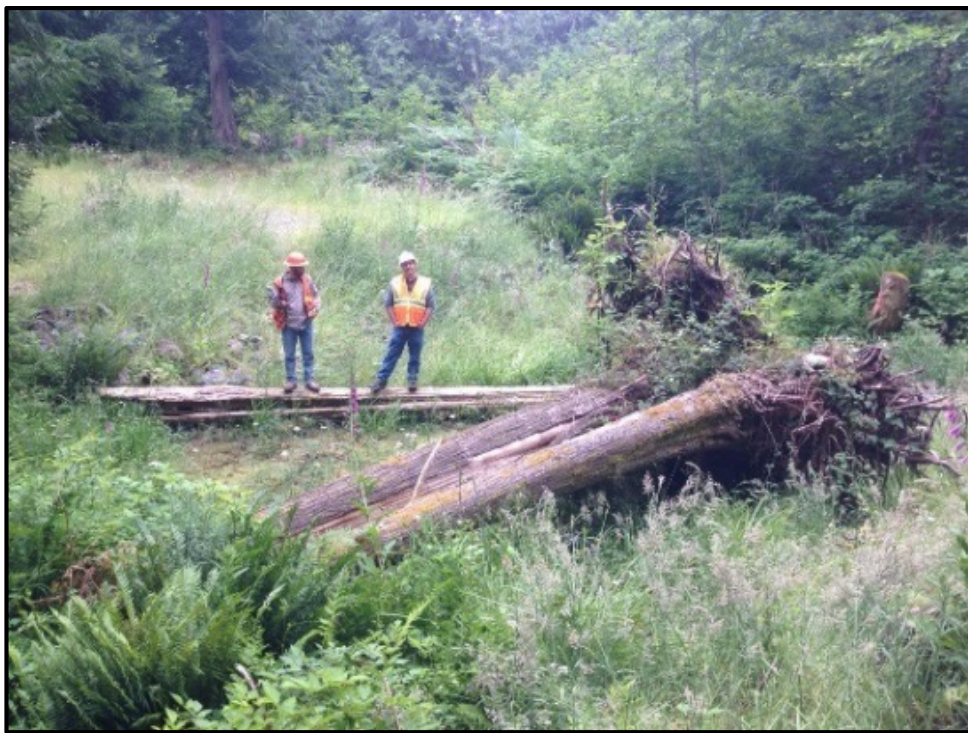
Figure 7. *Wood placement within a decommissioned road crossing may result in disturbance to the channel when the road is reopened, but this placement also deters off-road vehicle access which can be a more severe and persistent disturbance agent.*

the crossing is for access restriction to ORV's (Figure 7). It is possible in this situation that placement of wood within the crossing is desirable even if it requires later removal when the road is re-opened. This is because the temporary benefit of access restriction may outweigh the disturbance resulting from future removal since the overall frequency and severity of channel disturbance would be reduced.
