Eelgrass (*Zostera marina* L.) Restoration in Puget Sound: Development and Testing of Tools for Optimizing Site Selection

September 2014

RM Thom
JL Gaeckle
KE Buenau
AB Borde

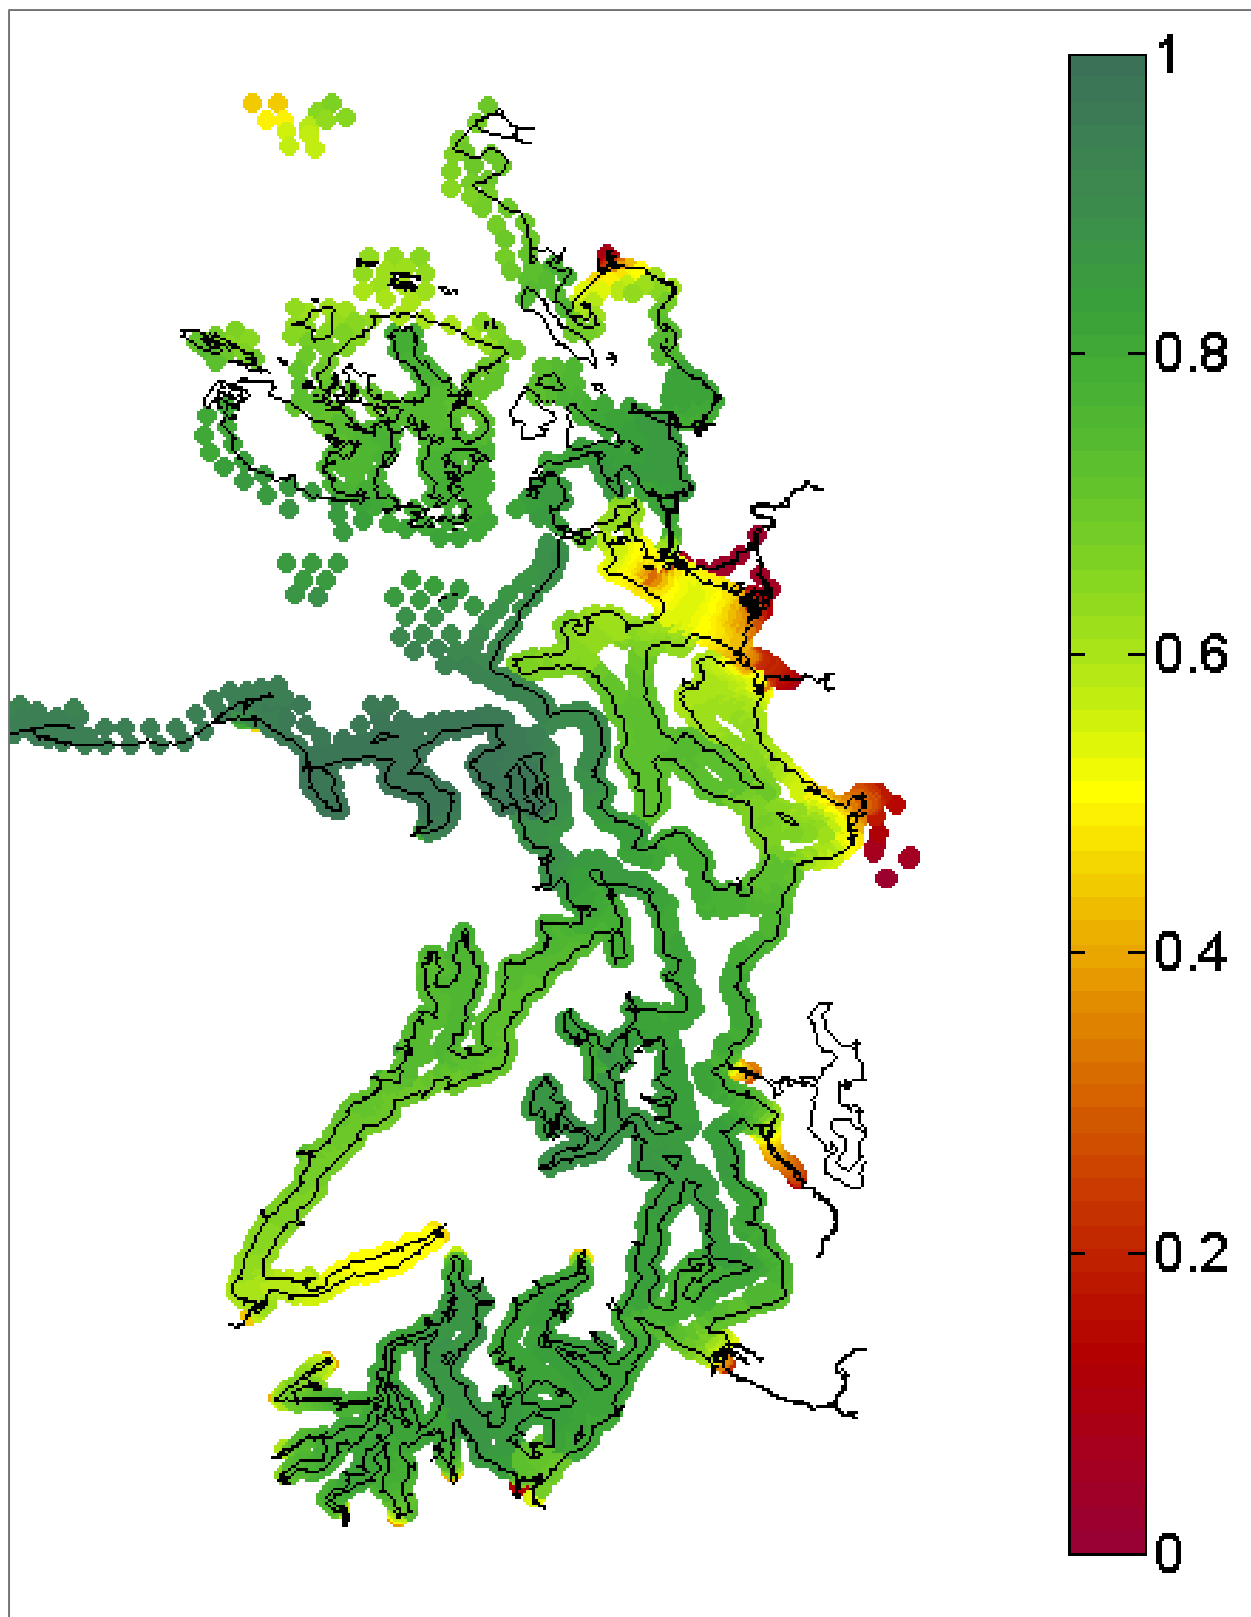
Figure 1. Eelgrass biomass model output after one calendar year (2007), normalized from 0 to 1, at a canopy depth of -1 m NAVD88. Initial biomass is one-third carrying capacity (2 mol C/m^2 .)

Model output at specific depths shows the broad effects of light availability, temperature, and salinity on eelgrass growth throughout Puget Sound (Figure 1 and Figure 2). At -1 m NAVD88, light is rarely limiting and eelgrass production is controlled by low salinity (e.g., in large river deltas, primarily in eastern Puget Sound) and higher temperatures (e.g., south Hood Canal). At -5 m NAVD88, production is driven most strongly by light, with areas prone to high turbidity due to sediment runoff (e.g., Skagit Bay, the Nisqually delta) or low circulation (South Sound, South Hood Canal) having notably reduced eelgrass production. The co-occurrence of stressors in some locations (e.g., those with reduced water circulation and near deltas) causes low suitability at both depths. At -5 m NAVD88, areas unsuitable at shallow depths remain so and areas with high turbidity become less suitable. Note that while model results indicate predicted growth for eelgrass below carrying capacity, the relative ranking of sites is not sensitive to initial conditions.

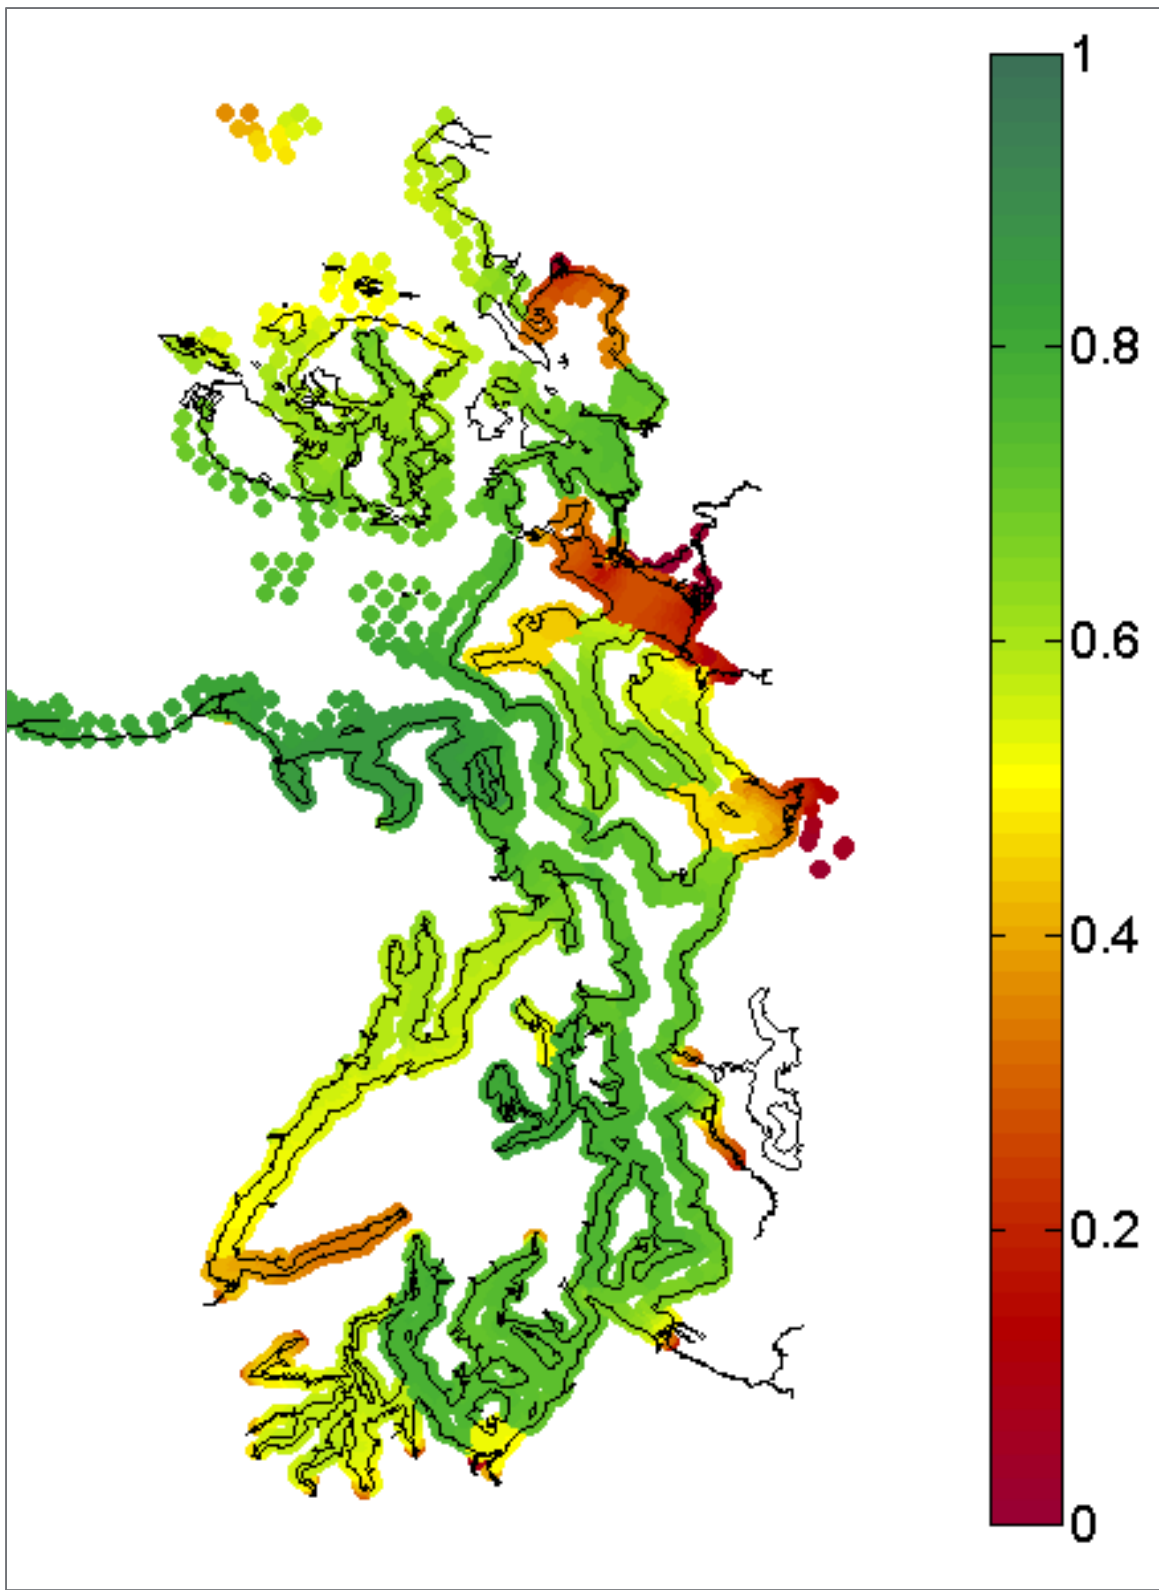
Figure 2. Eelgrass biomass model output after one calendar year (2007), normalized from 0 to 1, at a canopy depth of -5 m NAVD88. Initial biomass is one-third carrying capacity (2 mol C/m^2 .)

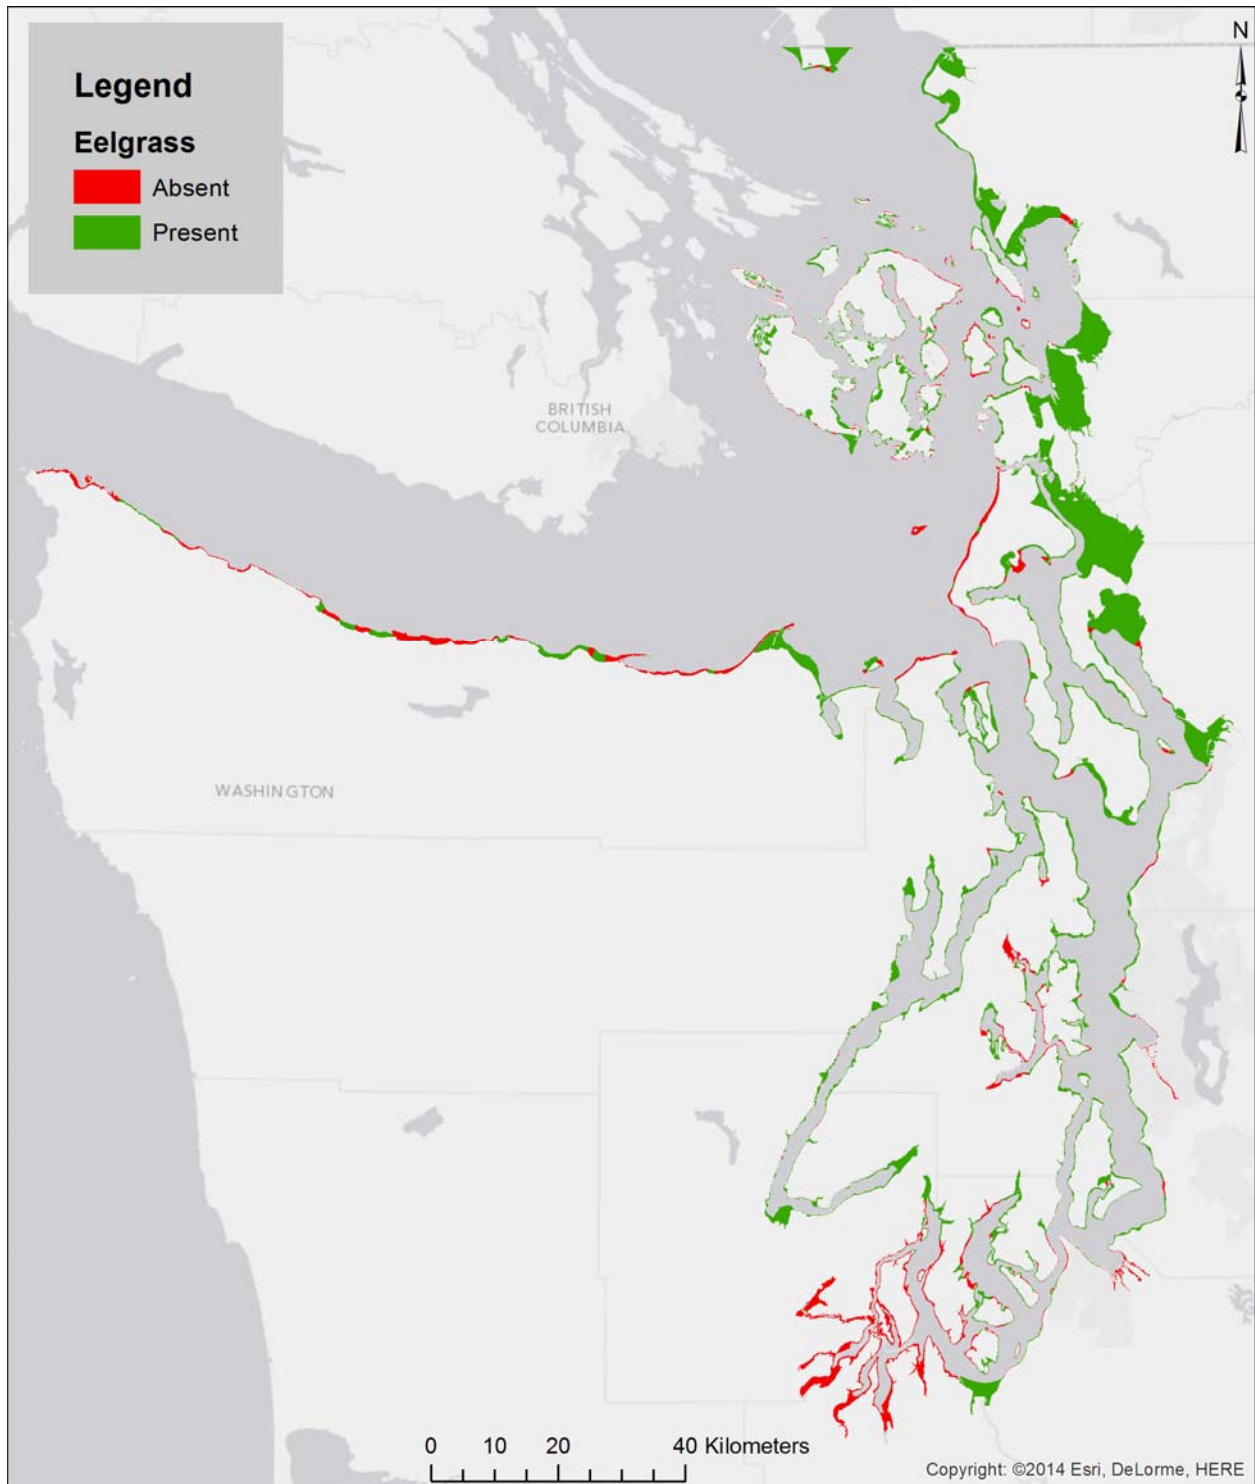
Figure 3. Current eelgrass presence/absence as derived from the Submerged Vegetation Monitoring Program, the Shorezone Inventory, and site visits conducted for this project.

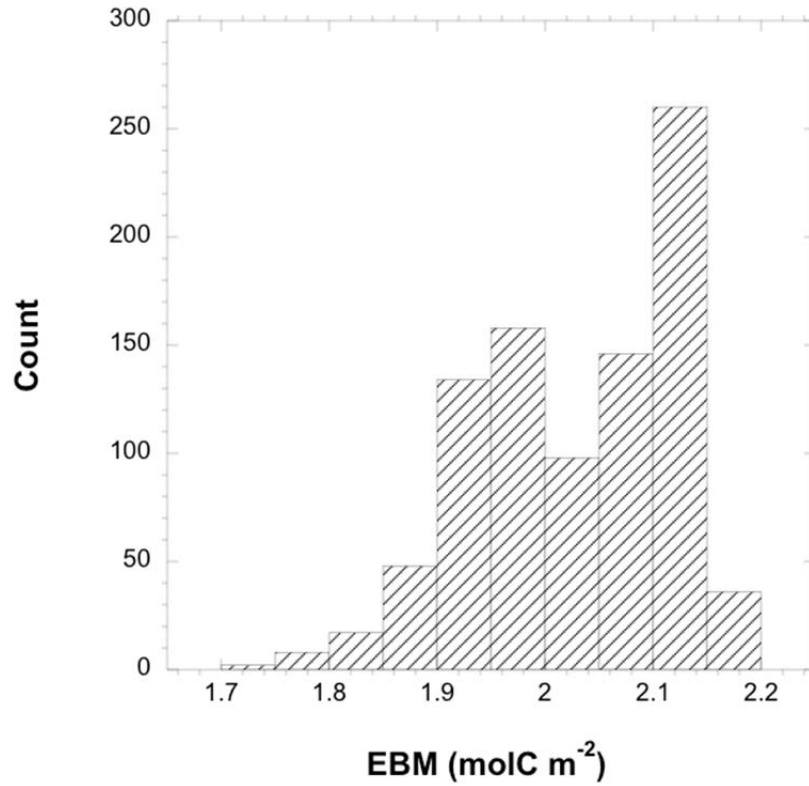
Figure 4. Histogram of EBM values for sites without eelgrass currently present.

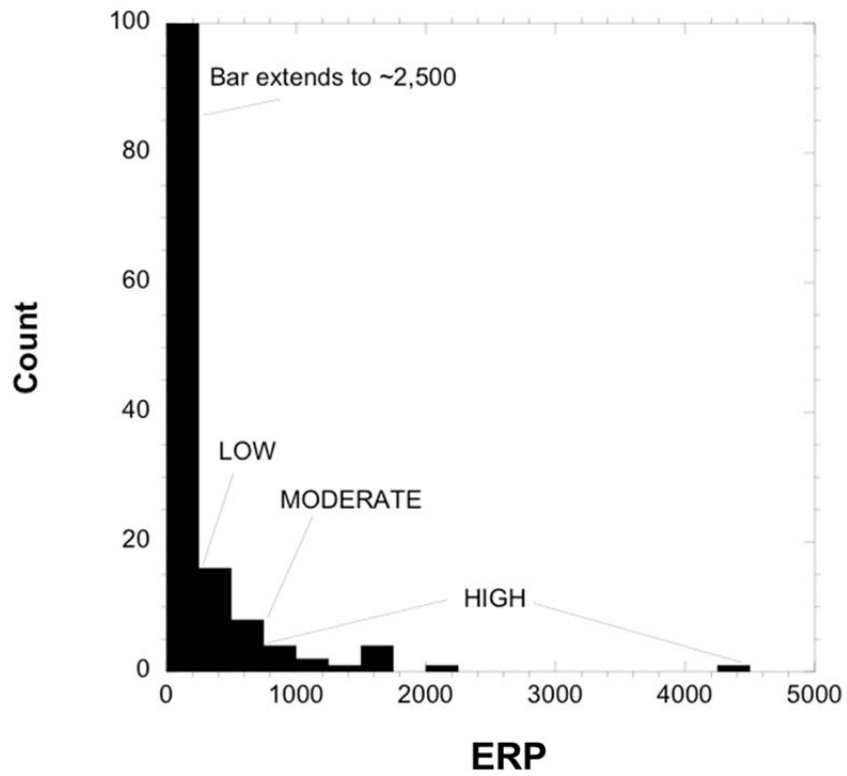
Figure 5. Count of ERP scores, indicating low, moderate, and high scores.

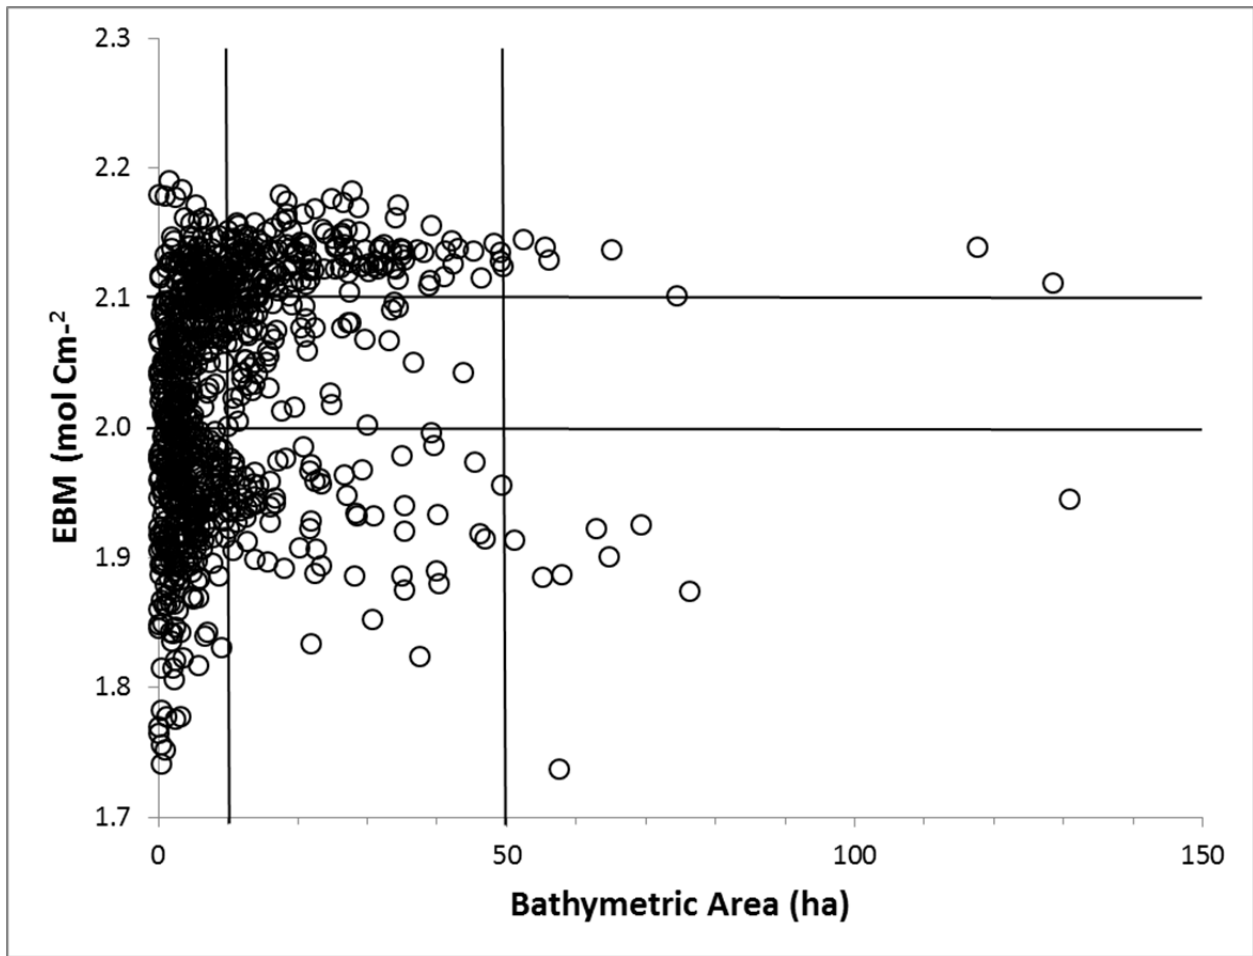
Figure 6. Plot of EBM versus bathymetry area for 993 sites containing no present eelgrass. The seven sites greater than 50 ha and with EBM scores of >2.1 represent larger sites with a relatively high potential for restoration. One 257-ha site with an EBM score ≥ 2.0 is not shown. Four >200 -ha sites with EBM scores <2.0 are not shown.

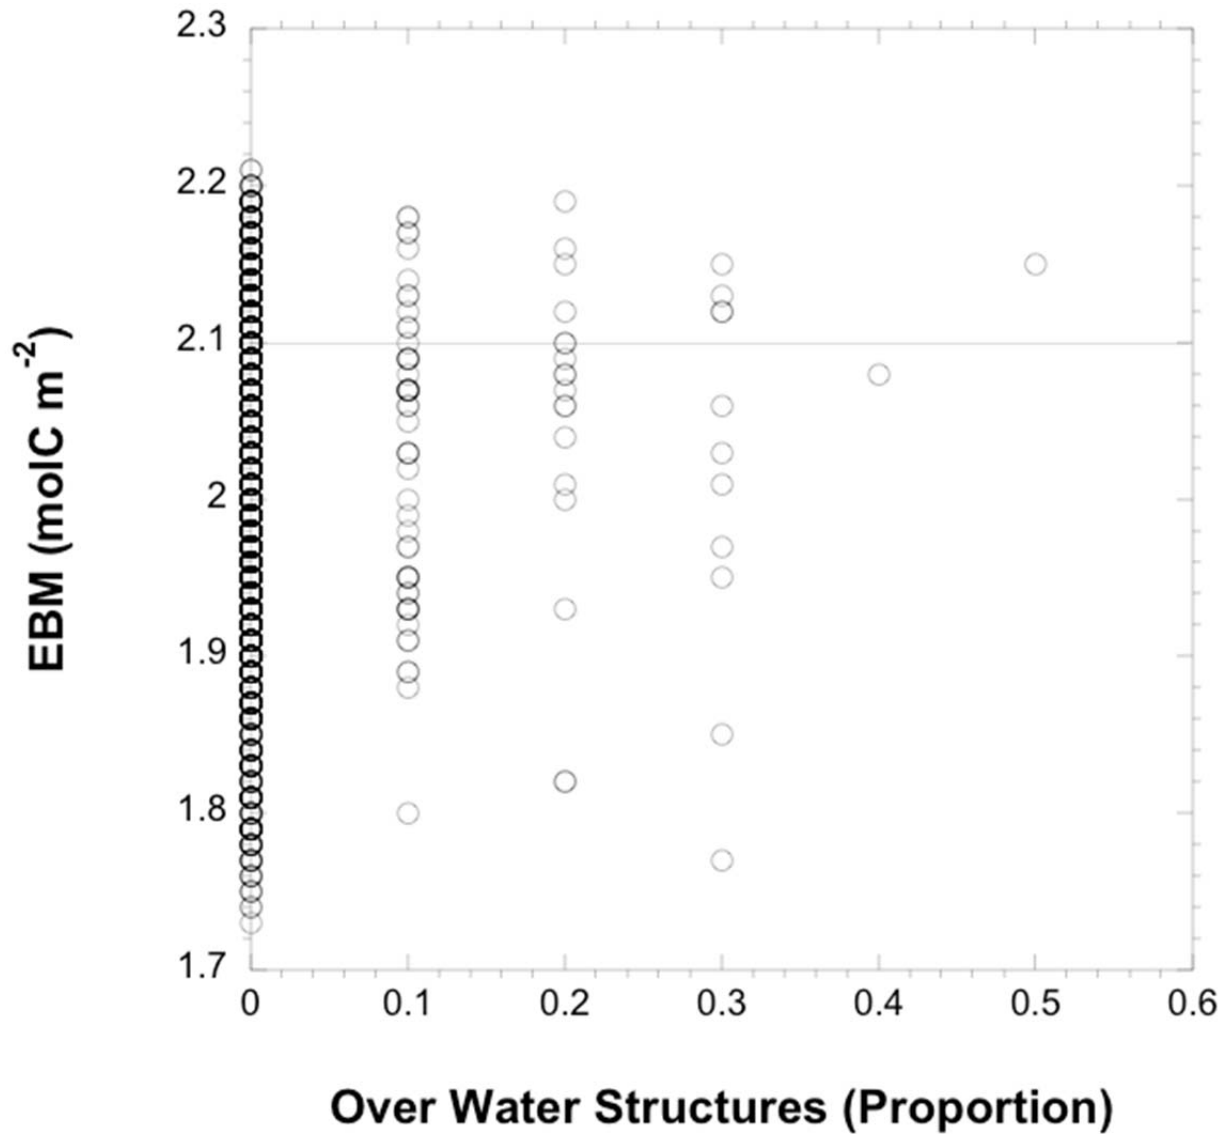
Figure 7. Plot of EBM for areas with no present eelgrass versus proportion of the site with overwater structures. Sites with EBM scores >2.0 represent potentially good sites for restoration, especially if the overwater structures are removed or improved to reduce shading. A total of 17 sites with the best growth conditions are indicated with scores >2.1.

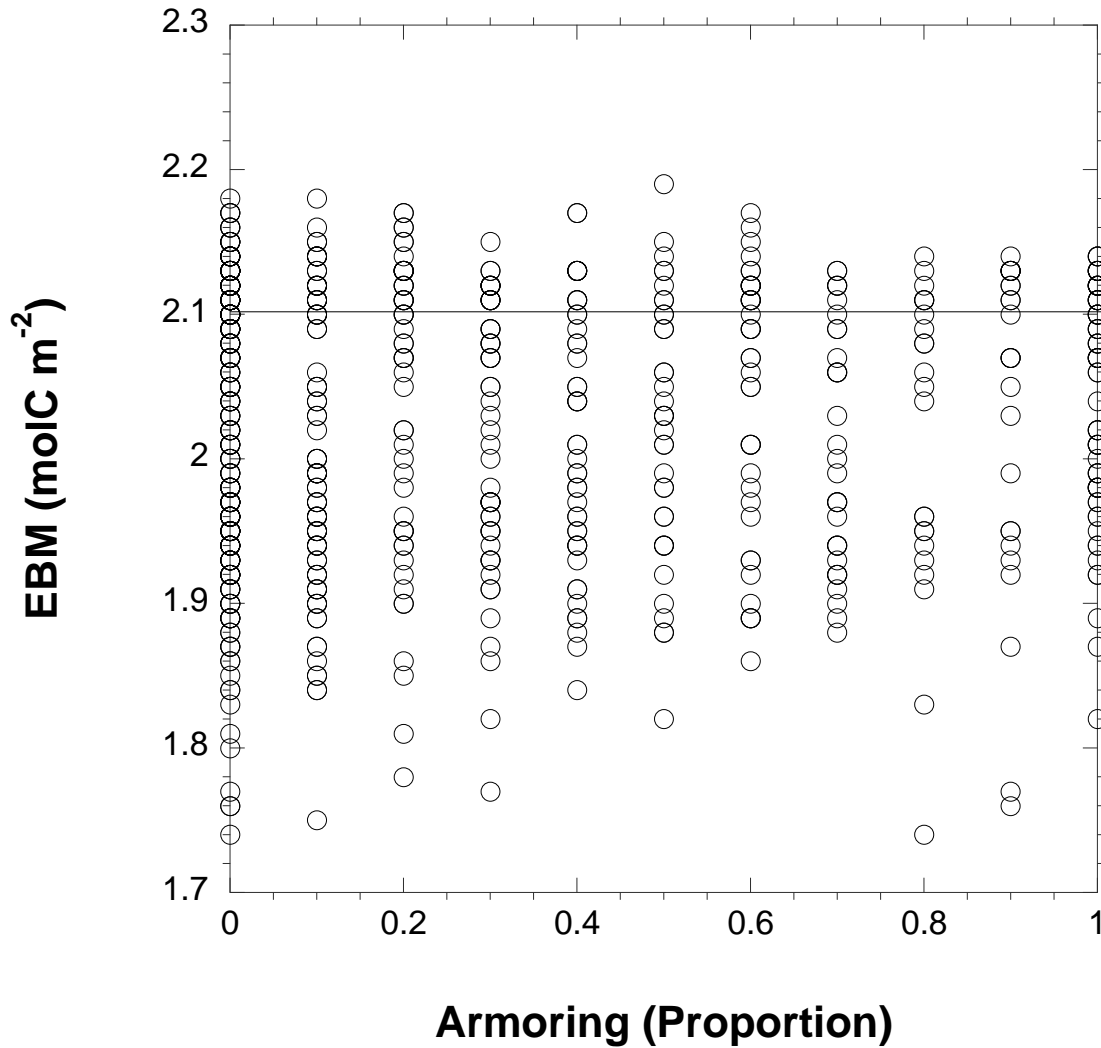
Figure 8. Plot of EBM for areas with no present eelgrass versus proportion of the site with shoreline armoring. Sites with EBM scores >2.0 represent potentially good sites for restoration, especially if the armoring is removed or the armoring is presently not disturbing potential eelgrass areas. Sites with the best growth conditions are indicated with scores >2.1.

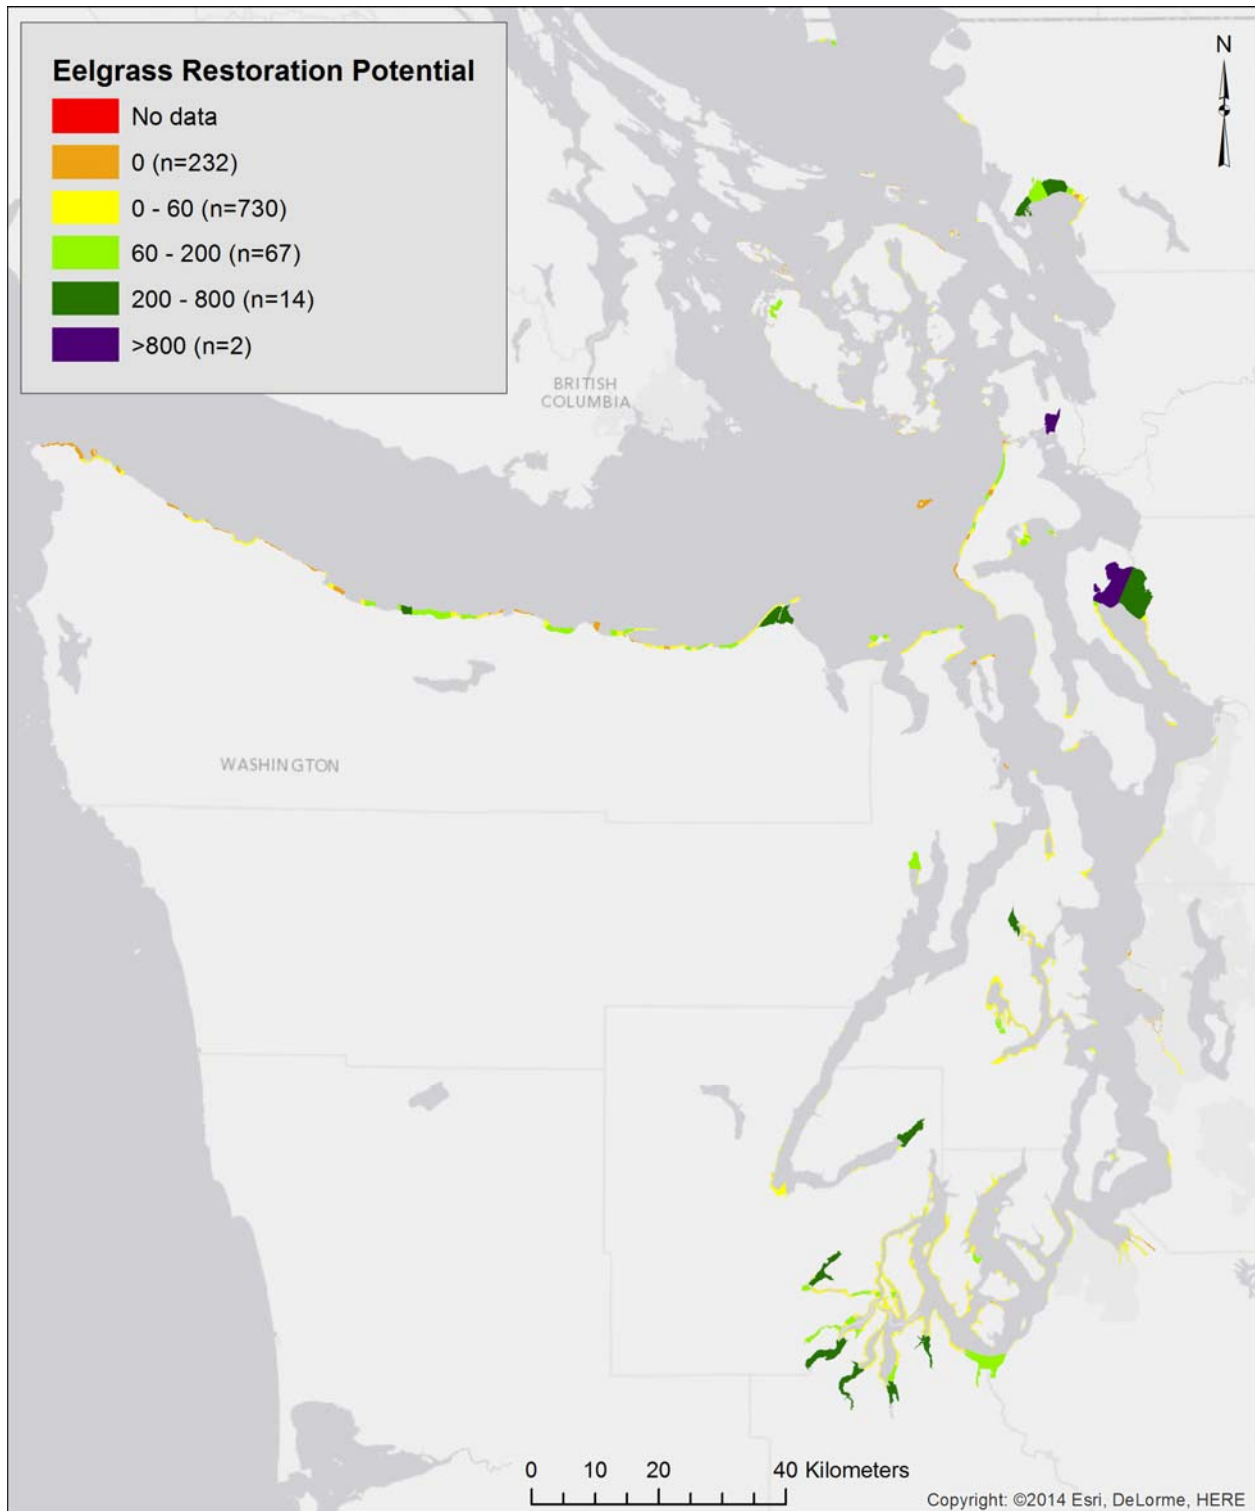
Figure 9. Eelgrass restoration potential (ERP: Environmental Condition x Area). Areas shown are those that currently have no eelgrass present. Note that spatial extent of the map limits resolution at fine scales.

A map of ERP (Figure 9) illustrates the location of potential restoration sites where eelgrass was not currently present, including the areas identified in the stakeholder survey; those with highest potential are shown in purple followed by green. The bathymetric area associated with the sites with an ERP >200 is greater than 100 ha per site for a total potential area of 4,492 ha. This is likely an overestimate because sometimes general areas were identified in the survey and they may not be completely devoid of eelgrass. Of the 67 sites with an ERP between 60 and 200, 31 sites (between 28 and 63 ha) have an ECI greater than 2.1, for an additional 1,215 ha of potential restoration area.

All regions of Puget Sound include sites we predict to be moderately to highly suitable for eelgrass (Figure 9). Large sites occur in South Sound, Hood Canal, Port Susan, Bellingham Bay, and Dungeness Bay. Based on our analysis, and with the goal of restoring 4,000 ha by 2020, our recommendations for priority actions are as follows:

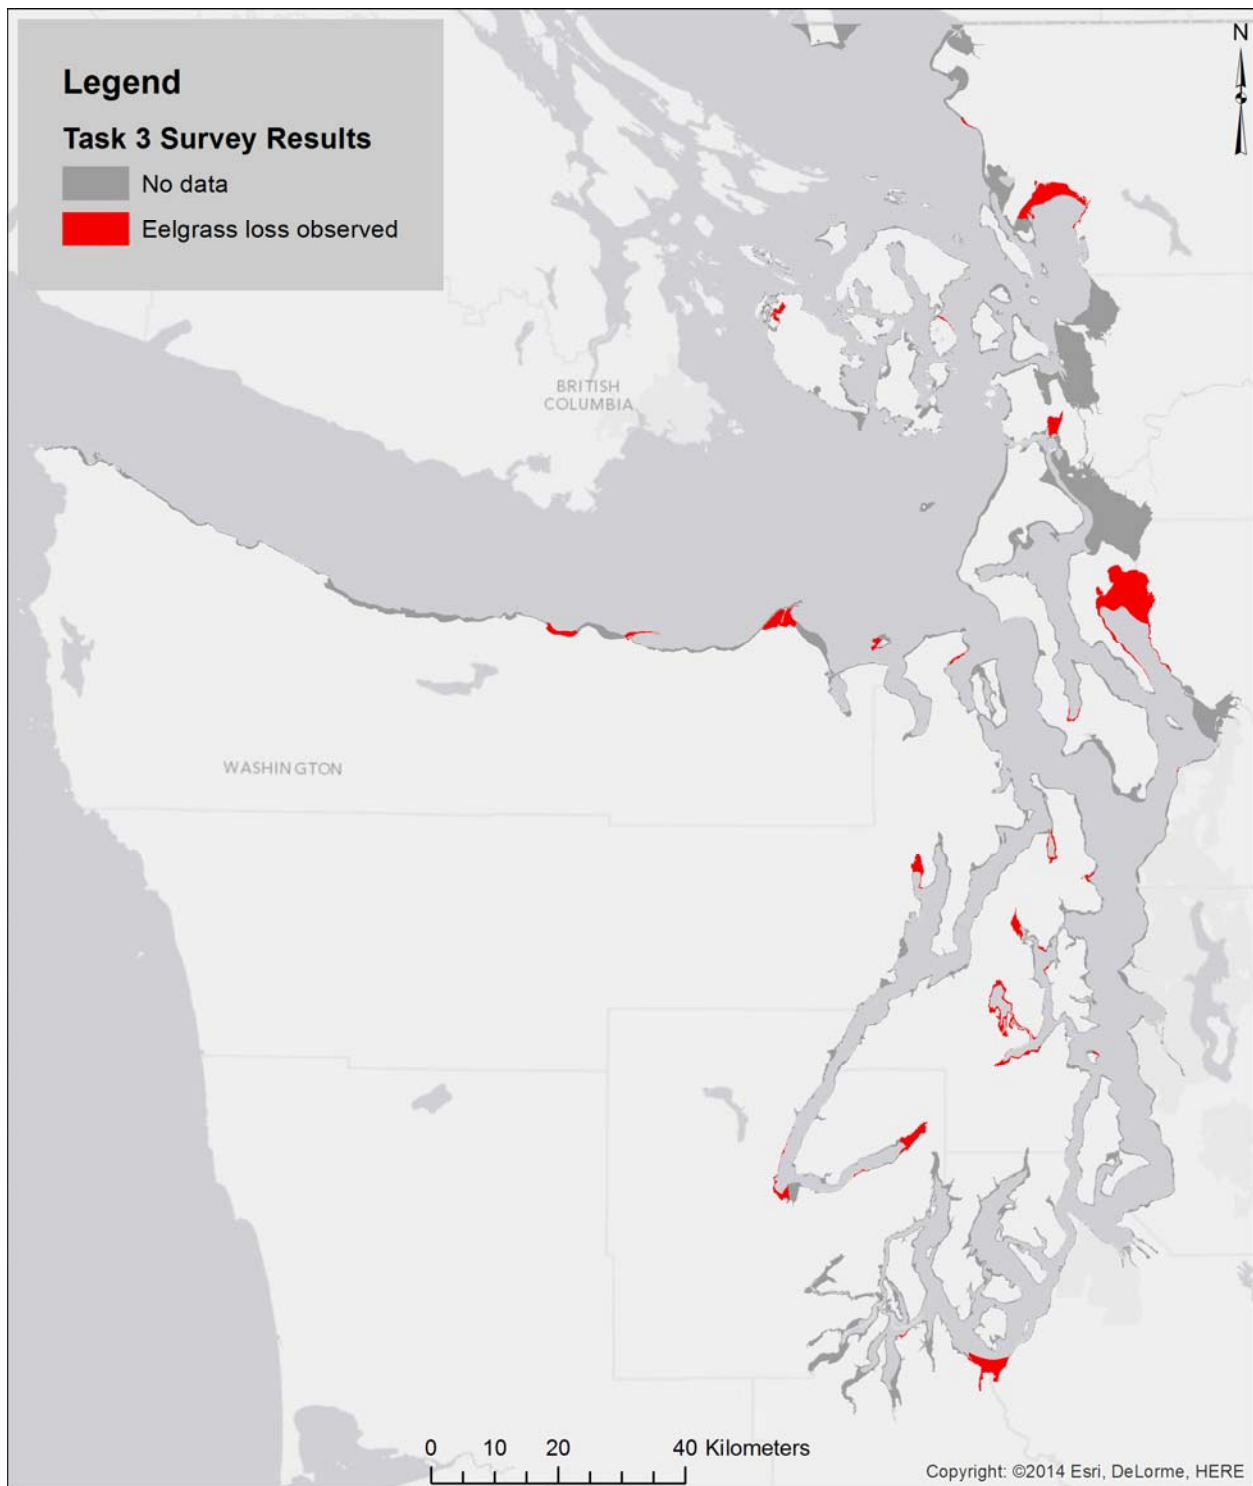
Figure 10. Stakeholder survey results indicating areas where respondents identified absence of eelgrass that existed previously. Note that spatial extent of the map limits resolution at fine scales.

The areas that survey respondents identified as having lost historically present eelgrass are shown in Figure 10. These areas are distributed around Puget Sound, and are mostly found in areas where circulation is reduced and, therefore, water quality and turbidity may be stressors on eelgrass populations.

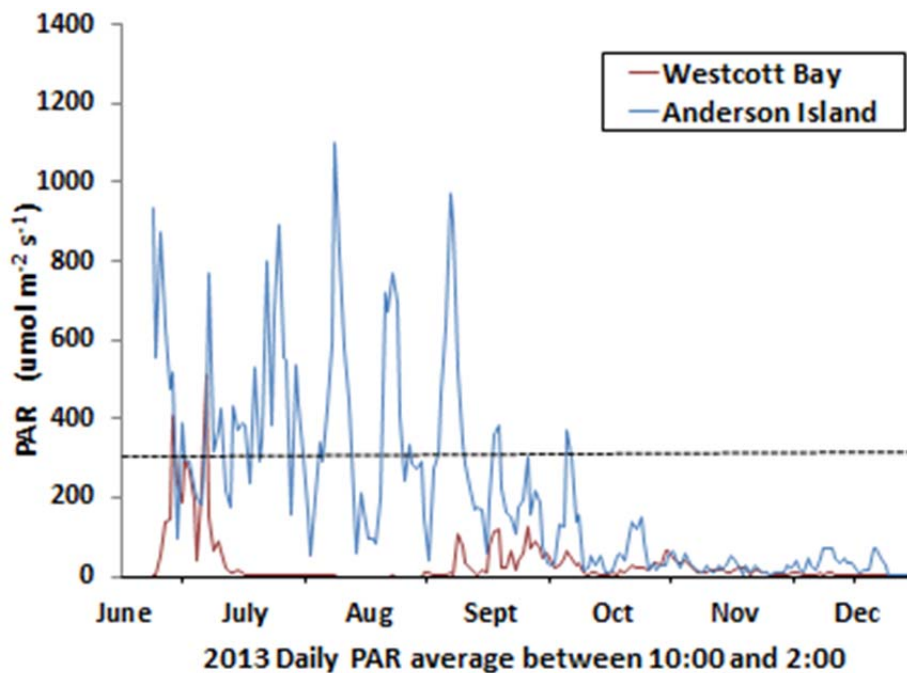
Figure 11. Daily PAR averaged between 10:00 a.m. and 2:00 p.m. for Westcott Bay and Anderson Island between June and December 2013. The dashed line marks $300 \mu\text{mol}/\text{m}^2/\text{sec}$, though to be the minimum light requirement for long-term maintenance of eelgrass (Thom et al. 2008).

The light sensor data exhibited responses to fouling over time, exposure to air, and seasonal changes of light availability (Figure 11). The most useable data collected was shortly after the sensors were installed or shortly after they were cleaned. We calculated mean daily attenuation for the South Sound and Westcott Bay the day after sensors were installed or cleaned (Figure 12). A 7-day average was also calculated for the following week to account for any temporal variation while sensors were still relatively clean. The average South Sound attenuation coefficient for the days immediately following installation and three cleanings was 0.71 m^{-1} . The averaged attenuation for the week following each of those dates was 0.64 m^{-1} . The average attenuation at Westcott Bay (0.99 m^{-1}) was higher than South Sound but only two dates were included (i.e., date of installation and one date of cleaning in October). The average for the week following those two dates was 0.89 m^{-1} at Westcott Bay.

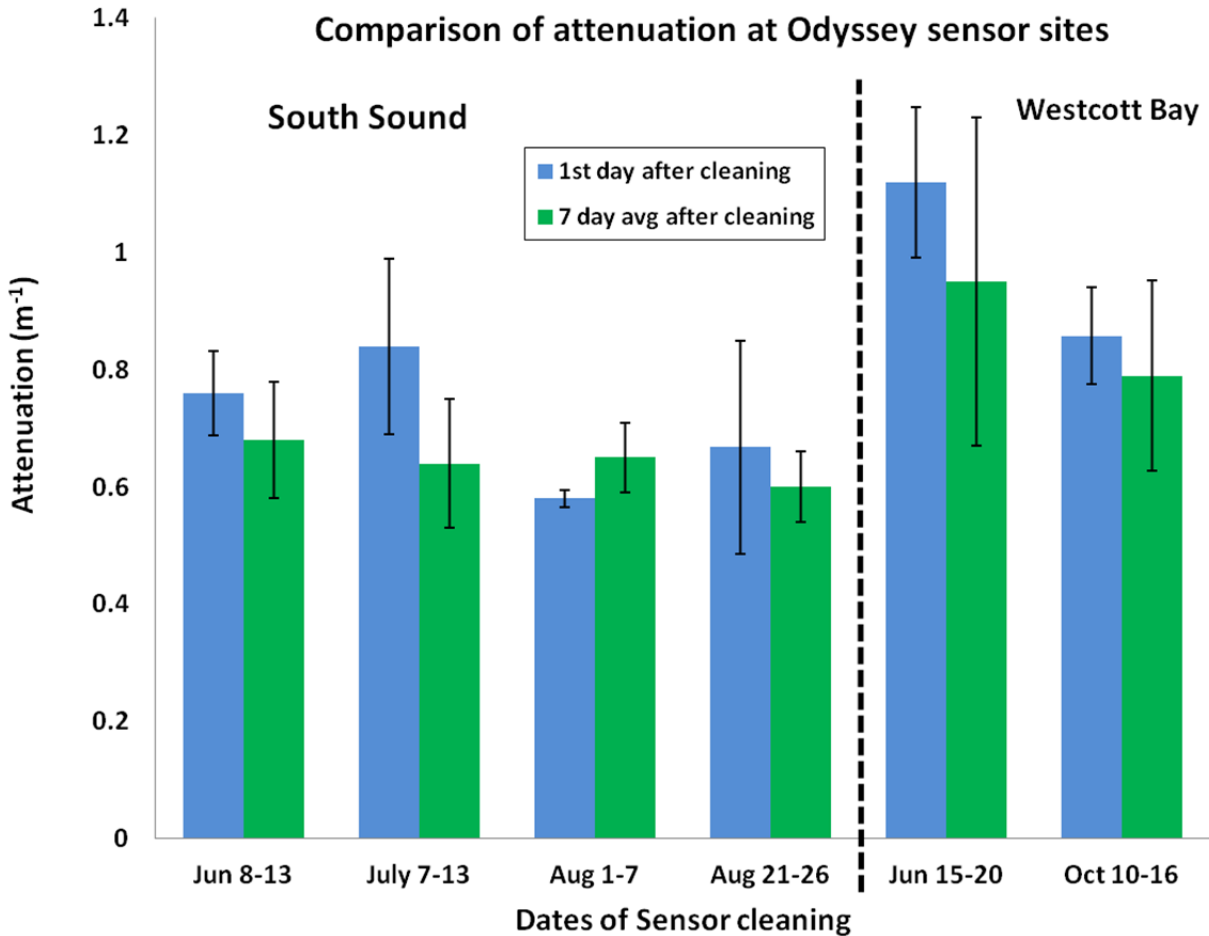
Figure 12. Comparison of average daily attenuation coefficients calculated when sensors were installed or cleaned, and calculated one week after placement. Error bars are 95% C.I.

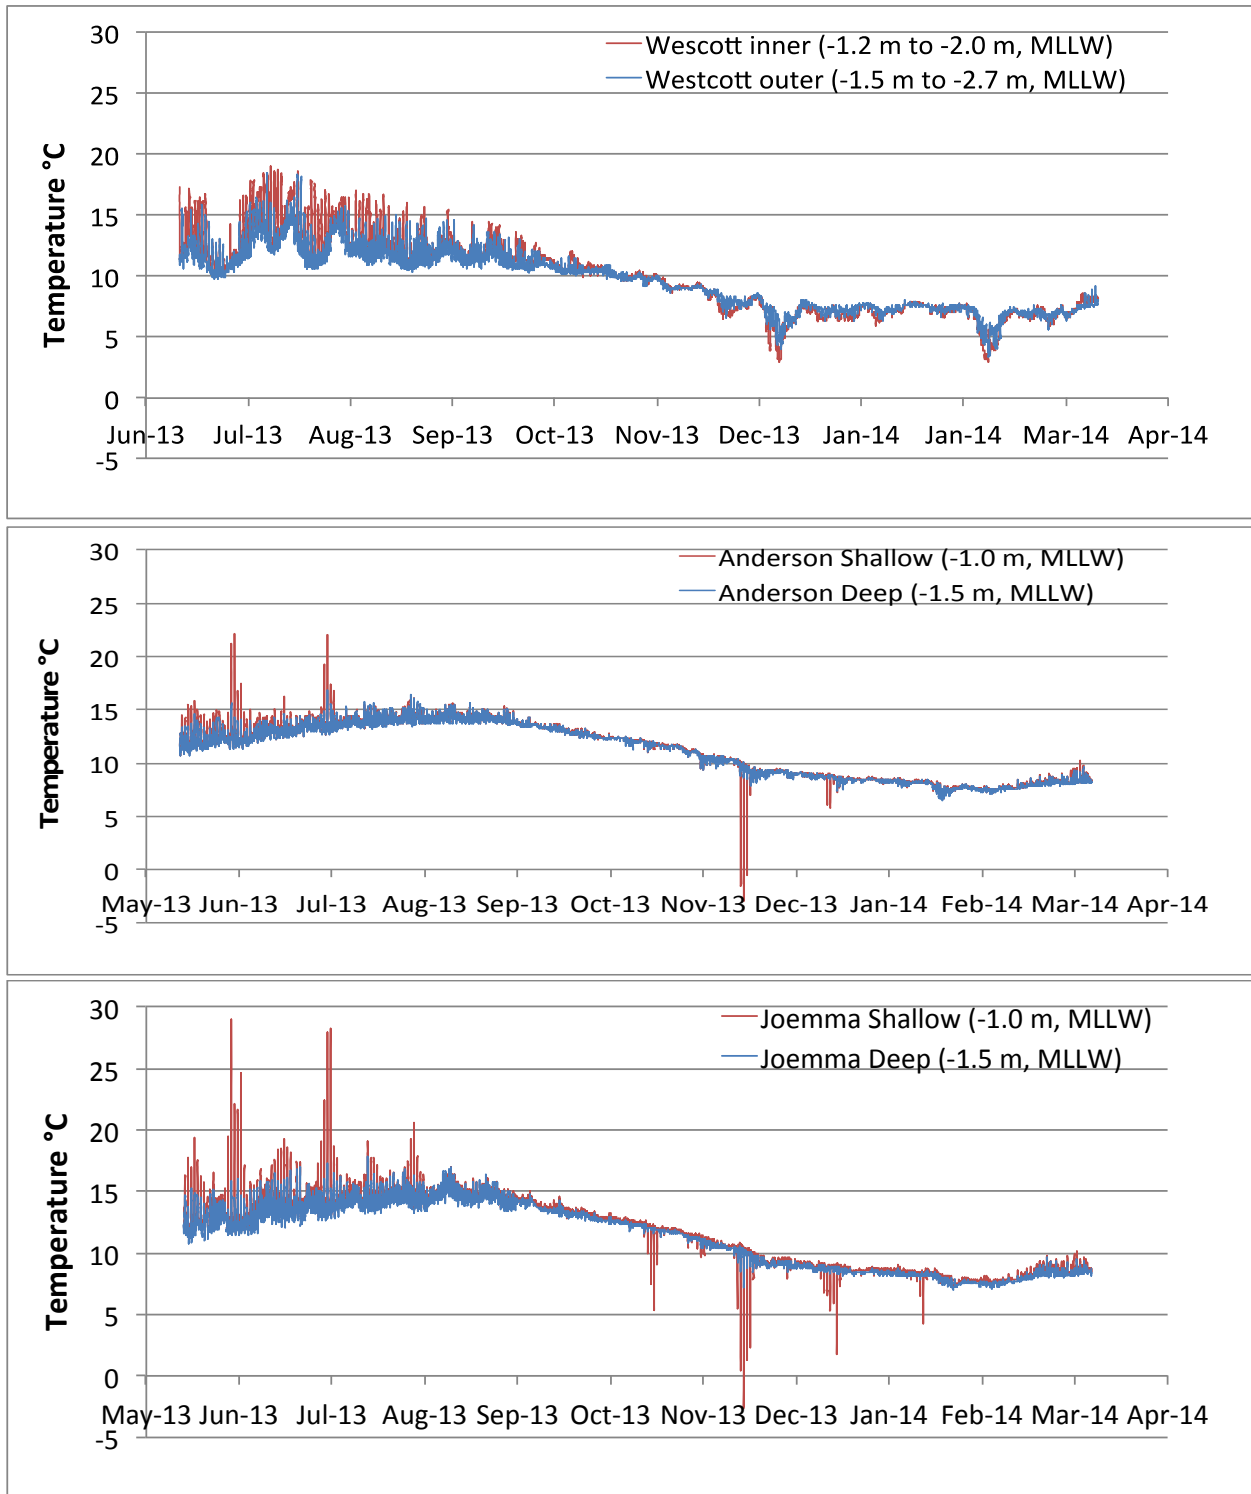
Figure 13. Daily temperature data at eelgrass canopy depth from selected eelgrass test planting locations in Puget Sound (Westcott Bay –top, Anderson Bay – mid, Joemma State Park (lower)).

Figure 13 provides temperature plots for Westcott Bay, Anderson, and Joemma State Park. The positive and negative spikes in temperature seen at Anderson and Joemma State Park for the shallow sites coincide with tides and likely reflect air temperature when sensors were exposed to air or were very shallowly submerged. With the exception of those cases, temperature varied more widely at Westcott than the other sites with the inner site showing consistent temperature above 15°C in summer. Warm periods were followed by much cooler periods at Westcott. Anderson and Joemma State Park showed less variability than Westcott during summer and were slightly warmer in fall and winter.
