WASHINGTON STATE DEPARTMENT OF
Natural Resources

Southern Willapa Hills Retrospective Study

Southern Willapa Hills Retrospective Study
 Forest Practices Division
 Department of Natural Resources

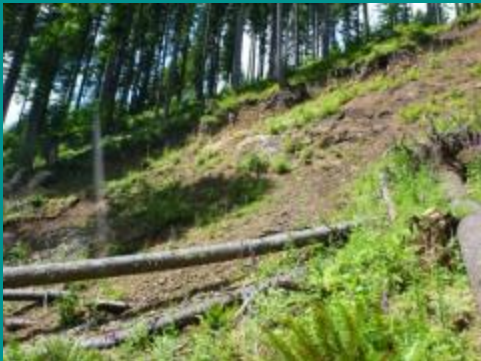
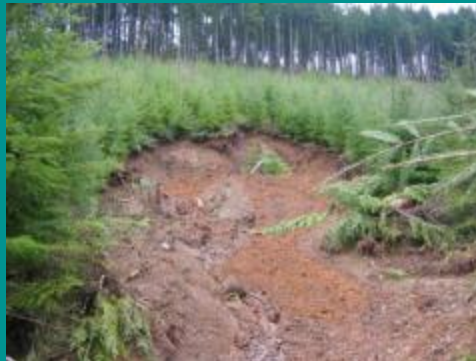
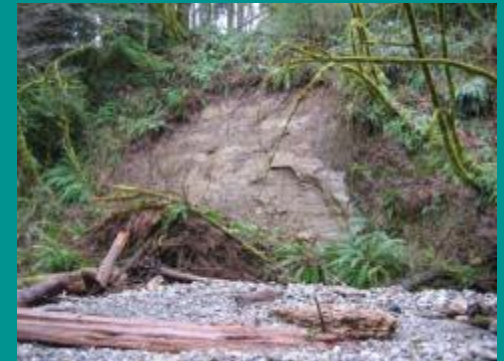
- A 2007 storm event in the Willapa Hills of SW Washington
- Many landslides delivered debris and sediment to typed waters
- Some landslides initiated in approved Forest Practices Application (FPA) areas

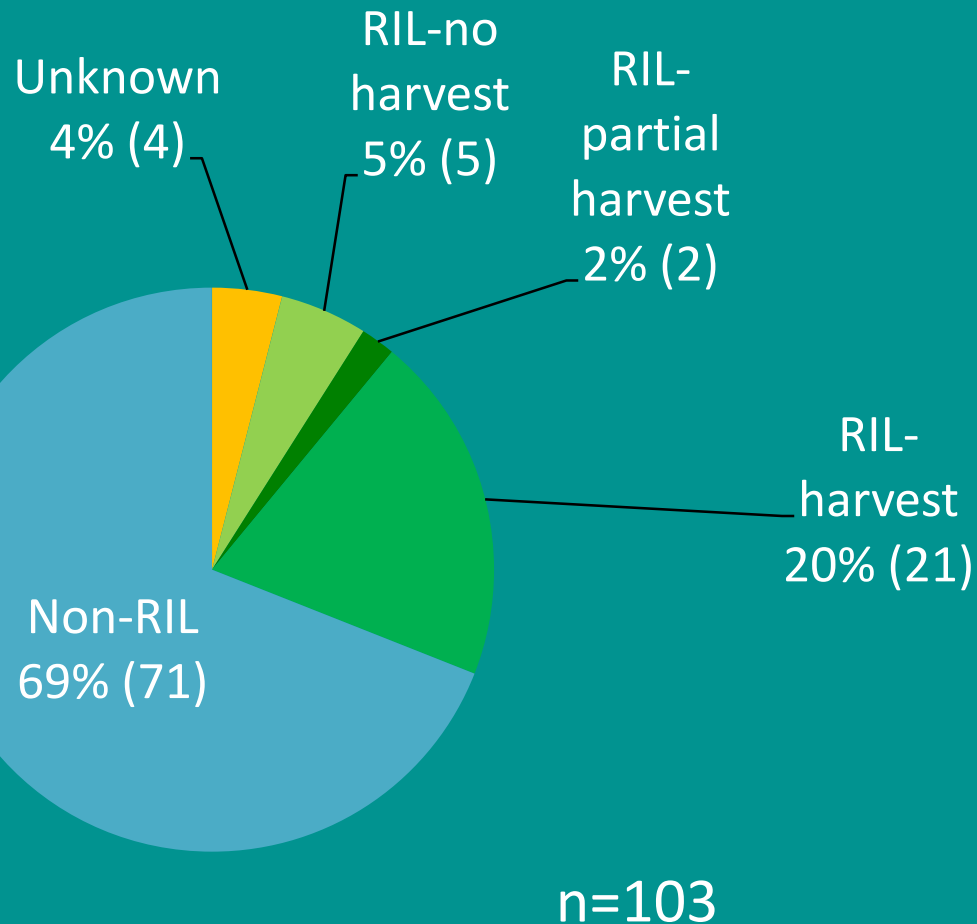
Landform and harvest type prior to failure

- 71 landslides from “non-RILs” (buttress support was removed, measuring)
- 4 landslides unknown
- 28 landslides from probable RILs
 - no harvest on 5
 - partial harvest on 2
 - 21 harvested

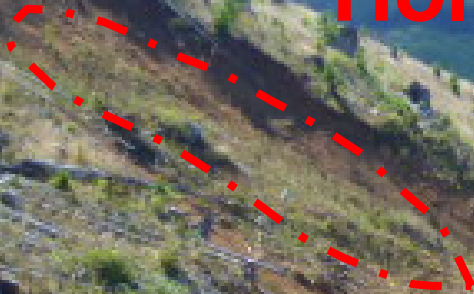
**Little Mill Creek
Stillman Creek Area**

**Removal of buttress support
by debris flow**

**Debris slide failure
Side slope 51%, planar,
no convergence
(as indicated by Lidar)**

**Debris Flow
Removes
Buttress support**

**Debris Avalanche Failure
55-60 percent slope**

**Bedrock
Hollow?**

**Landform
Obliterated?**

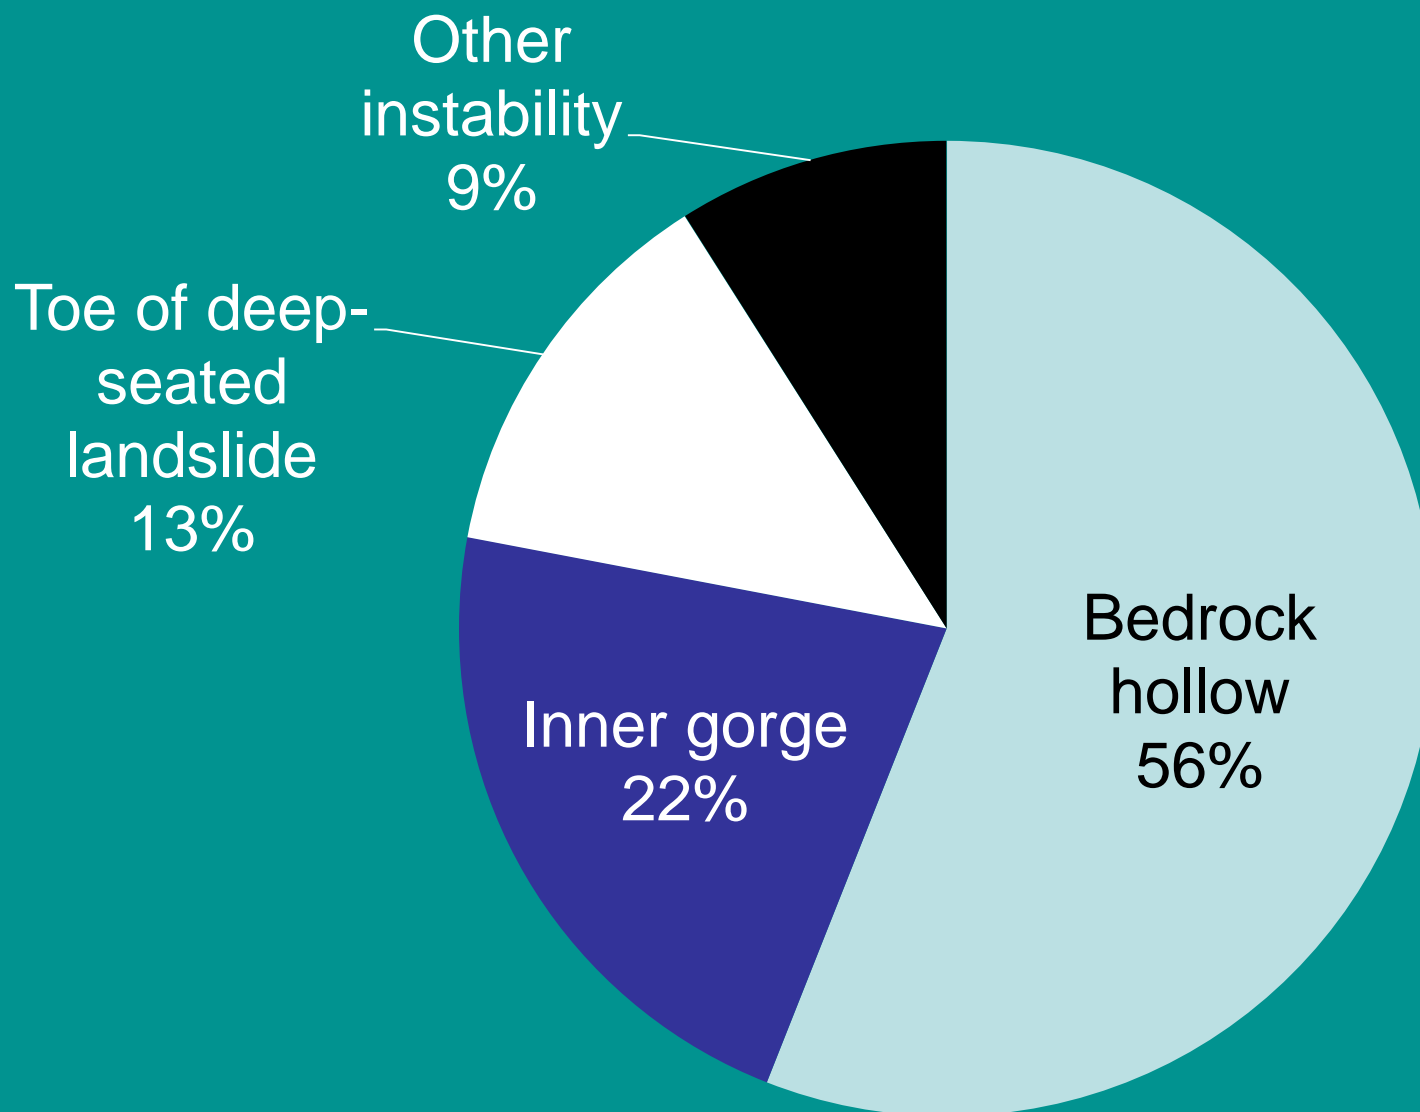
RIL type for harvested landslides originating in probable RILs

There were no glacial deep-seated landslides in the Willapa Hills Study

n=23
