**EFFECTIVENESS OF FOREST ROAD
AND TIMBER HARVEST BEST MANAGEMENT PRACTICES
WITH RESPECT TO SEDIMENT-RELATED
WATER QUALITY IMPACTS**

Interim Report No. 2

May 1994
Ecology Publication No. 94-67
printed on recycled paper

by
Ed Rashin
Casey Clishe
Andy Loch

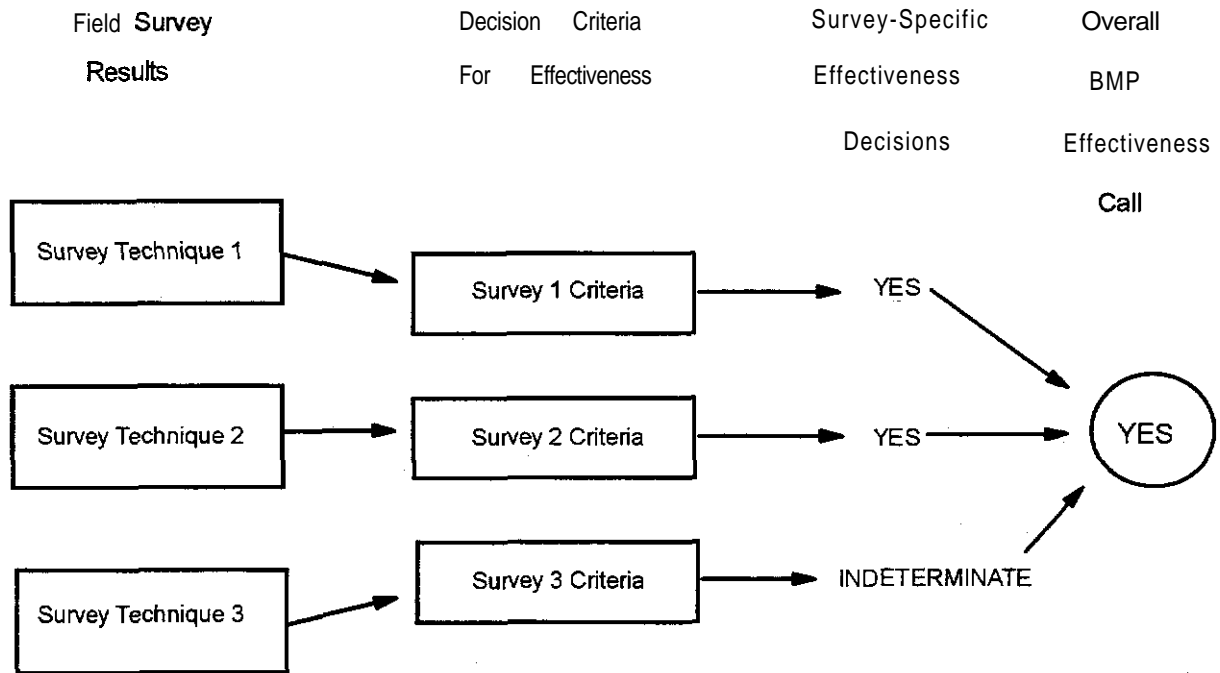
Figure 1: Weight-of-Evidence Approach for Determining BMP Effectiveness

(Applied to Each BMP Example)

The weight-of-evidence approach is illustrated in Figure 1. The results of each survey will be evaluated using decision criteria which relate survey results to the water quality standards and erosion processes the BMP is intended to control. Survey results will fall into one of three categories: "Yes," the BMP example was effective; "No," the BMP example was not effective; or, in some cases, "Indeterminate," meaning effectiveness could not be determined for this BMP example with the survey technique used. Indeterminate calls may be used where it is found that the survey technique was not appropriate to document the type of change that occurred at a particular site, or where interferences did not allow adequate evaluation of a particular practice. The evidence from the different survey techniques employed will be used collectively to determine effectiveness of that particular BMP example. However, since the survey techniques vary in their sensitivity, all survey results may not be weighted equally. The overall BMP effectiveness call for each example will be either "Yes," "No," or "Partially Effective" (in the case of mixed results).
