Cascadia Deep Earthquakes

2008

Deep earthquakes

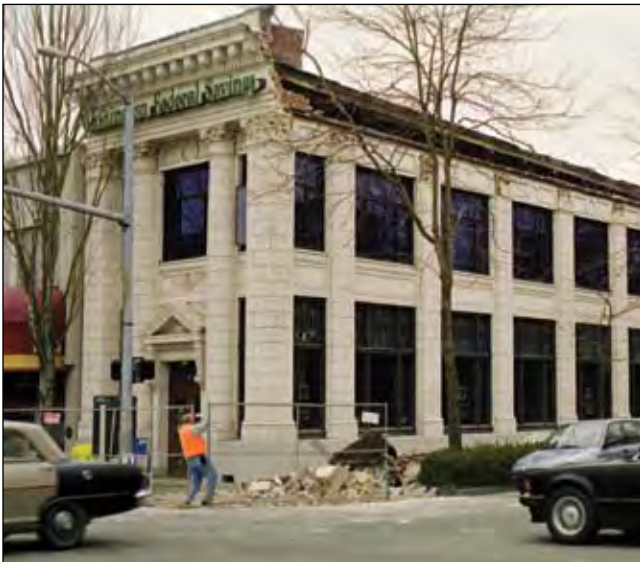
This photo of a building in Olympia after the 2001 Nisqually earthquake shows typical damage from a deep earthquake. A major source of injury is falling parapets, such as those seen above. Photo: Josh (Robert) Logan, DGER

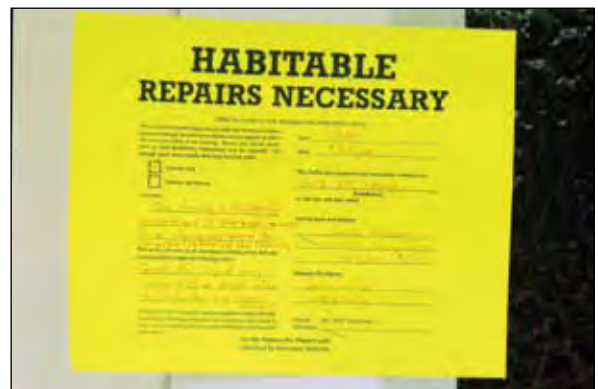
Many structures, utility lines, and transportation systems (road, air, rail, port) need to be inspected after a large earthquake. Structures can be given a yellow tag, like this one, meaning it can be used to some extent but repairs must be made. A red tag means the structure cannot be used until it is repaired. Photo: William S. Lingley, DGER

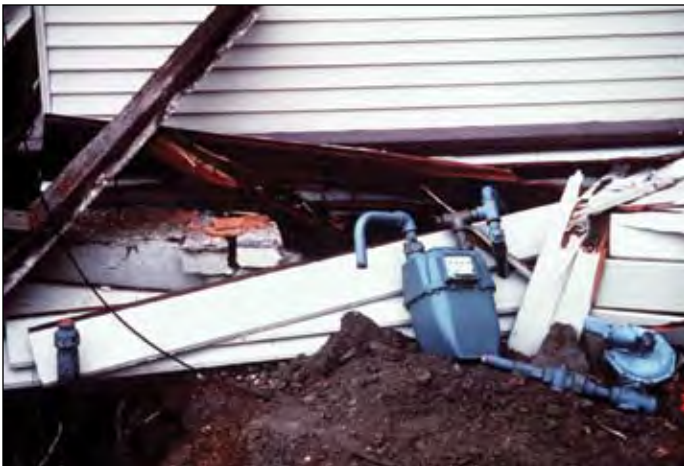
This house shifted off its foundation, breaking the utility lines and leaving it uninhabitable. Newer building codes require a house being tied to the foundation, but homeowners may need to retrofit older homes. Photo: USGS

Wood-frame homes generally fare well in earthquakes. But chimneys and brick facings can collapse and windows can break. If not securely fastened together, a house may separate from its foundation, disconnecting utility lines and making the house unlivable.

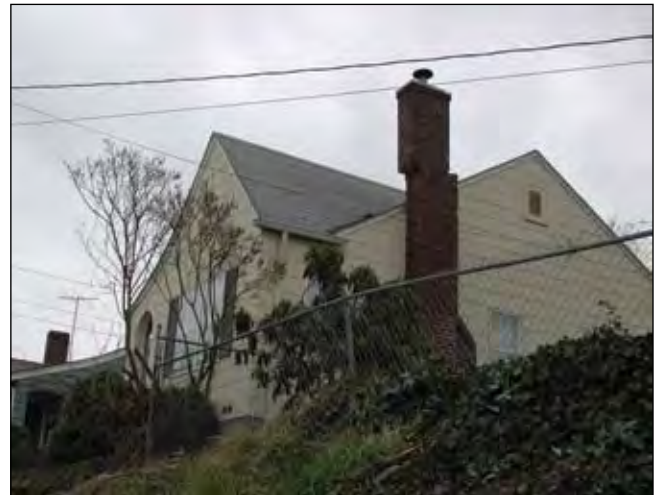
Chimney failures are a common problem for homeowners after an earthquake. The above chimney did not fall but remained a safety hazard until it was rebuilt. Photo: Michael Polenz, DGER

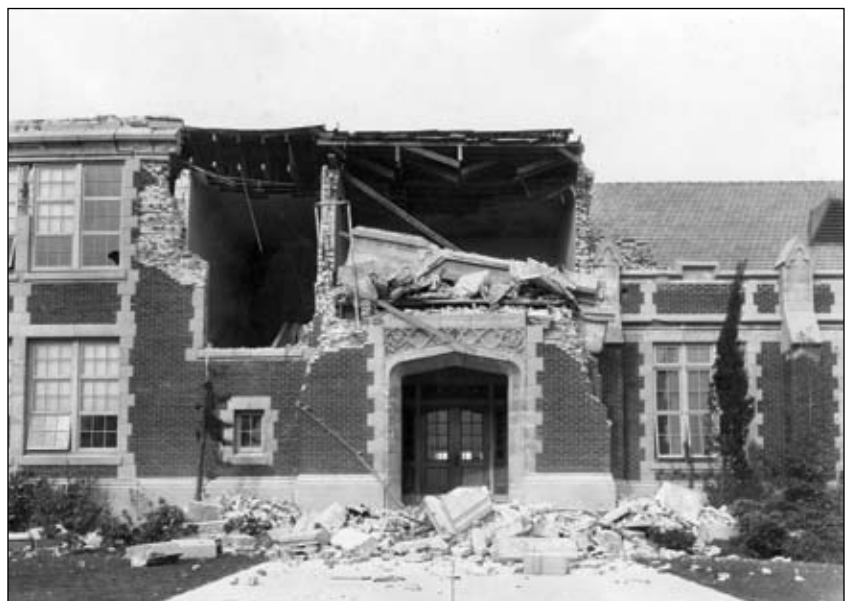
The Long Beach, California school above shows how dangerous old, brick buildings can be. In the 1949 Olympia earthquake, the Senior Class President of Castle Rock High School was killed by falling bricks. The gable on the school collapsed, even though the structure was more than 50 miles (80 kilometers) from the epicenter. Photo: USGS

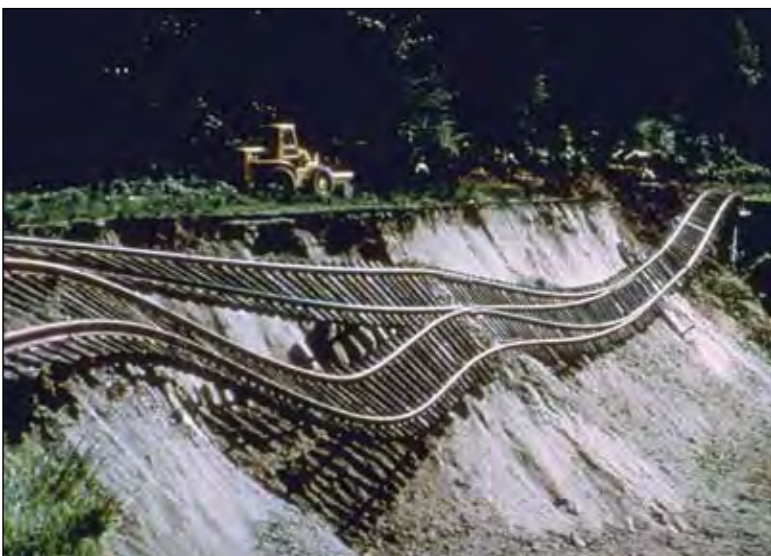
Landslides are an often-overlooked danger of earthquakes. They are particularly likely during rainy, water-soaked winter months in Cascadia. Almost 40 miles (60 kilometers) from the epicenter, this section of the Union Pacific Railway was left dangling after the hillside fill beneath it slid away in the 1965 earthquake. A sewer main also broke. Photo: University of California, Berkeley

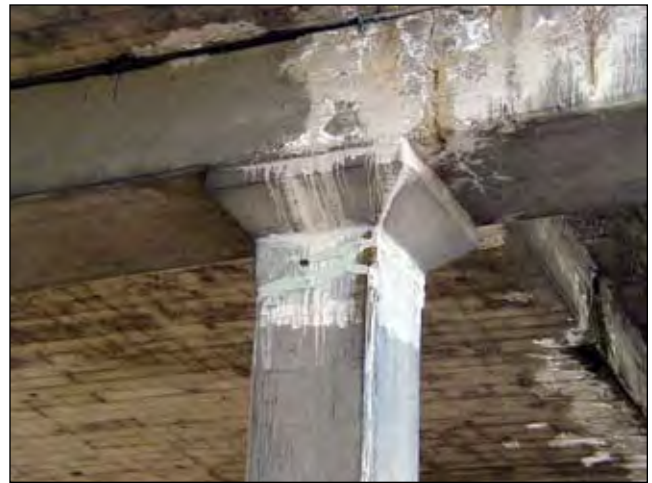
The South Park Bridge in Seattle suffered extensive damage. Above is one of 22 columns that cracked in the earthquake. Epoxy was injected to shore up the structure. Crews worked round the clock to repair this and other structures throughout the area. Photo: King County

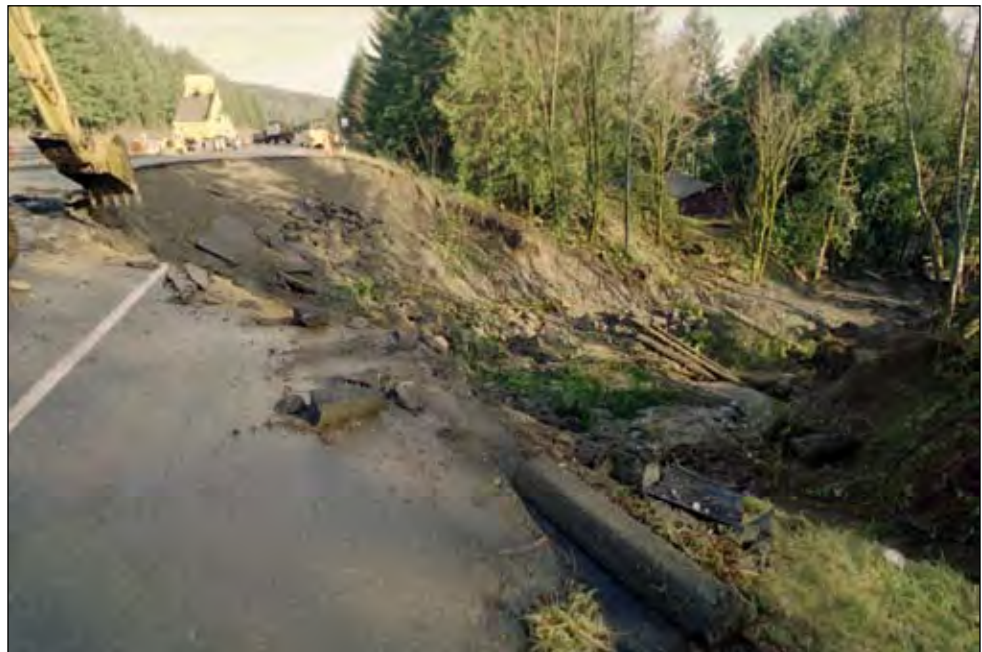
Liquefaction, lateral spreading, and landslides damaged many roads throughout the area. Photo: William S. Lingley, DGER

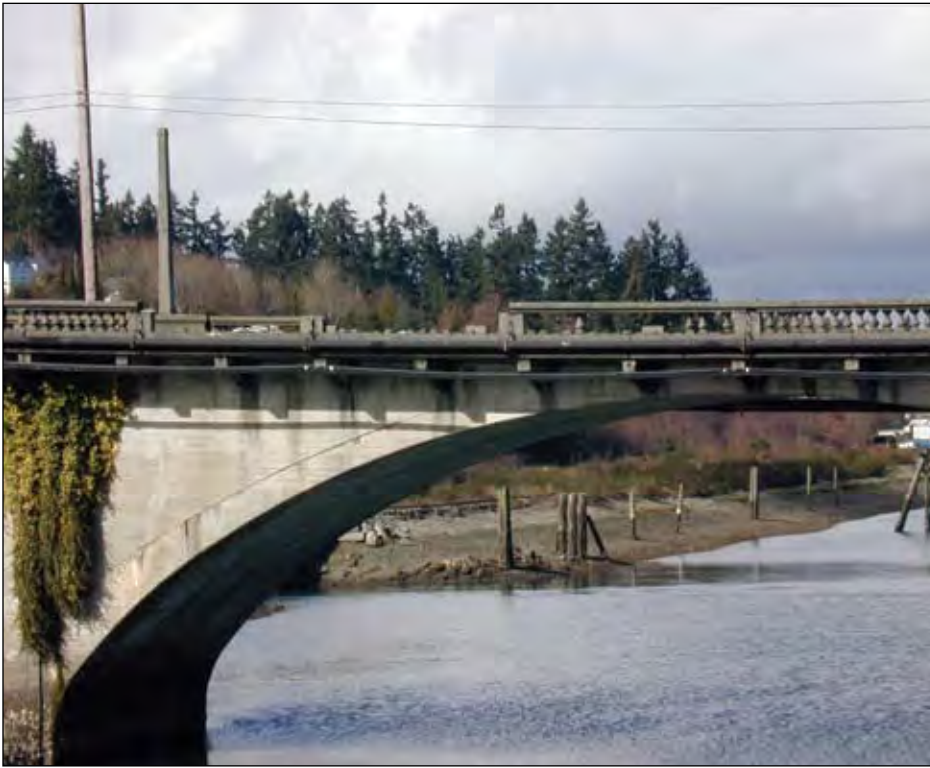
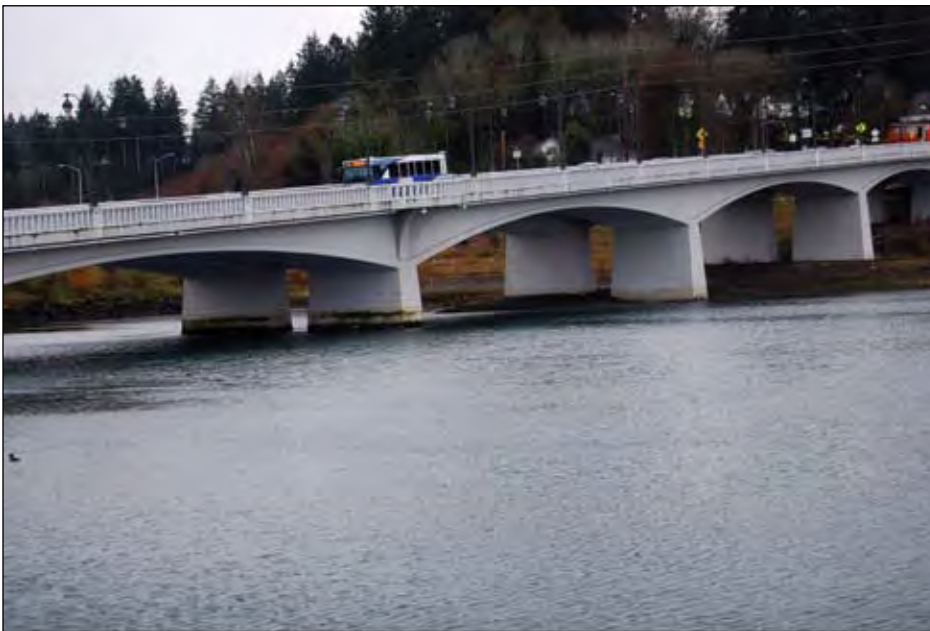
Olympia's Fourth Avenue Bridge was closed after the earthquake because of severe damage (above). The rebuilt structure (below) is an asset to the community, not only because of its aesthetics, but because it was designed for pedestrians and bicyclists as well as automobiles. Above photo: Robert J. Reid; Below photo: Timothy J. Walsh, DGER

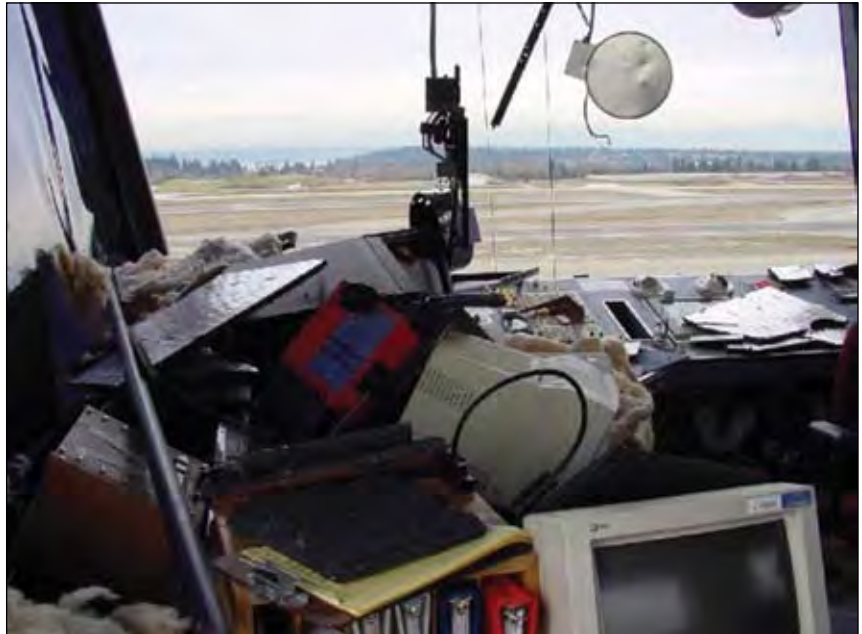
The tower at Sea-Tac sustained both structural and nonstructural damage. Even so, the airport was able to reopen after a few hours. Photo: Washington State Department of Transportation

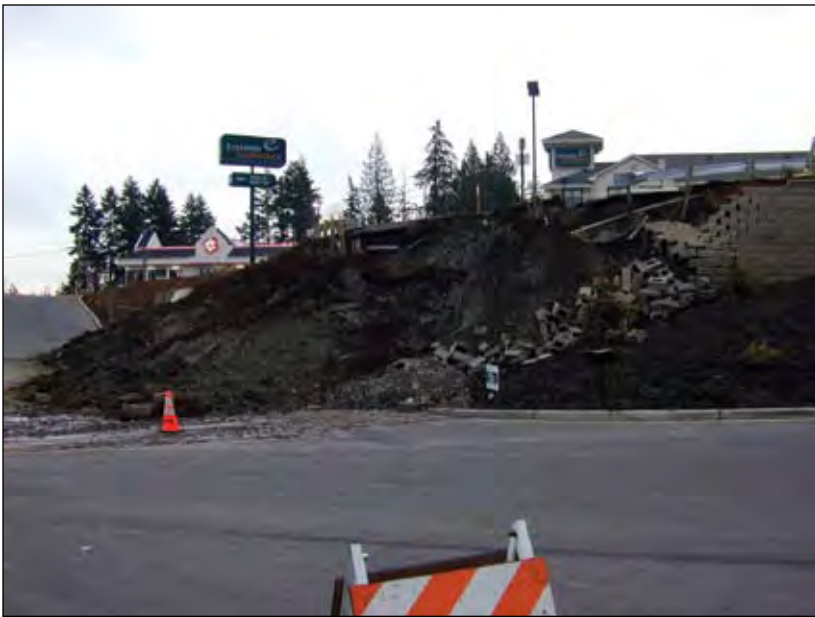
Liquefaction and landslides can break utility lines as well as damage roads and property. With widespread damage, repairs may take longer than expected. Photo: Robert J. Reid

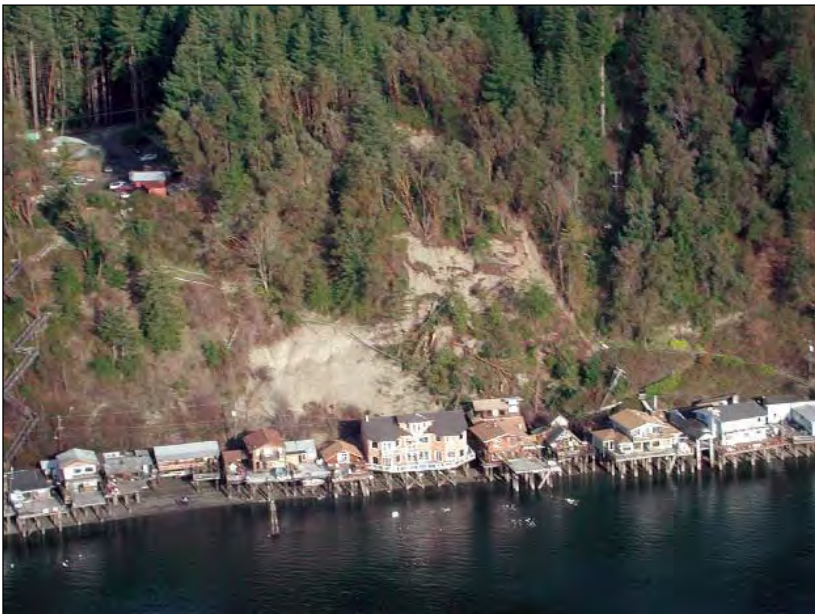
Salmon Beach, near Tacoma, was the site of a landslide three days after the 2001 earthquake. The same hillside slid after the 1949 event. Photo: Dave Sherrod, USGS

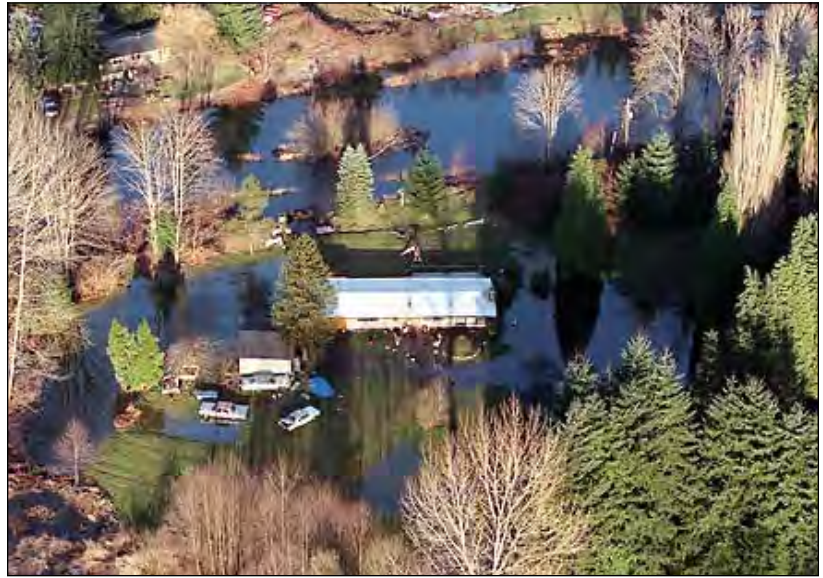
A landslide dammed the Cedar River, resulting in flooding that damaged two houses. Photo: King County
