**PREDICTION OF SEDIMENT YIELD FROM
TRIBUTARY BASINS ALONG HUELSDONK RIDGE,
HOH RIVER, WASHINGTON**

WASHINGTON DIVISION OF GEOLOGY AND EARTH RESOURCES
OPEN FILE REPORT 91-7

December 1991

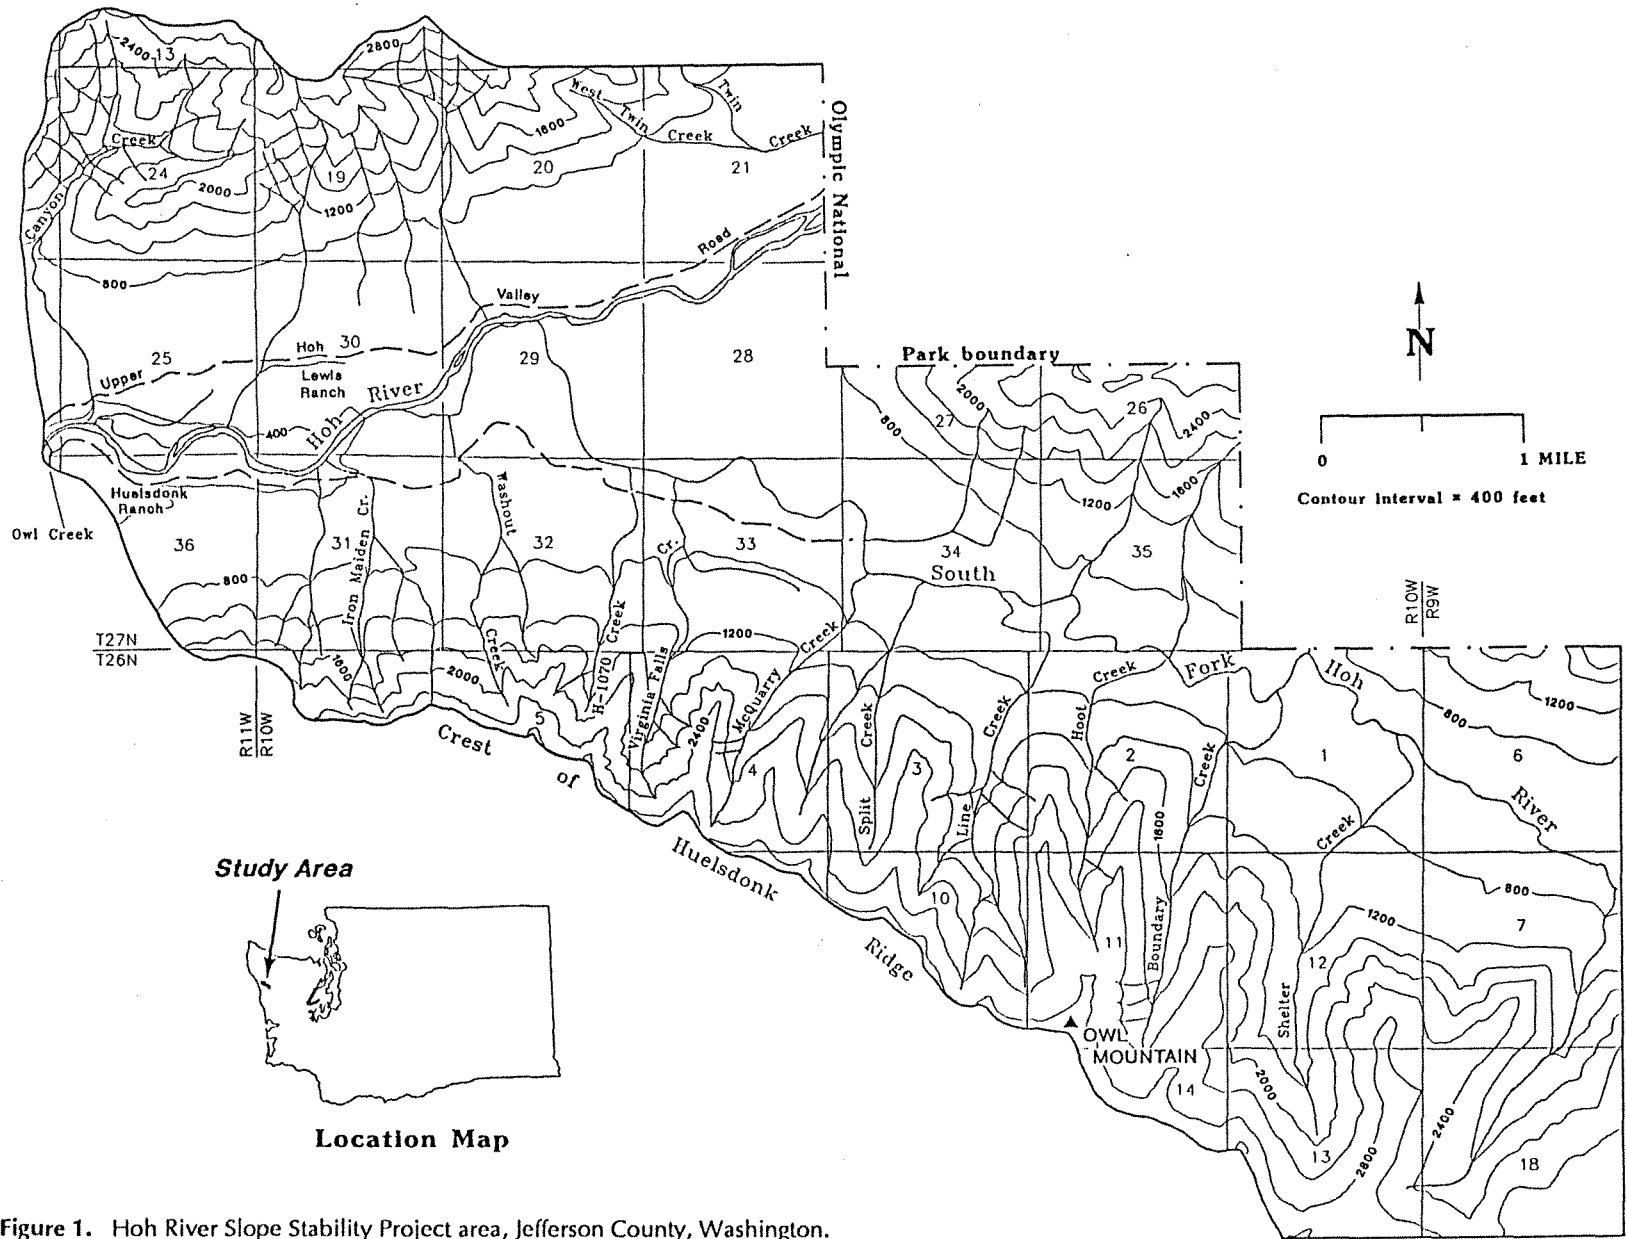
Figure 1. Hoh River Slope Stability Project area, Jefferson County, Washington.

This project is part of the Hoh River Slope Stability Project, a program designed to develop resource management alternatives for parts of the Hoh River basin (Fig. 1) and to be used as a model for developing management alternatives for other basins in which the Washington State Department of Natural Resources (DNR) has management responsibilities. In this study we have attempted to (1) assess the amount and timing of sediment delivered to the Hoh River by mass-wasting processes along the north side of Huelsdonk Ridge (Fig. 1) and (2) provide a critique of how this assessment was accomplished.

On the north side of Huelsdonk Ridge between the Olympic National Park boundary and the confluence of Owl Creek and the Hoh River (Fig. 1), nearly all slope failures that occurred during the fall and winter of 1989–1990 were spatially associated with clearcuts and/or roads. Where slope failures have been detected or investigated in old-growth areas along Huelsdonk Ridge, nearly all originated in areas affected by drainage alterations, clearcuts, or sidecasts.

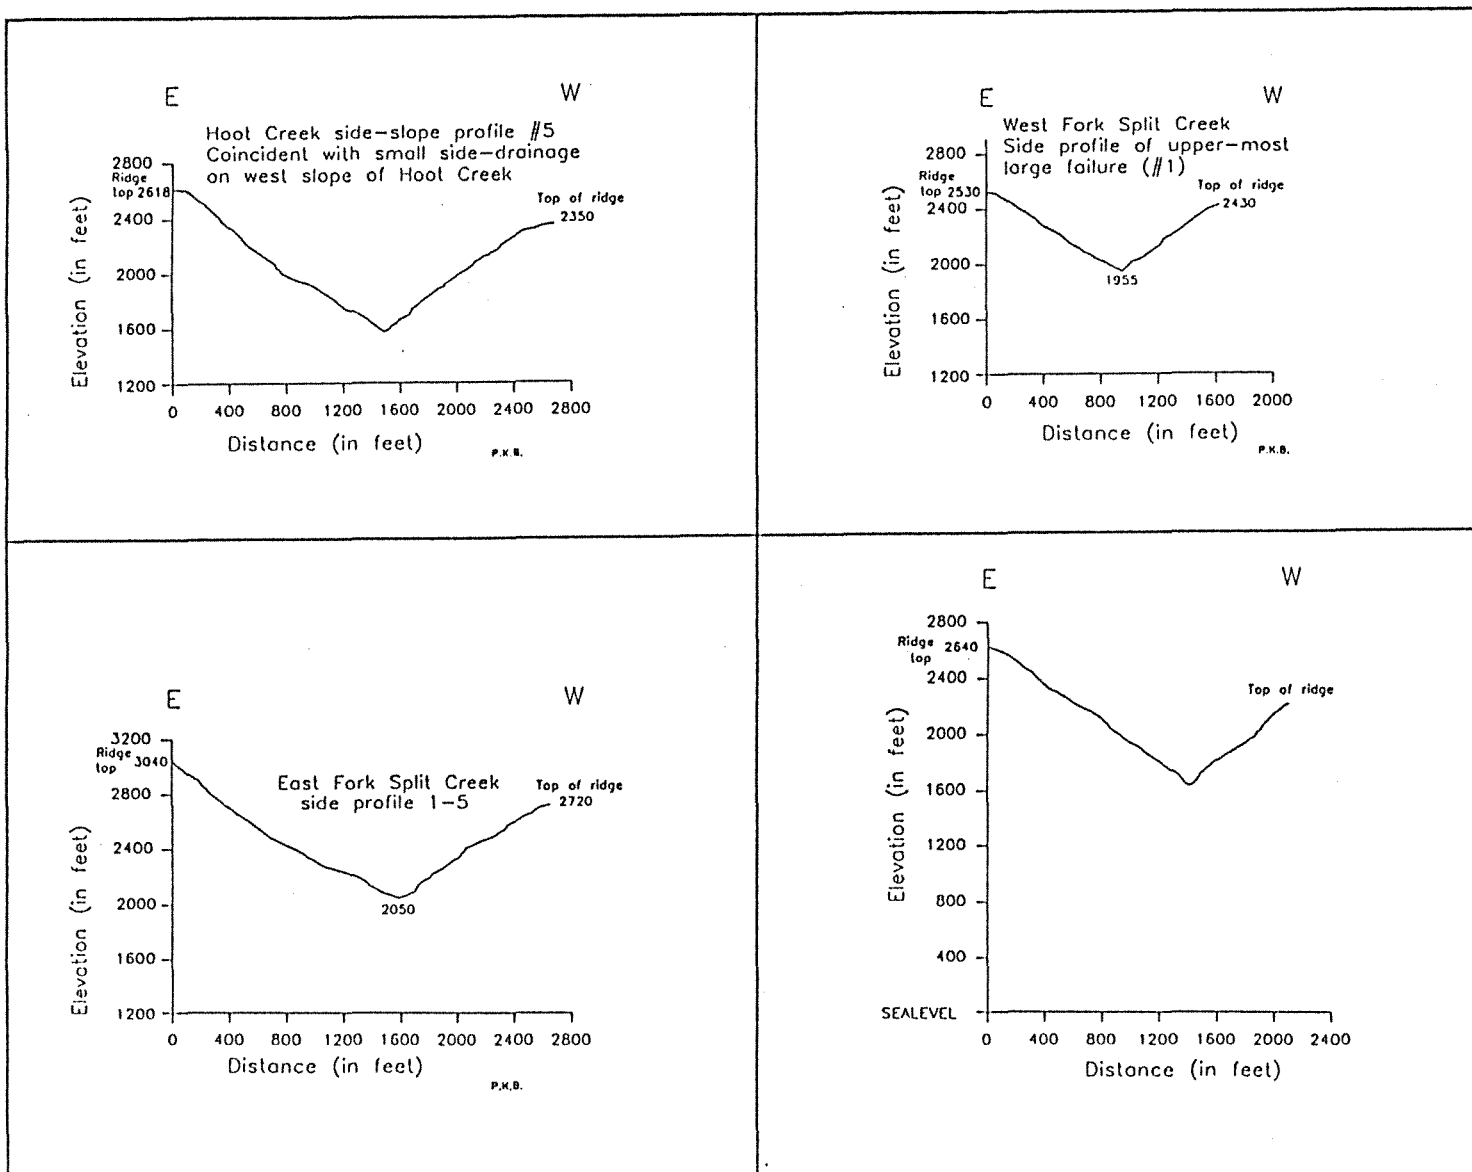
Figure 2. Cross sections of asymmetric tributary valleys. Landslides are commonly associated with the longer, straighter, or concave-upward slopes. Cross sections were scaled from DNR 1"=400' topographic maps, then digitized using computer-aided drafting (CAD).

A higher proportion of failures occurred on the long, planar slopes of asymmetric tributary valleys than on the shorter and/or convex-upward slopes (Fig. 2). This trend may be related to the distance of failures from the drainage divide, but this relation was not investigated. Because so many local factors, such as soil depth, soil density, discontinuity surfaces (soil/bedrock interfaces), and root cohesion (Buchanan and Savigny, 1990) influence slope stability, it is difficult to make accurate stability predictions over large areas without large-scale detailed investigations. Tributary-wide morphological factors, such as valley asymmetry, however, can be used to identify general areas of relatively greater landslide risk.

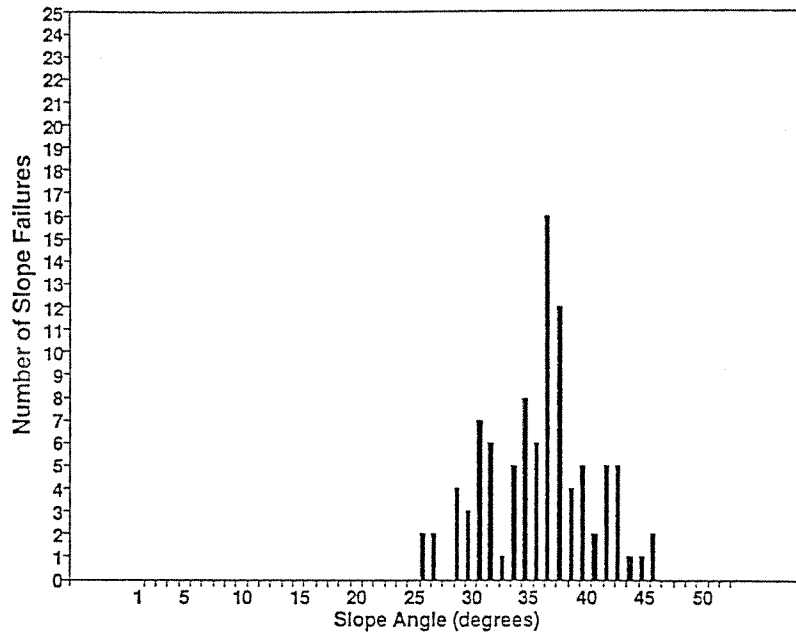
Figure 3. Slope angle vs number of slope failures in 10 tributaries on the north side of Huelsdonk Ridge.

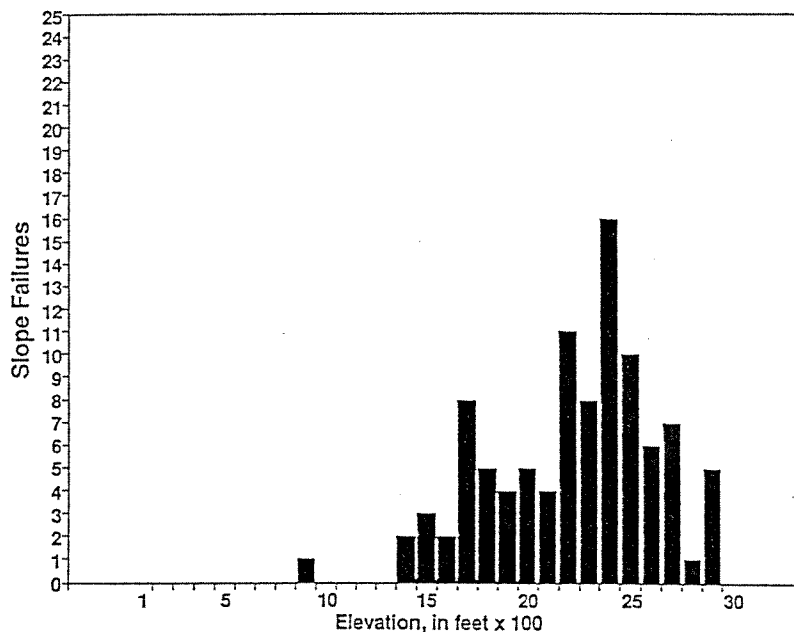
Figure 4. Number of slope failures vs elevation in 10 tributaries on the north side of Huelsdonk Ridge.

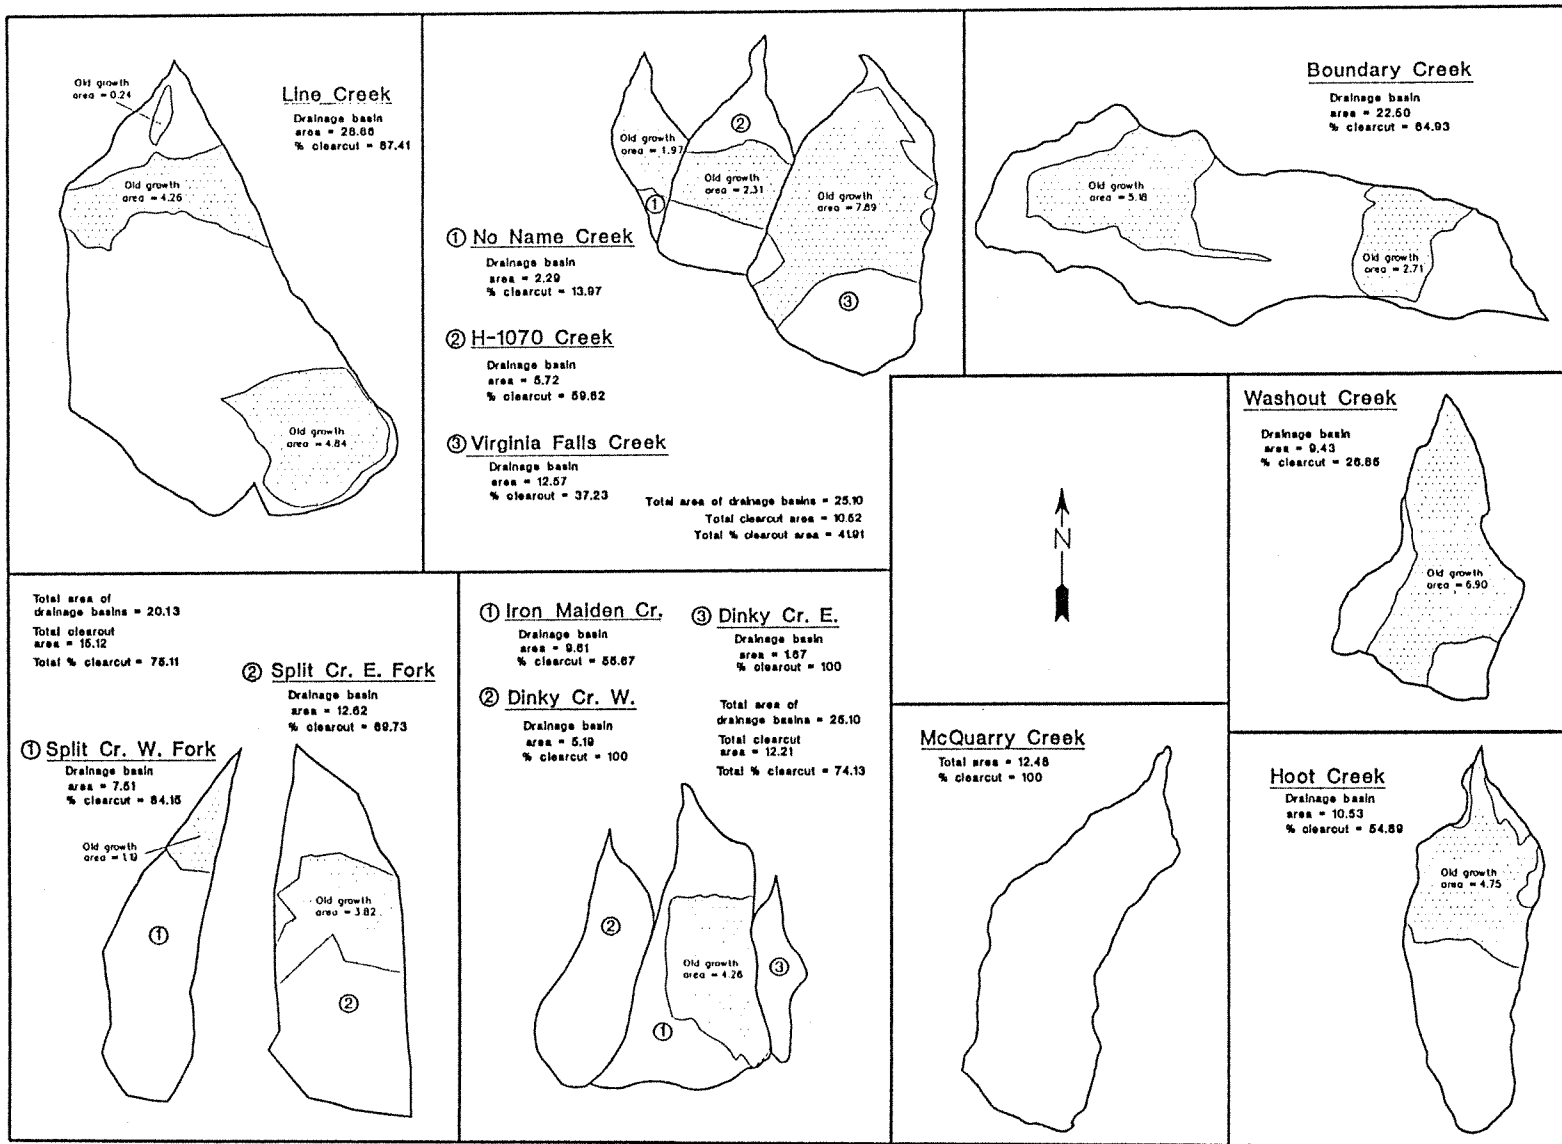
Figure 5. Maps generated by digitizing directly from aerial photograph overlays using computer-aided drafting (CAD). This is a rapid approximation of stand inventory, which can also be produced by other techniques such as Geographic Information System (GIS) and video image analysis. No calibration.

Future sediment delivery rates can be approximated by comparing the sediment inventory, which has been summarized in Table 5, with stand inventory maps (Fig. 5). The results are shown in Table 6. The roots of

Figure 5 shows the distribution and percentages of clearcut and old growth stands. Areas were measured directly from aerial photographs; they were not corrected for distortion and are, therefore, approximate. By comparing sediment inventory to areal distribution of old growth, it can be shown that for those basins in which mid-slope failures dominate, expected sediment delivery can be prorated on the basis of old-growth distribution. For example, Virginia Falls Creek (Fig. 5) is 63 percent old growth and 37 percent clearcut, that is, there

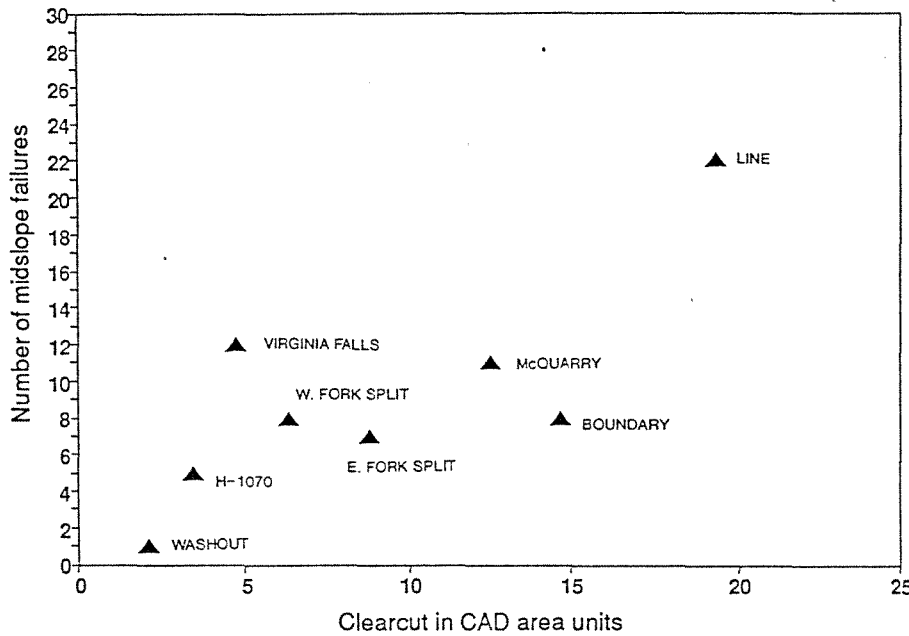
Figure 6. The relationship between the amount of area logged and the number of landslides is apparent in this chart. Area is plotted as CAD area units because they were measured by the computer on areas digitized directly from aerial photographs without terrain correction.

Although our data are limited, there is a rough correlation between the number of landslides and the amount of land logged on Huelsdonk Ridge (Fig. 6). This is consistent with the conclusions in Eide (1990), who showed that the number of landslides in the Deer Creek basin in Snohomish County is directly related to the size of the area logged.

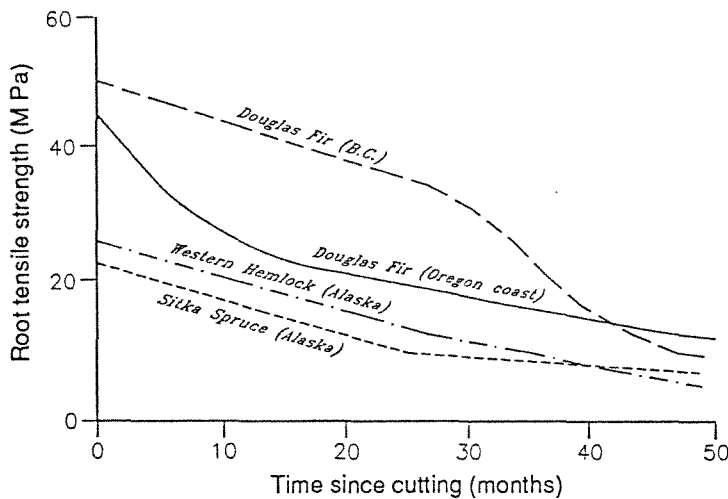
Figure 7. Curves of mean tensile strength vs time elapsed since tree felling for small roots of various conifer and hardwood trees (Modified from O'Loughlin and Ziemer, 1982).

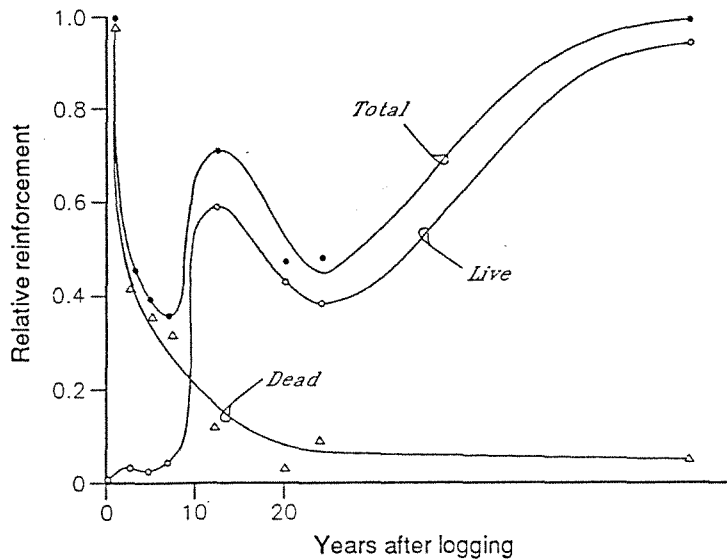
Figure 8. Relative reinforcement of soils by live roots generally increased while that by dead roots rapidly decreased with time after clearfelling. The total reinforcement by live and dead roots dropped to a low point about 7 years after logging (Redrawn from Ziemer, 1981).
