**Appendix 1: Cypress Island Net Pen Failure Engineering Review
(December 29, 2017)**

Cypress Island Net Pen Failure Engineering Review

December 29, 2017

Under contract with the State of Washington Department of Fish and Wildlife (DFW), Mott MacDonald reviewed information gathered following the collapse of Net Pen #2 on August 19, 2017. Net Pen #2 is owned by Cooke Aquaculture Pacific, LLC (Cooke) and is located near Cypress Island, Washington. The purpose of the work was to determine the physical cause(s) that led to the failure of the net pen structure.

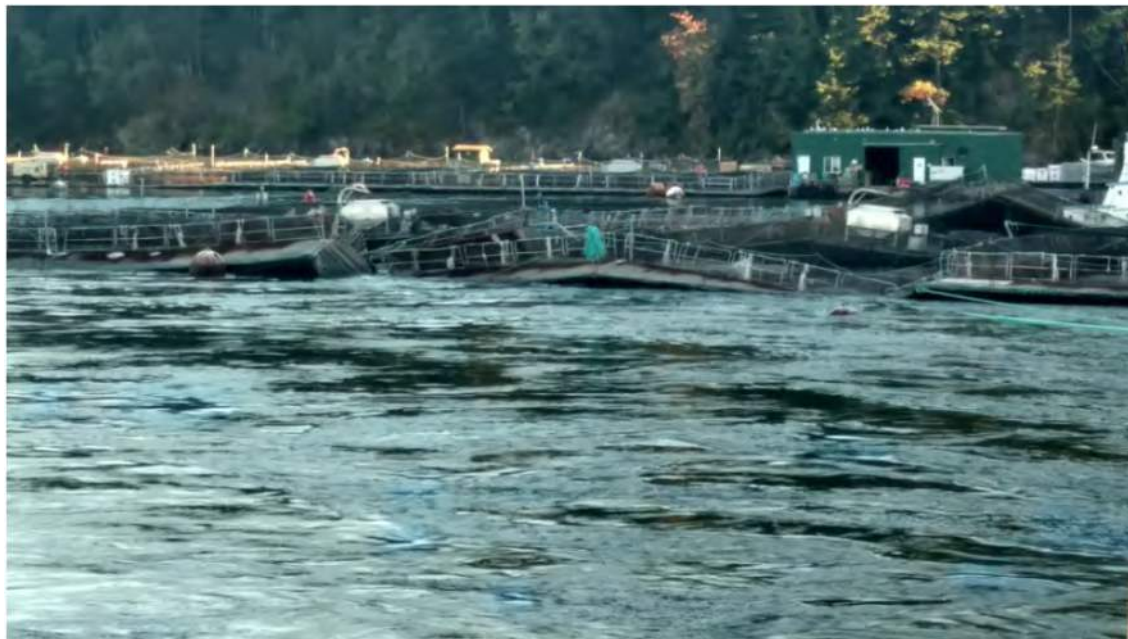
Figure 4.2 – Net Pen #2 in July 2017 (Source: Harley Marine)

Based on Cooke's response to the Administrative Order, on the evening of Monday July 24, 2017, staff at the facility reported mooring failures at Net Pen #2 (Figure 4.2). Ten anchor points

on the cages (walkways) had broken and other anchors had dragged, thereby causing Net Pen #2 to shift considerably. It is unclear if the “anchor points” meant individual pad eyes or the complete mooring bracket assemblies. Tug assistance was called to stabilize Net Pen #2. The vessel Millennium Star, from Harley Marine, was involved in the operations during this time. During the operations, moorage anchors which were replaced on July 25 had broken free from the connection points on the floats, causing the net pen to shift again. Operations to stabilize the net pen continued through July 29 (Figure 4.3). During this time, the entire mooring system and anchor points had been replaced and re-tensioned. As per Cooke’s response, by July 29, the facility had been tensioned and stabilized to a “95% level”. Based on inspection by divers, there were no signs of compromised stock nets or of fish escapes.

Based on available pictures of the repairs and the responses from Cooke (including the statements by Kyle Wood during the site visit on December 19, 2017), chains were laid across the top of the walkway decks to form an “exoskeleton” and secure the floats and connect the mooring lines. No engineering documents or calculations showing the design of the exoskeleton system were received or reviewed at the time of writing this report. Steel members were also added to the outrigger float sections to strengthen the permanently deformed floats, as shown in Figure 4.6.

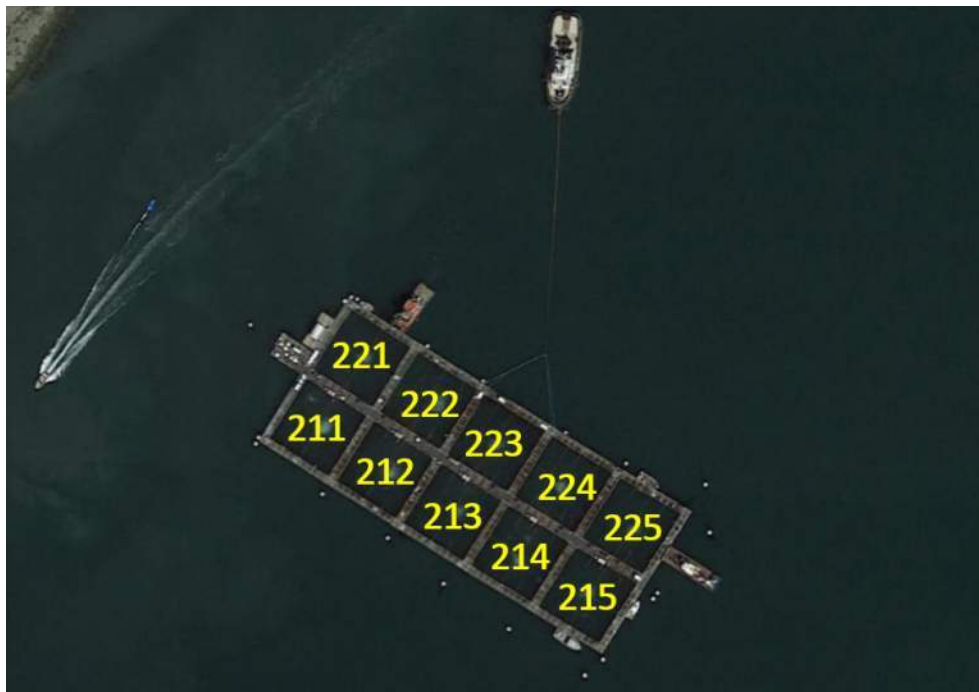
Figure 4.4 – Net Pen #2 showing the ten cages. (Source: Google Earth) Photo is from July 25, and shows the tug, towards the top of the picture, stabilizing the net pen facility. Also appearing in the picture are the Cooke work vessels outside cages 221 and 225.

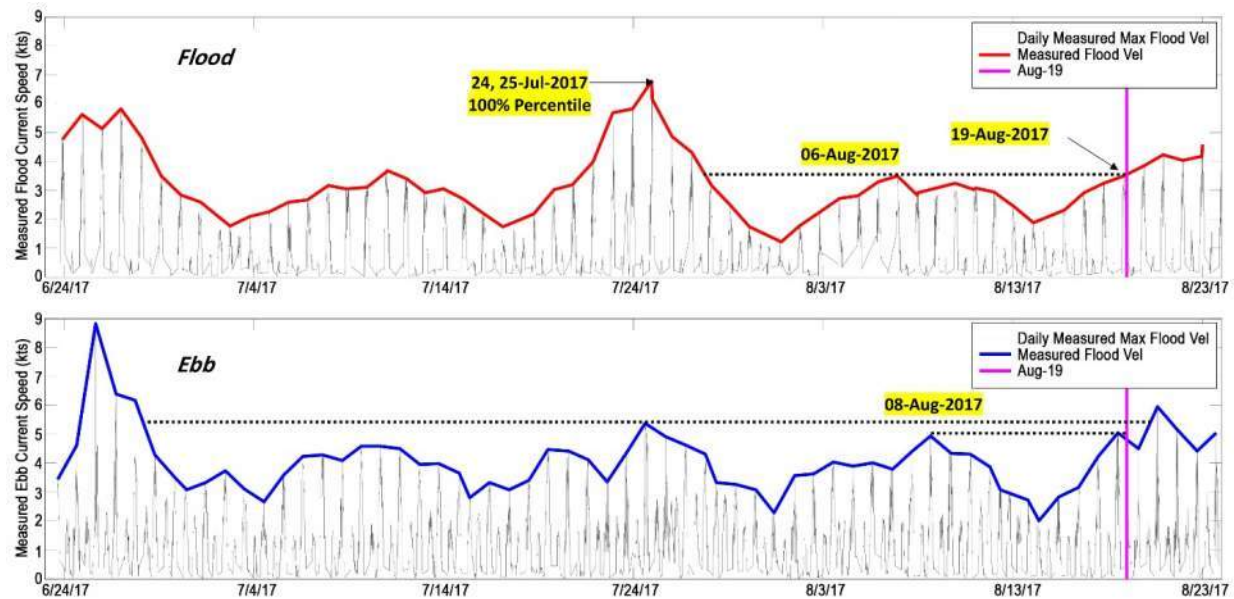
Figure 5.4 – Measured tidal currents in Bellingham Channel (20-ft. depth), June-August 2017

Although it was reported that failure events primarily occurred during flood tide, recorded daily maximum flood and ebb currents during the evaluation period (June-August) were reviewed, and are shown in Figure 5.4¹. The July 24 event first occurred near the seasonal peak flood tide current. The August event occurred during the following set of elevated flood tide currents. However, the system did not fail during flood tide currents in June, that exceeded the currents measured in August. There is less evidence that ebb tides affected the stability of Net Pen #2.

- The solar eclipse occurred on August 21, 2017. Daily maximum flood currents on August 19 were higher than normal (85th percentile during the period reviewed), but were less than the daily maximum currents measured in July.
- The currents measured on August 19 were the greatest measured since the net pen was stabilized following the July incident.
- On August 20, 2017, the measured daily maximum flood tide current increased relative to the measured daily maximum current on August 19.
- At periods between daily maximum measured currents, the currents were often measured at less than 2 knots (lower than the seasonal average).

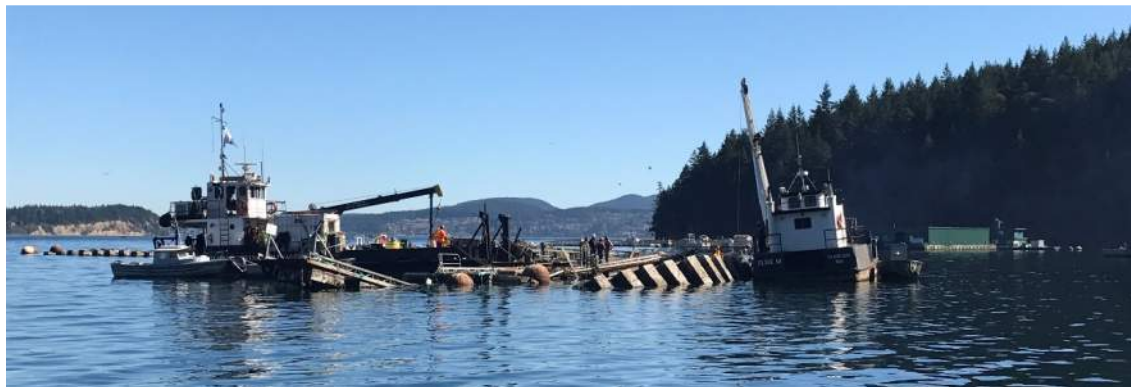
Figure 7.1 – Net pen salvage (Source: Mott MacDonald)

Following the stand-up meeting, Mott MacDonald visited the site of Net Pen #2. At the time, salvage operations were ongoing and the net pen could only be seen from afar (Figure 7.1). The components in the water were not observed closely. Some components of the facility that had been recently salvaged were on a barge near the Port of Anacortes building. This included stock nets, predator exclusion nets, walkway floats, buoys, and mooring lines.

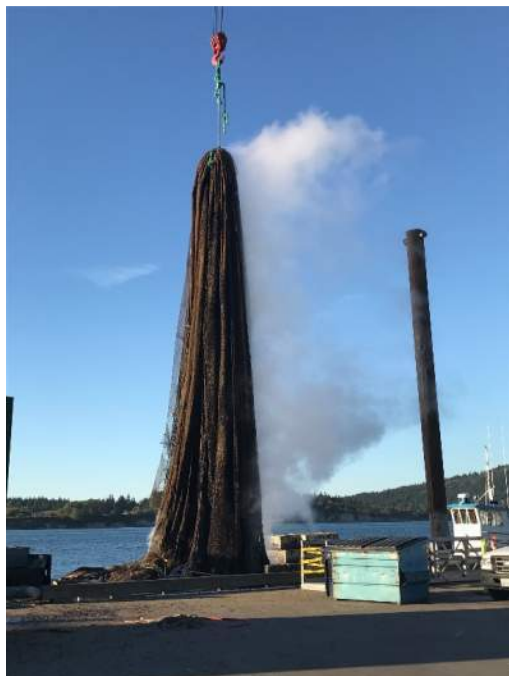
The stock nets showed considerable marine growth on them (Figure 7.2).

Figure 7.2 – Stock Nets salvaged from Net Pen #2 (Source: Mott MacDonald) Note: The steam is from the dying organisms fouling the net

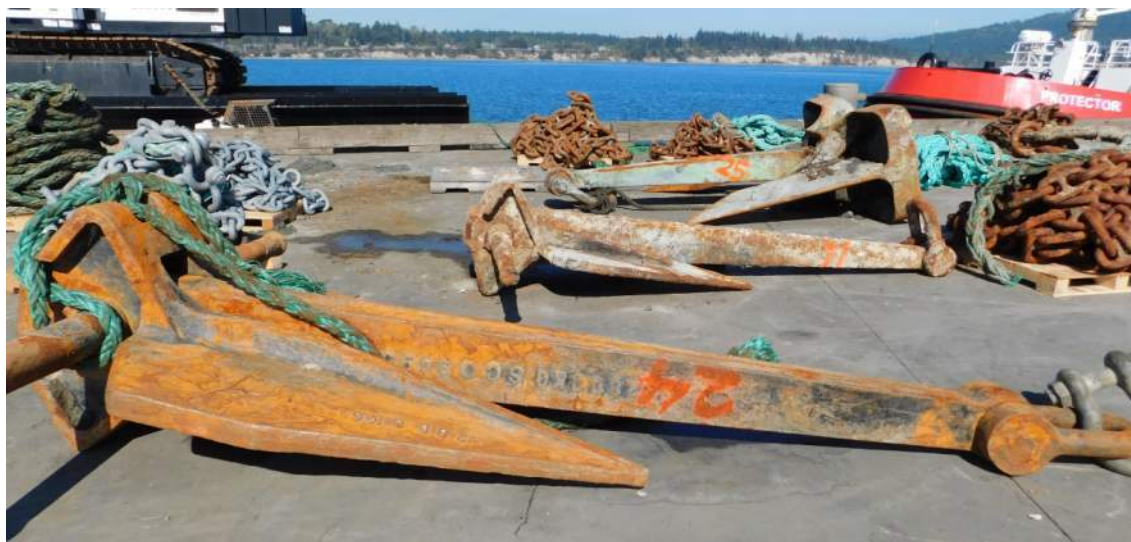
Figure 7.6 – Salvaged anchors showing different anchor types (Two Danforths in front, One Eells in back) (Source: Mott MacDonald)

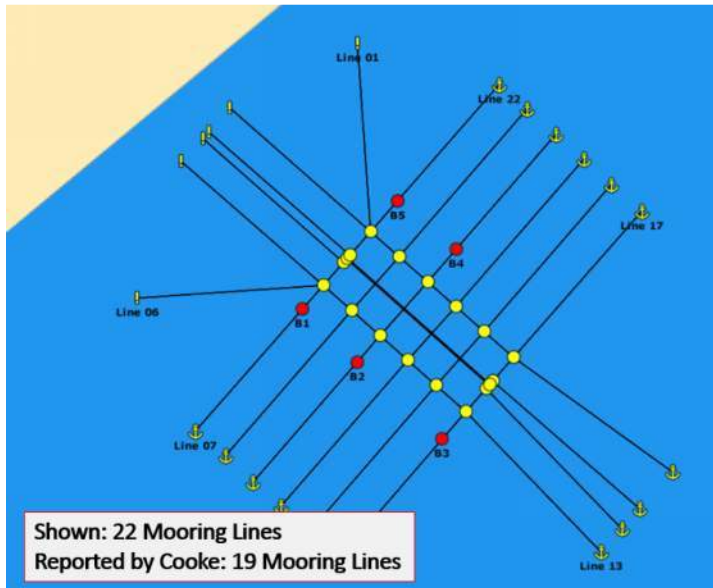
Figure 8.2 – Mooring arrangement in Aqua Knowledge Mooring Study (2015)

Upon reviewing the mooring system for Net Pen #2, the mooring arrangement on site was different from what was recommended from a mooring analysis conducted in 2015. There were fewer mooring lines than recommended. The mooring lines were arranged unevenly around the structure and did not have uniform tension in them. The connections of the mooring lines to the structure did not have the configuration recommended in the mooring analysis.

- Maximum anchor holding force calculated to be 33 tons.
- Number of mooring lines: 22.
- Mooring Arrangement given in Figure 8.2.
- Mooring Line Type/Length:
 - Variable length top chain, mooring rope, and bottom chain with counterweights.
- Maximum mooring line force should be approximately 29.5 tons
- Environmental Forces:
 - Currents: Vary by direction, 0.83m/s (1.61 knots) (50-year max), 0.75m/s (1.46 knots) (10-year max).
 - Wind-Waves: Vary by direction: 1.6m (10-year), 1.8m (50-year).
- Marine Fouling: Not specified. Solidity⁴ (including fouling) was 0.41 (2mm twine) and 0.26 (10mm twine).
- Mooring failure analysis conducted for failure of one mooring line/anchor.

- Waves: Waves used in the analysis appear reasonable and consistent with available analysis documents.
- Marine Fouling: Information on level of fouling in the mooring analysis is not known. Solidity is not provided with respect to fouled and un-fouled nets.

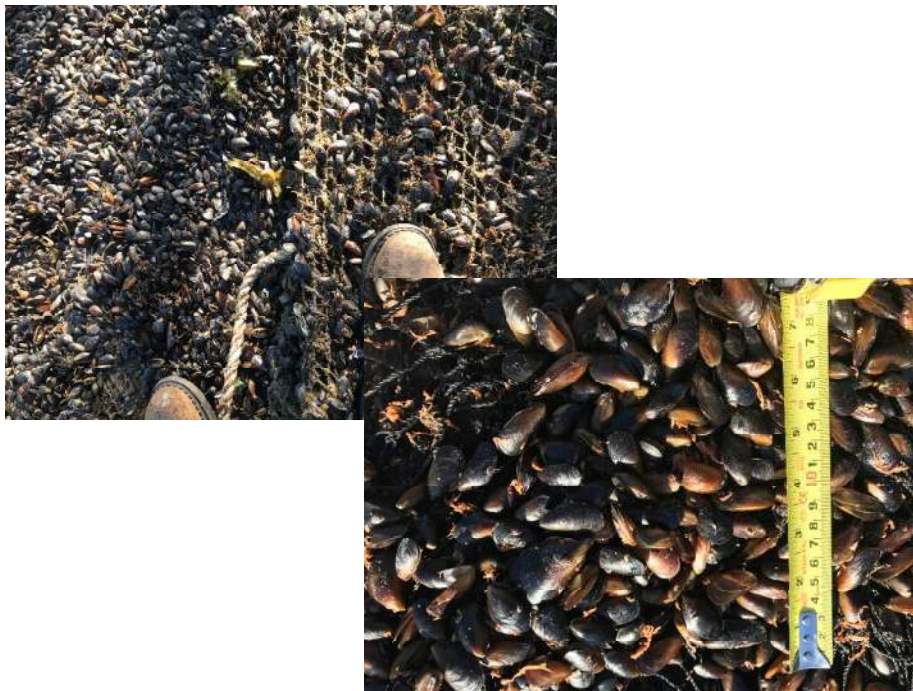
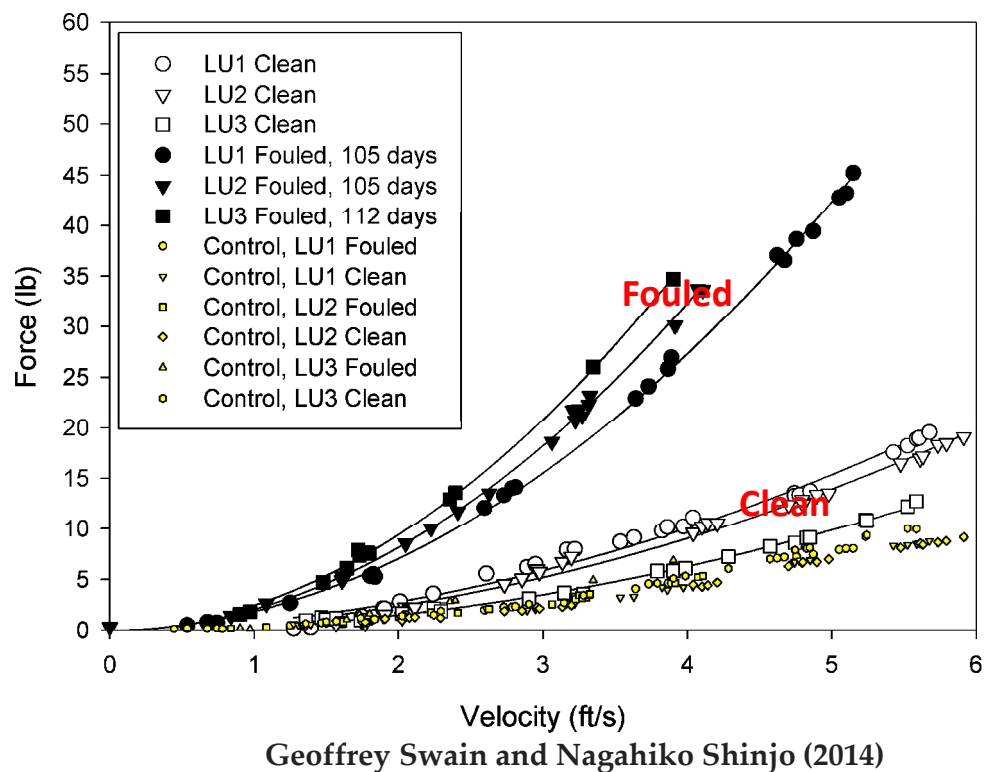
Marine Fouling

“Increase in fouling results in larger forces on the net.”

Fouling can increase loads due to currents by up to 5 times
