**A ROAD DAMAGE INVENTORY  
FOR  
THE UPPER DESCHUTES RIVER BASIN**

By  
Steven Toth

A Final Report  
Submitted to the SHAMW Committee.  
by  
Steven Toth  
January, 1991

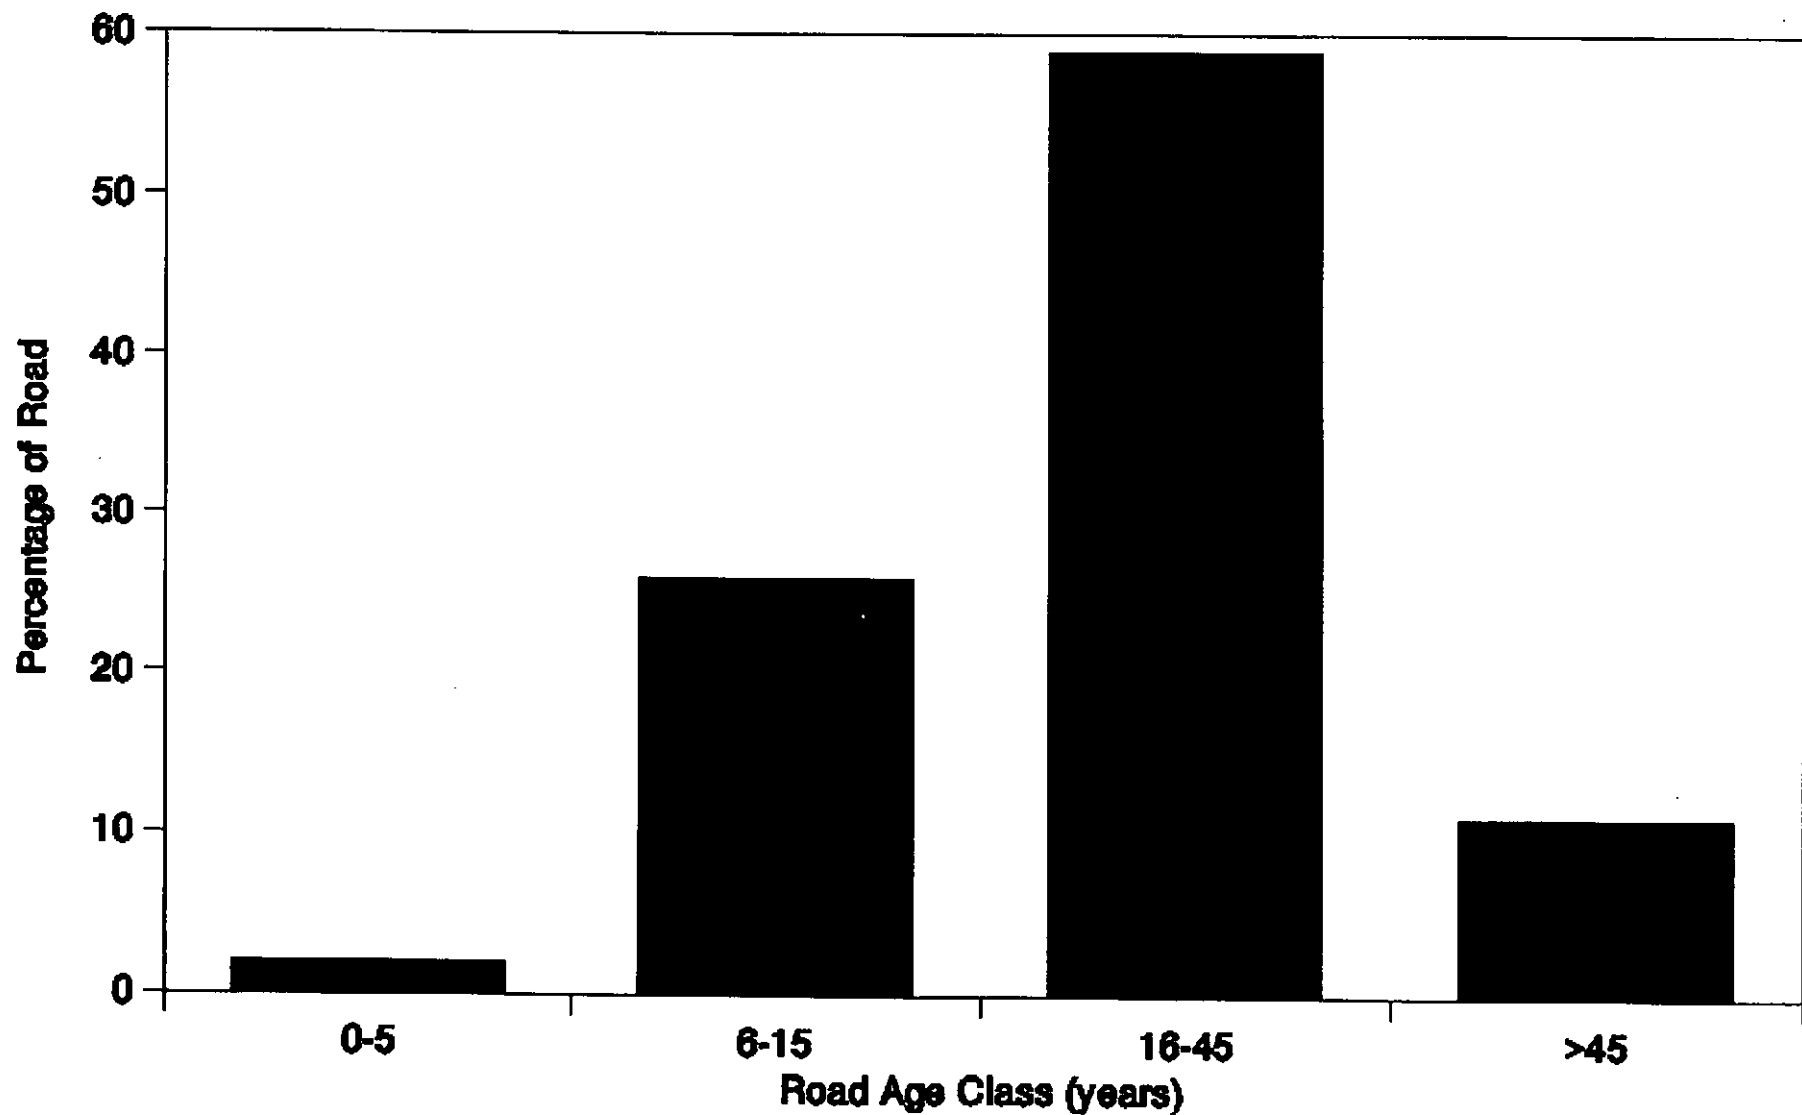
**Figure 7. Proportion of Roads in Basin  
By Road Age Category**

Figure 6 contains the road age map and figure 7 shows the proportion of roads in the basin by age class. The age classes were defined according to changes in construction standards. The oldest roads, 46-65 years old, were built upon old railroad grades, and had large amounts of fill with cedar puncheon culverts at stream crossings. Cedar puncheon culverts consist of two large cedar logs placed parallel along the stream channel with shorter pieces spiked or cabled crosswise on top of the logs (see figure 8). The roads generally had poor surface water drainage with few, if any, relief culverts. These roads are further classified into abandoned, partially-reconstructed, and fully-reconstructed roads. Abandoned roads were not considered because they were inaccessible. Partially-reconstructed roads have had some improvements made to allow for heavy truck traffic and for additional placement of relief culverts. Fully-reconstructed roads have had puncheon culverts replaced with steel ones, new fill material, and a better drainage network installed.

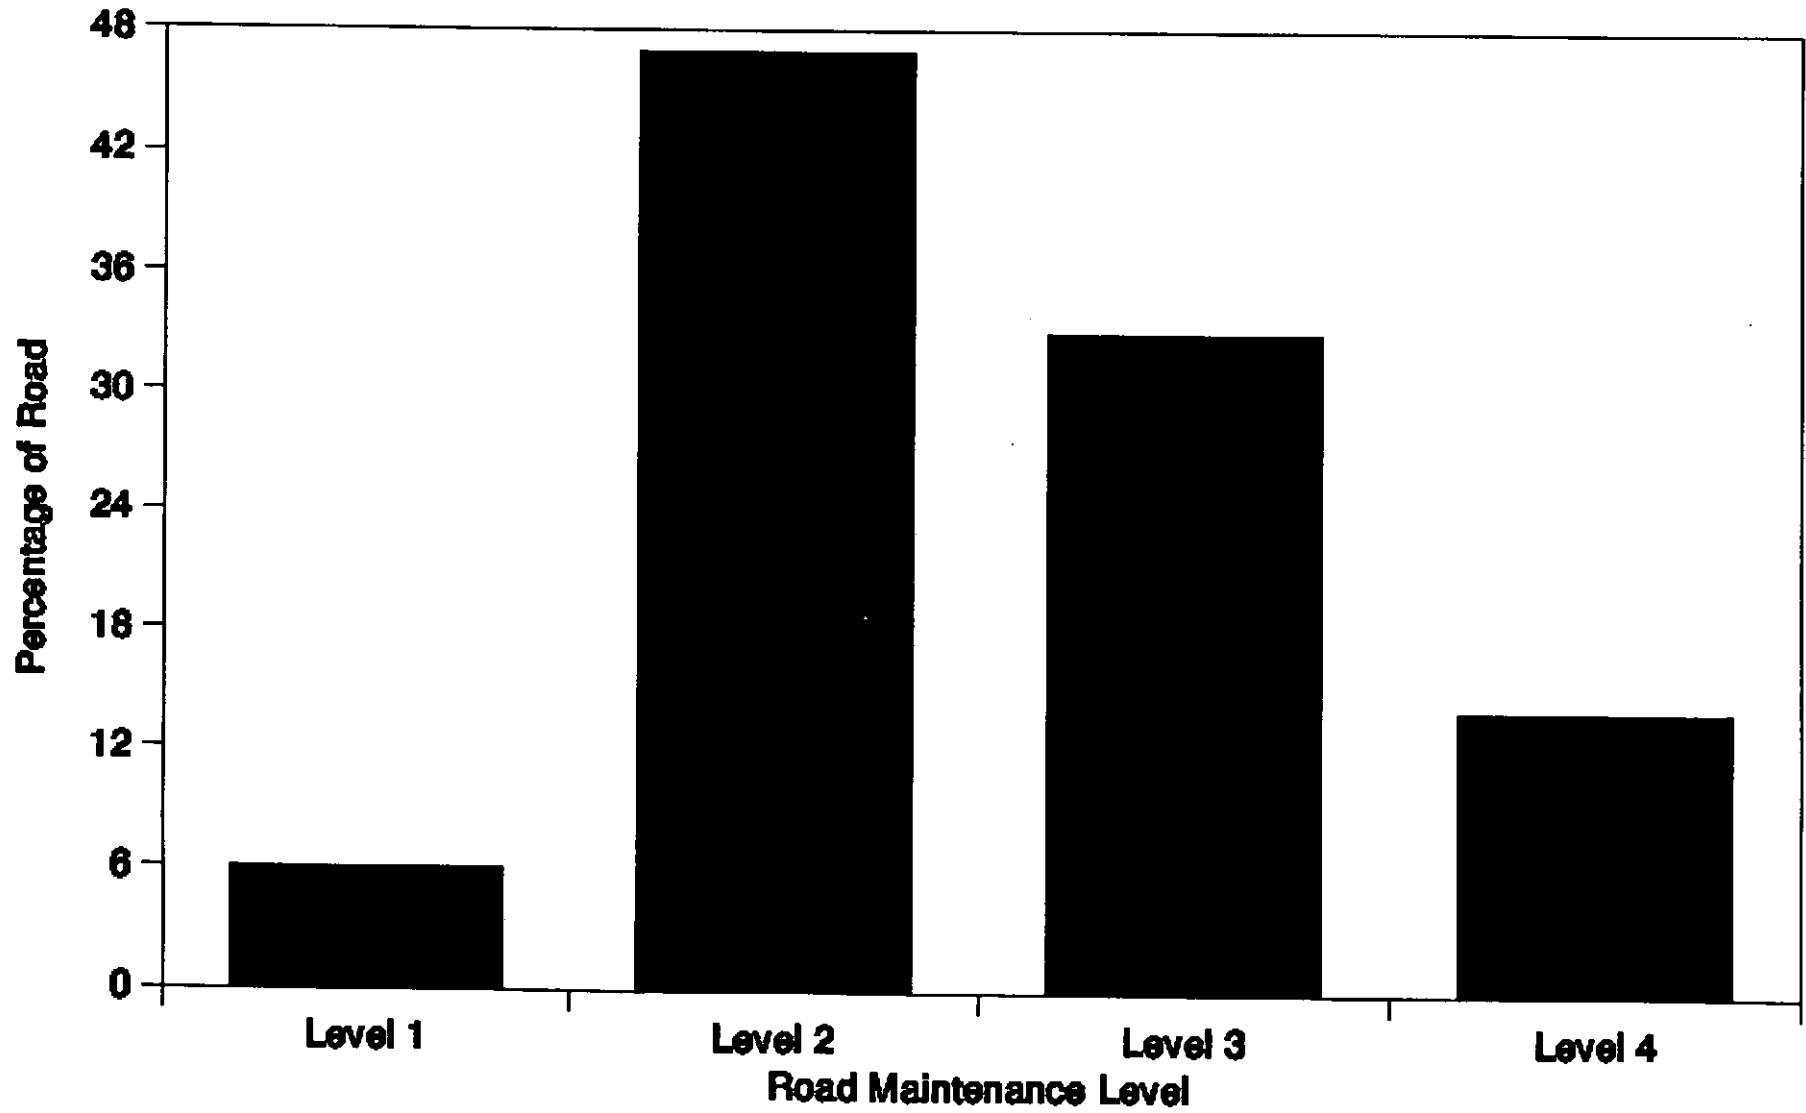
**Figure 11. Proportion of Roads in Basin  
By Road Maintenance Level**

In figure 10, the road maintenance level map divides roads into four categories, and in figure 11 the proportion of roads in the watershed by maintenance level is shown. Level 1 roads are closed roads that have been water barred, but have no drainage maintenance, grading or repairs. They may be inspected after major
