McNeil Island Habitat Restoration Project Feasibility Report

July 2015

Washington Department of Fish and Wildlife

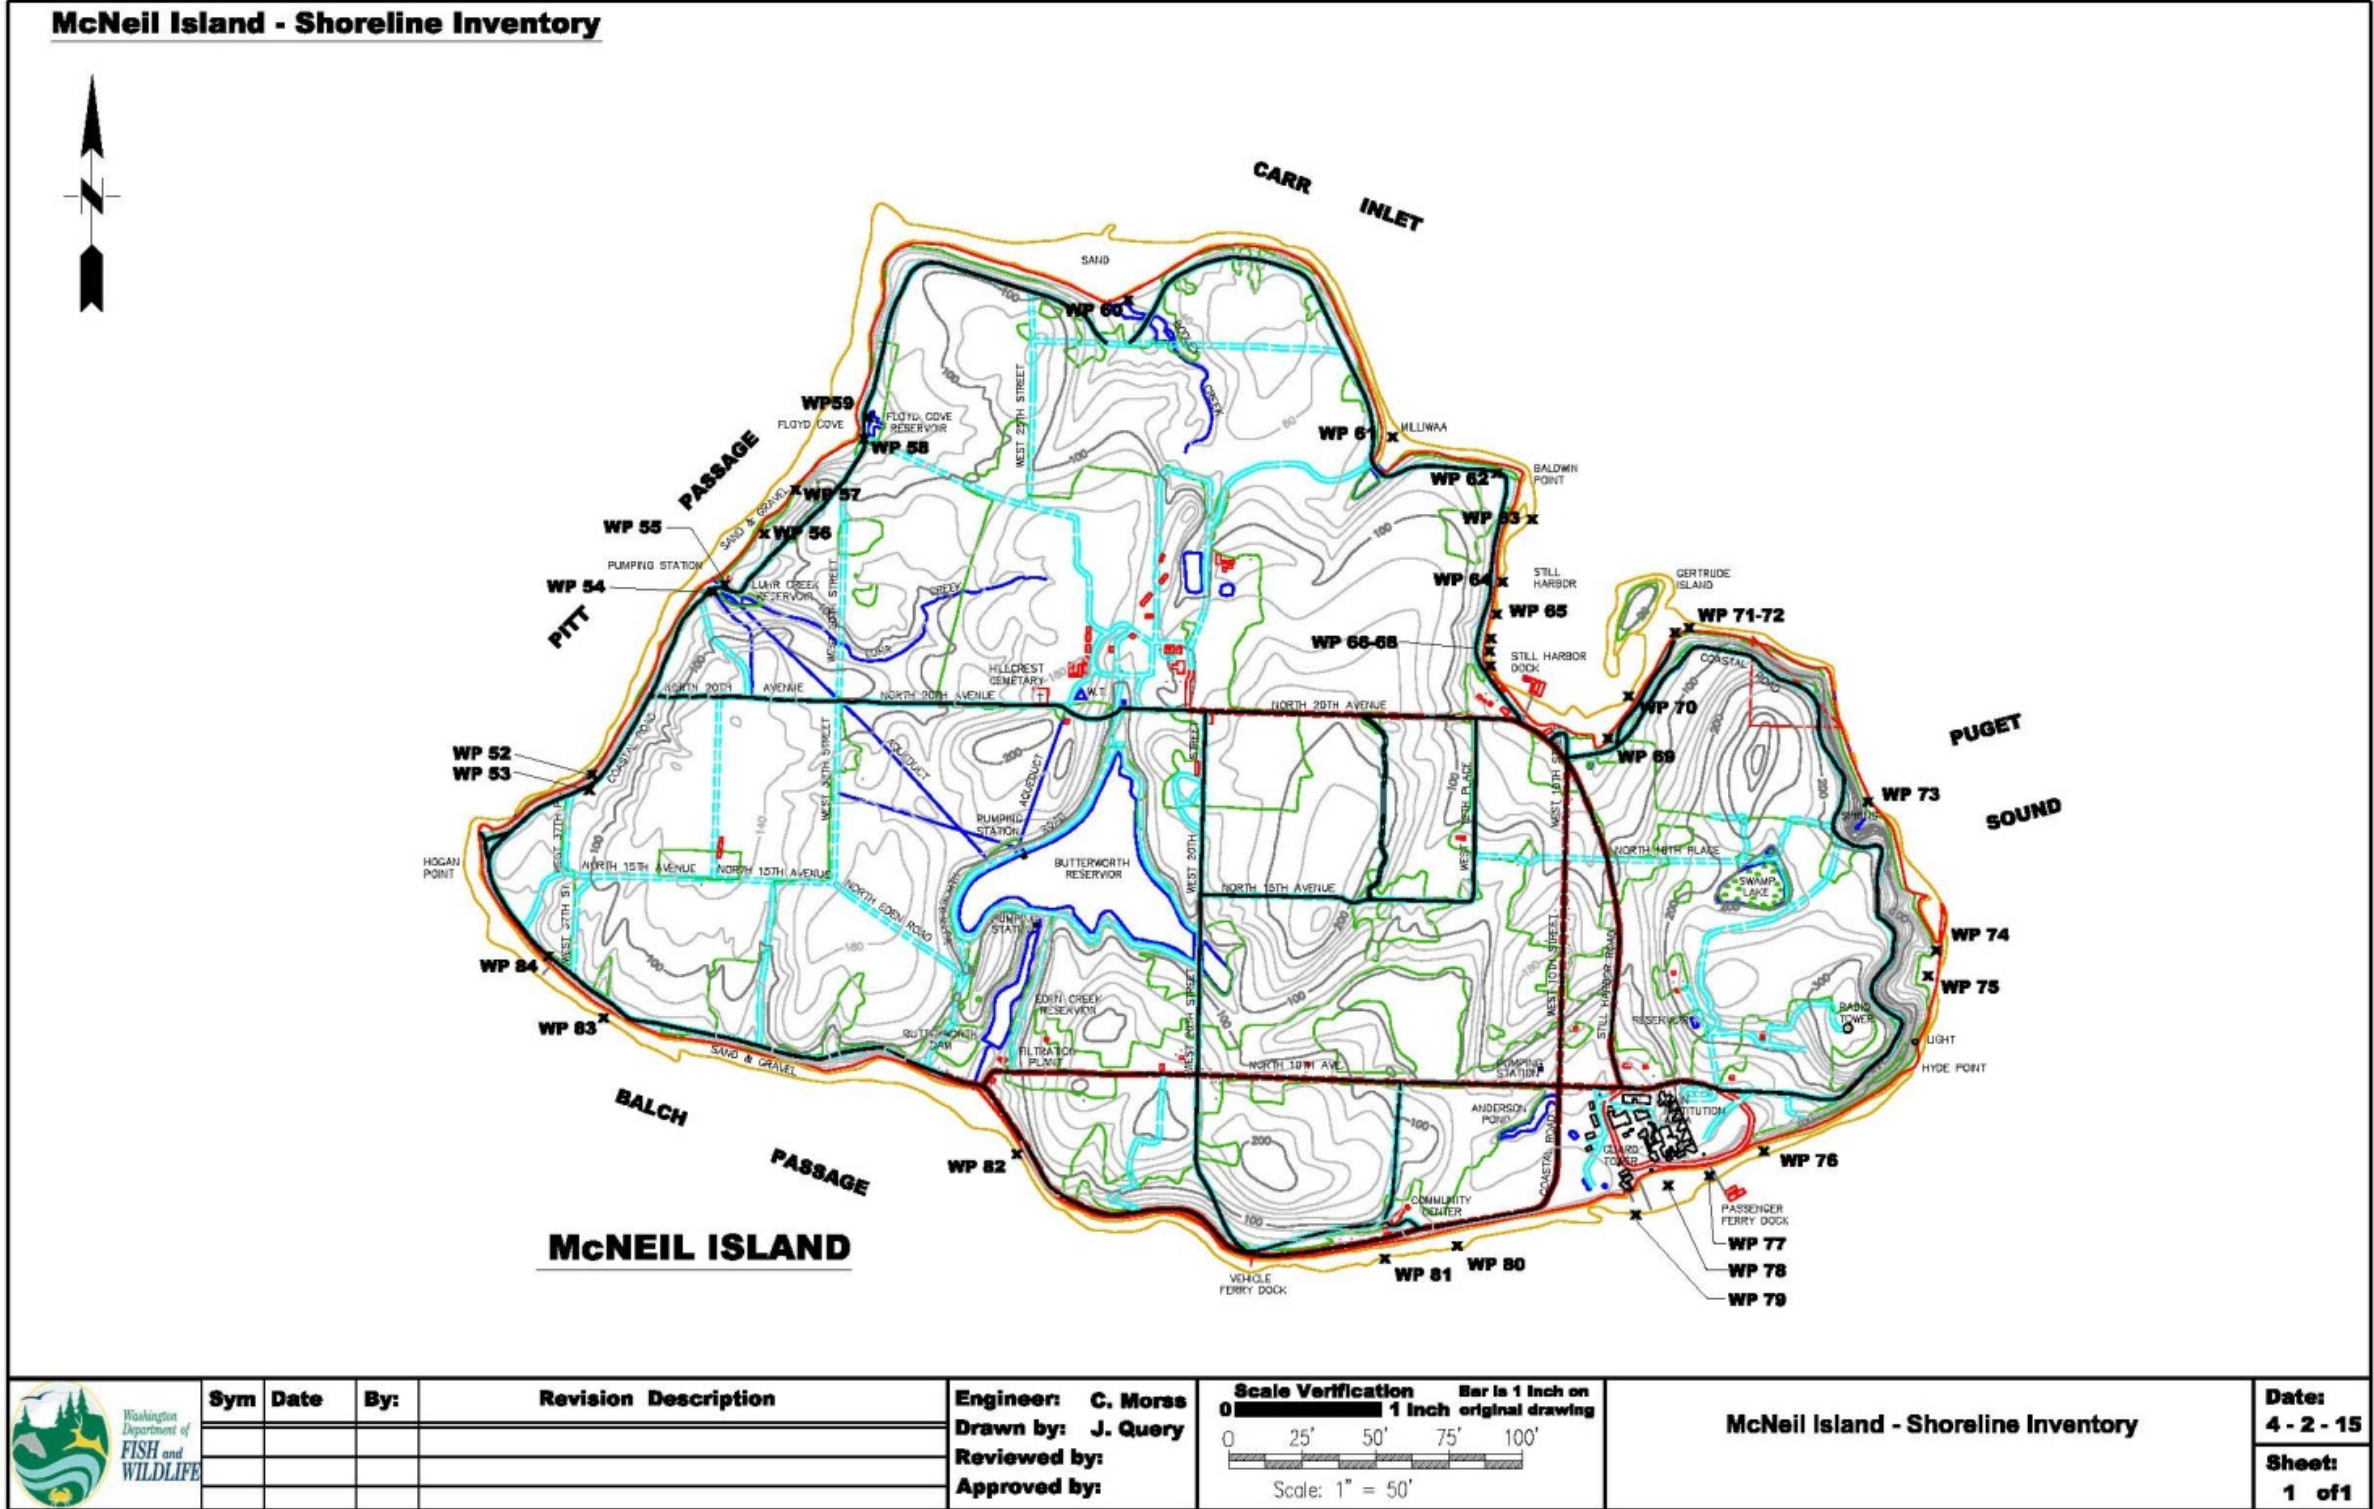
Figure 5: Shoreline Survey Waypoints

Half of the sites identified during the boat survey are debris, or remnant structures that pose a minimal risk to any infrastructure (sites 1, 3, 7, 8, 9, 11, 13, 14, 19, 20, 21, and 24). These sites will require little, if any, replacement or new bank protection. The implementation of these sites would be best suited to barge access, demolition/removal, and disposal.

The other half of the sites include more existing infrastructure (sites 2, 4, 5, 6, 10, 12, 15, 16, 17, 18, 22, and 23). Due to the light use of the majority of McNeil Island, this infrastructure should be assessed for use/longevity in order to potentially reduce the need for replacement bank armor. Most of this second group of sites will require some light handed, preferably soft shore, type armor at least temporarily to protect the existing infrastructure in place (the coastal road in most cases). Some of the sites may not be feasible for full removal of shoreline armoring (e.g. at the penitentiary) but some debris removal may be possible to improve beach conditions. Coordination with DOC for these sites is necessary.

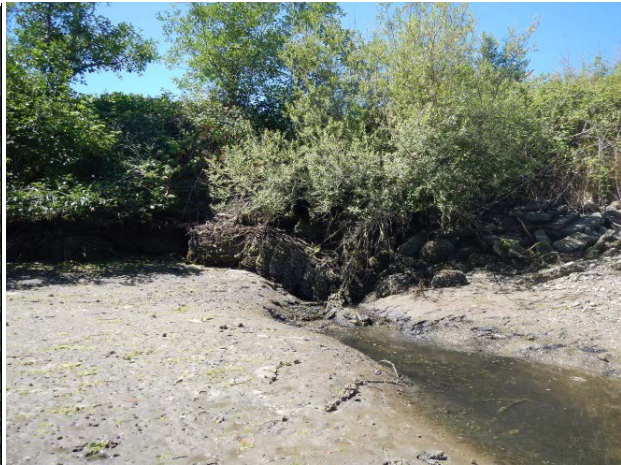
Debris over Culvert Outlet

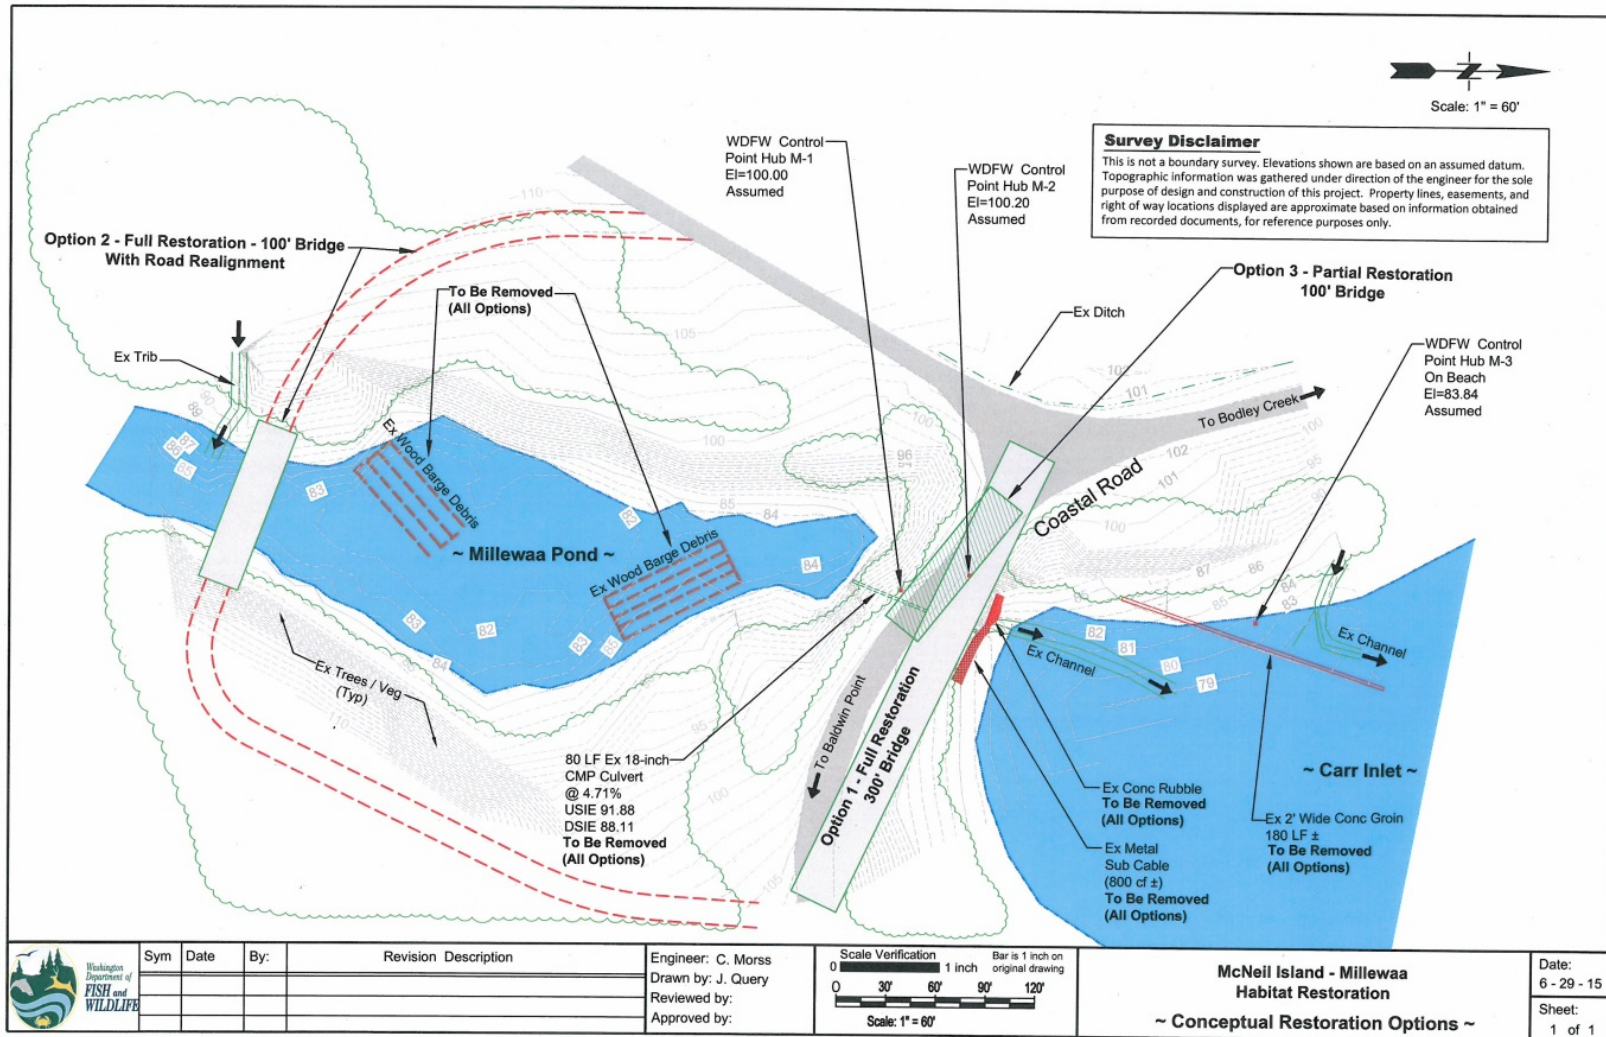
Figure 9: Conceptual design options for Milewa Creek habitat restoration

The road at Milewa Creek acts as a dam and the perched culvert reduces tidal inundation of the Milewa Creek Estuary, impacting approximately 2.5 acres of marsh. The existing road embankment was constructed after 1965 and replaced a 300 foot long bridge that was originally constructed at an unknown date. Due to the debris placed at the culvert outlet, and the pond elevations at the time of survey this culvert was not visible and was not surveyed or documented. Some tidal exchange may be taking place with this culvert or it could be completed buried and non-functional. A second 18" metal culvert directly above was surveyed and is described in the drawings below. This culvert is well above Mean Higher High Water (MHHW) and likely serves as an overflow during high flows. Additionally, a 2 foot wide by 180 foot long concrete groin extends from the existing culvert outlet location into the intertidal zone. The groin follows the slope of the beach, but the beach to the north is 3 feet above the beach on the south side of the groin. The footing for this groin is approximately 1 foot below the beach on its south side. The groin extends to +6.6 MLLW at the north, and +3.6 MLLW south. The current seawall/embankment is armored with a combination of concrete debris and submarine netting around the culvert. The orientation and condition of the culvert was difficult to observe due to overhanging banks and heavy vegetation. Within the impounded pond there are remnants of 2 barges and other concrete and construction type debris.

Restoration Options – The options listed below are all included on the feasibility level conceptual design drawing on Figure 9, with full size drawings in Appendix G. The cost estimates include the cost of design, contract administration, permitting, planning (geotechnical evaluation, wetlands, cultural resource assessment, etc.), construction cost, and contingencies (estimated at 30% of construction costs), but should be used with discretion. Archaeological and cultural resource assessment costs have been estimated; however the limitations, requirements, or potential isolation of sites as a result have not been accounted for.

This alternative is presented to describe the current impacts of the existing impoundment and the potential long term impacts. Continued impoundment will prevent the delivery of sediment and organic matter to the nearshore environment and potentially cause degradation of beach habitat and physical elevations.

- Portions of the other options described above can be incorporated to this option. Specifically, debris in the pond and the concrete groin could be removed, along with potential removal of the bank armor and replacement with more ecological techniques such as soft bank protection.
- Costs for removal of debris and re-placement of soft-shore armor are in the range of \$100,000-\$160,000.

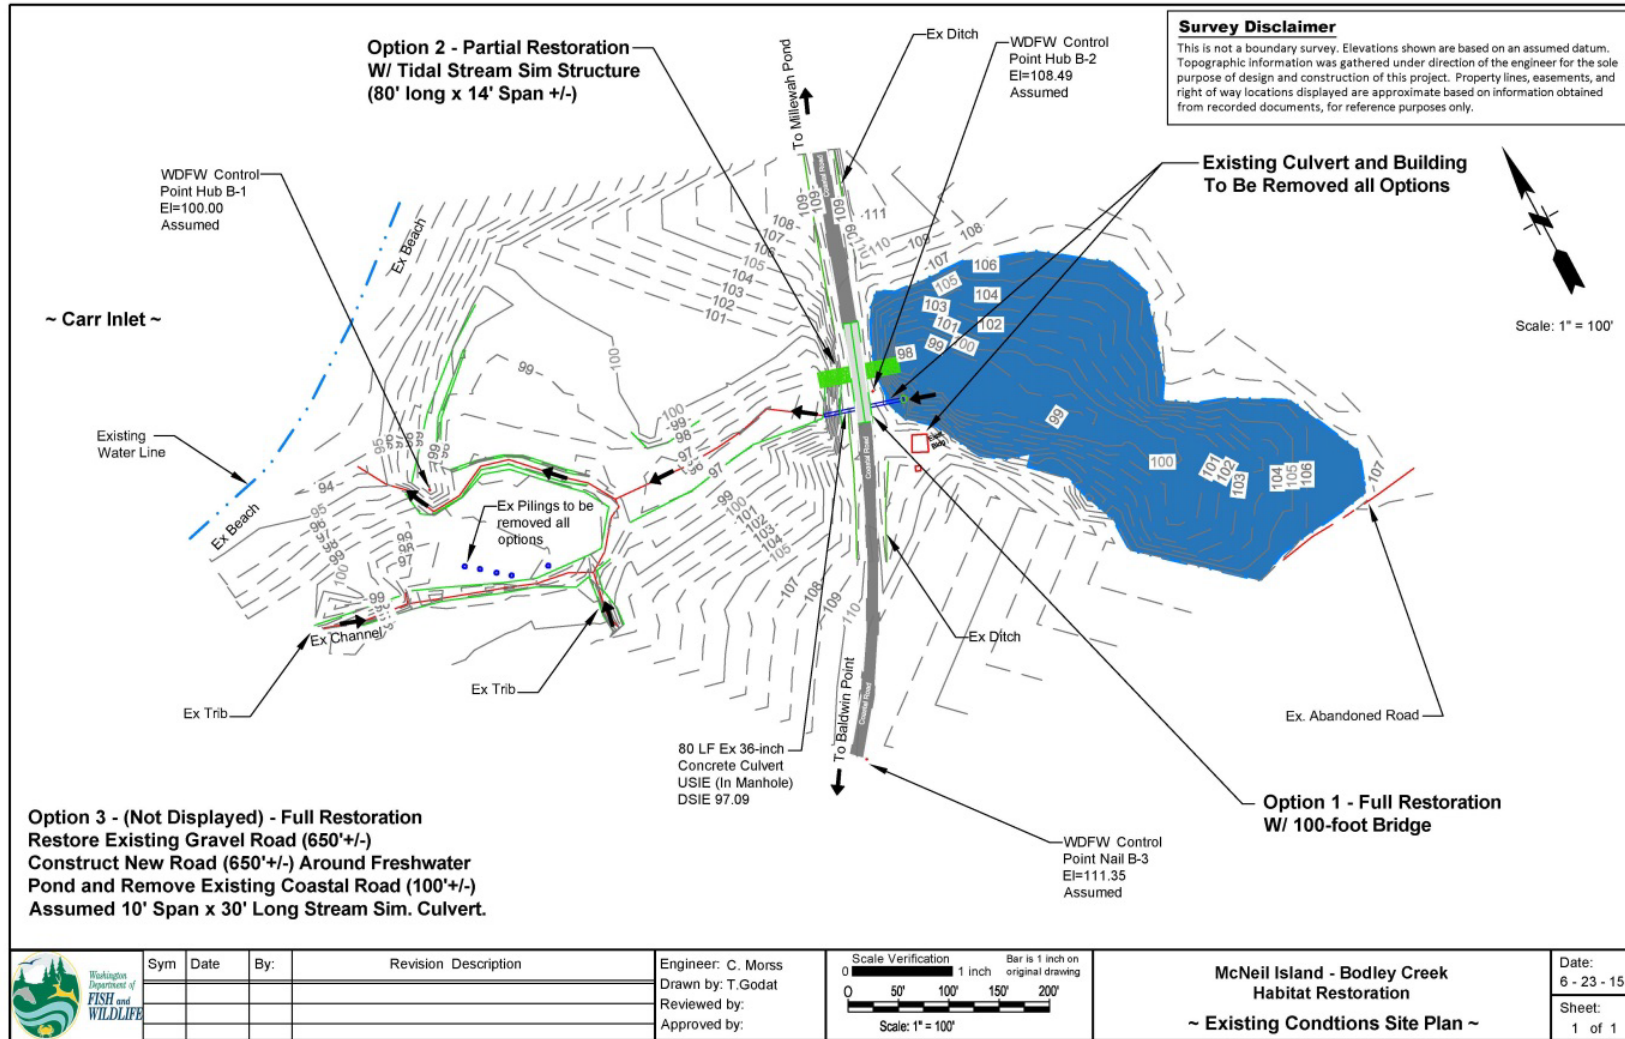
Figure 12: Conceptual designs for Bodley Creek

This alternative is presented to describe the current impacts of the existing impoundment and the potential long term impacts. This site is high enough in the tidal prism that it does not appear to have degraded the tidal processes and transitional habitat greatly. The small quantity of freshwater flow would likely not deliver a large quantity of sediment to the nearshore and the organic contribution would likely be deposited similarly to its existing arrangement. However, the road impoundment and infrastructure will need continued maintenance to retain current conditions.

Restoration Options – The options listed below are all included on the feasibility level conceptual design drawing on Figure 12, with a full size drawing Appendix G. The cost estimates include the cost of design, contract administration, permitting, planning (geotechnical investigation, wetlands, cultural assessment, etc.), construction cost, and contingencies (estimated at 30% of construction costs), but should be used with discretion. Archaeological and cultural resource assessment costs have been estimated, however the limitations, requirements, or potential isolation of sites as a result have not been accounted for.

- This option will restore the entire tidal prism to pre-developed conditions and will restore all tidal/estuarine processes at the crossing.
- This option is the highest cost, range \$700,000-\$1 Million, with comparable ecological benefits to Option 2, described below.

Description: Completely remove the existing road embankment and replace the assumed crossing of Bodley Creek upstream of the marsh area. Additionally, remove the existing pilings, pump house, pump diversion and allow natural regrading of the marsh area. This crossing would be entirely outside of the intertidal zone and could be achieved with the use of a culvert designed using Stream Simulation methods estimated to be the range of a 10 ft span. This option would also require the re-construction of approximately 650 lineal feet of the abandoned gravel road, and the new construction of approximately 650 feet of new gravel road.

- The existing pilings, the abandoned road, and the crossing associated with the abandoned road should be removed regardless of the selected option. Cost of removing these features is in the range of \$10,000-\$25,000.

Each of the above options could be modified to include the construction of a setback dike to preserve the ability to impound a portion of flows for continued diversion to the Butterworth Reservoir. This would maintain the existing culvert in addition to the selected option. The additional cost for this type of option would be in the range of \$30,000-\$50,000.

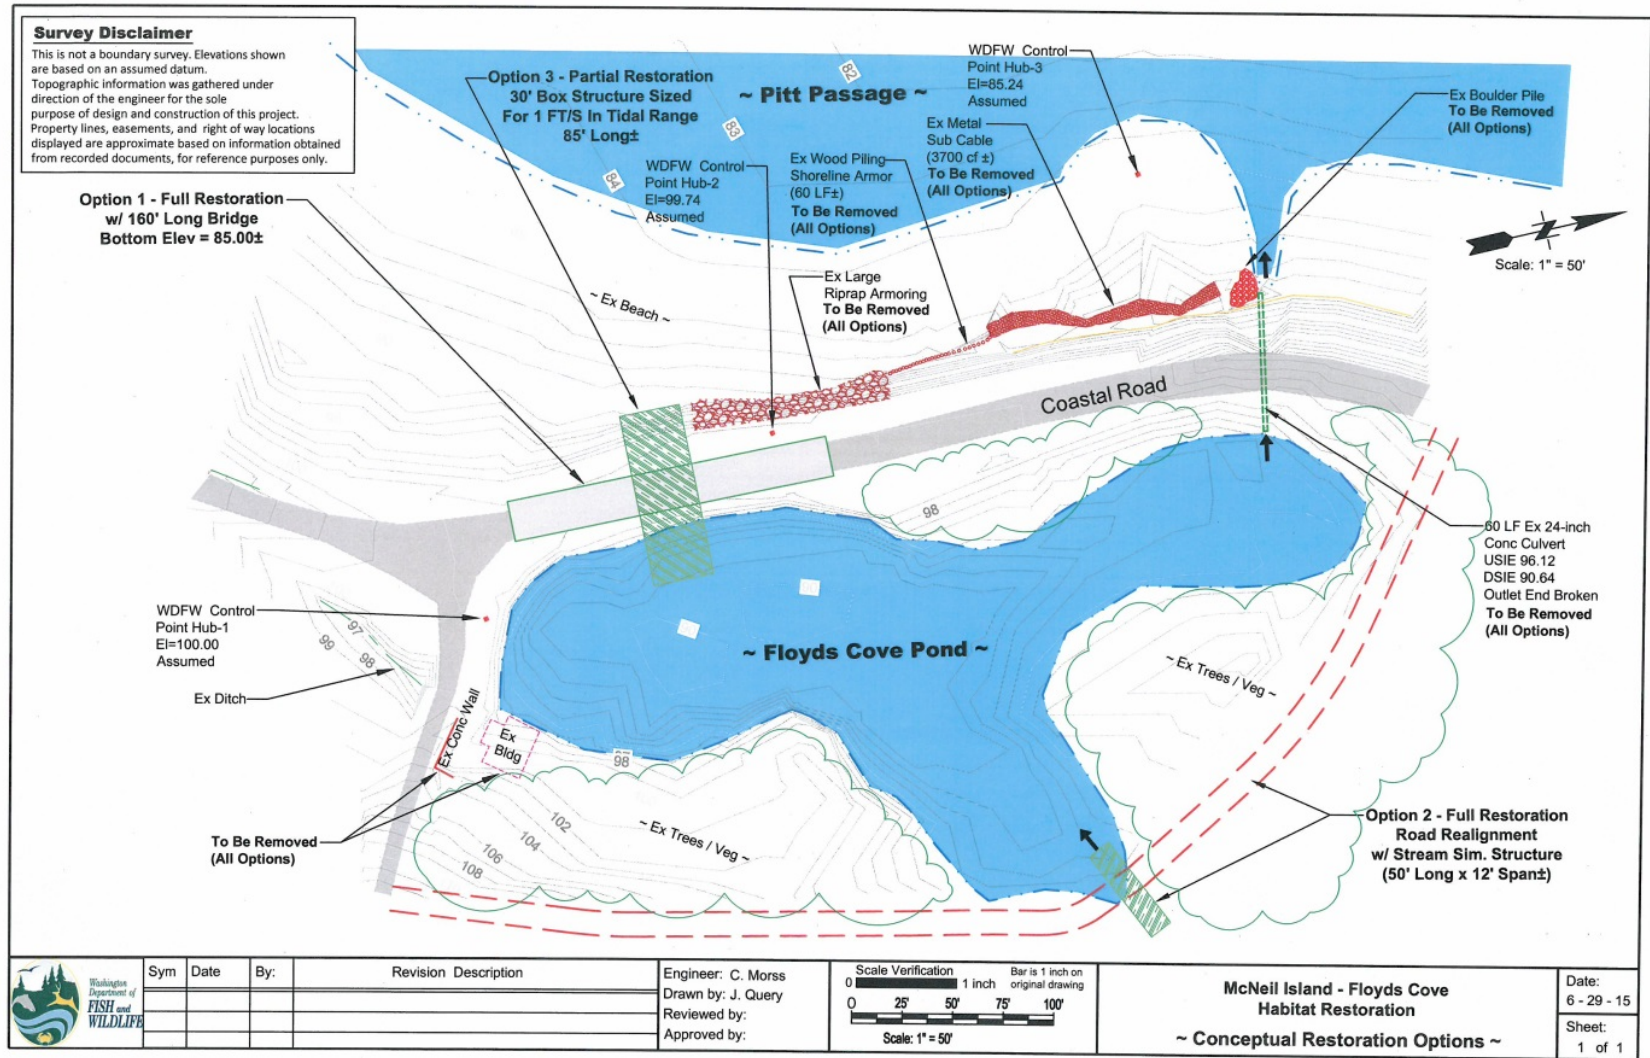
Figure 15: Conceptual designs for Options 1 - 3 for Floyd's Cove

The road embankment and perched culvert along Floyds Cove has blocked the tidal inundation of approximately 0.5 acres at MHHW. The existing pond bottom is assumed to have aggraded significantly since the embankment was constructed. Field crew indicated that the substrate was covered in about a foot of loose fine sediment over more solid substrate throughout much of the pond. The existing culvert is a 24" concrete pipe culvert that is perched above the beach and has one or more sections that separated. The pump house and diversion are not in operation at this

Restoration objectives for Floyds Cove focus on re-establishing natural processes at the site. The impounded area is high in the tidal prism such that tidal influence is only inhibited at highest tides. However, the impoundment of the area with a perched culvert creates an artificial condition of open water wetlands at a site of former high salt marsh and transitional marsh habitat, resulting in an abrupt transition from saltwater habitat to freshwater habitat. In addition, sediment dynamics along the shoreline and input and transport of large woody material is interrupted by the impoundment structures. Amphibians currently occupy the freshwater impoundment, such that the benefit of restoring the transitional marsh habitat and habitat connectivity with marine shoreline will need to be balanced with current wildlife use.

The options listed below are all included on the feasibility level conceptual design drawing on Figure 15, with full size drawing in Appendix G. Cost estimates include the cost of design, contract administration, permitting, planning (geotechnical investigation, wetlands, cultural resources assessment, etc.), construction cost, and contingencies (estimated at 30% of construction costs), but should be used with discretion.

Description: Completely remove the road embankment that closed off the historic opening of estimated at approximately 160 feet and replace with a bridge. Remove the existing pump house, and freshwater diversion. Remove the existing culvert drain and allow the cove to re-establish a natural substrate. Remove the existing bank armor and reduce road elevation to minimize the need for soft shore armor.

This alternative is presented to describe the current impacts of the existing impoundment and the potential long term impacts. The pre-development shoreline similarly impeded the influx of sediment and organic matter to the nearshore; however the barrier spit feature was likely partially, or entirely, washed away during high flow events. The surrounding high banks and quantity of large wood would be prevented from contributing to the shoreline processes. A project to remove bank armoring materials (submarine cable, pilings, rip rap) would involve replacement with different shoreline armoring if the road was retained in its current location. Due to the high elevation of the existing marsh and toe of the existing embankment, bank armor modification without accompanying habitat restoration work may not be cost effective.

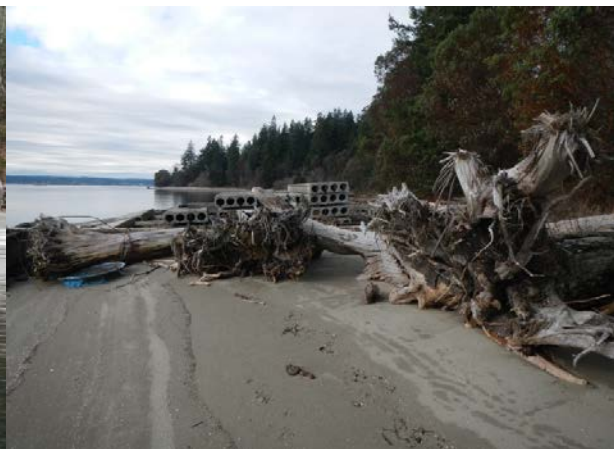
Voided slabs and anchored rootwads at the site

The barge landing site is a documented forage fish spawning site for both surf smelt and Pacific sand lance and supports excellent quality spawning substrate along much of the beach in the vicinity, with the exception of the storage yard. The concrete structures and piling shoreline armoring cover the upper beach and remove this from potential use by forage fish and wildlife. The boat launch is covered with sand and natural debris, and is gated to prevent vehicle access. It is either lightly used or not in use at this time. The debris at the site is mostly concrete ecology blocks stacked variably 1-2 blocks deep and 1-2 blocks high forming a flat staging/parking area. Additional concrete debris on this parking area is 15 voided slab bridge sections. The ground surface of the staging/parking area is covered with crushed basalt quarry spalls. Adjacent to the staging/parking area is a series of log piles (50 +/-) forming a wall that the access road runs along. The toe of the log piling wall lies approximately 1.4 feet below MHHW while the toe of the block wall lies approximately 1.2 feet below MHHW. Large logs with rootwads have been placed and anchored around the concrete debris. The anchored rootwads are partial mitigation for construction work on the ramp in the past. Regulatory agencies will need to review any modifications of the mitigation to assure the function is retained (e.g. moving the rootwads to the upper beach as part of the project). Only two options are discussed below due to the simplicity of this site.

Description: Remove all of the debris from the beach. Dispose of all concrete debris off site and remove the quarry spalls from the upper landing area. Expose existing beach material and regrade the beach to match the profile of the adjacent stretches of beach. Some backfilling of the beach after removal of crushed gravel and quarry spalls may be necessary to reach grade level. Remove the concrete boat launch and similarly regrade the beach. Pull all of the log pilings and dispose of at an approved landfill. Leave or reposition the logs with rootwads. The cost of this option is estimated at \$20,000-\$40,000
