ENGINEERING GEOLOGIC FIELD RECONNAISSANCE

**DEBRIS SLIDE, EARTH SLIDE, DEBRIS FLOODS,
AND
AFFECTED PROPERTIES**

**3208, 3235, 3260, and One Un-Addressed Property, Clipper Road
Whatcom County, Washington**

September 3, 2009

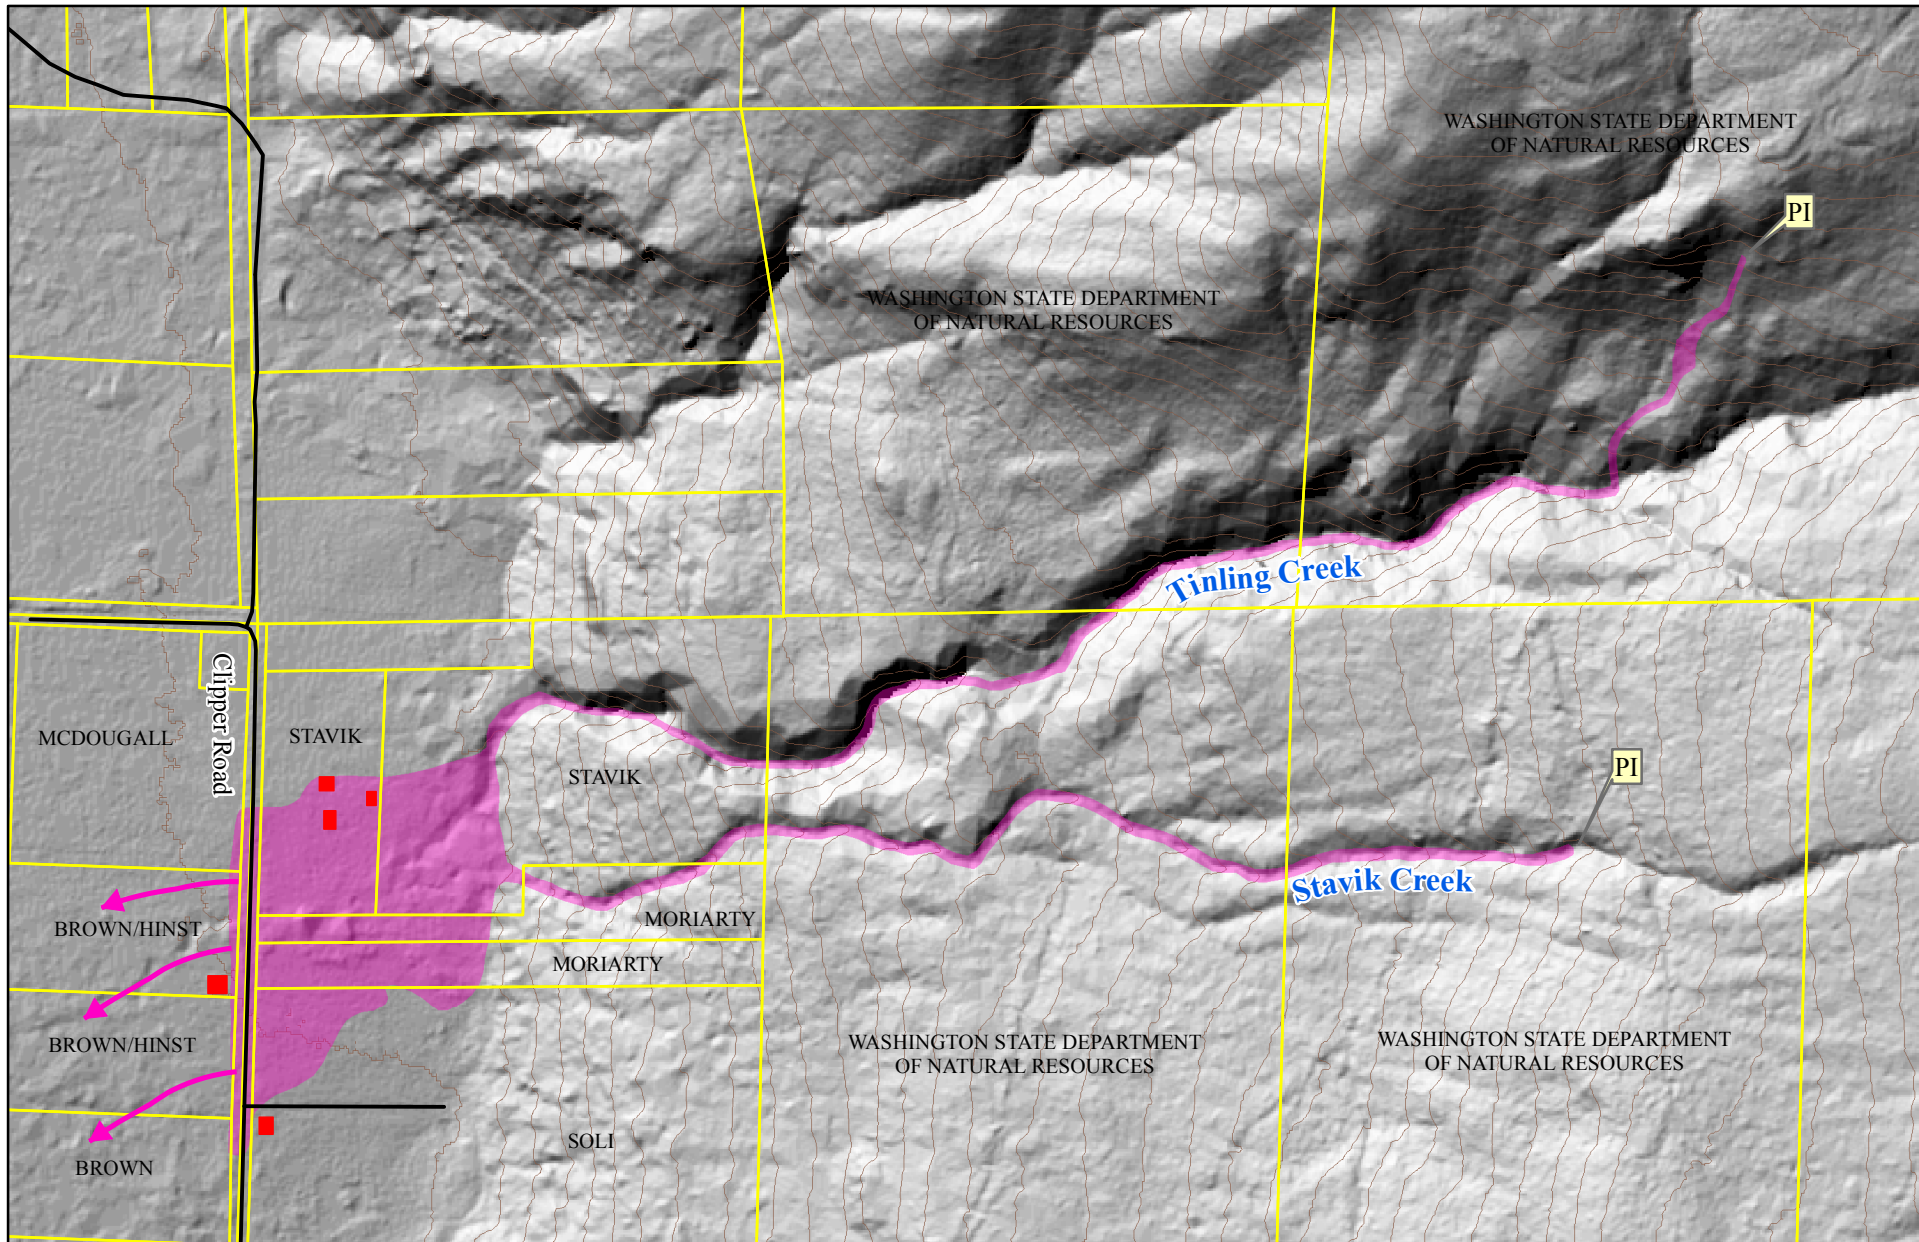
Figure 2. Simplified Map Showing Property Owners, Debris Flow Tracks, and Approximate Depositional Areas.

Debris from Tinling Creek spread out and down the south side of the alluvial fan that has developed at the mouth of the creek (Figure 3) and created a new channel across the south side of the alluvial fan. Debris from Stavik Creek spread out across the entire alluvial fan at the mouth of that creek. Debris from both creeks combined to spread out over an area to the southwest of the mouths of the creeks (Figures 2 and 3). The structures at 3260 Clipper Road were surrounded by debris; the height of the debris being a couple of feet (Figures 12 and 13), and the interior of some of the outbuildings were flooded by a slurry of water and gravel. Very thick deposits of sediment accumulated near the mouth of the creek in the back areas of the property (Figure 14). Portions of the other properties to the southwest (Figure 15) were flooded by a shallow mixture of water,
