# THE PUGET LOWLAND EARTHQUAKES OF 1949 AND 1965

REPRODUCTIONS OF SELECTED ARTICLES  
DESCRIBING DAMAGE

Compiled by  
GERALD W. THORSEN

WASHINGTON DIVISION OF GEOLOGY AND EARTH RESOURCES  
INFORMATION CIRCULAR 81

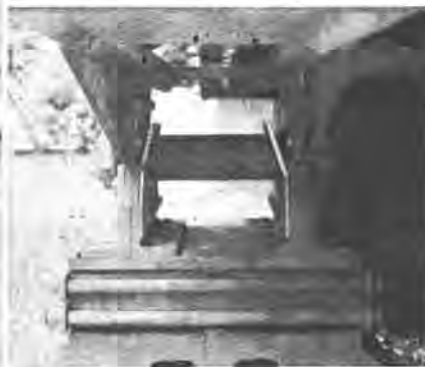
**BRIDGES** damaged by the quake. Left—Horizontal reinforced concrete struts between viaduct and trestle in Spokane were destroyed by differential movement of the structures. Below—Adna bridge over Chehalis River moved perpendicular to center line of road to bend pin plates on all shoes.

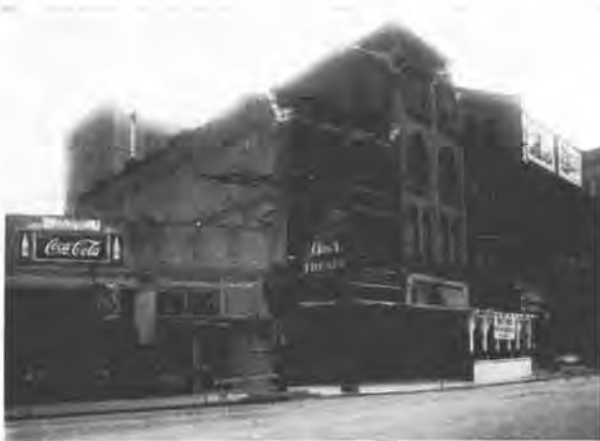
FIG. 1—Parapet wall of the second story wall fell due to lack of anchorage and inferior masonry.

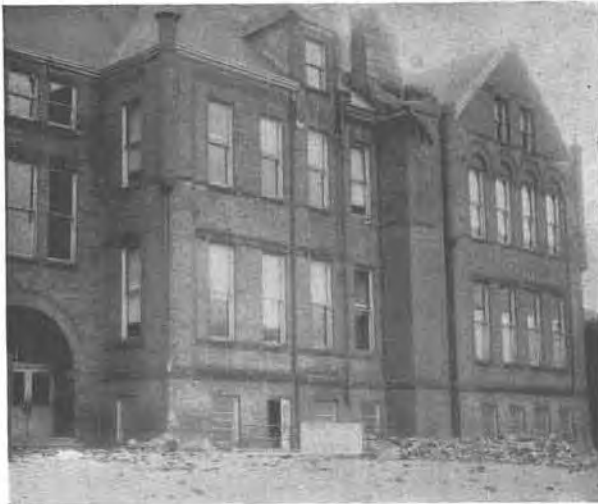
FIG. 5—Lafayette School, west Seattle. A large number of brick from the chimney fell in the school play-yard.

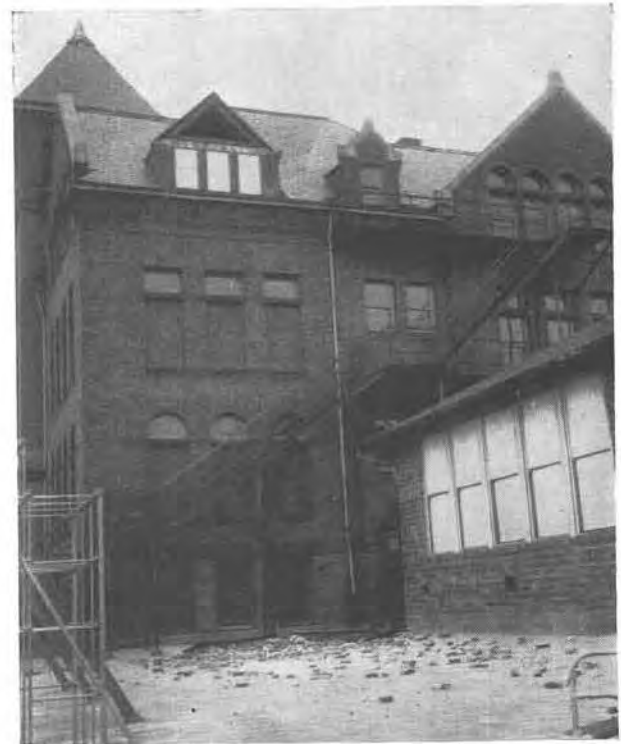
FIG. 8—School in Tacoma. The gable wall fell and killed a small boy.

Only a comparatively small amount of damage was done in Tacoma. A school building similar to the Lafayette School in Seattle was damaged, a brick gable having fallen above an entrance, causing one fatality (see Figure 8). A steel cable saddle which was being placed on the top of the tower of the new Tacoma Bridge was shaken off and fell through a barge in the channel. The earthquake cracked ground adjacent to the banks of the Tacoma Narrows causing a landslide some time after the earthquake. This endangered a number of dwelling houses.

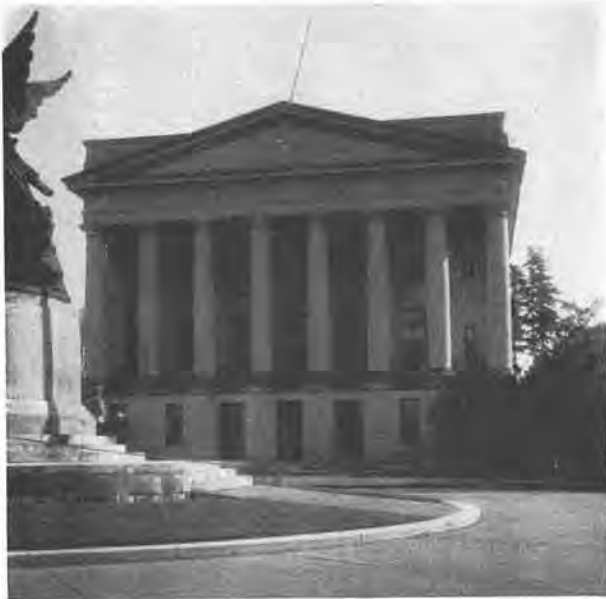
FIG. 12—State Insurance Building, Olympia. Stone cornice at upper righthand corner was shoved out and ready to collapse.

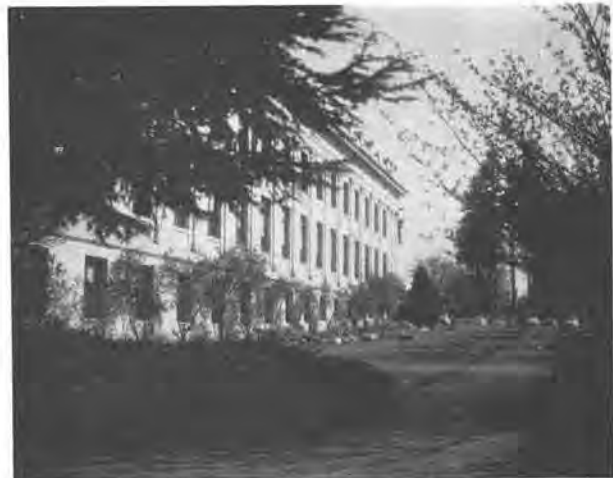
FIG. 13—State Insurance Building, Olympia. Heavy stone ornamental parapet was thrown off for the entire length of the building.

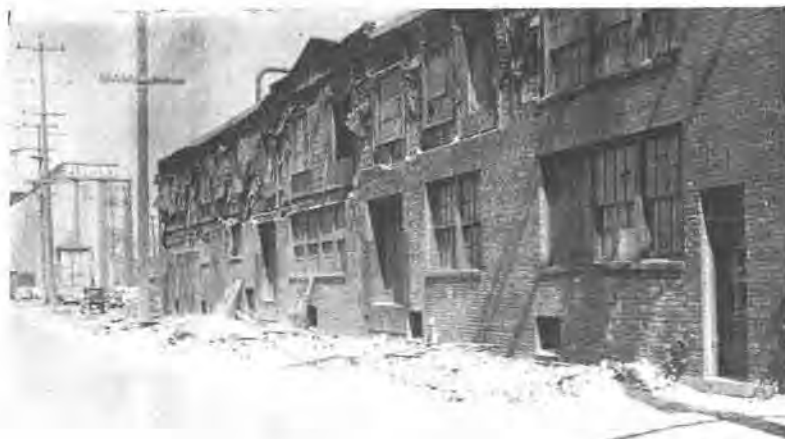
FIG. 3—Building occupied by the Cohen Bag Company, 3435 Klickitat Avenue, Seattle, showing failure of brick veneer—Seattle Times photo.

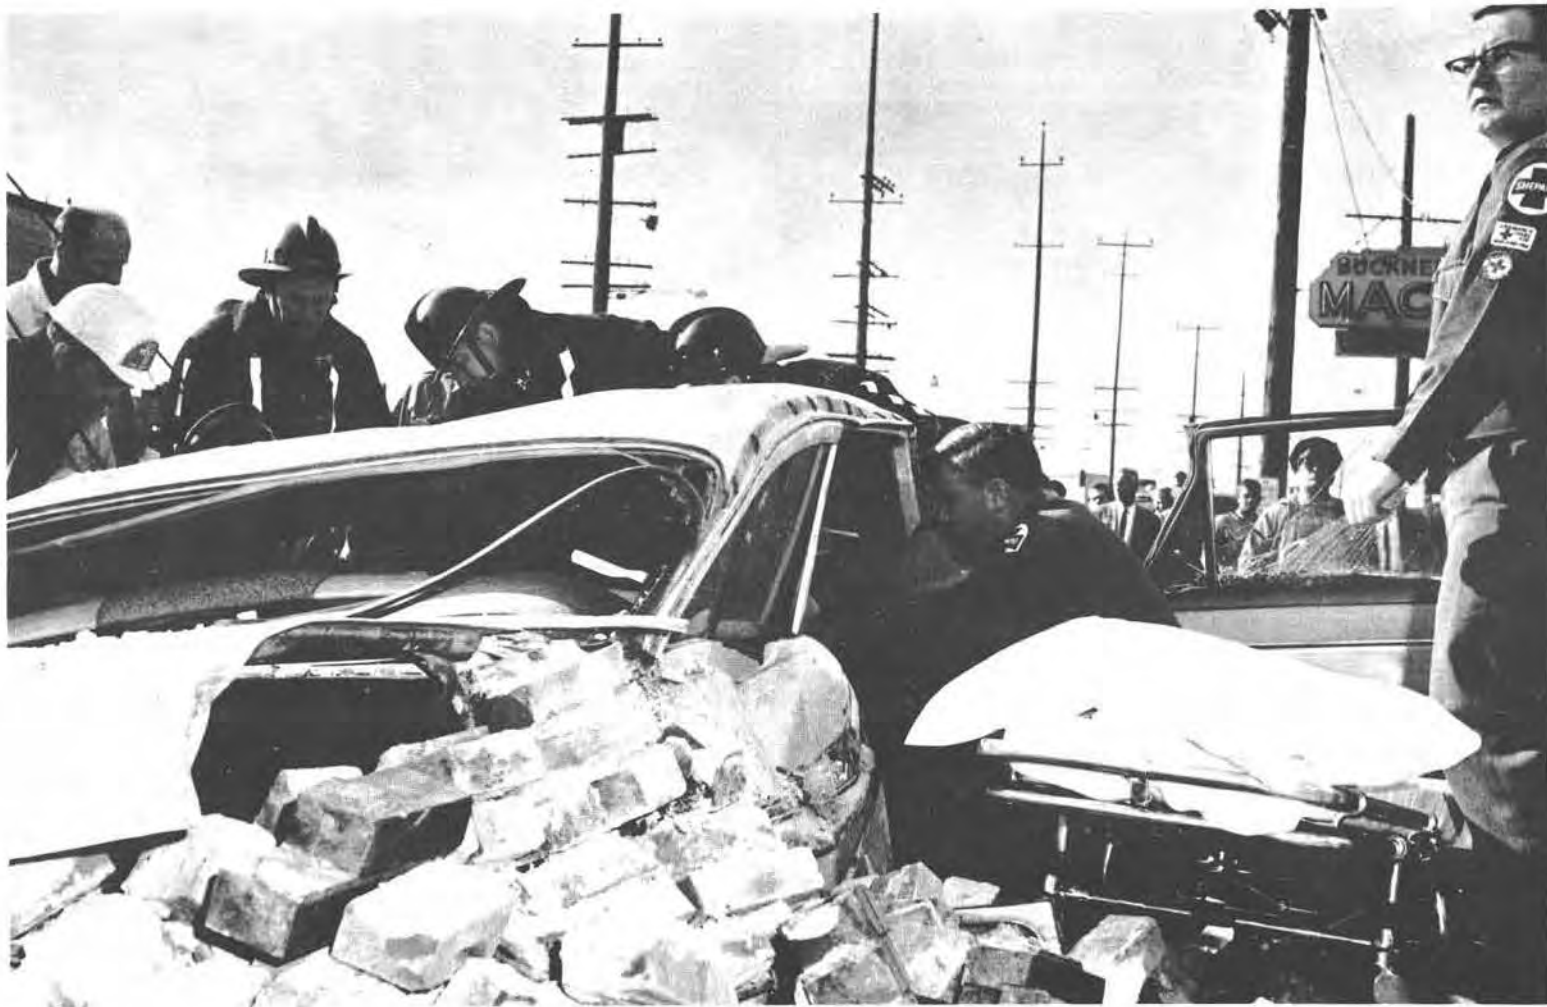
*Figure 13.—Failure of an unreinforced brick gable in Seattle. The masonry fell on a parked car, injuring occupant (see Figure 14). (Photo by Seattle Fire Department.)*

Figure 14.—Rescuing man injured in automobile due to collapse of gable (see Figure 13). (Photo by Ken Harris, Seattle Post-Intelligencer.)

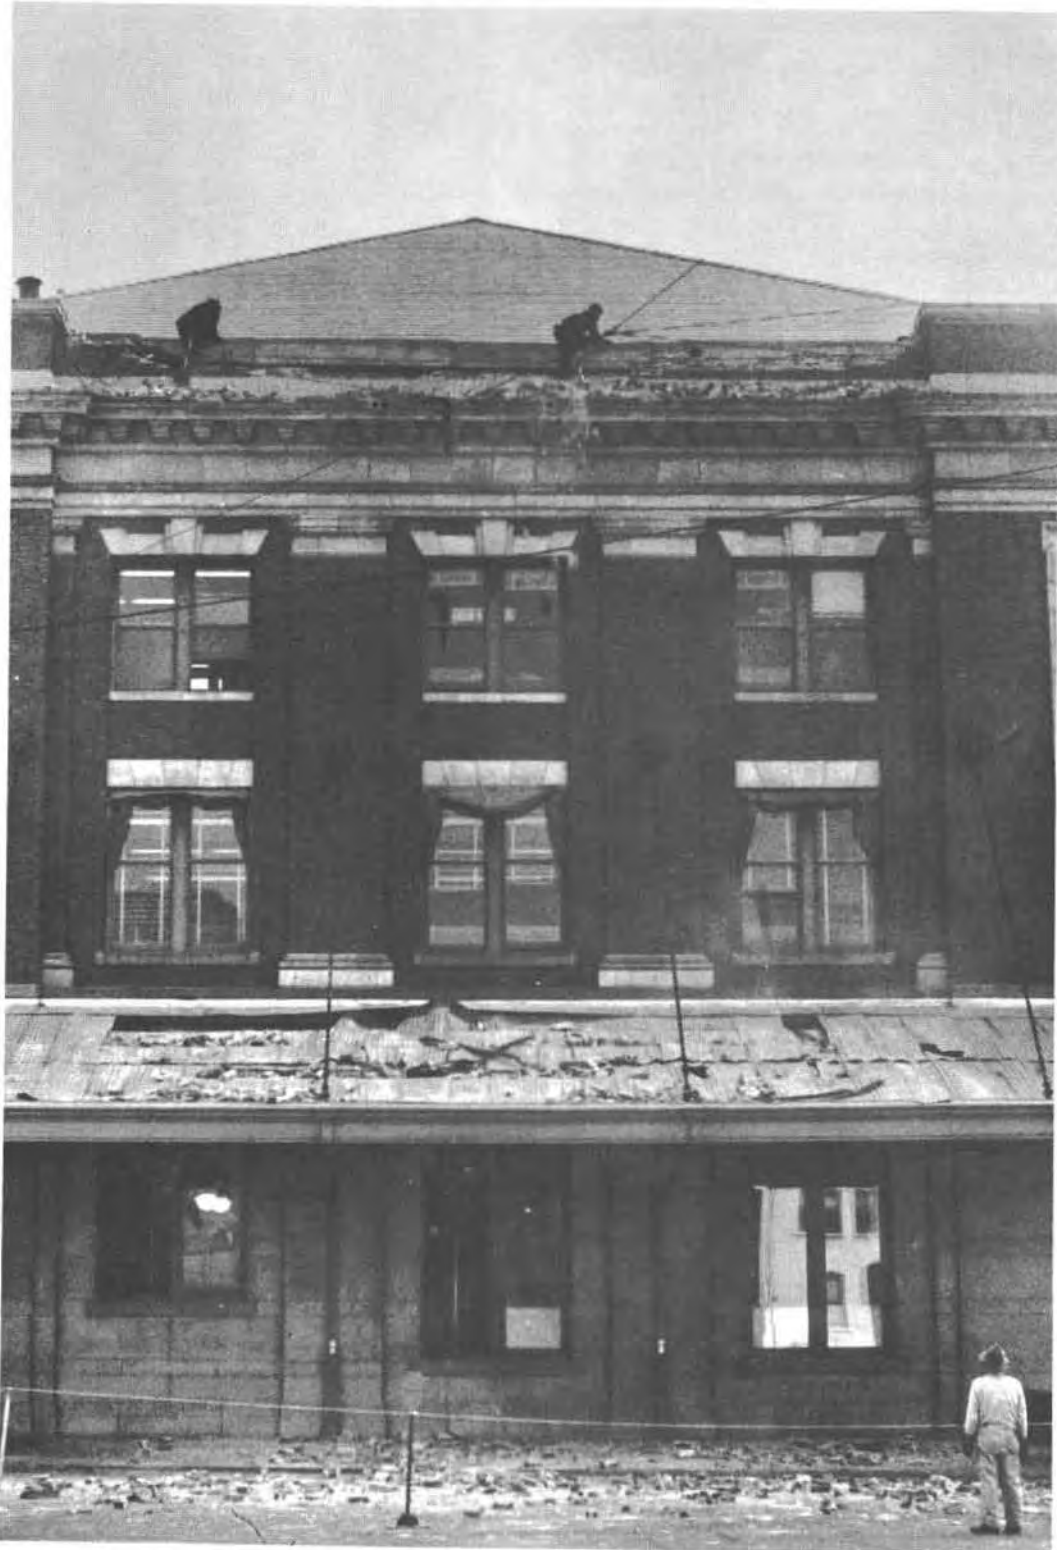
*Figure 15.—King Street Railroad Station in Seattle. (Photo by Seattle Fire Department.)*

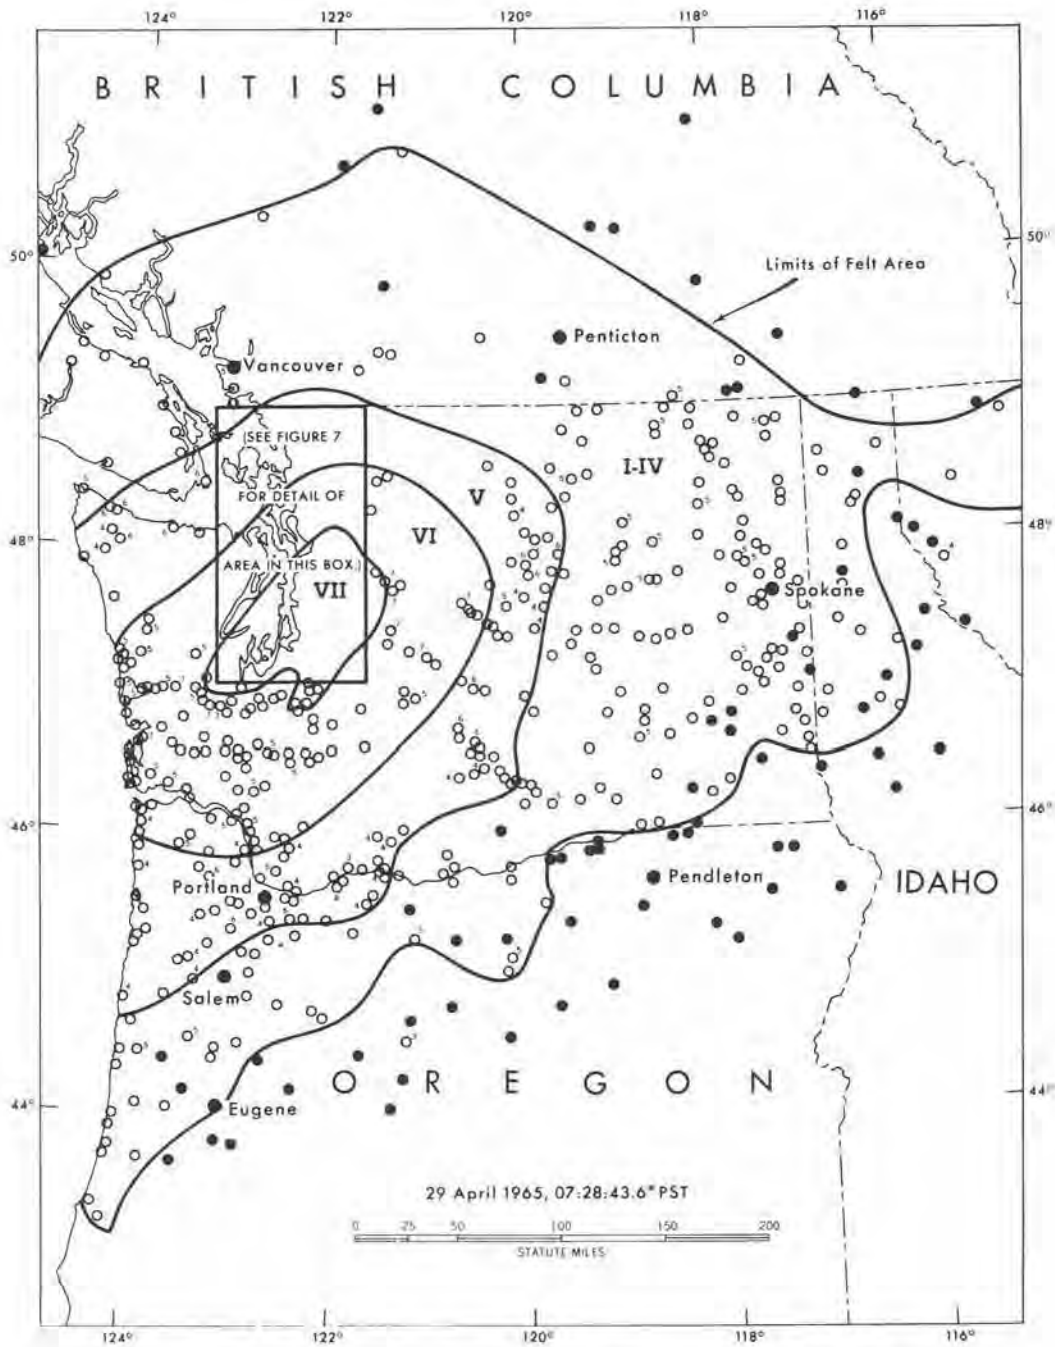
FIGURE 6.—Area affected by Puget Sound, Wash., earthquake of April 29.

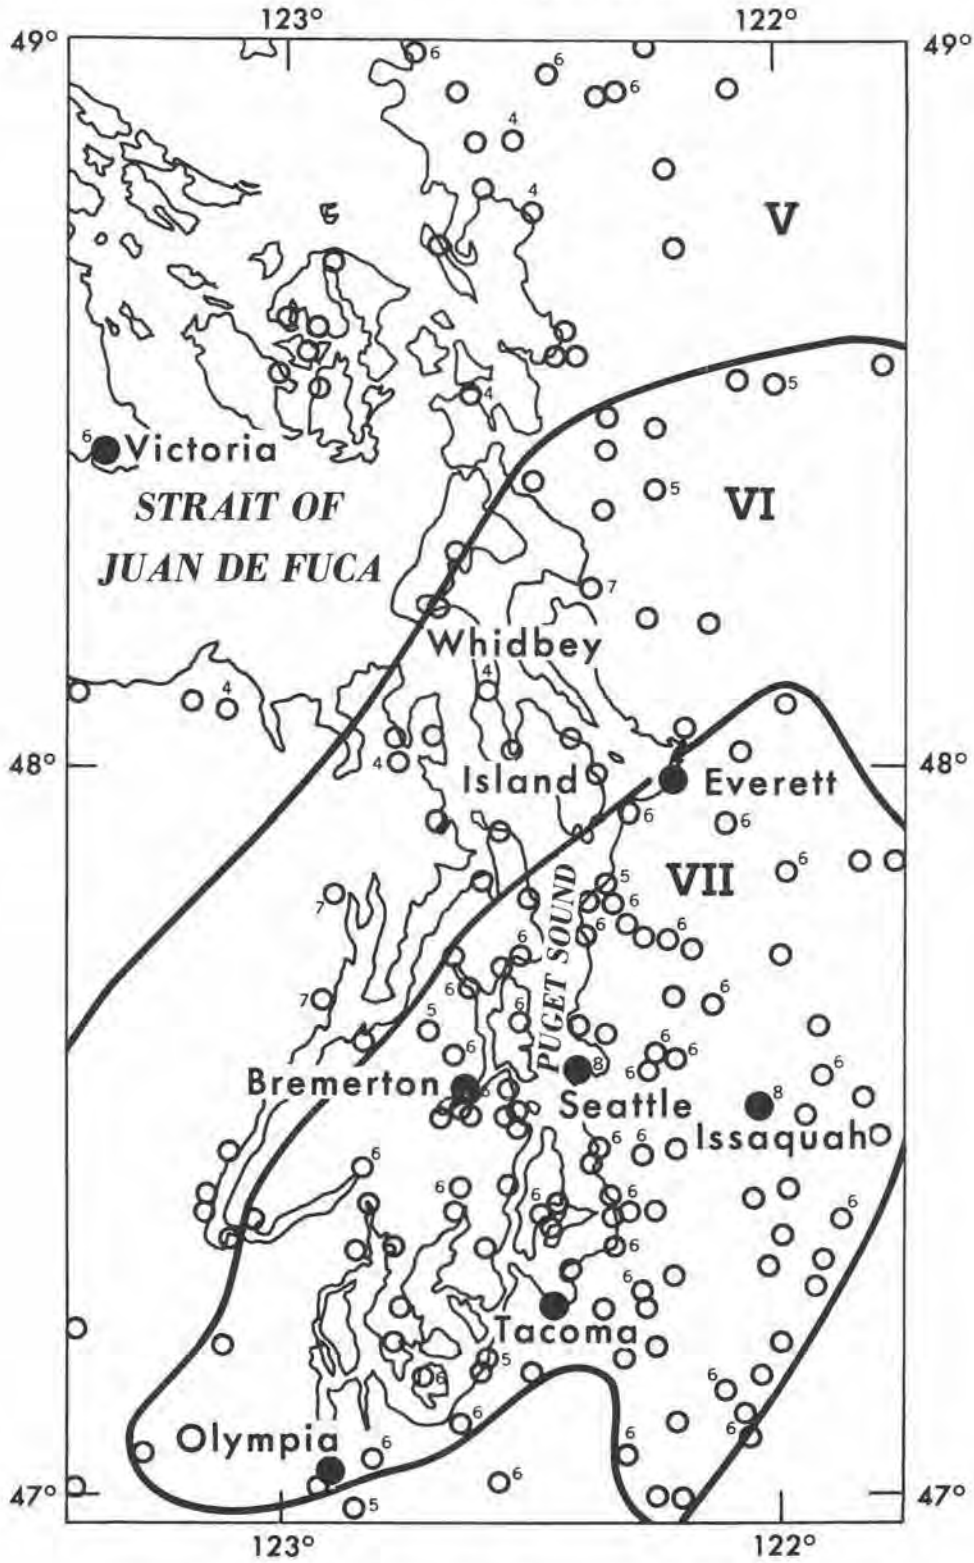
FIGURE 7.—Epicentral area of Puget Sound, Wash., earthquake of April 29.

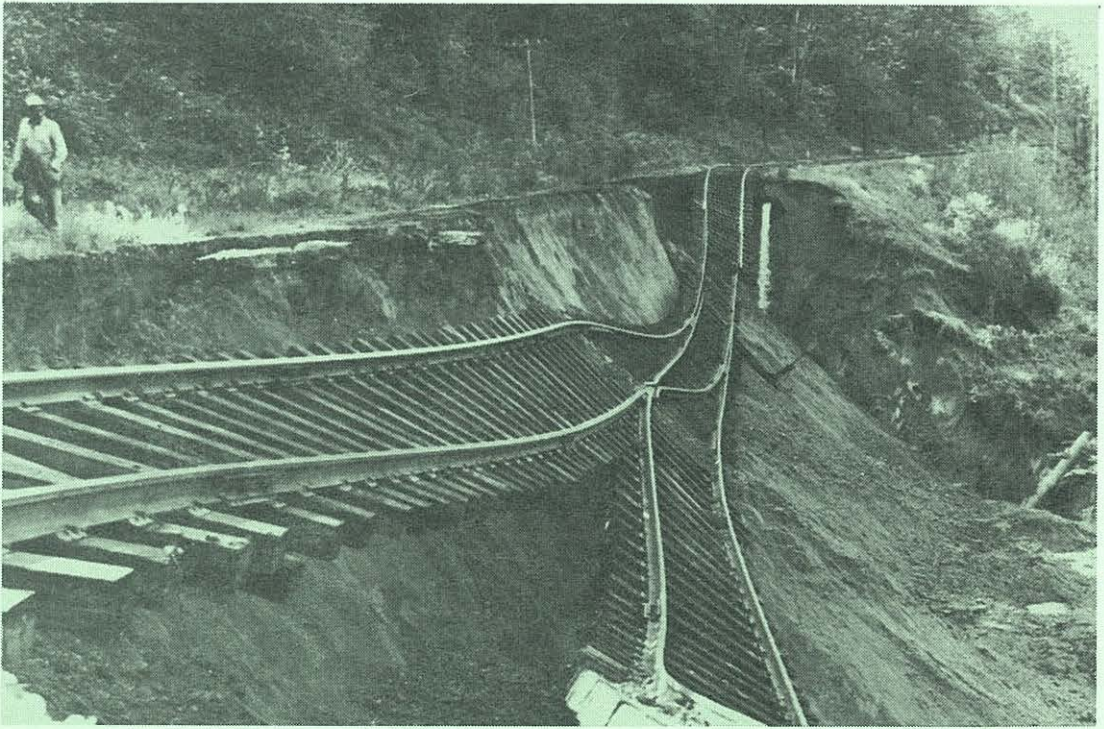
A

- A. Earthquake-triggered landslides cut rail lines in both the 1949 and 1965 events. This slide occurred between Olympia and Tumwater. (1965 Daily Olympian photo by Greg Gilbert)
- B. "Sand boils" were created by geysers of muddy water escaping from saturated sediments along Capitol Lake. Soil liquefaction, such as occurred here, was a common source of damage in low-lying areas of fill underlain by flood plain, tide flat, or delta deposits. Sidewalk slabs in this 1965 Division staff photo provide scale.
- C. Suspended fluorescent light fixtures, such as this one in an Olympia school, commonly sustained damage during the 1965 quake. Three mail sorters were injured in the newly completed Olympia post office when similar fixtures fell. (Daily Olympian photo by Del Ogden)
