**ENGINEERING GEOLOGIC FIELD RECONNAISSANCE**

**DEBRIS SLIDES, DEBRIS FLOODS,  
AND  
AFFECTED PROPERTIES**

**6459, 6488, 6489, and 6500 Goodwin Road, and 6474 Siper Road  
Whatcom County, Washington**

July 2, 2009

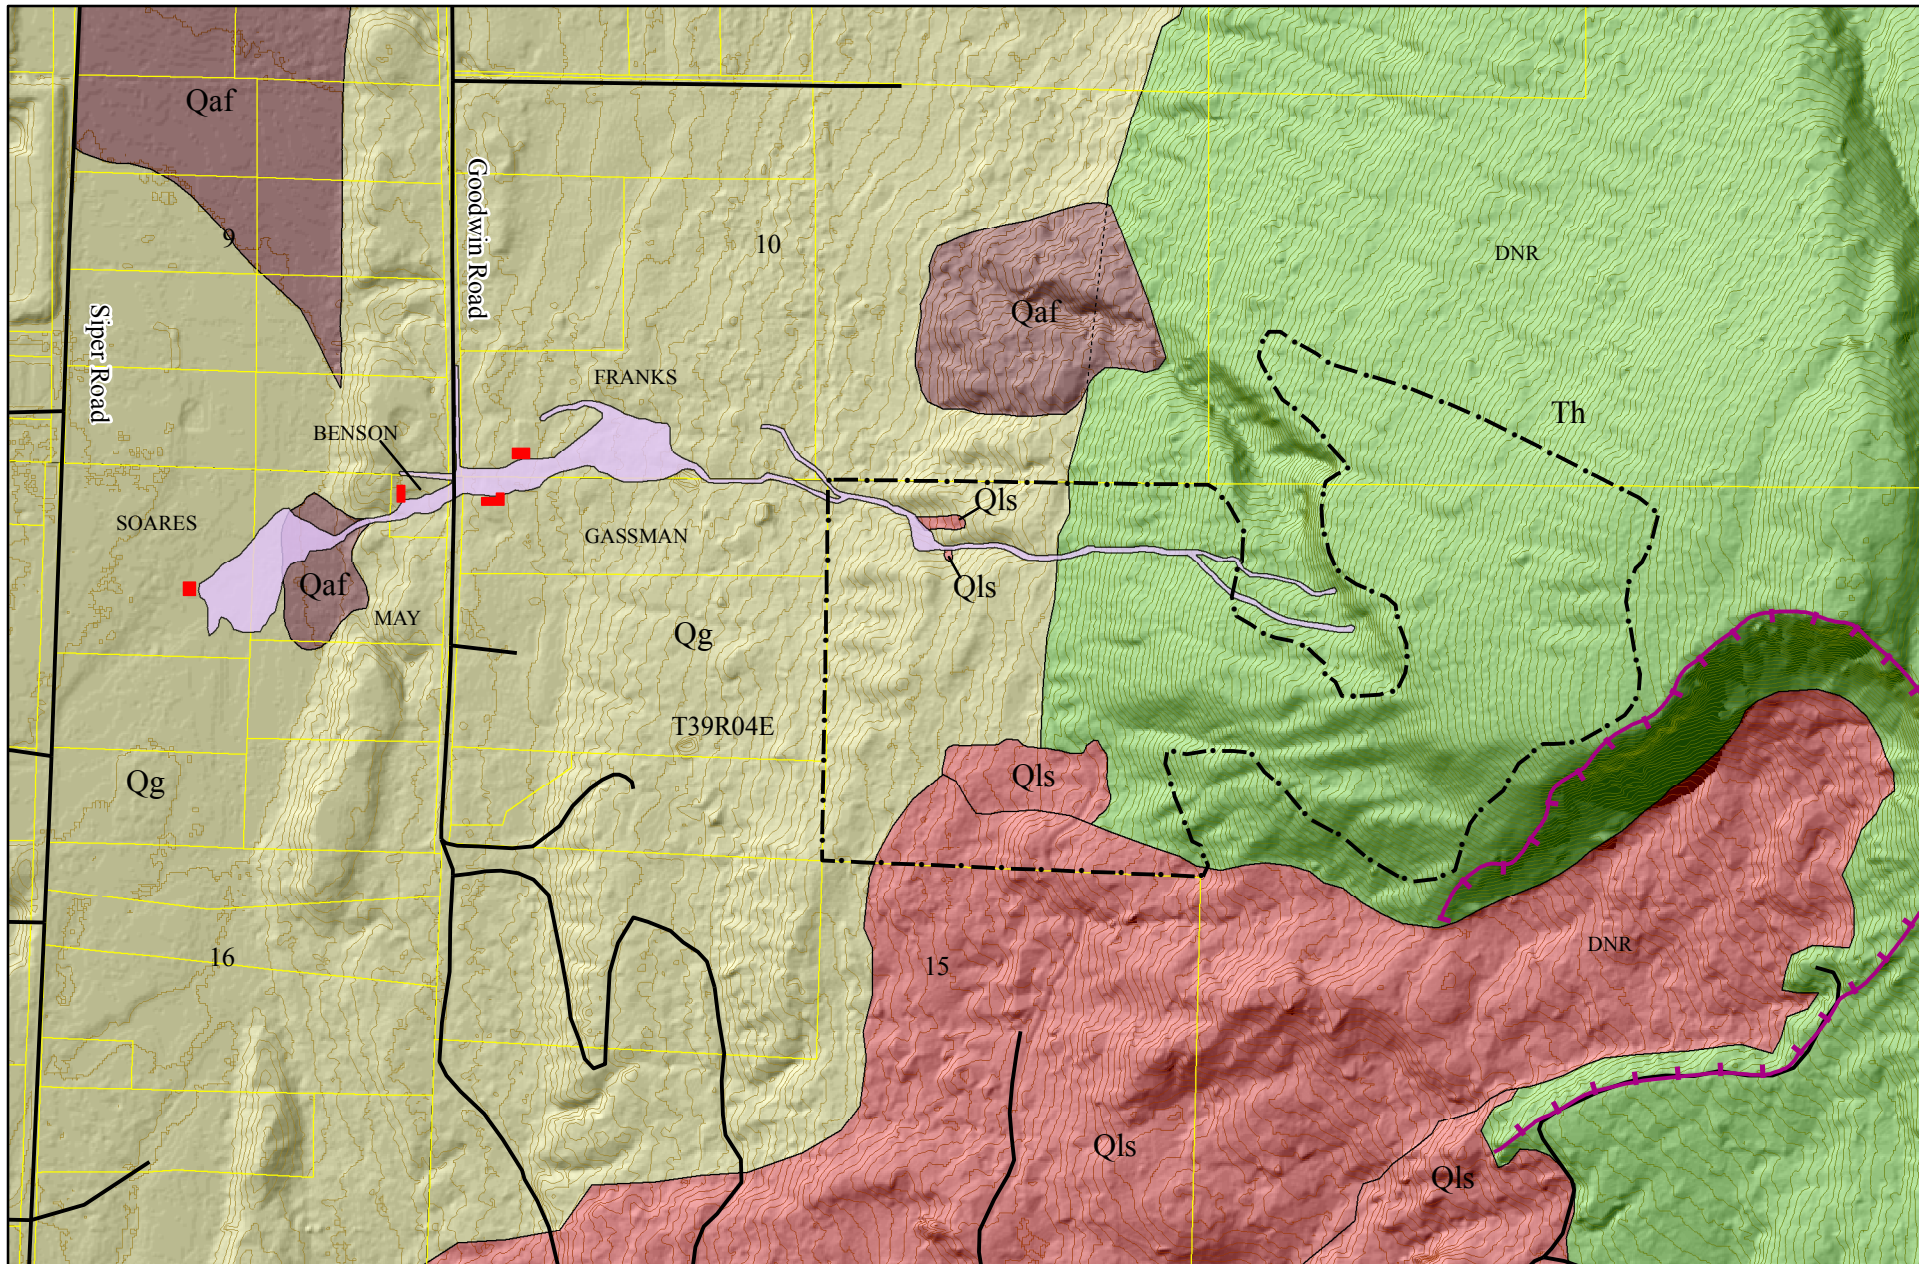
**Figure 2. Geologic Map**  
 Engineering Geologic Field Reconnaissance  
 6459, 6488, 6489, and 6500 Goodwin Road; and 6474 Siper Road  
 Whatcom County, Washington  
 Geology modified from Lapen (2000), interpretation of LiDAR topography, field observation, and photographs.

The topography of the Site is represented by two distinctly different types of terrain (Figures 1 and 2). The PIs (Herein referred to as North PI and South PI) are in an area of steep westerly-facing hillside topography. The affected residences are located on relatively gentle hillside topography or on a slightly elevated topographic bench underlain by glacial deposits that border the east side of the relatively flat plain of the Nooksack River. In the area of the Site the west-facing slopes of Sumas Mountain exhibit an average inclination of about 27%. However, locally bedrock cliffs characterized by essentially vertical inclinations of several tens of feet are present. Overall, on the east side of Goodwin Road the hillside in question exhibits slopes of 60 to 65% in the steep upper portion of the Site and hillsides with inclinations of 25% or less characterize the moderately-steep lower areas of the Site (Figure 2). Goodwin Road and areas to the west of the road are located on a relatively narrow topographic bench that gives way to the west to a steep west-facing slope about 50-feet high and then the generally flat, raised Holocene age surface of the glacial deposits that border the old Nooksack River flood plain. The PIs are situated at elevations of about 1,000 feet. The depositional areas and affected residences are situated on relatively gentle

**4.3.2. Surficial Deposits** – Lapen (2000) shows the **glacial sediments (Qg)** at the Site are represented by outwash deposits and undifferentiated deposits (Figure 3). These deposits are characterized by loose, moderately-well to well-sorted gravels with medium to coarse sand and occasional sand and silt beds. These sediments are mapped to underlie the lower moderately-steep slopes, the areas to the west of Goodwin Road, and the Holocene surface upon which the Soares Property is located.
