GEOLOGIC REPORT FOR THE 2409 REMNANT HARVEST UNIT AND ROADS

May 13, 2024

Harvest Unit Name: 2409 Remnant
HPU Number: 122112
Watersheds: North Fork of the Toutle River
Location: Cowlitz County, Washington
Sections 15, 21, & 22
T10N R2E, W.M.

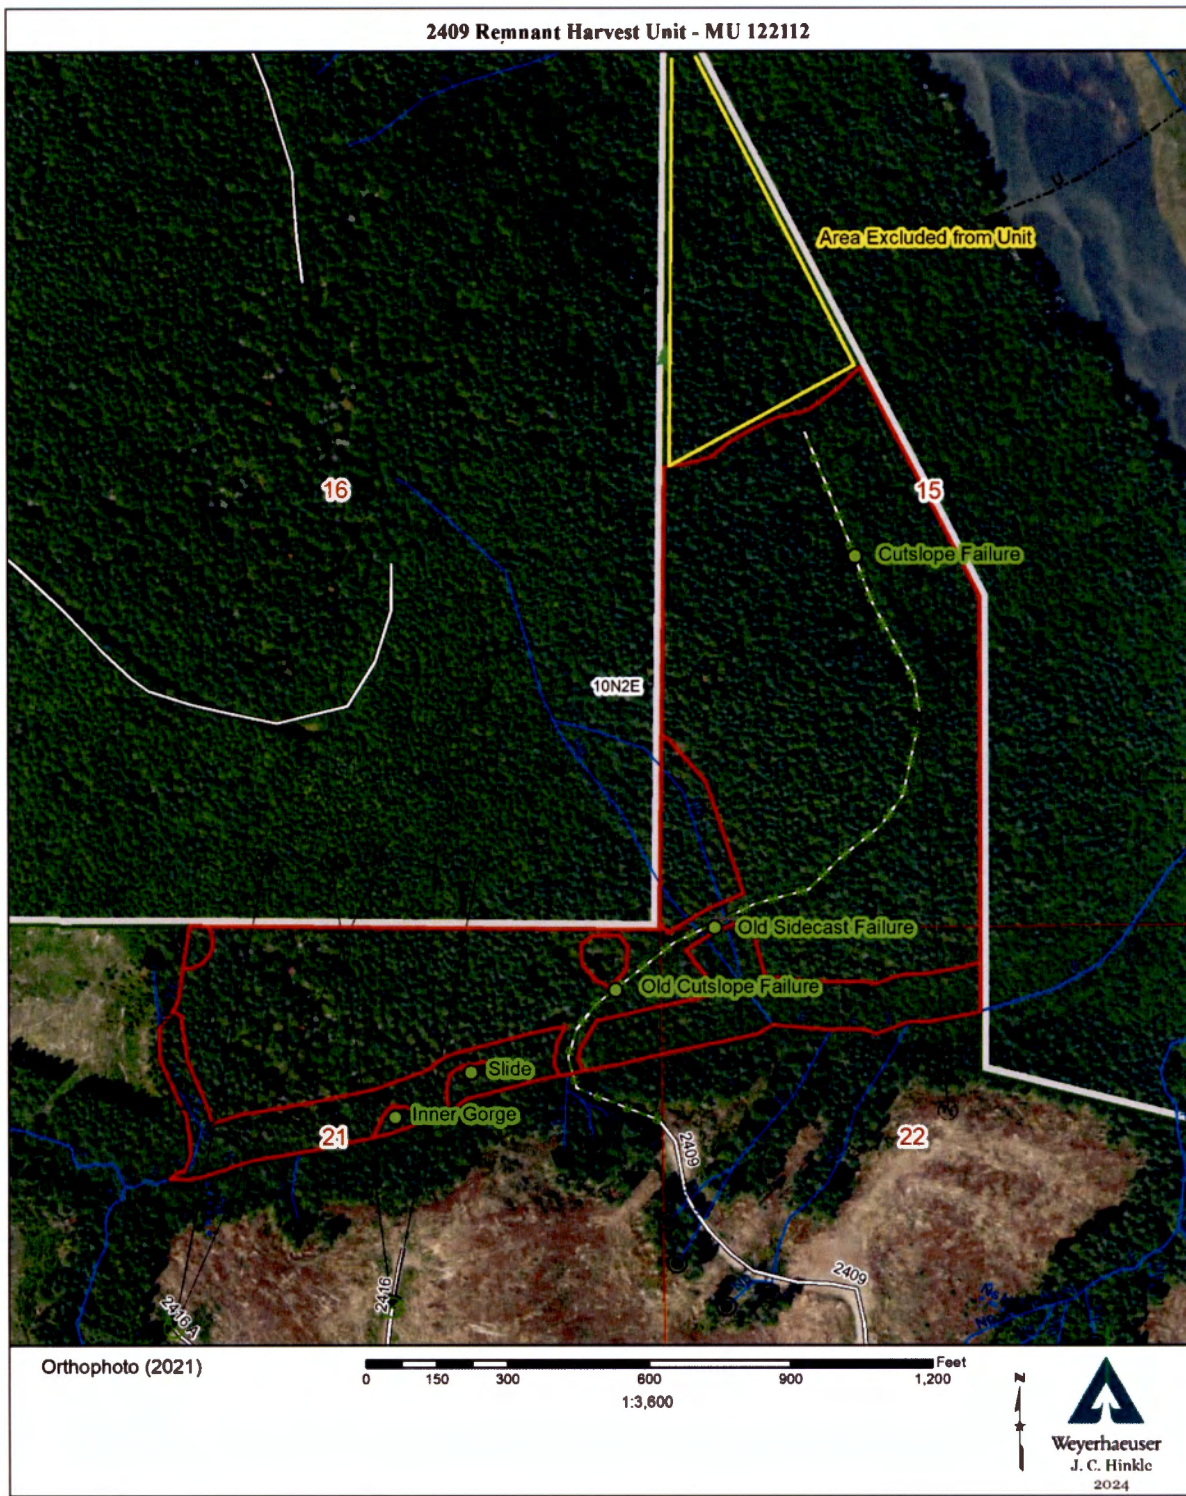
Figure 1: 2021 Orthophoto.

The harvest unit consists of several stand types dominated by 45 year old second-growth Douglas fir with western hemlock and other species in places (Figure 1).
