**REVISED REPORT OF GEOLOGIC HAZARD EVALUATION
GEODESIGN INC., AN NV5 COMPANY
MAY 27, 2020**

Revised Report of Geologic Hazard Evaluation

Naff Pit

Geologic Hazard Evaluation

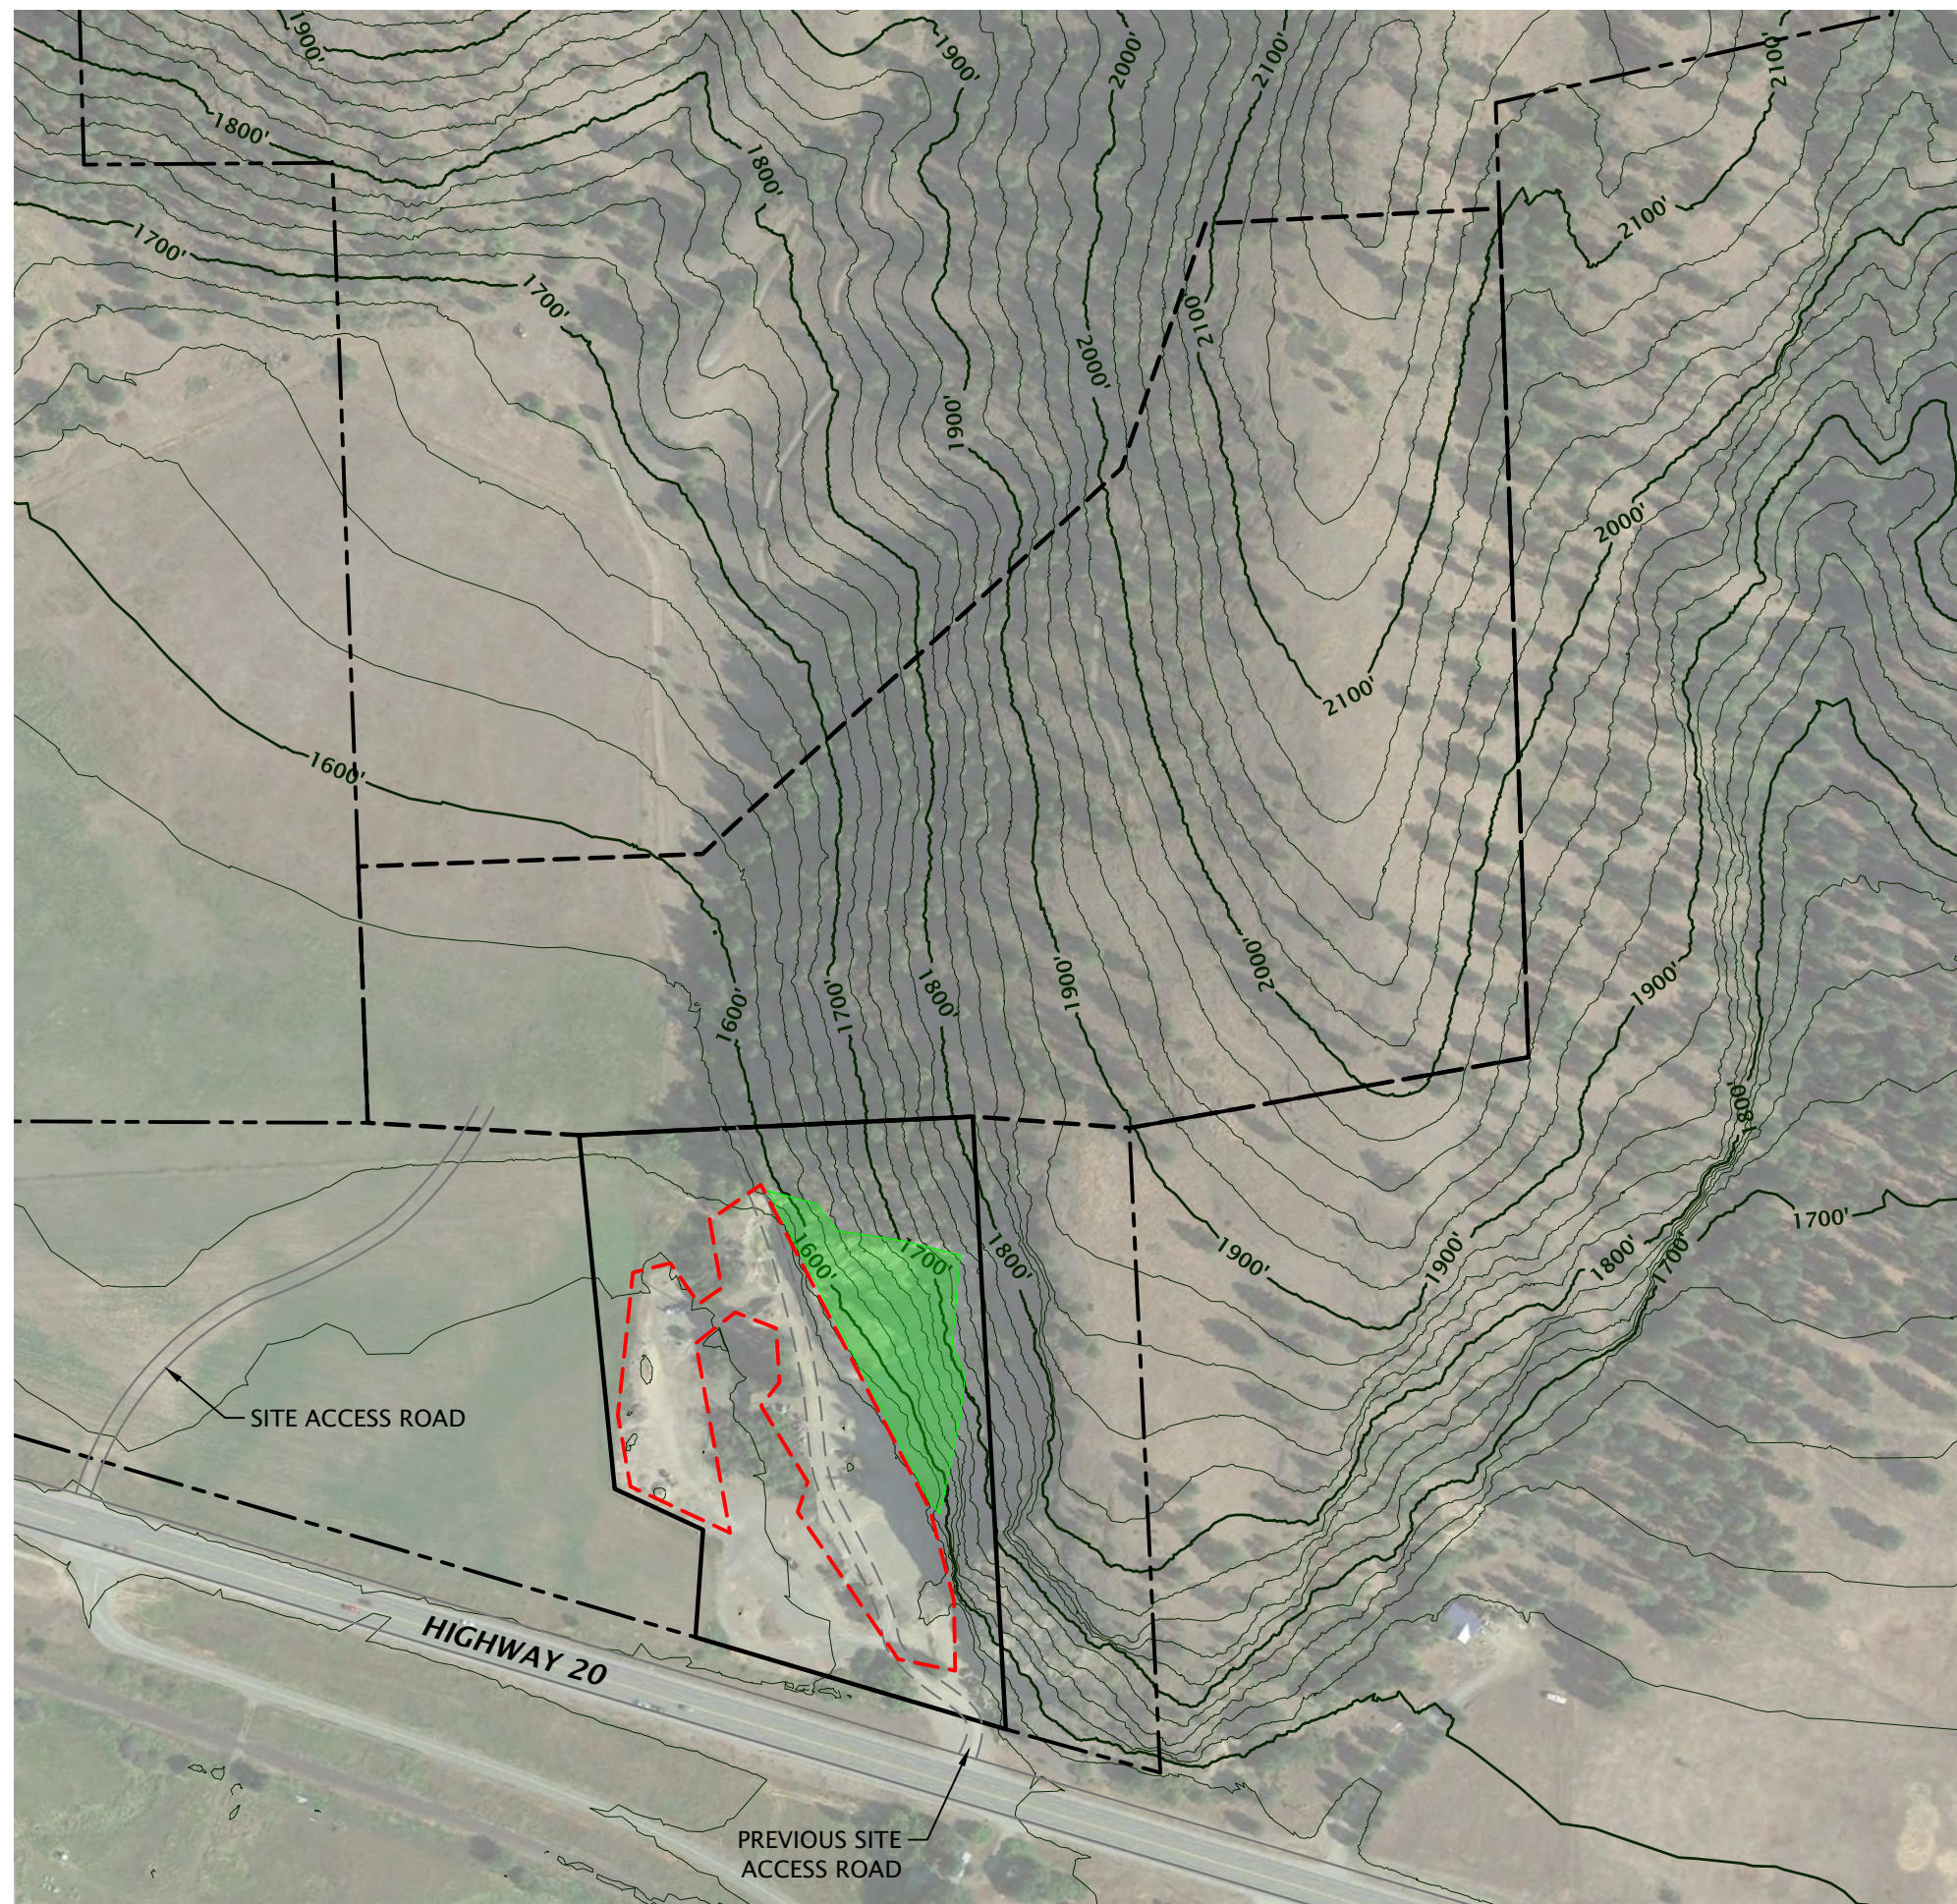
VAAGEN BROTHERS LUMBER, INC. VAAGENBROS-1-01 MAY 2020	SITE MAP NAFF PIT (DNR #70-013126) STEVENS COUNTY, WA SECTIONS 25 & 26, TOWNSHIP 36N, RANGE 38E W.M.	FIGURE 2

Prior to Vaagen acquiring the property, a small mine existed on the site operated by Mike Naff. The prior mine extracted bedrock and talus along a steep working face on the west side of a steep-sided ridge. This resulted in local slope instability including raveling of loose talus from above the mine excavation and large block failures of jointed, dipping bedrock falling to the mine floor. The prior mine roughly corresponds to the green-shaded “reclaimed area” and backfilled floor to the southwest shown in Figure 2.

CVR backfilled much of the prior bedrock mine excavation with non-resource rock material, as shown in the aerial image and by the topographic contours below the green-shaded “reclaimed area” on Figure 2. However, expanded mining north of the prior mine has not followed the top-down mine plan and benching parameters recommended by GeoDesign. The following summarizes Fulcrum’s observations of current site conditions and associated geologic hazards.

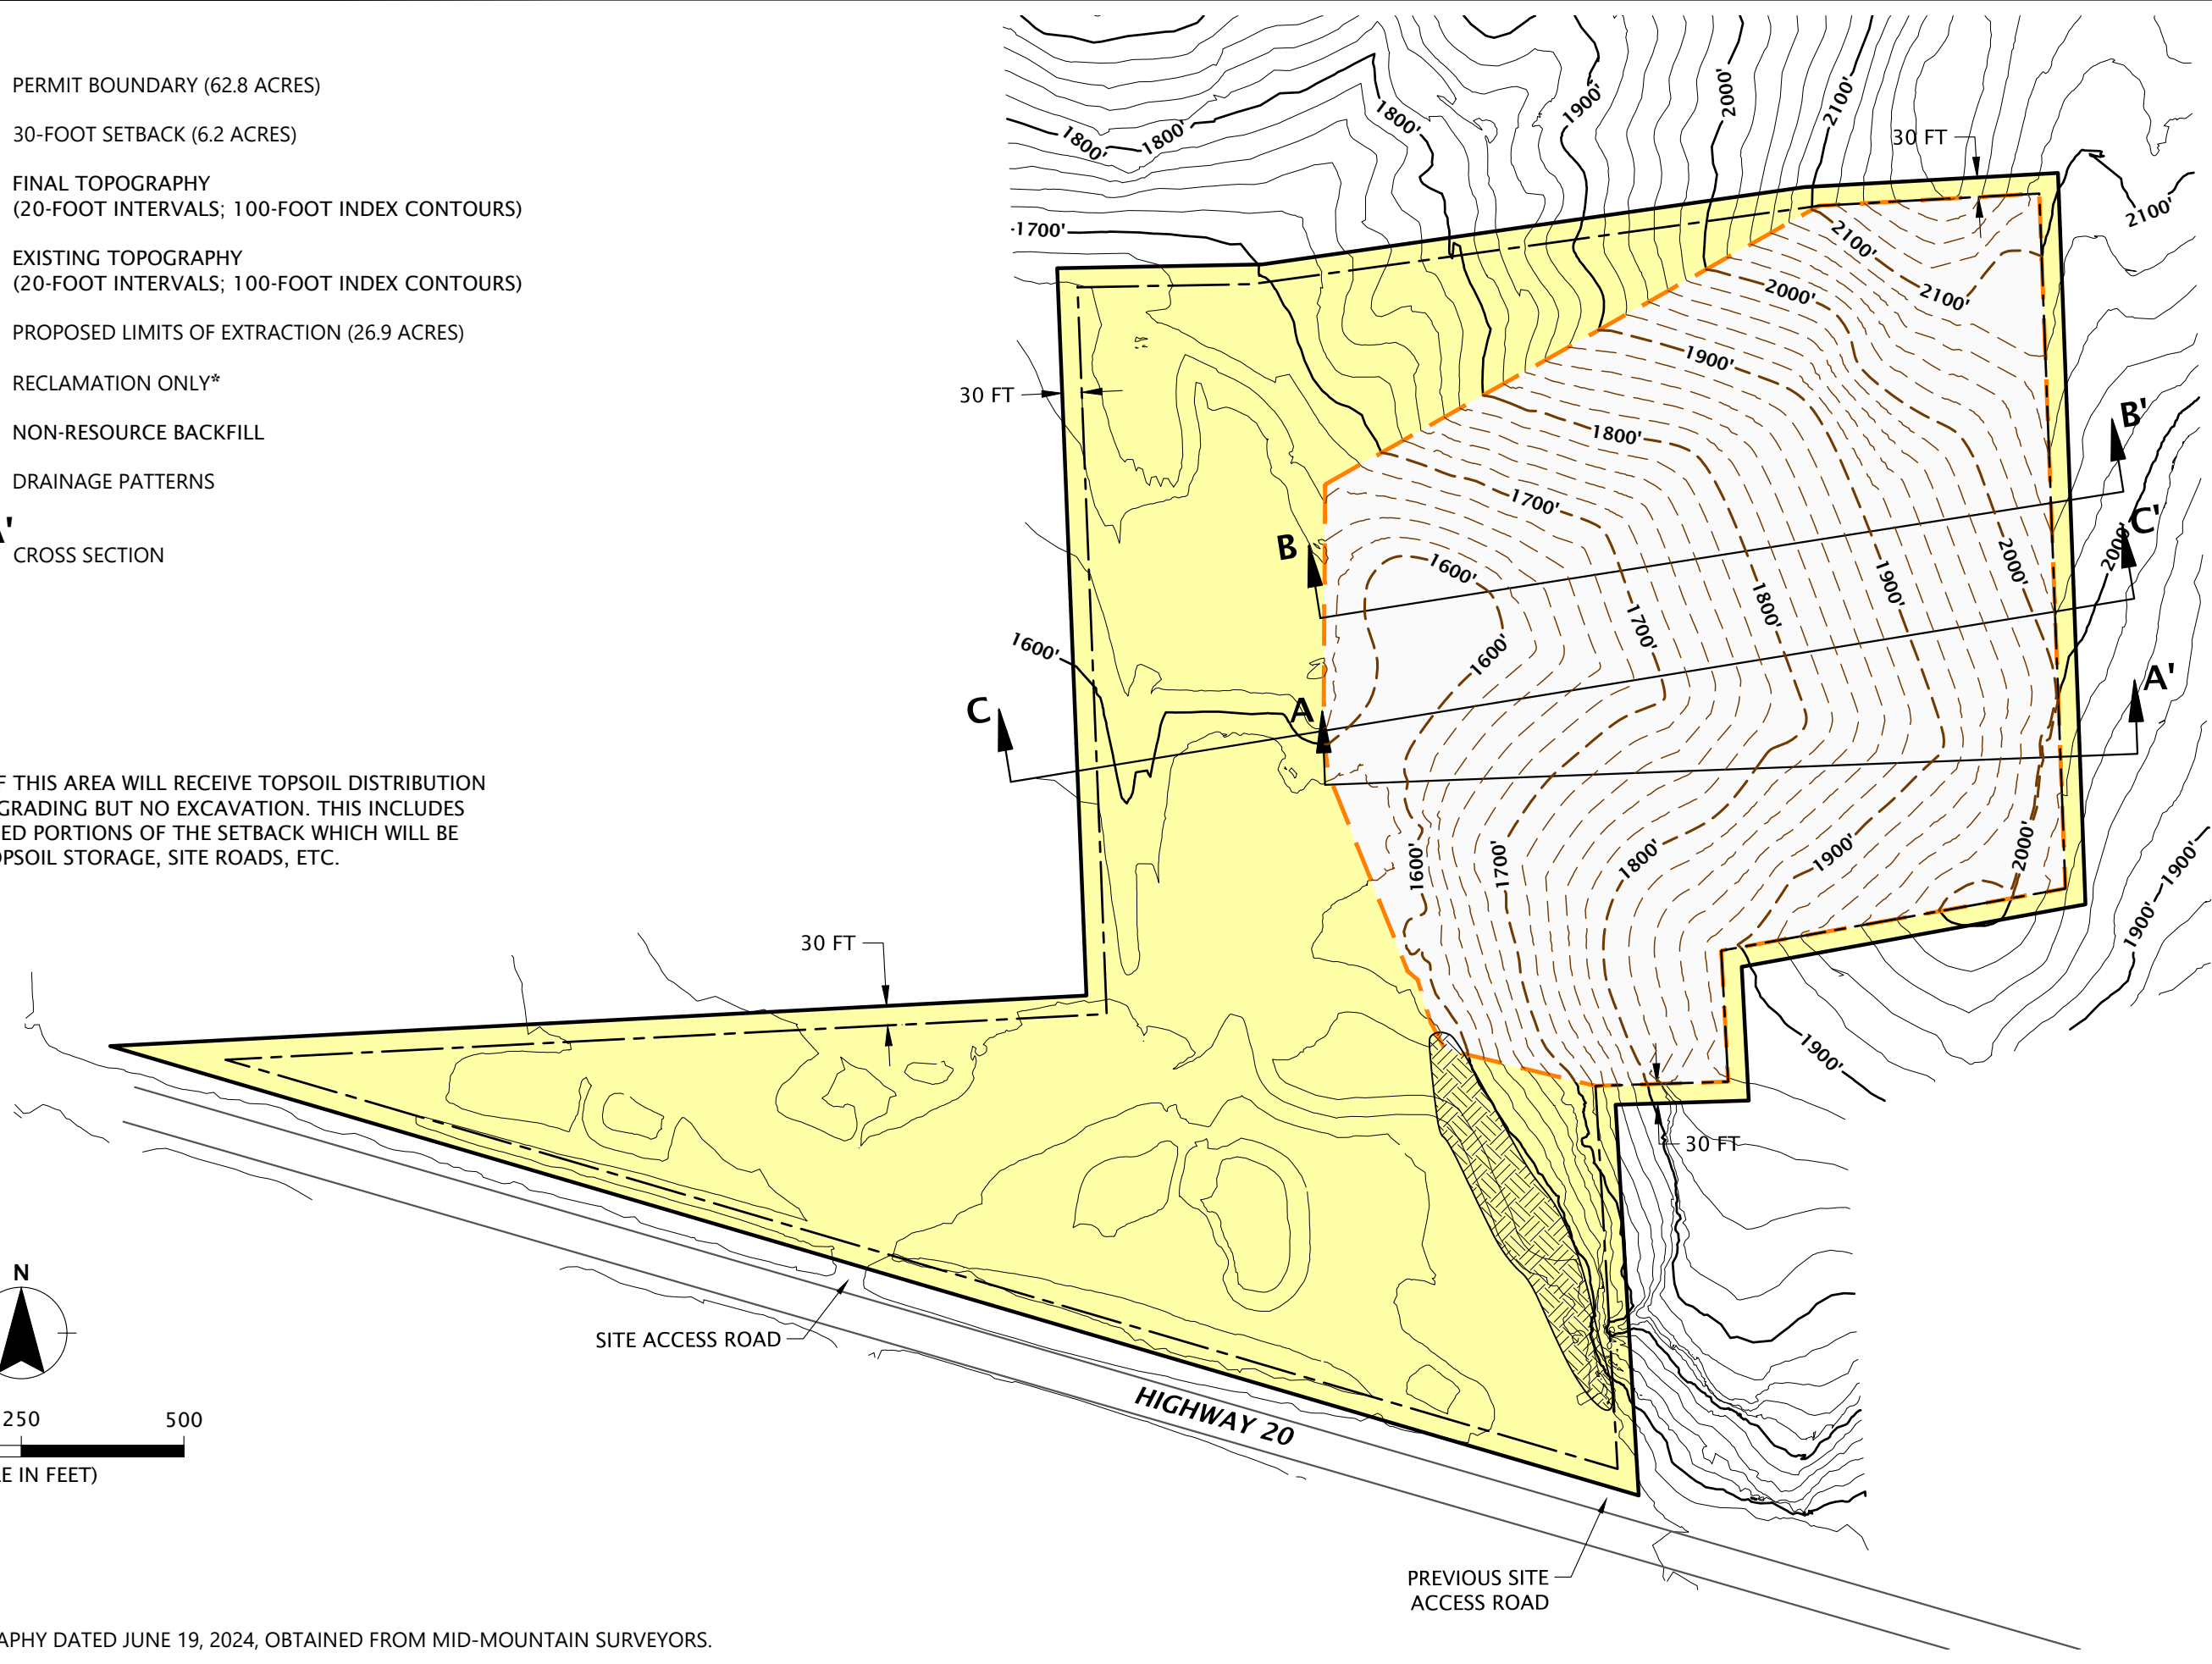
FULCRUM GEO RESOURCES	VAAGEN BROTHERS LUMBER, INC. PROJECT 012.01.01 AUGUST 2024	FINAL TOPOGRAPHY MAP NAFF PIT - GEOLOGIC HAZARD EVALUATION STEVENS COUNTY, WA SECTIONS 25 & 26, TOWNSHIP 36N, RANGE 38E W.M.	FIGURE 4

The finer-grained strata – particularly the slate – located at the base of the east wall in Cut 1 is of significant concern. Slate is a much weaker rock than the overlying conglomerate and sandstone, as exhibited along the dozed roadways north of the mine. If Cut 1 were expanded northward or southward from the current box cut into a longer bench, it could lead to a global failure of the ridge, where the overlying conglomerate and sandstone could slide over the exposed slate. Based on the proposed final contours on Figure 4 and cross section A-A' on Figure 5, Cut 1 has been excavated below a final floor projecting at 2H:1V from the east edge of the proposed extraction limits. As such, some of the current Cut 1 may require backfill to achieve the proposed final topography presented on Figures 4 and 5.

If it is determined that any portion of the currently mined slopes lie below the proposed final contours shown on Figures 4 and 5, those excavations should be backfilled to blend into adjacent areas to achieve the final 2H:1V grades. Backfilling operations should be planned to avoid requiring mine staff to be present below potentially unstable slopes.
