Appendices I and J

Effectiveness of Forest Road and Timber Harvest Best Management Practices with Respect to Sediment-Related Water Quality Impacts

December 1999
Publication No. 99-350

APPENDIX J: CASE STUDY SUMMARIES

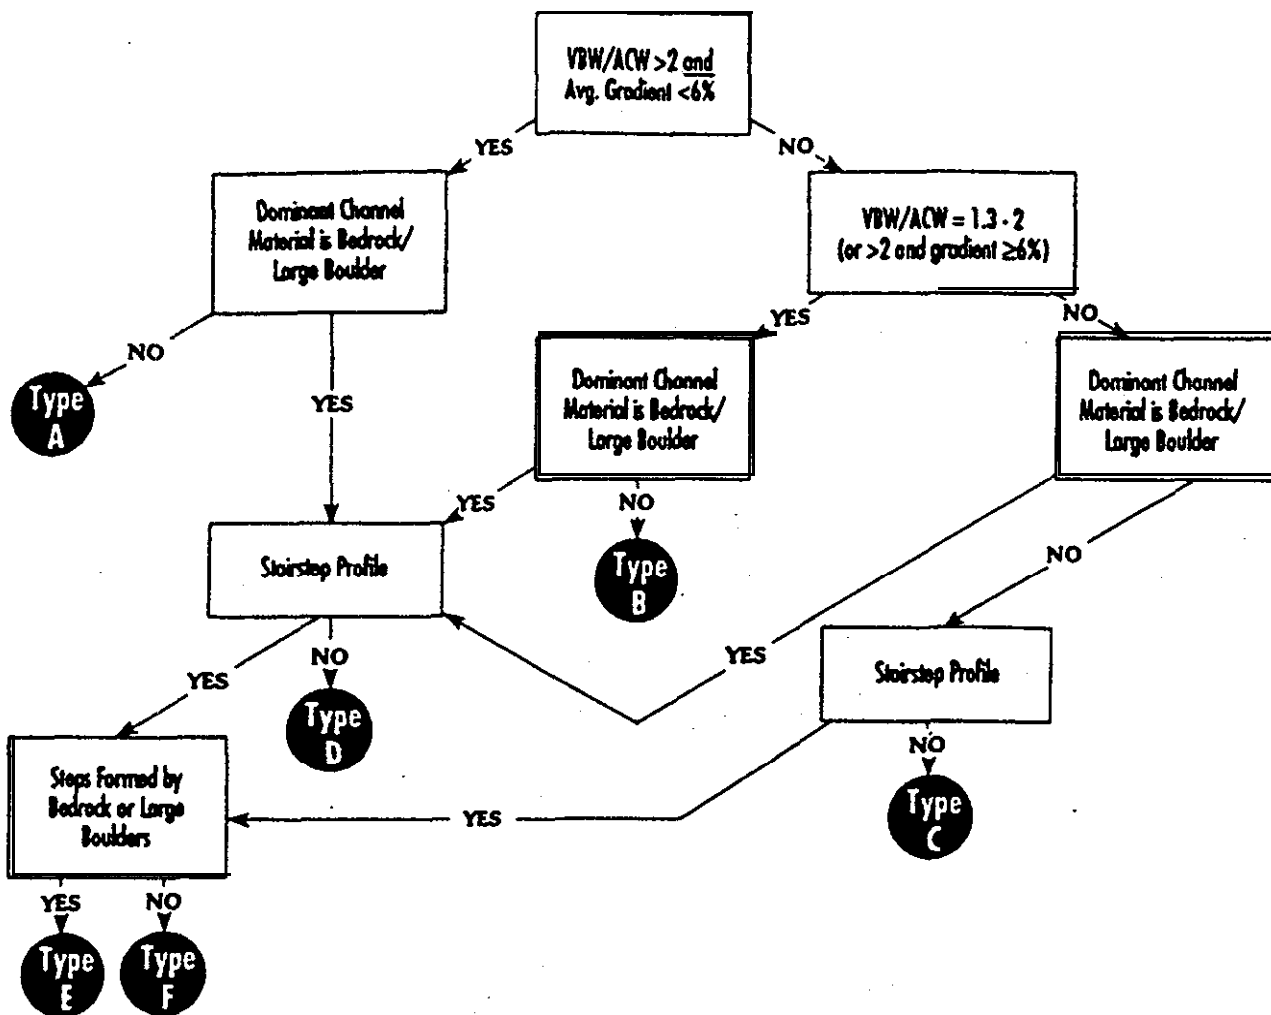
Flow Chart for Determining Response Category Type

RESPONSE CATEGORY TYPE	POTENTIAL RESPONSE TO INCREASED PEAK FLOW
Type A: Unconstrained	Increased width and meander wavelength through bank cutting; may also downcut
Type B: Slightly constrained, unconsolidated bottom	Increased width through bank cutting; this may result in undercutting of the upper banks and accelerated mass wasting; may also enlarge by downcutting
Type C: Laterally constrained, unconsolidated bottom	Most likely to downcut; may also increase width through bank cutting, which could trigger accelerated mass wasting of upper banks
Type D: Constrained, bedrock/large boulder bottom and banks	Cannot enlarge through downcutting, may widen slightly where banks can erode; will transmit water, sediment, and debris to lower reaches
Type E: Boulder/bedrock stairstep	High stream energy will transport water, sediment, and debris to lower reaches; if upper banks are not bedrock, may widen slightly and accelerate mass wasting

Type F: Woody debris stairstep	If "steps" are stable, will respond as Type E, or may trigger debris flow/dam break flood if debris recruitment is high and "steps" fail

From flow chart, peak flow response category is:

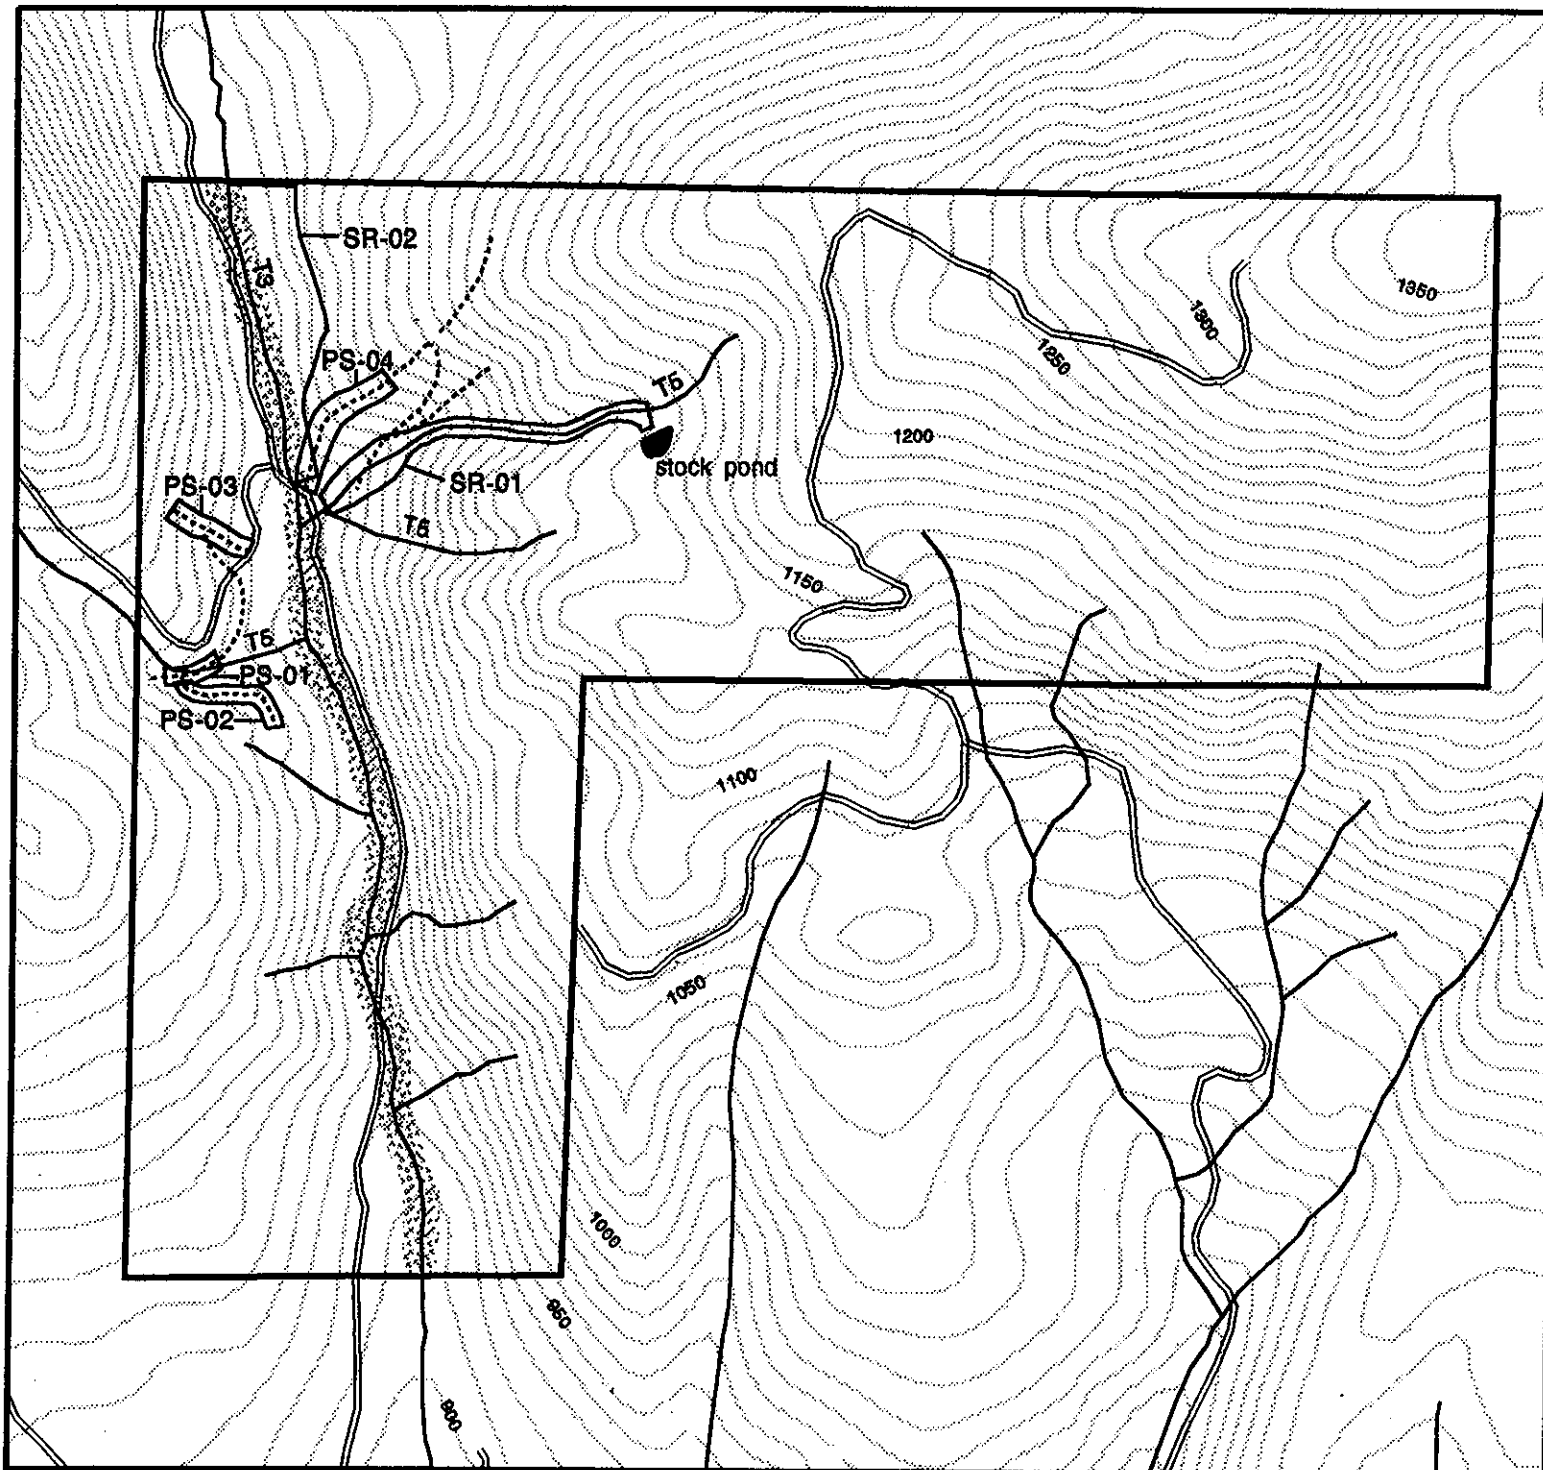
Site E-04 Green Canyon

BMPs evaluated at the site included the RMZ on the Type 3 stream with adjacent ground-based harvesting, and ground-based harvesting in the vicinity of Type **5** streams without stream buffers. Photo point surveys evaluating skid trail erosion and sediment delivery were conducted in November 1992 and April 1994. Two sediment routing surveys were conducted in April 1994 along one of the Type 5 streams and along a portion of the RMZ.
