**MASS WASTING PRESCRIPTION-SCALE EFFECTIVENESS
MONITORING PROJECT (POST-MORTEM)
Quality Assurance /Quality Control (QA/QC) Report**

July 17, 2009

Teresa Miskovic and Jack Powell

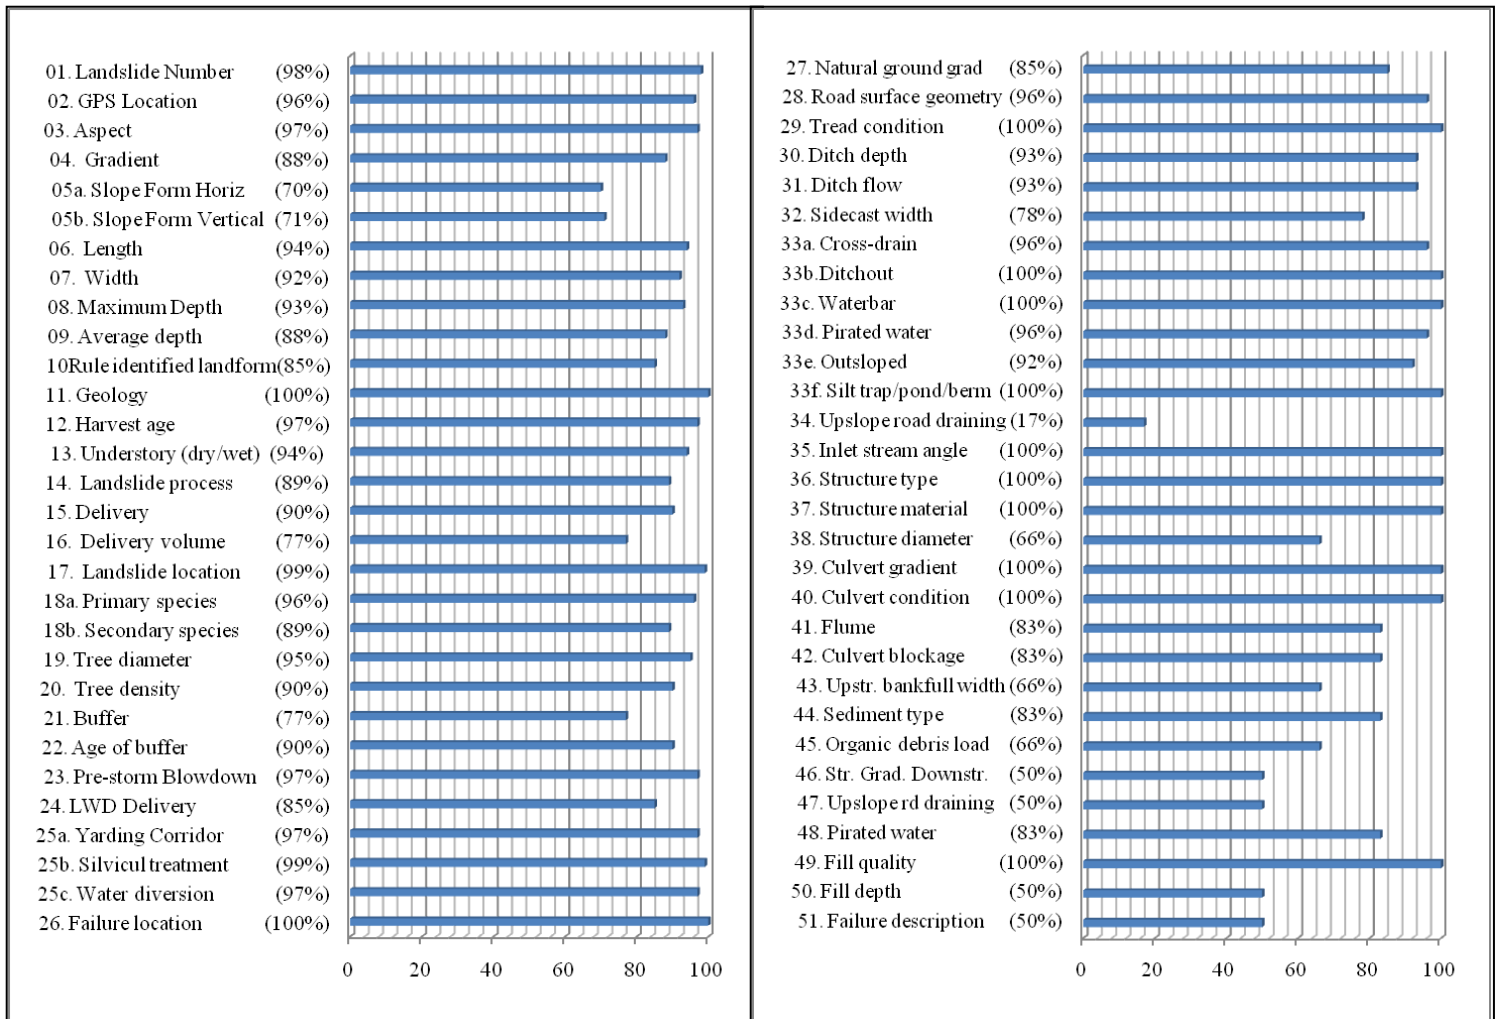
**Summary showing the agreement between observations of the Post-Mortem Team
and the QA/QC Team on various parameters examined during this study**

Executive Summary

This report presents the Quality Assurance/Quality Control (QA/QC) Team's findings of the Post-Mortem Team's data collection at individual landslides. The Post-Mortem Team collected 60 data categories to tabulate basic information about each landslide and to examine the relationships between forest management activities and the landslides produced by the December 2007 storm in Southwest Washington. Landslides were evaluated for physical attributes, initiation settings, sediment delivery, and relationships to forest management activities. The QA/QC Team evaluated observations made by the Post-Mortem Team. Approximately 10% of the landslides evaluated by the Post-Mortem Team were examined by the QA/QC Team for consistency and validity. The QA/QC Team's findings are summarized in the chart below and more completely on the following two pages.

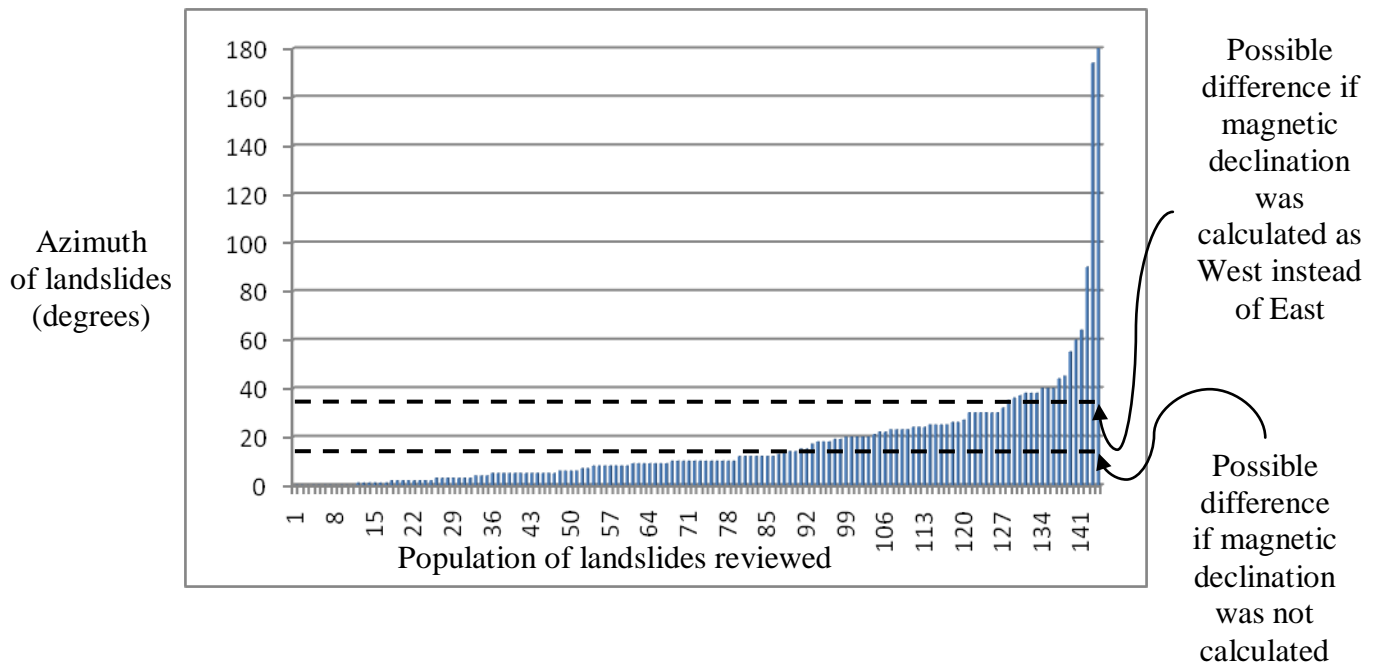
Differences in aspect readings between the QA/QC Team and the Post-Mortem Team for 144 landslides.

Figure 1. Graph showing the difference between aspect readings determined by the QA/QC Team and the Post-Mortem Team for landslides reviewed during the QA/QC process. Only four landslides were truly anomalous: however, disagreements between readings determined by the two teams were common, but still reasonable. Part of this may be due to the natural variation in determining aspect, although some of the error may be related to not using or misusing the magnetic declination correction.

The QA/QC Team used a magnetic declination correction of 18°. Some of the variation in aspect between the QA/QC Team and Post-Mortem Team may be partly due to the Post-Mortem Team using incorrect magnetic declination corrections. This may have provided a maximum 36° error (see Figure 1). Given the large potential for variation in this measurement from the irregular nature of landslides it was not possible to say whether any declination error was made in any given landslide.

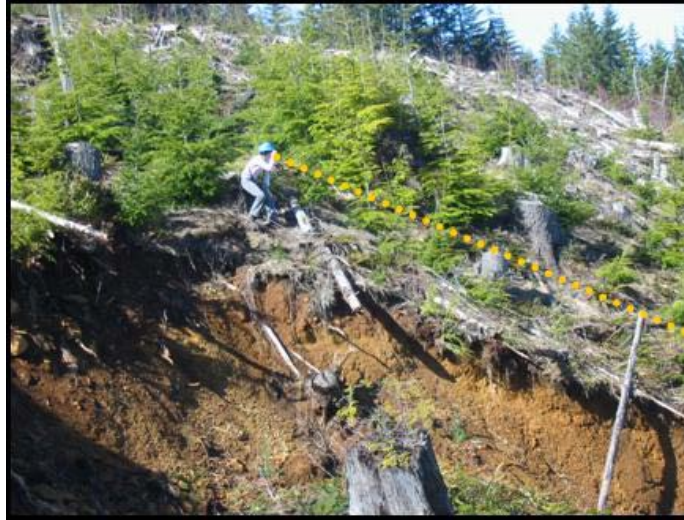
Figure 2. Example of measuring hillslope gradient at the failure initiation site (from Post-Mortem Field Manual Photo: Julie Dieu).

The Post-Mortem Field Manual describes how to measure the gradient of the hillslope adjacent to the landslide initiation elevation. It states “Using a clinometer, measure the gradient of the hillslope ADJACENT to the landslide initiation (Figure 2). If the landslide initiated within a road fillslope, measure the adjacent fillslope gradient. If the landslide initiated within a road cutslope, measure the adjacent cutslope gradient. For consistency, the measurement should be taken facing down the slope and over a length of at least 20 feet where possible. (*Be careful to record the gradient in percentage (%), not degrees – both are displayed inside most clinometers.*)” Figure 2, taken from the Field manual, illustrates how to measure slope gradient.

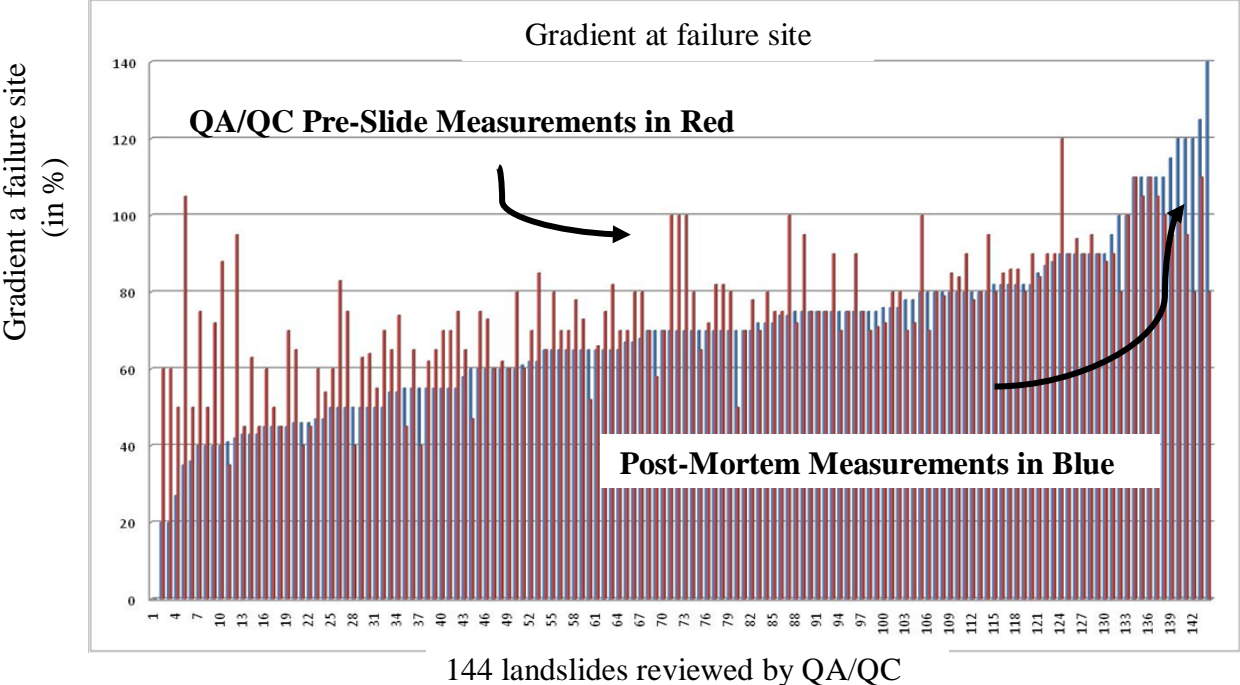
Graph showing gradient at the failure site where the Post-Mortem Team measurements (which were reviewed by the QA/QC Team) were sorted from gentlest to steepest slopes (in blue). The QA/QC Team measurement is paired to the right of each measurement (in red).

Figure 3. Although measurements were similar between the Post-Mortem and QA/QC Teams, some appear quite dissimilar at both ends of the spectrum.

Figure 3 graphs variations in slope gradient determinations between the QA/QC Team and the Post-Mortem Team. On the high end of the graph it appears the Post-Mortem Team may have been recording the slope of the landslide head scarp and not the slope gradient. At the low end of the chart it appears the Post-Mortem Team was measuring the gentler slope above the landslide head and not the slope that failed. Some of these low readings may have resulted from confusion between recording slope percent and slope degree measurements.

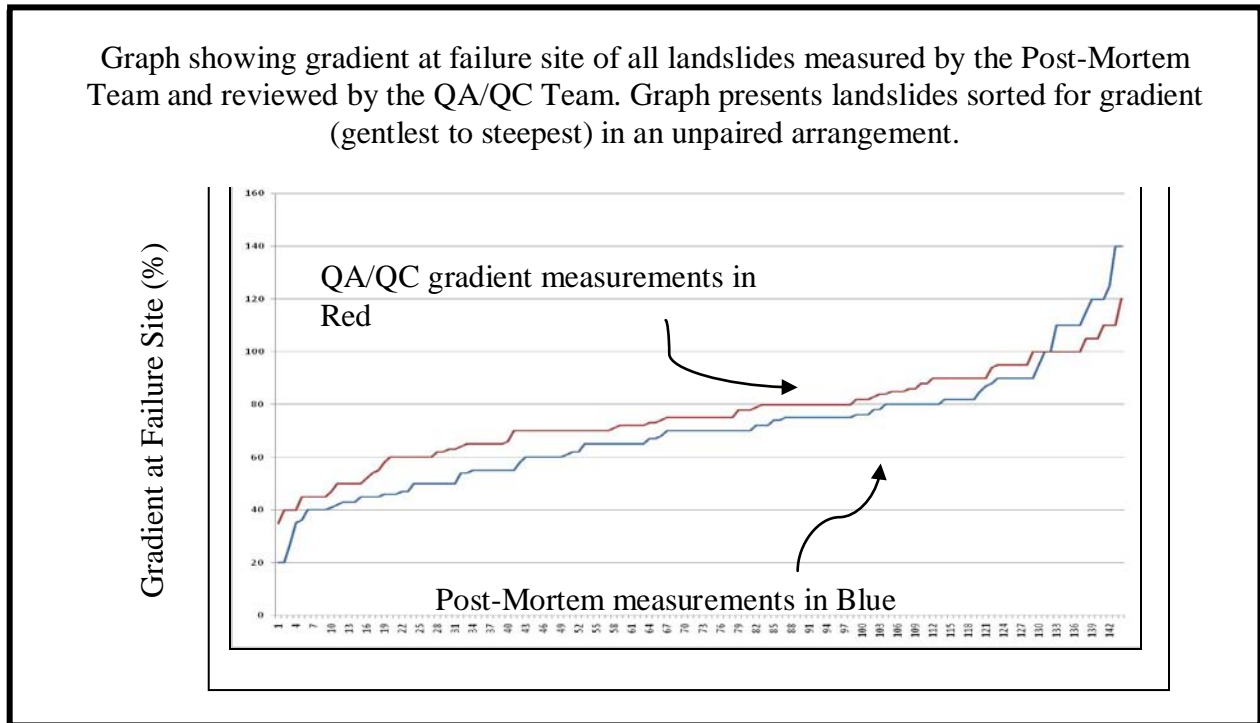
Figure 4. If the gradient at the failure site for all of the Post-Mortem Team landslides measured by the QA/QC Team are plotted in an unpaired arrangement, it appears the QA/QC Team measured steeper slope measurements than the Post-Mortem Team.

Figure 4 is a graph of all slope gradients measured by the QC/QA Team and compared to the Post-Mortem Team measurements. The readings have been sorted in order from smallest to largest and appear to show consistently higher slope angle readings taken by the Post-Mortem Team than measurements taken by the QA/QC Team.

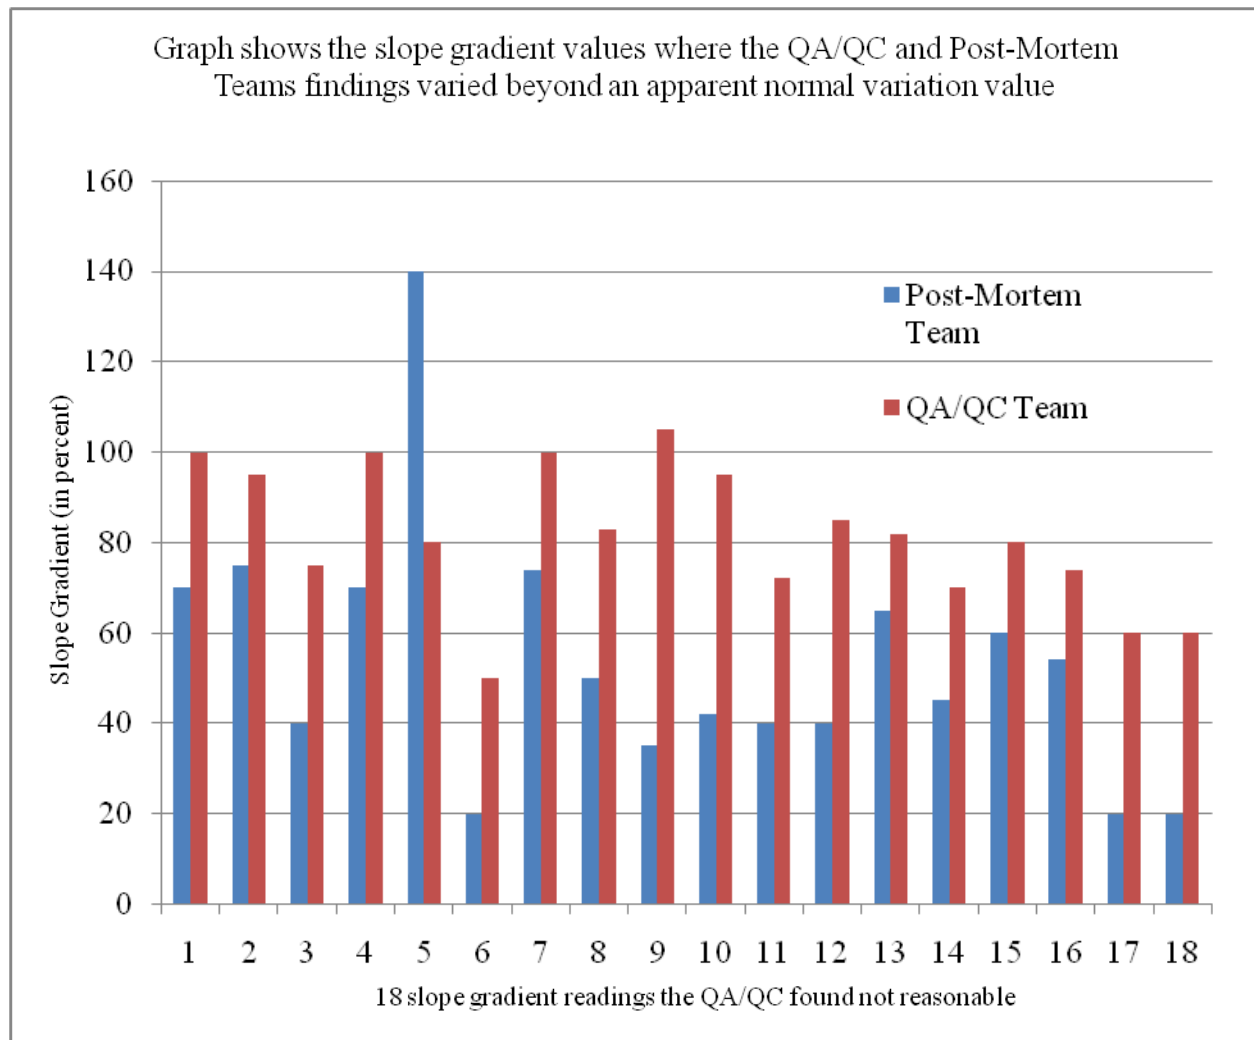
Figure 5. This graph of the 18 slope gradient readings the QA/QC Team found not reasonable, shows that all but one were below what the QA/QC Team had determined for the slope gradient adjacent to the landslide.

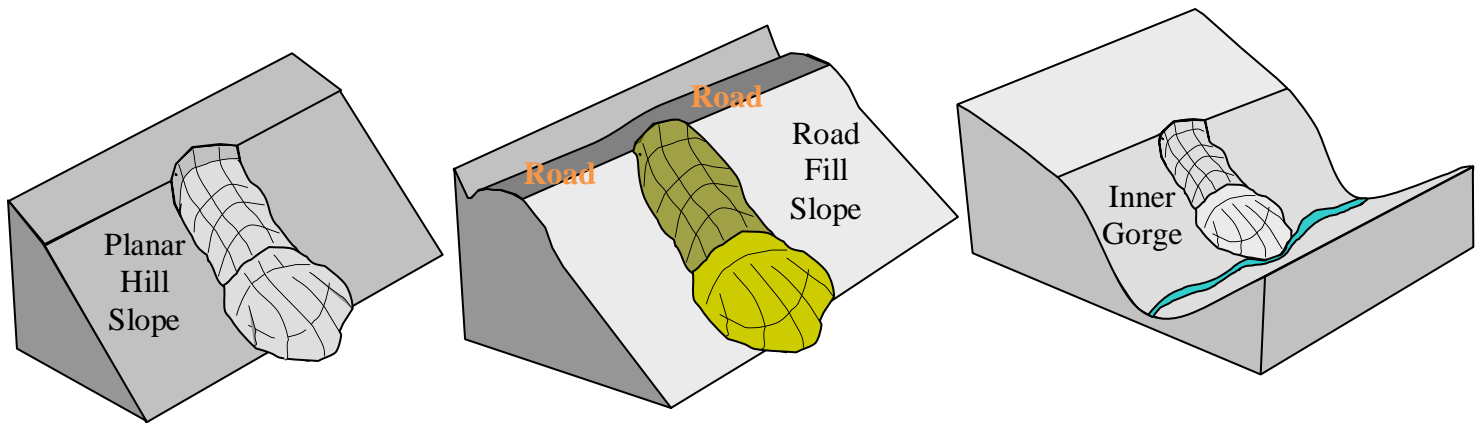
Diagram of Slope Form examples

Three examples of planar/convex or planar/planar slopes that the Post-Mortem Team commonly labeled "convergent/concave"

Figure 6. The Post-Mortem Team would commonly record a landslide as having occurred on a convergent/concave slope even though the slope was planar. It appeared the Post-Mortem Team was recording the post landslide slope form instead of the pre-landslide slope form. Examples of slope forms that were described as convergent/concave include planar hill slopes, planar road fill slopes, and planar side slopes of inner gorges.

The QA/QC Team and the Post-Mortem Team differed on pre-landslide slope form observations more often than any other type of field observation. The QA/QC Team found 30% (50 of 165) of the Post-Mortem Team’s slope form determinations to be unreasonable. In half of these cases (26 of 50) it appeared that the Post-Mortem Team determined the post landslide slope form to be convergent and concave even though the slope prior to this failure appeared to have been planar and convex or planar and concave (Figure 6). In twelve cases the Post-Mortem Team determined that landslides occurring within a bedrock hollow had failed on planar slopes. This appears to be contradictory

because bedrock hollows are convergent topographic features however it is not uncommon for bedrock hollows to contain planar areas. In 4 of 12 landslides the QA/QC Team was unable to find any planar areas in the convergent features and determined that the Post-Mortem Team's findings were in error. Two landslides which occurred where roads crossed streams were described as failing on planar slopes, however, the road fill appears to have had a convergent nature prior to its failure.

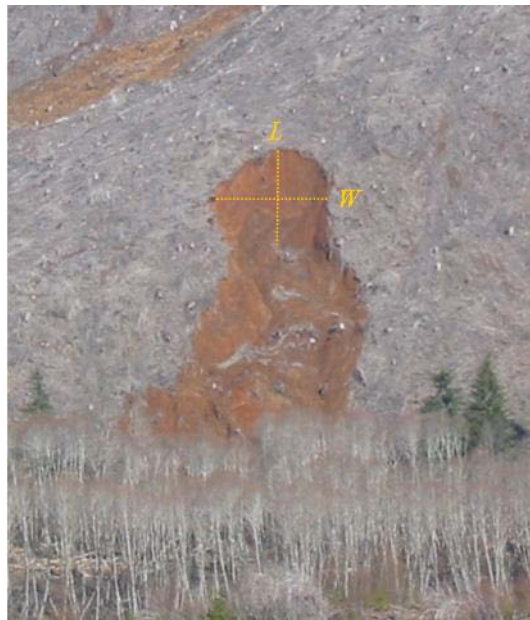
Figure 7. Photograph from Post-Mortem Field Manual that illustrates how to measure the failure initiation dimensions. (Photograph: Julie Dieu)

The *Width* is defined in the Post-Mortem Field Manual as, “the distance between side scarps across the widest part of the scarp” (Figure 7). The irregular nature of some landslide head scarps created a fairly large variation in width measurements even among members of the QA/QC Team. Although there was significant variation between width measurements taken by the QA/QC Team and the Post-Mortem Team, most of the time rationale for this variation was apparent. This variation in measurement was especially problematic with shallow landslides occurring on active deep-seated landslides that had moved during the December 2-3, 2007 storm. All other variations in width measurement could be explained by the uncertainty of which landslide was being measured in areas where the landslides were not flagged with a unique number in the field; these were not used in this analysis.

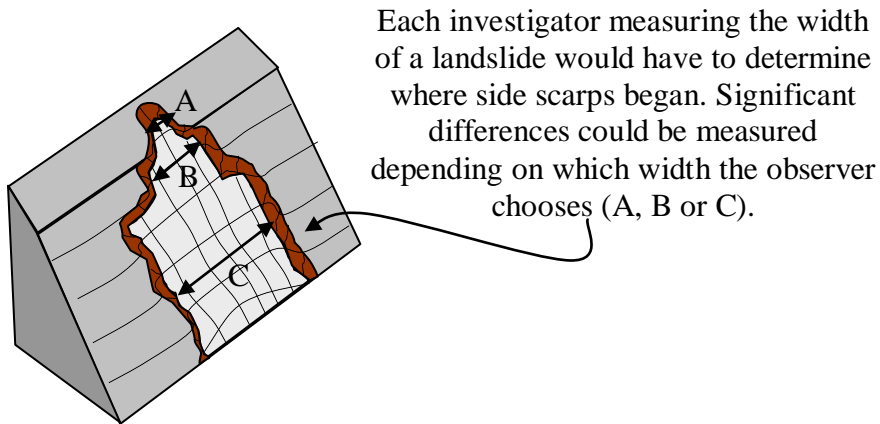
Figure 8. Major differences in determining the width of a landslide stemmed from the difficulty of determining the distance between side scarps across the widest part of the scarp.

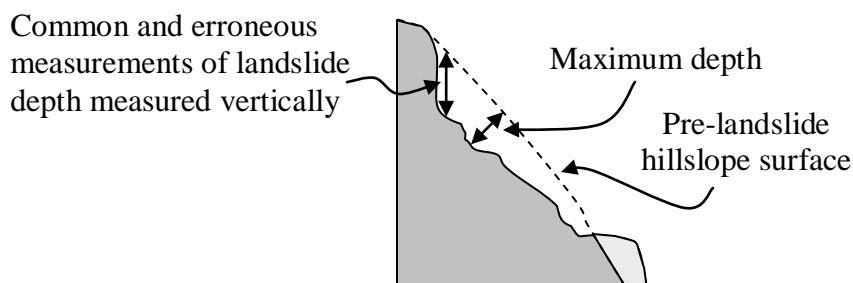
Figure 9. The major variation in depth measurements resulted from the tendency of some members of the Post-Mortem Team to measure the depth of a landslide vertically instead of perpendicular from the estimated pre-landslide hillslope surface.

The field manual defines “*Average depth* and *Maximum depth* as the depth of material that failed during the landslide. These estimates require making some assumptions about the hillslope surface prior to the failure, and they are meant to be visualized as perpendicular to the *Length* (i.e., not measured in the vertical, but perpendicular to the hillslope).” It is easy to overestimate the depth of a landslide. The most common error observed in measuring the depth of a landslide was to record the height of the head scarp which is often a vertical measurement versus a measurement perpendicular to the hillslope (Figure 9). It was very difficult to physically measure the maximum depth of a landslide without crawling down onto the slip plane to allow measurement of the side scarp wall. Estimates of the maximum depth varied the most when an observer would stand above the head scarp to make an estimate. The QA/QC Team definition of reasonable varied depending on the size (scale) and irregular nature of the landslide. A reasonable observation was one that could be reproduced logically in the field or that was generally within 40% of the QA/QC Team measurement. The difficulty with using a set figure for reasonable agreement is the scale of the landslide. A 3 foot difference in maximum depth (5 vs 8 feet) is usually easy to see in a 10-foot-wide landslide but difficult to determine on a 50- foot-wide landslide. Figure 10 shows the Post-Mortem Team recorded greater maximum depths than the QA/QC Team.

The average depth of a landslide was a measurement that was difficult for various individuals to reach consensus. The Post-Mortem Team would usually have a greater depth estimate, probably due to measuring this datum vertically instead of perpendicularly to the original hillslope surface (Figure 9).

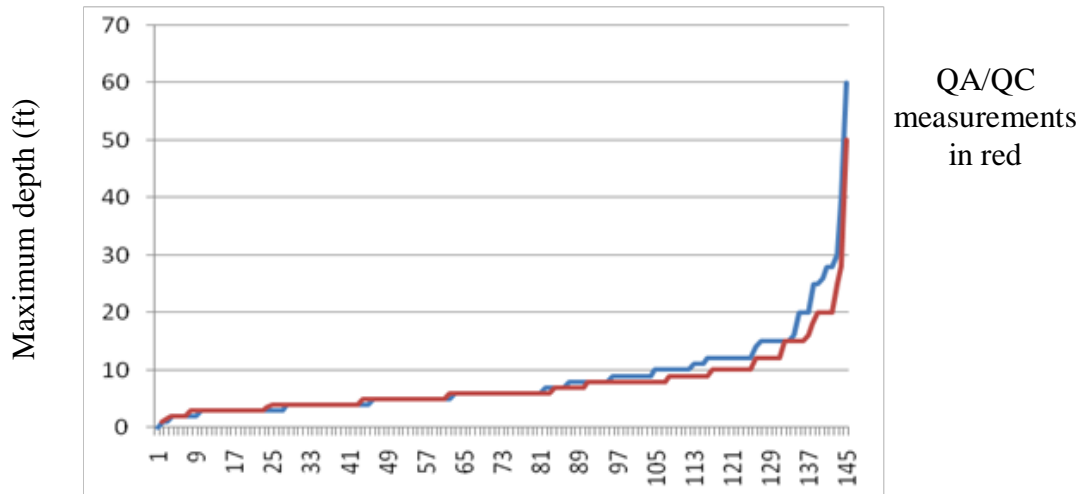
Graph showing maximum depth of all landslides measured by the Post-Mortem Team which were reviewed by the QA/QC Team. Graph presents landslides sorted by depth in an unpaired arrangement.

Figure 10. This graph demonstrates a tendency for the Post-Mortem Team to record greater maximum depths than the QA/QC Team.

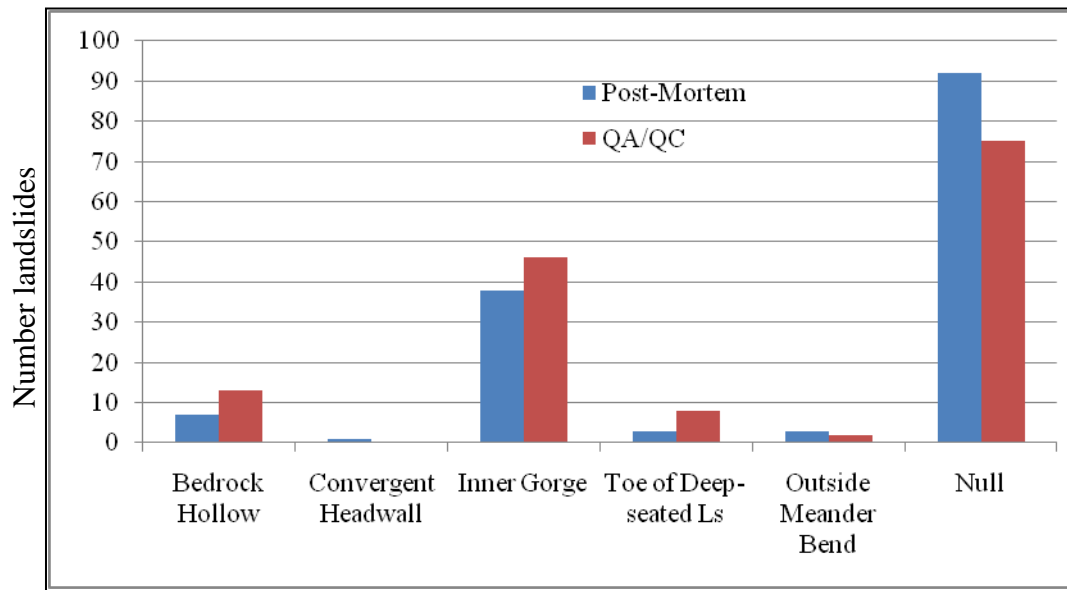
Rule-Identified Landform

Figure 11. Graph shows the determinations of the presence of rule-identified landforms located at the initiation point for the 144 landslides reviewed by the QA/QC process.

Figure 11 and Table 1 show how the QA/QC determinations varied from the Post-Mortem Team observations for each landform noted at each of the 144 landslide compared during the QA/QC process.

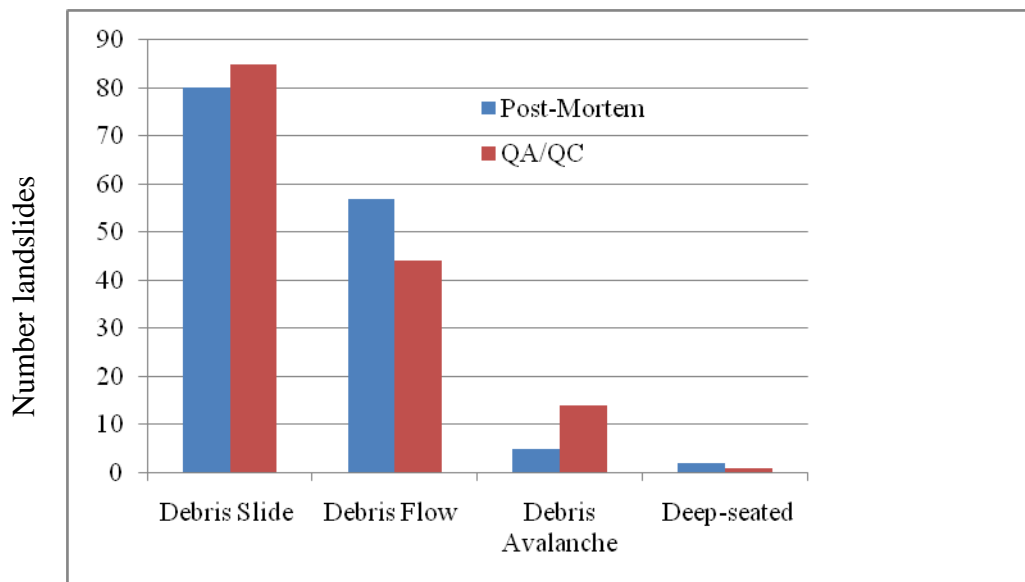
Figure 12. Graph shows the landslide process for each of the 144 landslides reviewed during QA/QC process.

Classifying landslides as one landslide processes (debris slide, debris flow, debris avalanche, deep-seated landslide, dam break floods, or other) is problematic as one type often grades into another. The QA/QC Team agreed with the Post-Mortem Team's determination 89% of the time. The QA/QC Team could not find a rational explanation for 16 of the Post-Mortem Team's determinations out of 144 landslides.

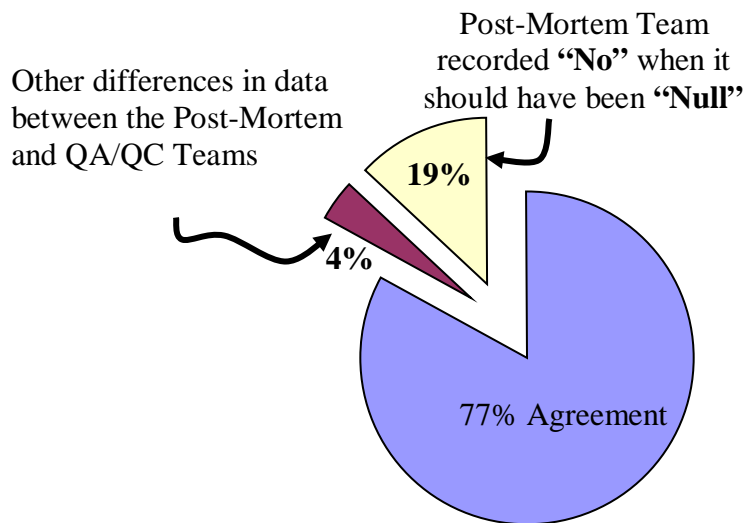
Figure 13. The major differences between the Post-Mortem and QA/QC Teams related to the question of whether the answer should have been "No" or "Null.”

Of the 110 landslides checked, the Post-Mortem Team answered “No” 18 times and “Yes” 5 times when the correct answer was “Null” (“No” indicates a buffer should have been left and was not, “Null” indicates the unit hadn't been harvested).

After the field season the QA/QC Team had to correct their initial field determination by checking the age of the stand adjacent to the landslide. The chart below (Figure 13) illustrates this confusion between “No” and “Null.” Without this No/Null issue, agreement between the Post-Mortem and QA/QC Teams would have been 96%.

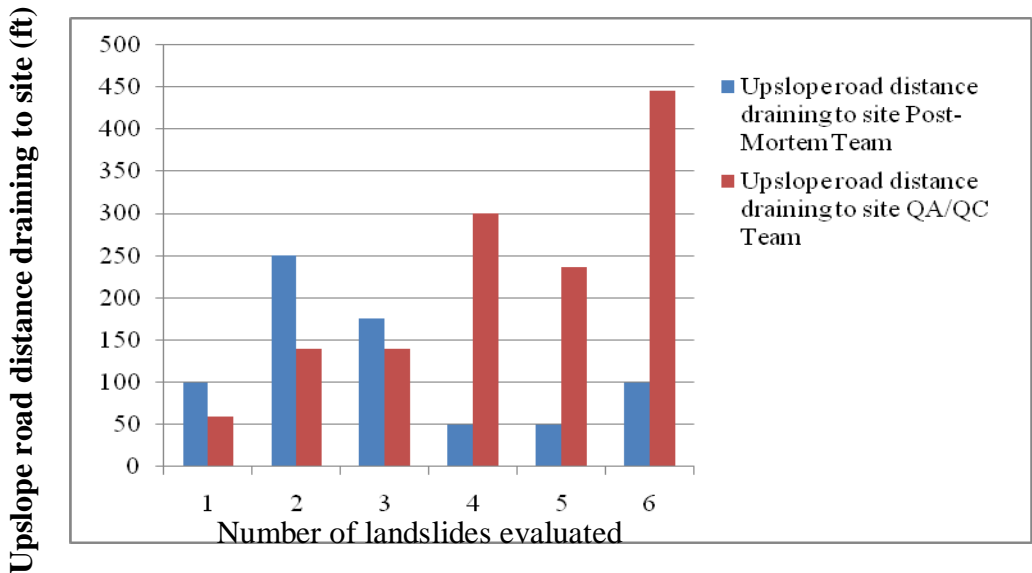
Figure 14. Graph showing comparison of the upslope road distance that drained to the site of the landslide being evaluated. This agreement was generally poor and no explanation was discovered for this discrepancy.

The agreement between the Post-Mortem Team and the QA/QC Team was generally poor when evaluating upslope road distance draining to the site and no explanation was ever discovered for this discrepancy.
