# **STREAM CHANNEL CONDITIONS ASSESSMENT**

**A Methodology to Evaluate Channel Damage  
Related to Increased Peak Flow**

**Weyerhaeuser Environmental Forestry Division  
Technology Center, WTC-1A5  
Tacoma, WA 98477**

**Jones & Stokes Associates  
2820 Northup Way, Suite 100  
Bellevue, WA 98004  
(206) 822-1077**

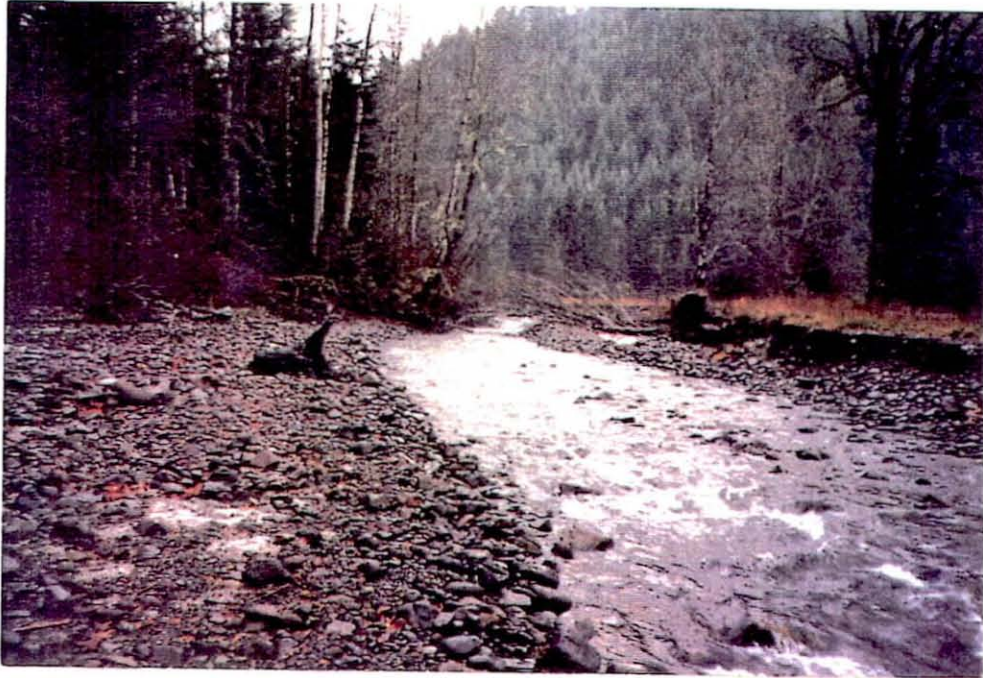
Kiona Creek is a relatively low gradient channel with an associated valley bottom that is more than twice as wide as the active channel. It is classified as Response Type A (unconstrained). The stream can cut into its banks and migrate laterally across the valley floor. While widening is the typical response of a Type A channel to increased peak flows, downcutting could also occur.

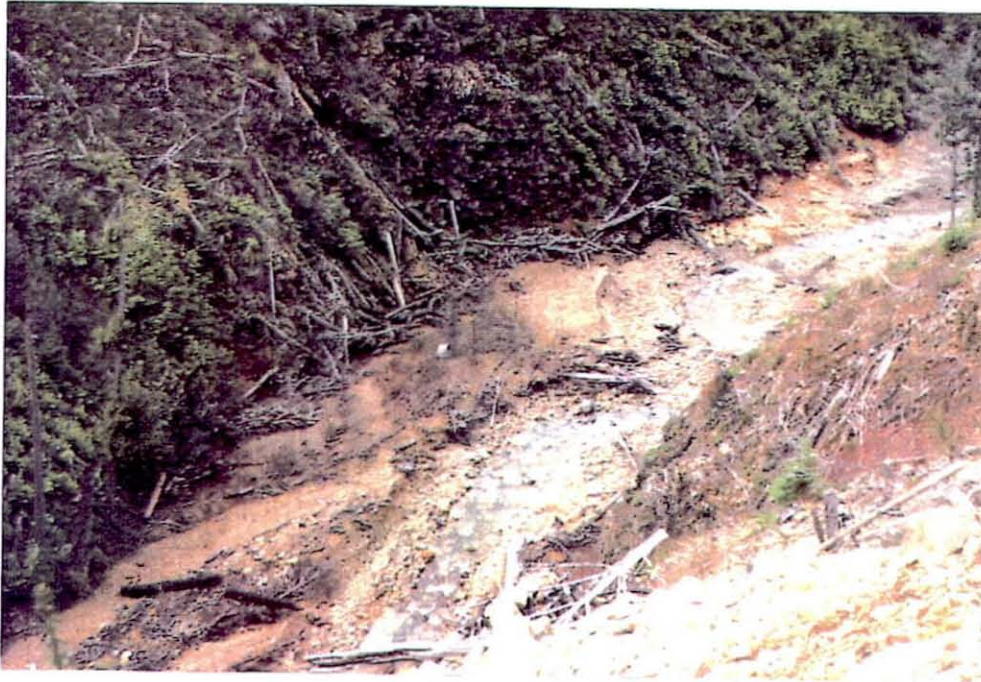
In this Response Type B (slightly constrained, unconsolidated bottom) segment, Milky Creek flows through a relatively narrow valley bottom, between 1.3 and 2 times as wide as the active channel. While the stream has room to meander or migrate laterally, the degree of movement is limited by the valley walls. The stream may widen or downcut in response to increased peak flows. Channel widening could undermine the upper banks and result in accelerated mass wasting.

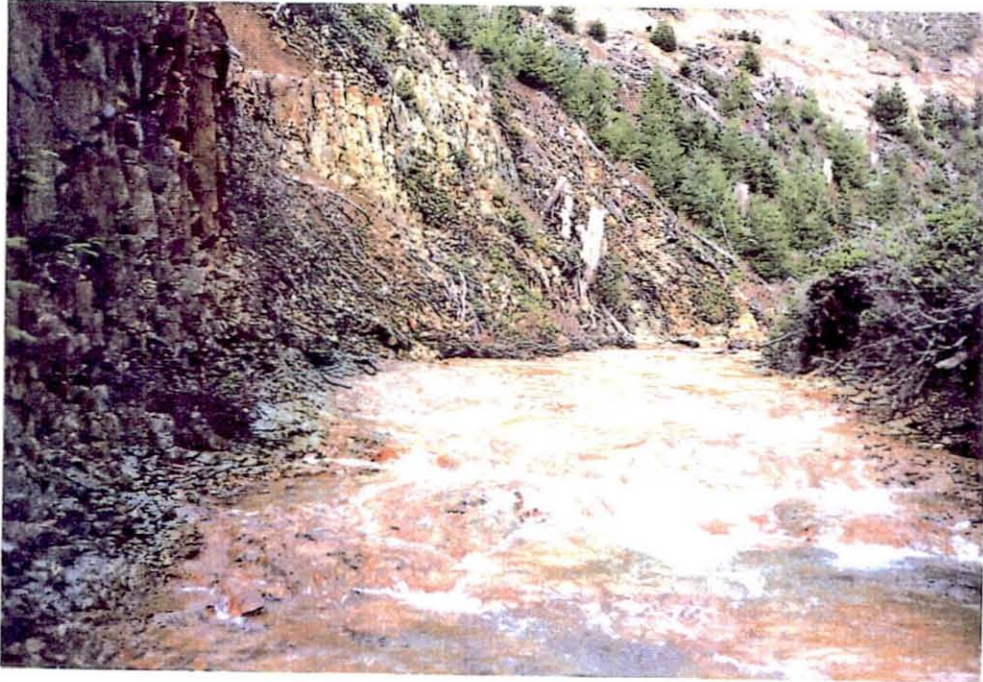
This Response Type D (constrained bedrock/large boulder bottom and banks) channel cannot enlarge through downcutting because the bed consists of resistant bedrock. Such channels are usually tightly confined by the valley walls. In response to increased peak flows, the channel may widen slightly where the banks are erodible. If the banks are mostly resistant bedrock, it may be difficult to detect a response to increased peak flows in Type D channels; the effects will be more apparent in downstream reaches.

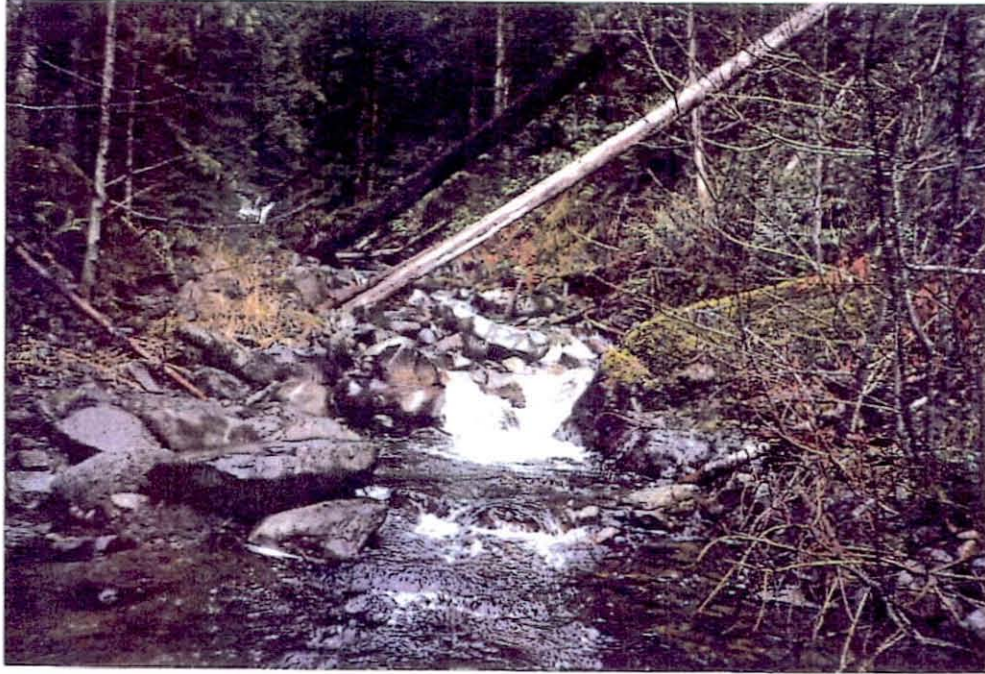
East Fork Silver Creek is a Response Type E (boulder/bedrock stairstep) channel: stream gradient is greater than 6% and boulders create a stairstep profile. The channel may widen slightly where banks are erodible, but in-channel impacts of increased peak flows are more likely to occur in lower gradient reaches.

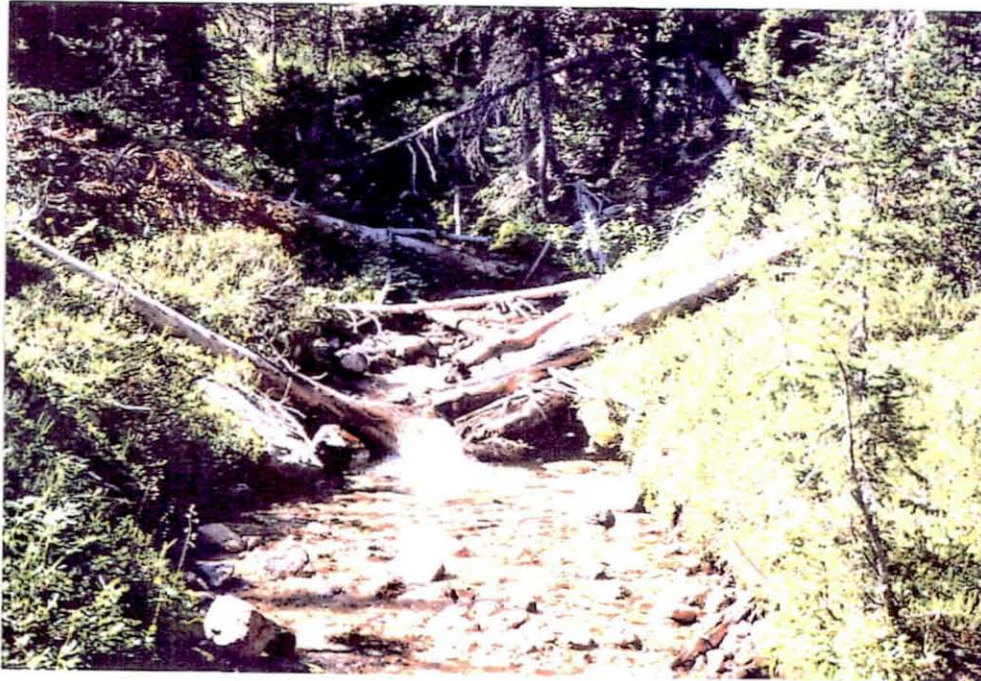
Response Type F (woody debris stairstep) channels are similar to Type E except that the steps are formed primarily by woody debris. The expected response to increased peak flows is also similar, unless the debris forming the steps is unstable. A peak flow event could trigger failure of the steps and result in large volumes of debris being transported downstream to lower gradient reaches.

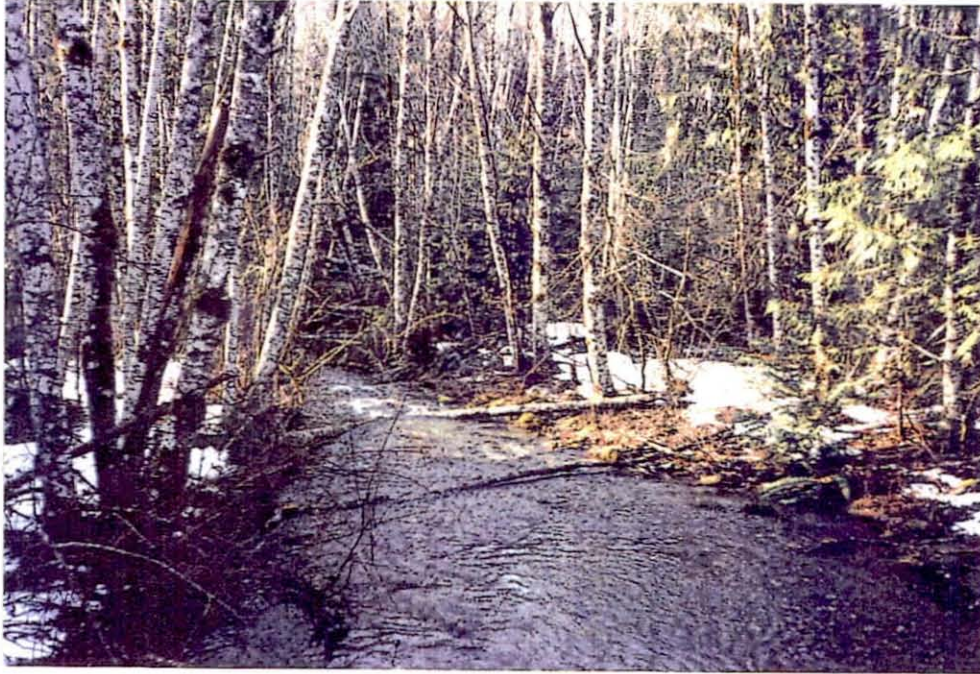
In this Response Type B channel (shown at a fairly high flow), the active channel is adequate to carry the average annual flood. Larger flood events overtop the lower banks and spread across the floodplain where energy is dissipated by the dense forest (channel capacity rating = a). Other notable features of the banks include protection by a deep, dense root network, which can be inferred from the dense, mature alder lining the banks. There is little flow deflection into the banks and no bank cutting occurs in this reach.

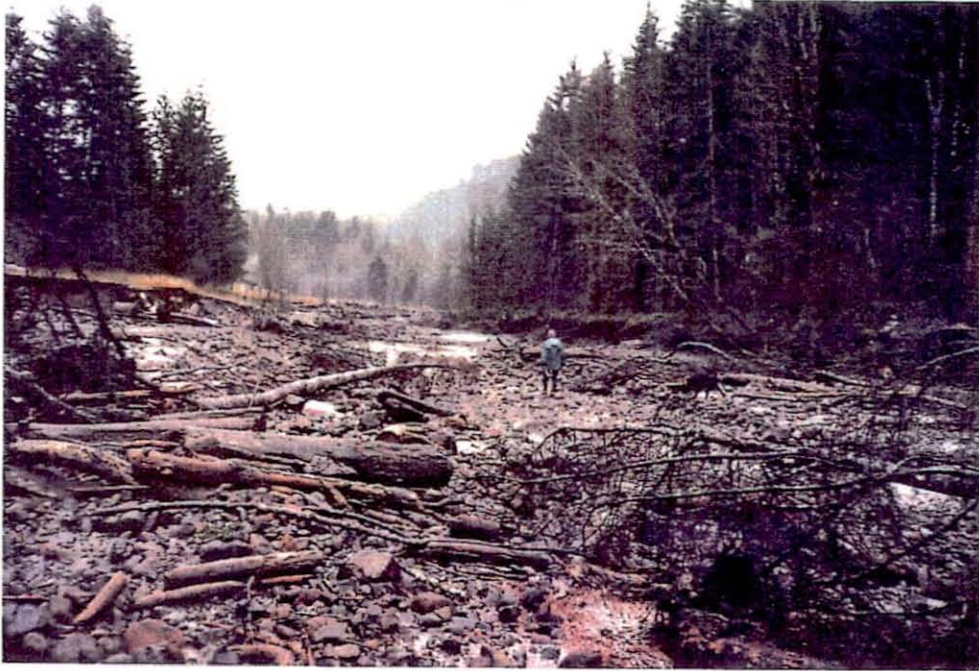
Channel capacity of this Response Type A channel has been enlarged primarily by widening. Peak flows would rarely overtop the banks and spread onto the floodplain (channel capacity rating= b).

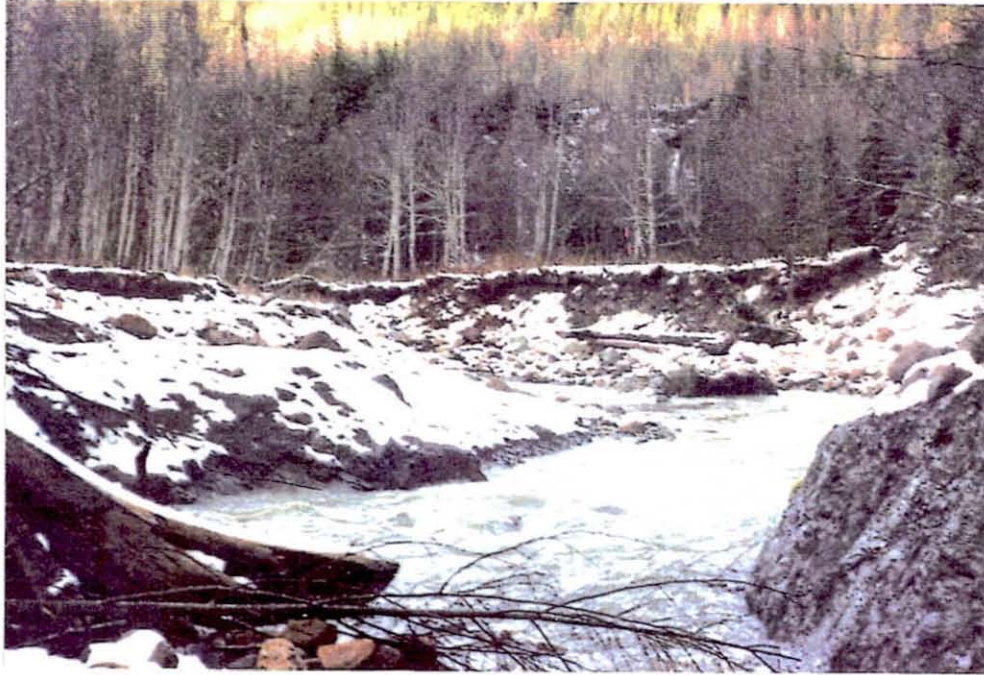
This Response Type B channel has downcut and enlarged to the extent that peak flows will never reach the old floodplain. An inner terrace is developing within the recently enlarged active channel area (channel capacity rating = c).

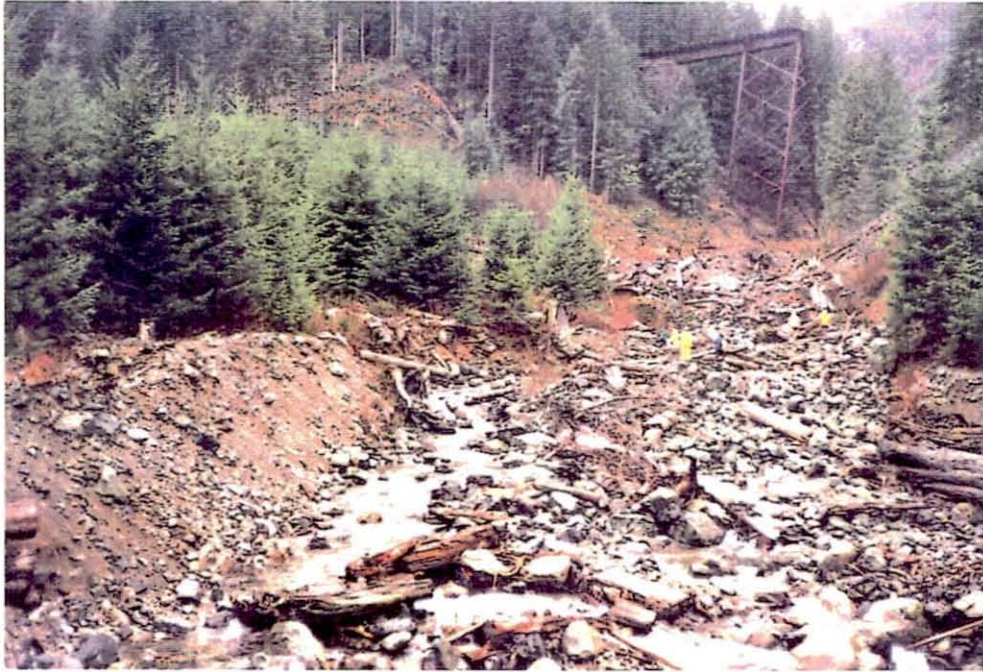
A debris flow or flood event has caused obvious damage in this channel. The channel has both widened and downcut, resulting in a greatly enlarged cross-sectional area (channel capacity rating = c and d).

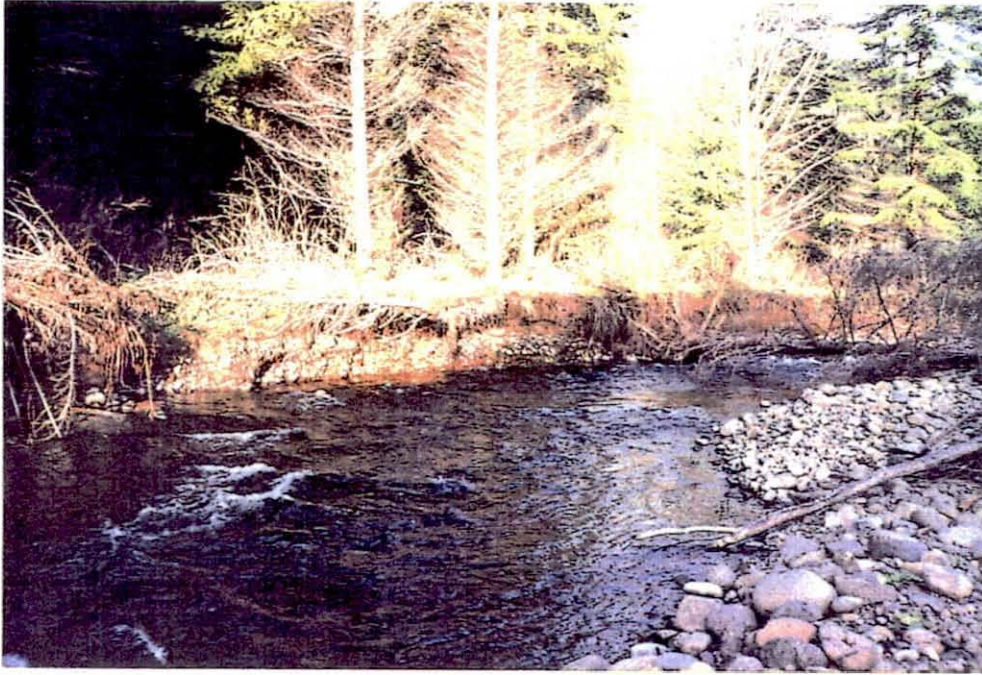
On this reach of the East Fork Grays River, bank cutting occurs in expected places, such as on the outside of this bend. Exposed banks are vertical or slightly overhanging. Predominant bank vegetation is immature conifers (20-60 feet high) which have deep roots interspersed with several open areas. Bank rock content is 40-65% and banks consist of a noncohesive assortment of mostly gravel to cobble-sized rocks. While these conditions do not indicate existing damage from increased peak flows, there is a moderate potential for damage if peak flows are increased in the future. Bank cohesion may be insufficient to withstand increased erosive energy.

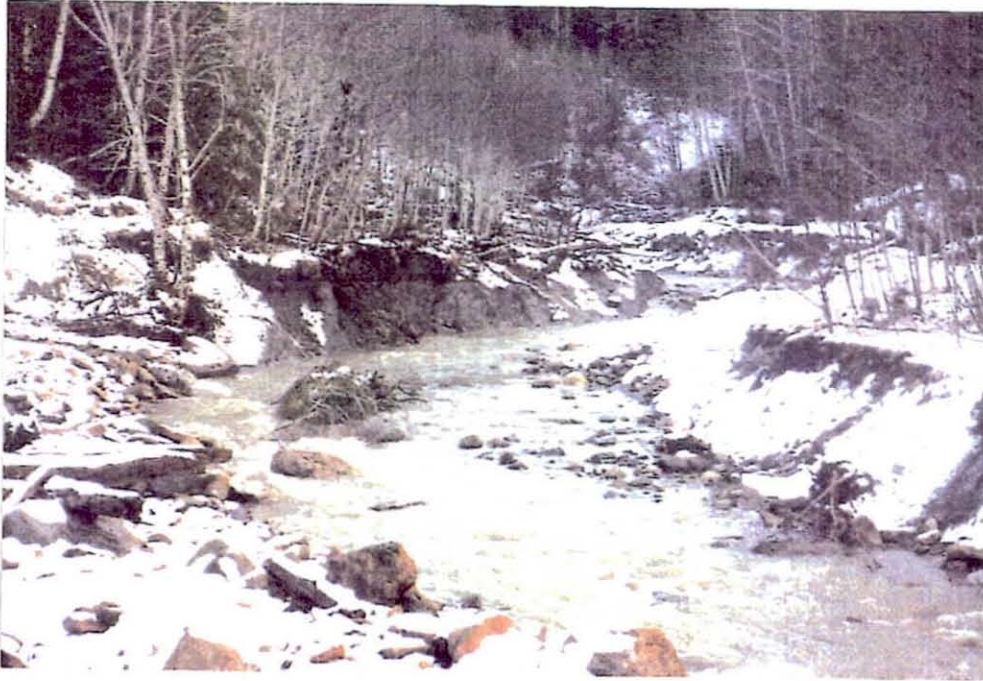
Bank cutting in upper Deer Creek occurs on the inside as well as the outside of bends. Exposed banks are mostly angled back, indicating less internal cohesion than a vertical bank. Bank vegetation is predominantly immature hardwoods which have a shallow root network and numerous openings along the bank. Bank rock content was rated as 20-40% overall. Bank materials include both a cemented matrix of fine material containing rock particles, and cohesive but erodible silt/clay. The condition of the channel banks indicate that significant channel damage has occurred.

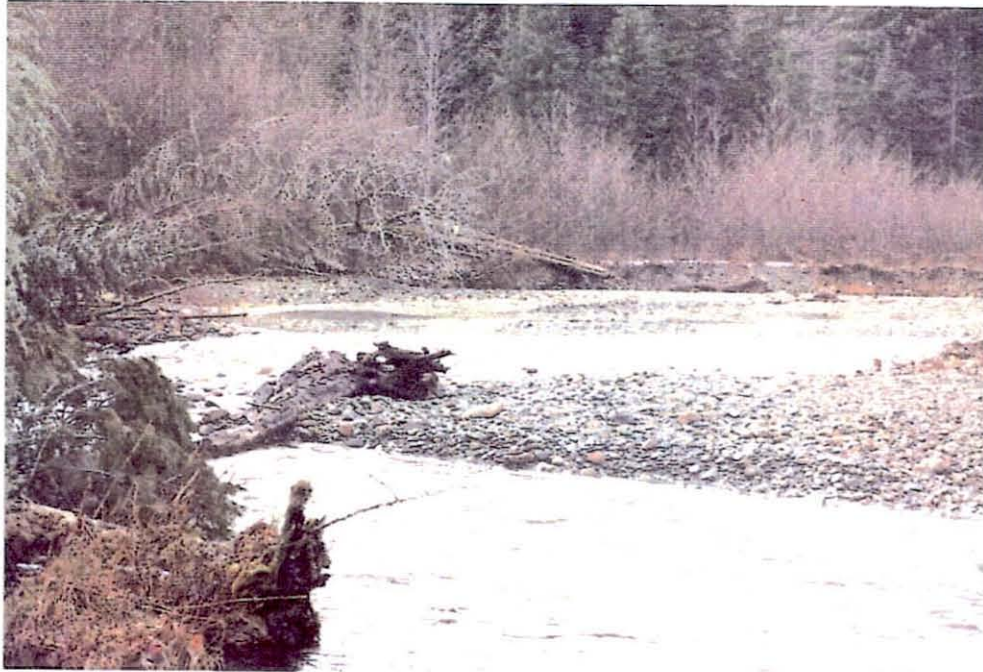
In this segment of Finney Creek, 20-50% of the bottom is covered with fresh deposits, including these point bars. The deposited material is mostly gravel to cobble-size. The extent and size of deposited material does not indicate that there has been significant damage related to increased peak flow.

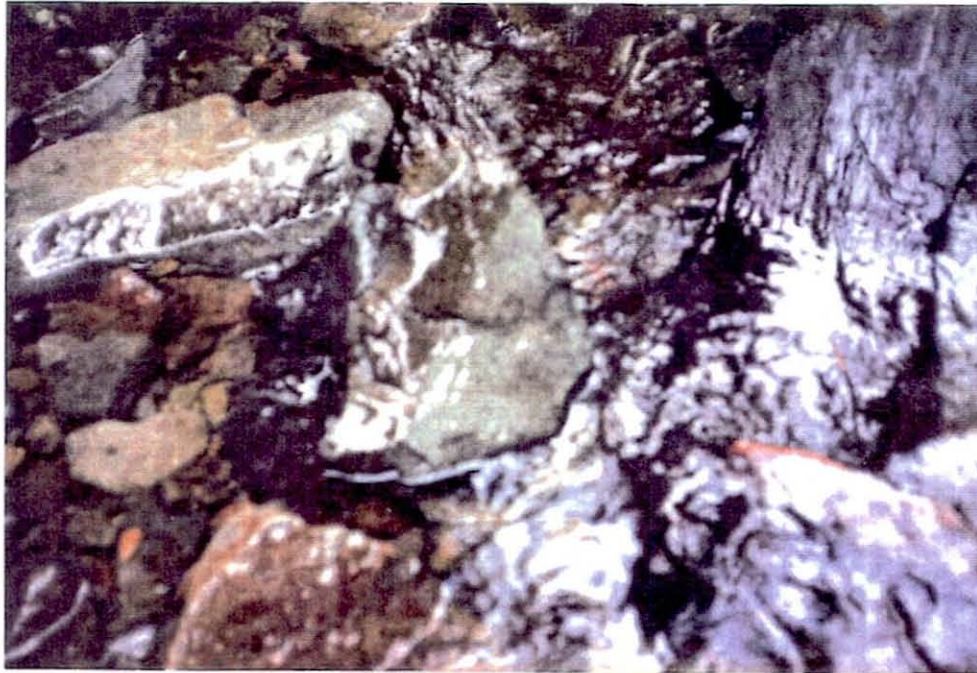
This upturned rock displays algal staining, evidence that the channel bottom is rarely mobile.

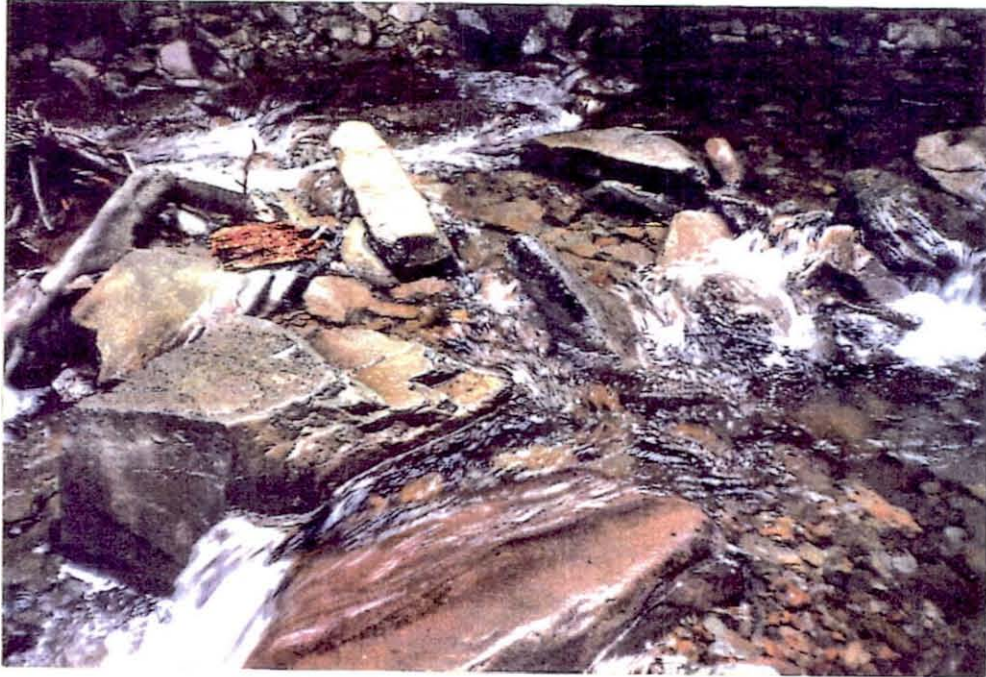
These angular rocks are resistant to rolling; larger particles are surrounded by smaller particles, creating a tightly packed matrix that is resistant to scour.

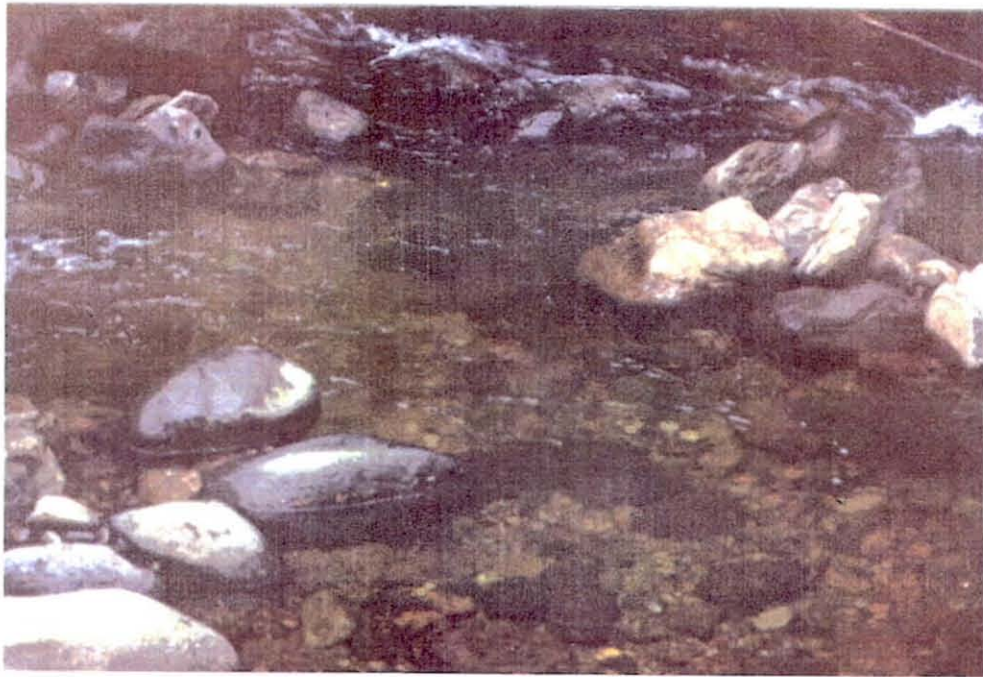
The bottom of Camp Creek consists mostly of subangular rocks. The larger rocks can be moved with little resistance, but they are surrounded by a tightly packed matrix of smaller particles.

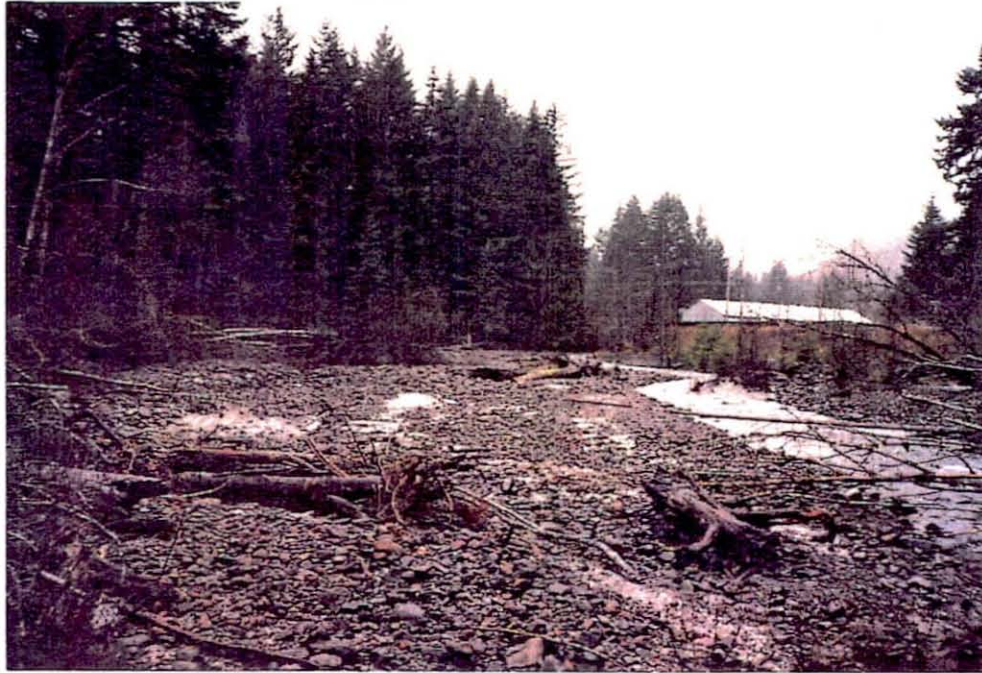
Woody debris in this widened channel has been moved to the outer margin of the active channel area during a high flow event. The wetted channel area now consists of a long, shallow riffle with little cover or holding habitat for fish.

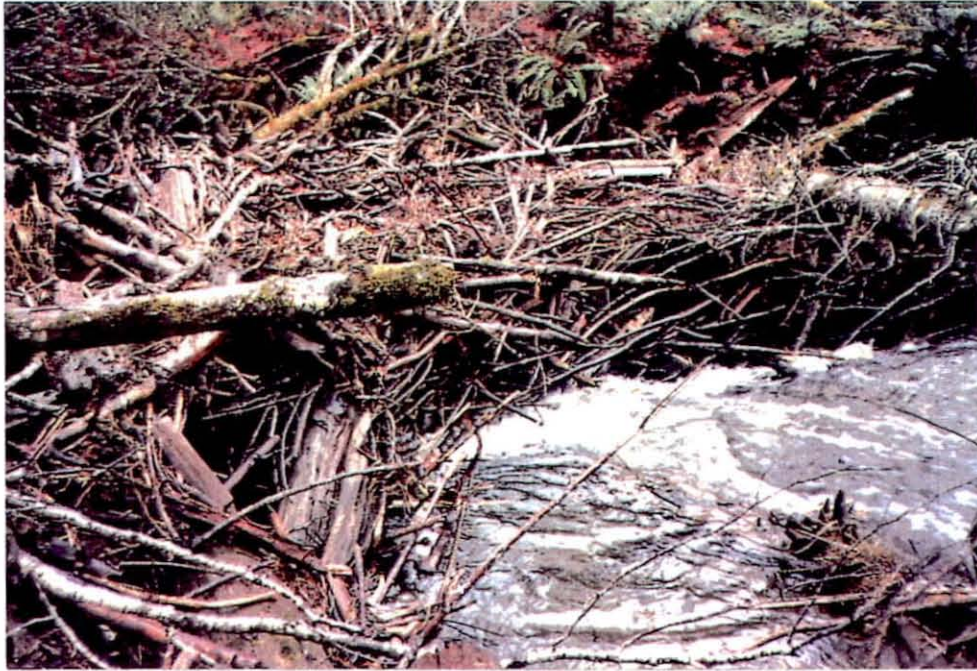
A debris jam blocking the channel can become a temporary dam during a high flow. This jam consists mostly of small material that is not embedded or tightly packed. When pressure builds behind the dam during high flow, it is likely to fail.

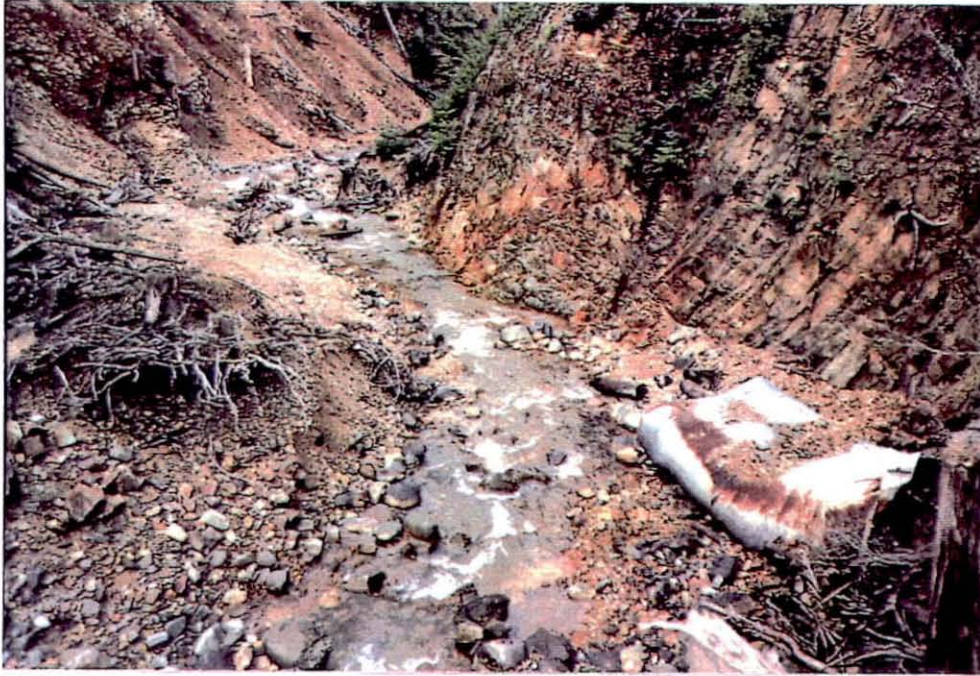
This culvert in Milky Creek was obviously inadequate to handle the water, sediment, and debris load transported down the channel.
